# HIGH RESOLUTION X-RAY MICRO-CT OF ULTRA-THIN WALL SPACE COMPONENTS

**ABSTRACT.** A high resolution micro-CT system has been assembled and is being used to provide optimal characterization for ultra-thin wall space components. The Glenn Research Center NDE Sciences Team, using this CT system, has assumed the role of inspection vendor for the Advanced Stirling Converter (ASC) project at NASA. This article will discuss many aspects of the development of the CT scanning for this type of component, including CT system overview; inspection requirements; process development, software utilized and developed to visualize, process, and analyze results; calibration sample development; results on actual samples; correlation with optical/SEM characterization; CT modeling; and development of automatic flaw recognition software.

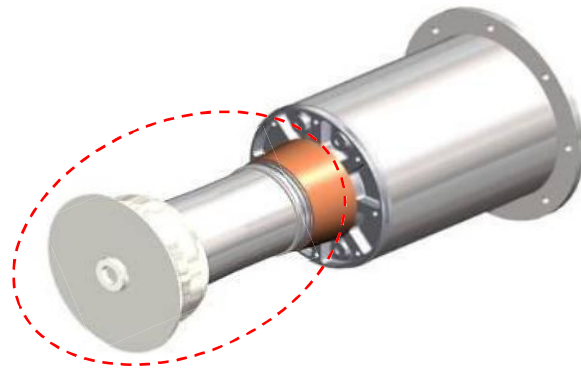
**FIGURE 1.** Heater head component (within ellipsed area) in Advanced Stirling Converter.

Although increasing both the temperature and pressure of the working fluid will place an increased burden on all components of the converter, the thin wall complex-shaped heater head (essentially a pressure vessel containing the working gas helium) will be the most severely tested (see figure 1). To withstand the temperatures and stresses imposed on this structure, the heater head for the ASRG is fabricated from a high-strength cast superalloy 247LC. The head has a very thin-walled section of proprietary dimension, and also contains a tapered region in which the wall gradually doubles in thickness. Being a cast alloy, it is likely that at least some regions of the starting material will contain defects such as porosity or deleterious phases. Many of these types of defects were found in design heads by destructive methods to be below the limit of detectability of conventional NDI (non destructive inspection) techniques that were previously available. To address this, NASA GRC assembled a state-of-the-art x-ray micro-computed tomography ( $\mu$ CT) system for

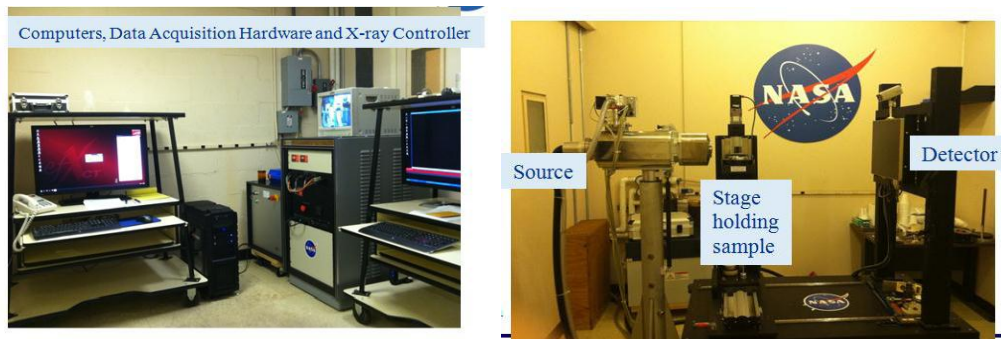
**FIGURE 2.** NASA Glenn Research Center X-ray CT system.

The Microfocus X-ray Computed Tomography ( $\mu$ CT) facility is a non-destructive imaging technique designed to inspect complex-shaped parts for micron scale flaws. Multiple x-ray projection images are acquired, followed by software reconstruction techniques using the projection images to obtain cross-sectional slices of the part. The cross-sectional images can be viewed individually or used to render a volume. The source is an X-ray WorX XWT-225-THE microfocus X-ray 225 keV transmission tube (< 5  $\mu$ m spot size, 25W power) that produces a cone beam. The detector is a Dexela 2923 Detector (0.0748 mm pitch, 29 x 23 cm area, and 3888 x 3072 pixel elements). The acquisition, reconstruction, and visualization software is from NSI, Inc and 3M/Hytek, Inc. 4-axis motion control allows automated positioning and scanning. The system, shown in figure 2, has resolution capability > 30 line pair/mm.

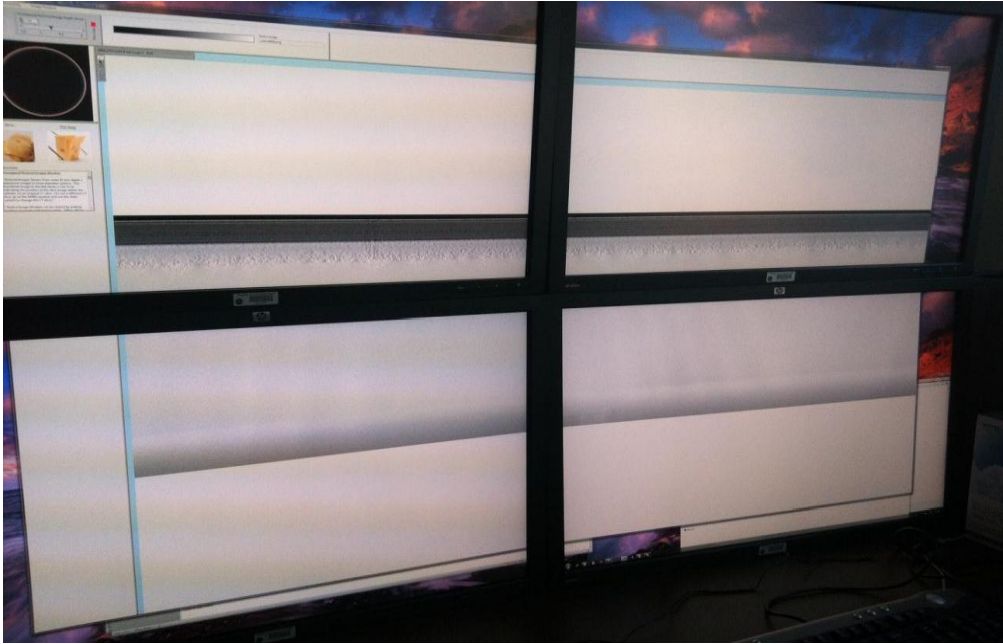
**FIGURE 3.** Four x 30" monitor visualization setup showing unwrapped reslices spanning the four monitors.

An additional improvement to the system included the development of a reasonable-cost high resolution display system to evaluate  $\mu$ CT results. Because the detector has  $\sim 12$ M elements, resulting slice images can be on the order of 4000 x 3000 pixels. "Unwrapped" images (to be discussed below) can be on the order of 11000 x 3000 pixels. This presents a significant difficulty for viewing images on a single 30" LCD panel display that would normally be considered high resolution (2560 x 1600 pixels). The large images are effectively downsampled automatically in order to view on such monitors, resulting in potential lost data, which was undesirable for this project. Because of this, NASA assembled a 4 x 30" display panel setup with dual video cards in an HP z800 workstation with 192 gbyte RAM resulting in 5120 x 3200 display resolution. The display is shown in figure 3. Even this is not fully adequate to view full resolution unwrapped images, but it helps greatly in image evaluation, and a display of eight large-size monitors required for no downsampling is likely impractical for any inspector to use for analysis.

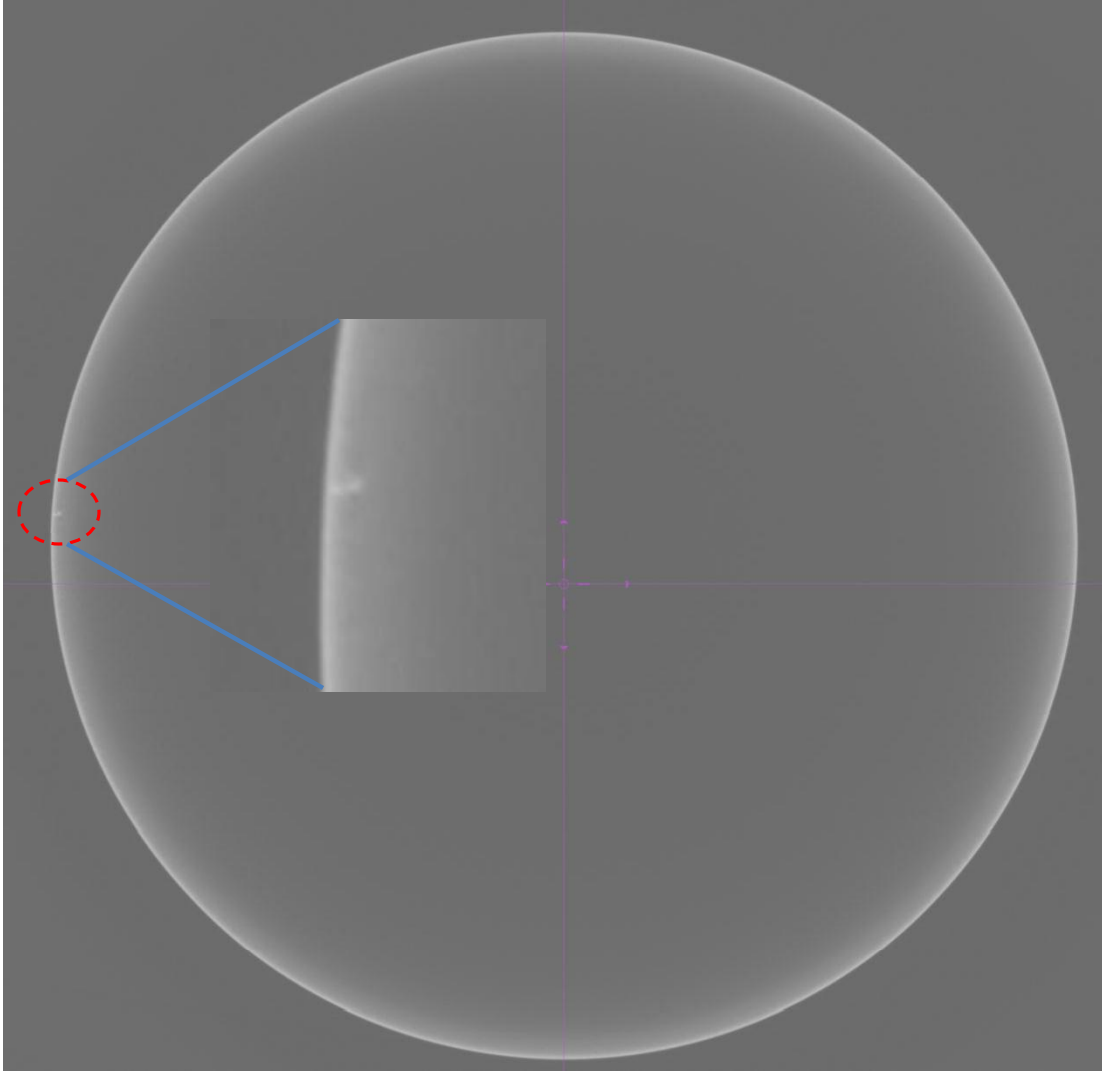
**FIGURE 4.** Top view CT slice of heater head showing the thin, ill-defined inner wall, and exploded view of an actual flaw found. This image illustrates the difficulty of inspecting top view CT slices for flaws.

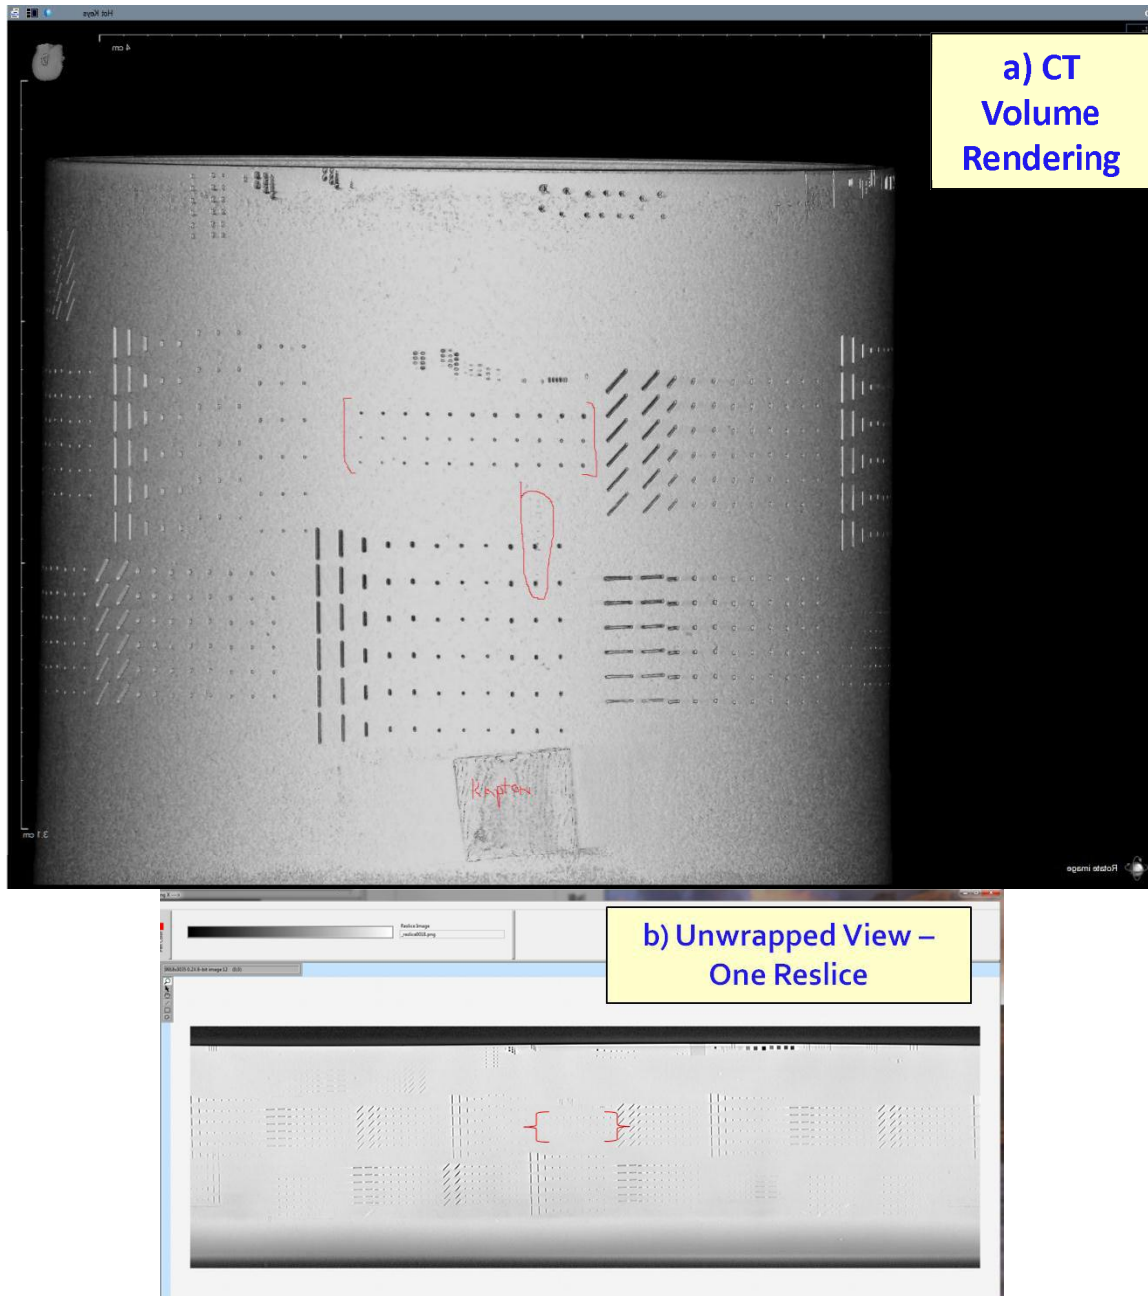
**FIGURE 5.** a) CT volume rendering and b) one unwrapped reslice for heater head sample with machined-in flaws. Brackets surround one flaw pattern that most closely conformed to specification.

Prior to knowing the critical-size/depth flaw specification discussed above, an excess heater head sample with a non-optimized surface finish had hole and slit flaw patterns laser-machined into it. The specification was for holes ranging in diameter from 10 – 70  $\mu$ m and ranging in depth from 50 – full wall penetration. The slits were to range in depth from 10 – 30  $\mu$ m, in width from 10 – 40  $\mu$ m, and in length from 40 - 200  $\mu$ m. The machined flaws did not conform to specifications, and were difficult to characterize due to the taper character and debris in the slits and holes characteristic of laser machining. Additional flaws that were machined into the excess heater head were even further out-of-conformance. However, figure 5 shows a volume rendering and one unwrapped reslice of the head with the many flaw patterns. The red-bracketed area in the volume rendering and reslice of figure 5 shows the CT representation of a hole pattern in the thin wall region that came closest to specification. All holes were easily found in the red-bracketed region at 70 kV and 200  $\mu$ A settings. Attempts to create a valid heater head detectability standard based on the critical flaw depth are in process using the micro-electrical discharge method (EDM). The slits are to range in depth from 80 – 120  $\mu$ m, in width from 20 – 70  $\mu$ m, and length from 20  $\mu$ m - 1200  $\mu$ m. The holes are to range in depth from 80 – full wall penetration and in diameter from 20 – 120  $\mu$ m.

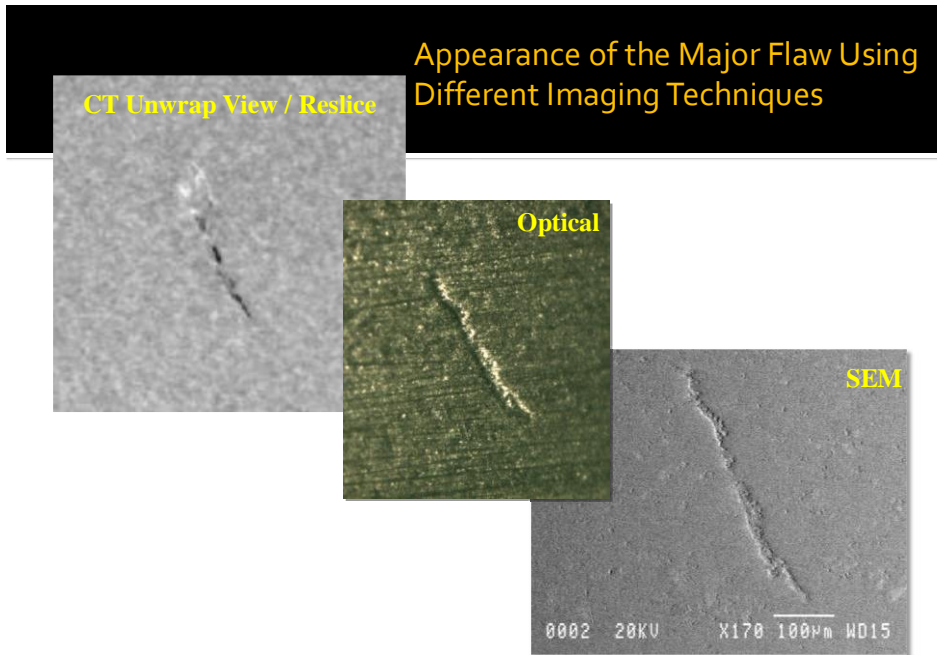
**FIGURE 6.** Correlation between CT, Optical, and SEM results.

Excellent correlation between lateral flaw indications found on the CT unwrap reslices and optical and scanning electron microscope (SEM) results have been found with an example shown in figure 6.

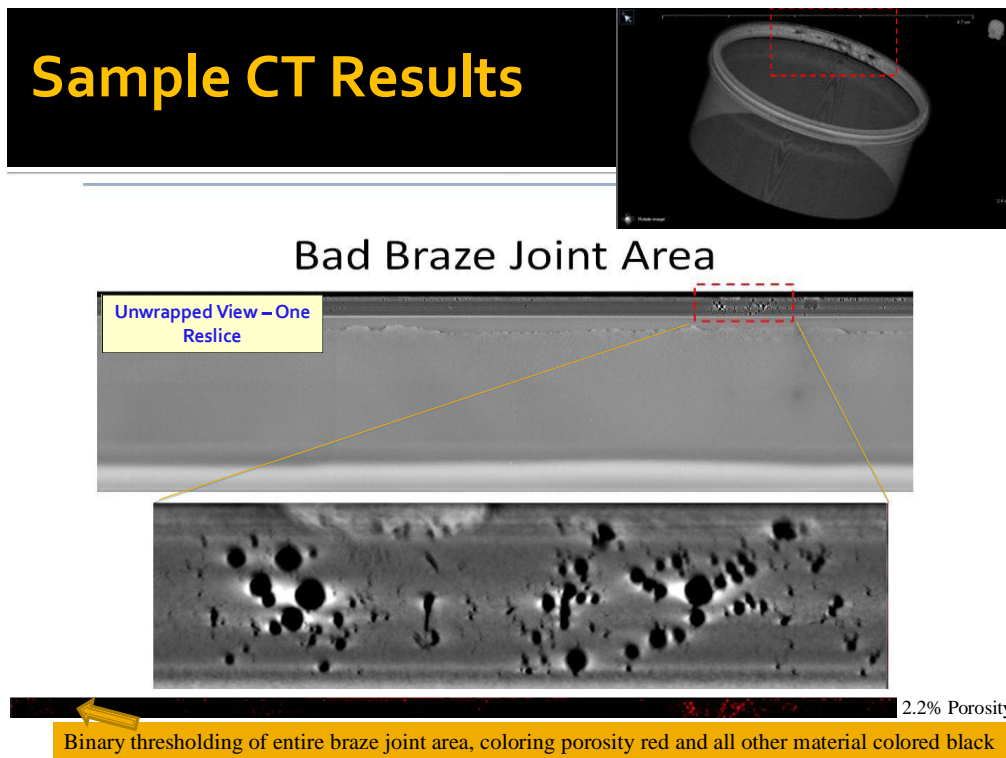
**FIGURE 7.** CT volume rendering, unwrapped reslices view, and magnified view of braze joint porosity. Braze joint region of image is binarized using threshold method and areal fraction of porosity automatically calculated in CT-CURS. The % porosity in the entire braze joint is 2.2%.

The porosity fraction of the braze joint was evaluated per [3] again using the unwrapped reslice where the pores became most focused. The braze joint is about 0.2 mm thick and the CT does an excellent job of characterizing pore fraction, size, and location as shown in figure 7. The CT-CURS software has a binary threshold image processing operation to binarize the images, followed by an automated areal fraction quantitative image analysis to calculate porosity fraction. In the example shown in figure 7, even though there is significant porosity in one area of the braze joint, the % porosity in the entire braze joint is only 2.2%.

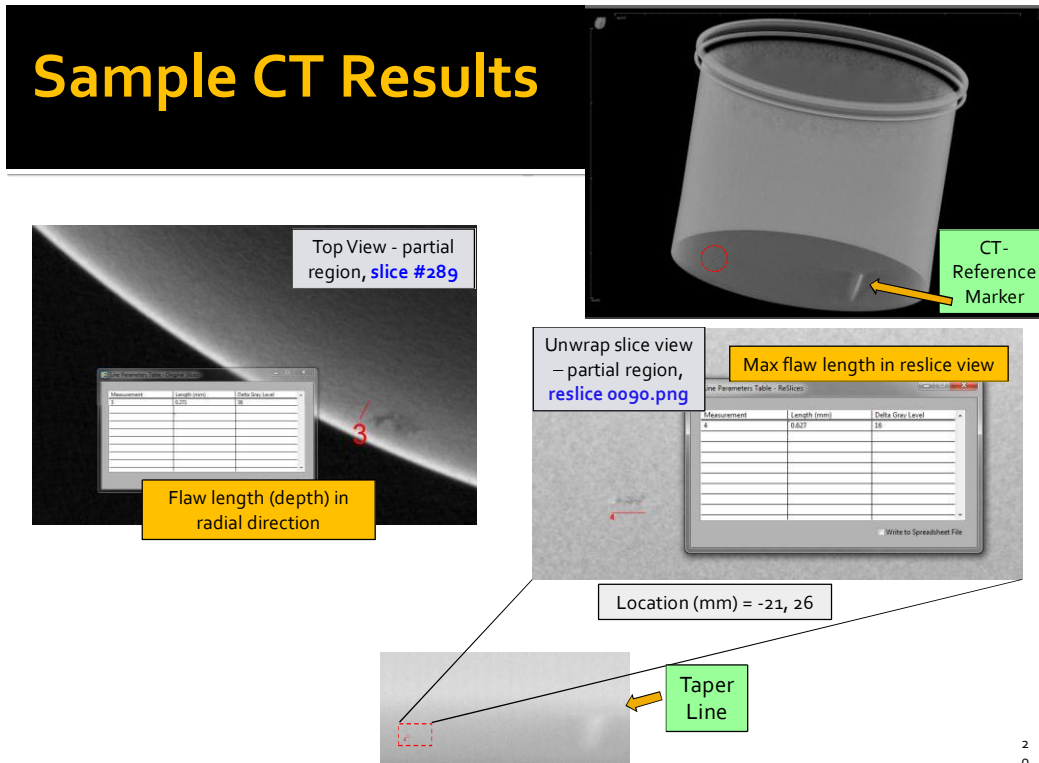
**FIGURE 8.** CT results on actual heater head sample including top and reslice views, volume rendering, and quantitative information on lateral size, depth, and location.

Figure 8 shows results from one of the flight heater head inspections. Documentation required includes top and reslice views, volume rendering, and quantitative information on lateral size, depth, and location.

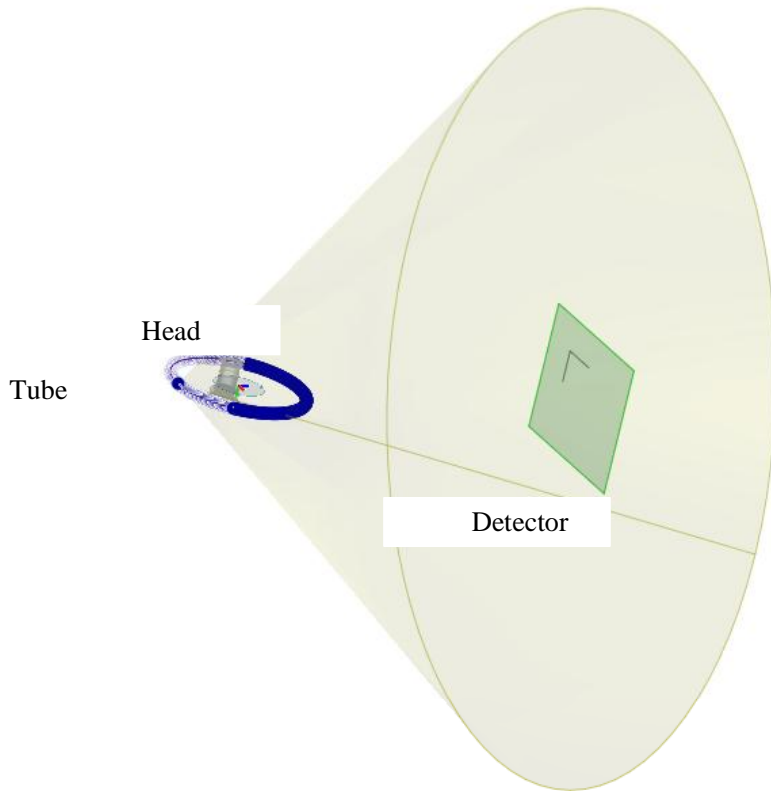
**FIGURE 9.** Simulation for heater head inspection showing the solid model of the heater head located in between the x-ray tube source and the detector.

NASA GRC is pursuing CT inspection modeling using CIVA v10.1 to determine the expected detection capability for the experimental setup in this inspection prior to having a valid detectability standard available for CT scanning. Modeling will be done for both the thin wall and taper regions. The flaw patterns for the new detectability standard will be incorporated into the model. Valid modeling will require accurate descriptions of specimen, source, detector, inspection setup, and flaws. Once the detectability standard is obtained and CT-scanned, results between modeling and experiment can be compared in order to validate the model. Figure 9 shows a screenshot of the setup for modeling of the head.

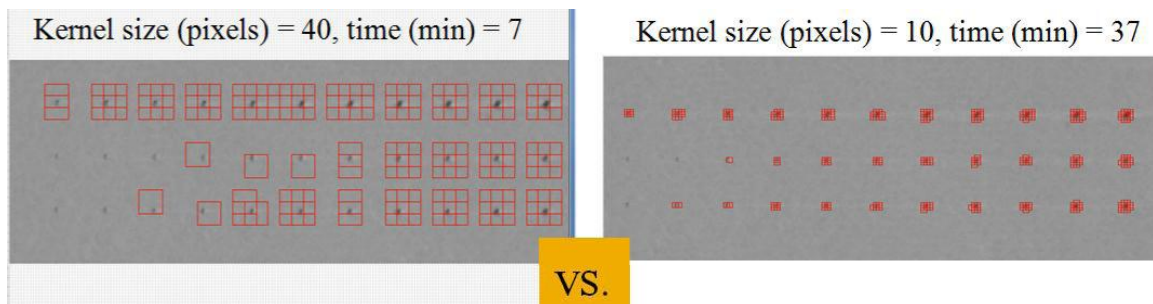
**FIGURE 10.** Some results for automatic flaw detection experiments using unsupervised neural network approach. Red squares show flaws detected for machined flaw pattern demarcated in figure 5.

Since inspection is time-consuming and difficult as previously explained, an automated method for flaw detection would be highly desirable. NASA worked with Neural ID to create a software program using supervised and unsupervised neural network methods [6] for automated flaw detection. These methods showed some promise in automated flaw detection basically training on the gray scale characteristics/statistics of small regions (kernels) of the reslice images. This approach can also be considered for flaw detection in the top view slices. However, the images are so large that the automated approach is too computationally intensive and currently not rapid enough to implement as an aid to the inspector. An ~ 1000x improvement in speed would be required to apply to CT image sets. NASA continues working with Neural ID, Inc. and National Instruments on strategies for speed improvements including possibly dedicated hardware.
