Contamination Control Assessment of the World's Largest Space Environment Simulation Chamber

NASA/TM—2012-217823

Prepared for the
27th Space Simulation Conference
cosponsored by the IEST, NASA, CSA, AIAA, ASTM, and JHU/APL
Annapolis, Maryland, November 5–8, 2012

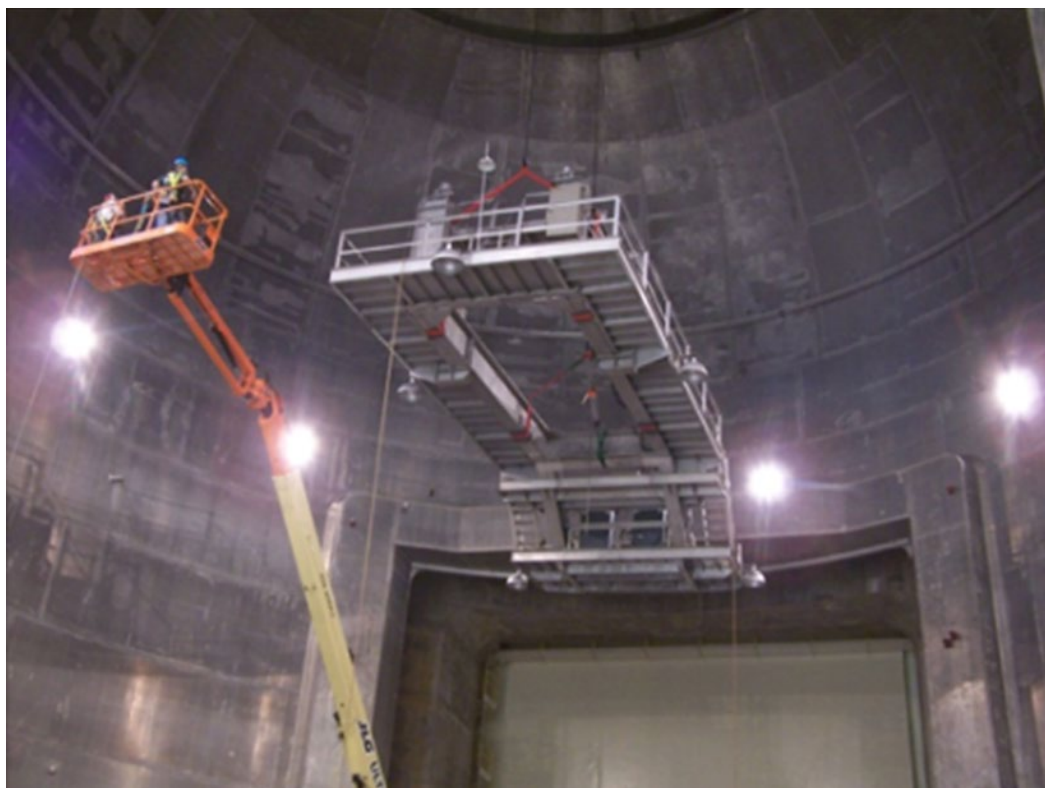
Figure 3.—Lowering of the polar crane bridge.

It is important to review the main reasons crane modifications were useful and needed. First, the crane had been neglected over the years and exhibited visibly evident sources of contaminants such as leaked greases and oils deposited on surfaces, leaking seals, degradation of adhesives, and disintegration of electrical resistor banks. This condition was not acceptable for customers having sensitive hardware. Second, the crane needed to be lowered to repair critical cracks in its structure. Third, due to its essential utility, reinstallation will be necessary after each crane removal, and reinstallation is a complicated procedure accompanied with risks. Fourth, crane utilization followed by its removal imminent to testing is not a viable option due to the difficulty and risks associated with lowering the crane with a test article and cryoshroud in the chamber. The picture presented in Figure 3 shows the polar crane bridge as it was being lowered for repair in 2007. In the case of reinstalling lifting hardware, such as a hoist, the hoist must be load tested before being used again for critical lifts. It would be problematic to load test a hoist if a valuable test article or cryoshroud is present in the chamber. Lowering the crane to make structural repairs presented the opportunity to upgrade the crane in additional areas. In addition to the contamination control upgrades, upgrades were made to the electrical controls, gears, motors, and brakes to improve safety and operating performance.

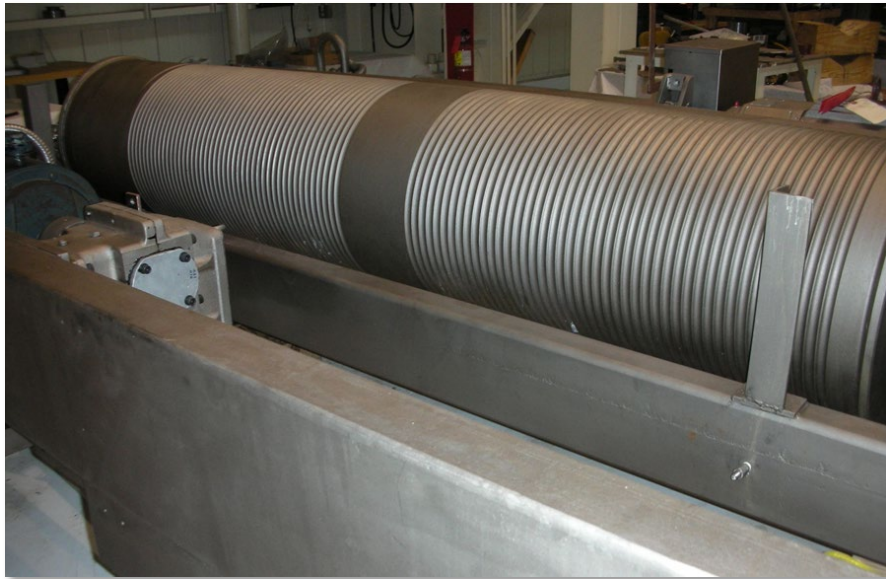
Figure 8.—Main hoist drum and trolley after electroless Ni-plating.

The mechanical hardware changes made were extensive. The largest improvement consisted of electroless nickel plating many components after removing original paint coatings. The pictures presented in Figure 5, Figure 6, and Figure 7 show examples of components before being refurbished. The pictures presented in Figure 8 and Figure 9 show examples of components after being electroless nickel plated.

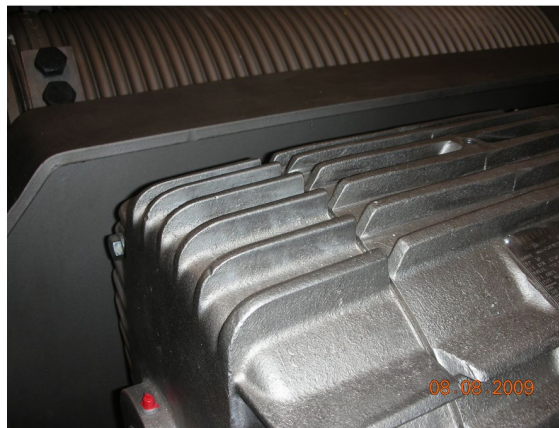
Figure 9.—Main hoist motor casing after electroless Ni-plating.

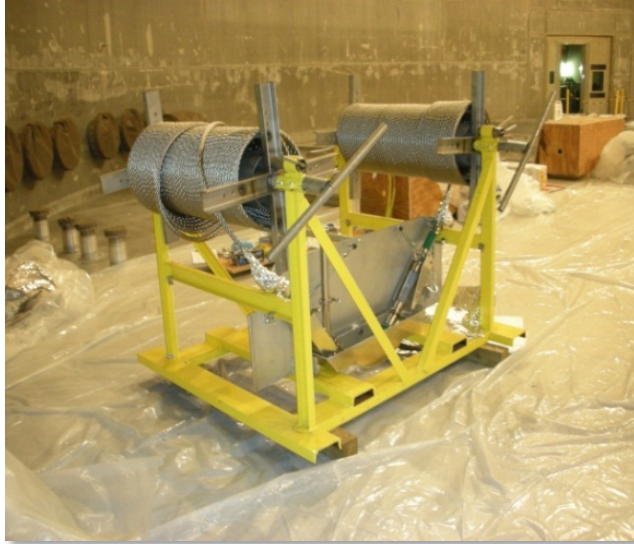
Figure 10.—Arrangement for applying low vapor pressure oil to hoist wire ropes.

Prior to installation, the new stainless steel wire ropes were cleaned and then re-lubricated with a low-outgassing fluorocarbon polymer lubricant. The first step in cleaning the wire ropes was performed by a commercial vendor where they had been shipped to remove the greases and oils applied during fabrication. This cleaning process comprised three cycles. Each cycle consisted of a submersion of a wire rope into a trichloroethylene (TCE) ultrasonic bath followed by raising it into the TCE vapor and spraying using distilled TCE. After this TCE cleaning process, the wire ropes were heated under vacuum at SPF to remove remaining volatile residues. Following these processes, the wire ropes were lubricated with the low-outgassing perfluoropolyether lubricant. The application of this oil used a special framework, which is shown in the picture given in Figure 10. This arrangement allowed the cleaned cable to be uncoiled from one drum, immersed for a controlled amount of time within a circular conduit containing the oil and solvent bath, and then coiled onto another drum where it remained until the bulk of the solvent evaporated. Lubrication of wire ropes is necessary to maintain their safety load margin and to ensure the ropes do not become damaged during use.

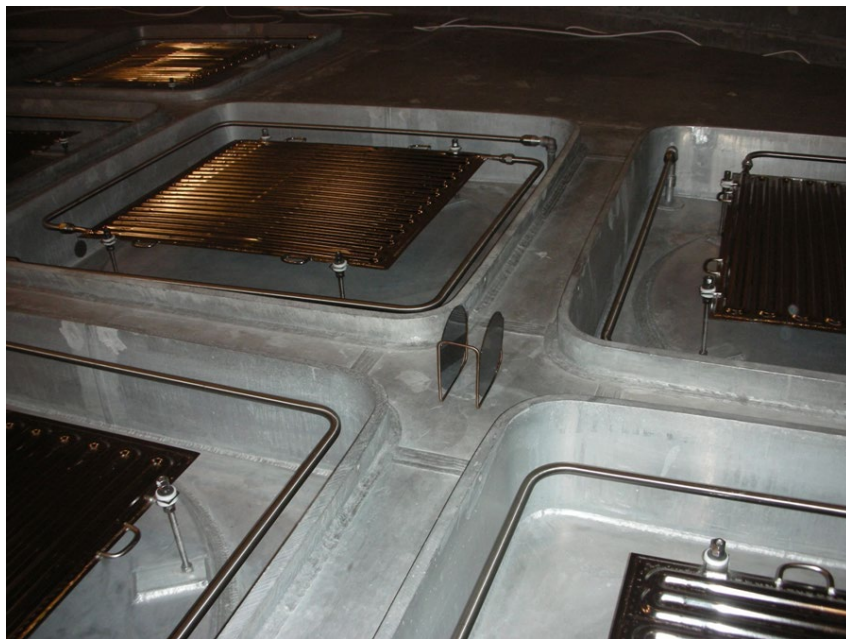
These witness coupons were placed at various locations in the chamber. In the case of IST-2010, the gold coated slides were placed at the central chamber floor, among the scavenger plate wells, on the main-door pockets ledges, and on the polar crane bridge. The aluminum sheets were placed at similar locations as the slides, and also placed adjacent to the chamber walls using hanger rods. The witness coupons were placed in sets, each set consisting of a pair of wafers. A wafer pair was held in a bracket designed for parallel positioning of the pair. The wafer placement location within the chamber was the same for each IST. The first wafer set, Set1, was placed upon the polar crane bridge, the second set, Set2, was placed upon the chamber floor, and the third set, Set3, was placed among a group of scavenger plates, as shown Figure 11.

Figure 11.—Silicon wafers mounted among scavenger plate wells.

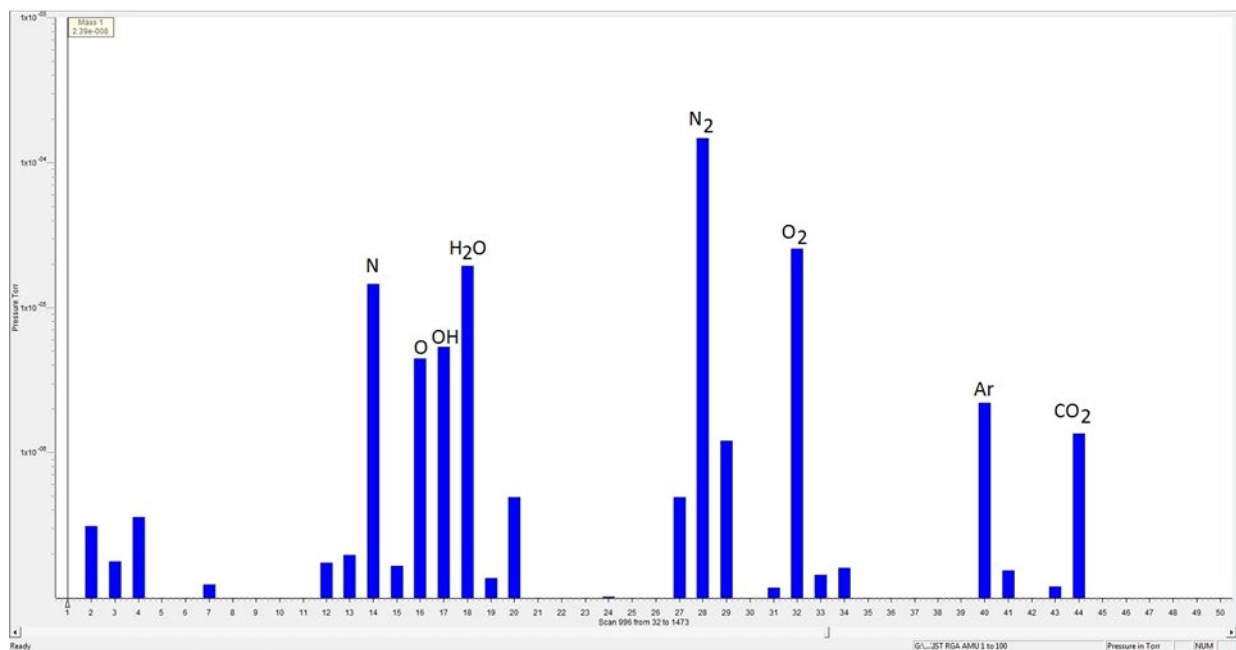
A portion of a typical RGA scan obtained during IST-2010 is given in Figure 12. This histogram gives relative partial pressures for the range of atomic mass from 1 to 50. The most abundant atomic mass units (AMUs) are labeled with their respective key fragments to facilitate discussion. This scan is typical of the IST-2010 data because the key fragments were seen as the major components in all the RGA data. The data indicate the presence of an air leakage. No significant amounts of lower AMU hydrocarbons are indicated. Lack of significant hydrocarbon fragments was also the case throughout the 51 to 100 AMU range. The data were taken on August 12, 2010 near the end of the IST when the pressure had reached approximately 0.5 mPa (lower 10^{-6} torr range) and had remained near this level. This is at a time when all the significant leak sources not arising from direct annulus-to-chamber avenues had been found and sealed during the course of this IST. After the existing leaks were discovered and corrected, the chamber pressure tracked in-step with the variation in annulus pressure. Thus, this indicated that only direct annulus-to-chamber leakage remained. Leakage around the large chamber doors appears to be the air source, because other major sources of possible leaks had been checked thoroughly and “fixed”, if noticeable, before commencing IST-2010. Based on the low vacuum pressure obtained during the IST, chamber outgassing was considered to be a minor contributor to the vacuum pressure compared to air leakage during the latter stages of the IST. The rate of leakage was approximately 60 sccm based upon agreement of a vacuum-rate-of-rise calculation and a pumping-system-throughput calculation at the corresponding pressure.

Figure 12.—IST-2010 RGA histogram spectrum.

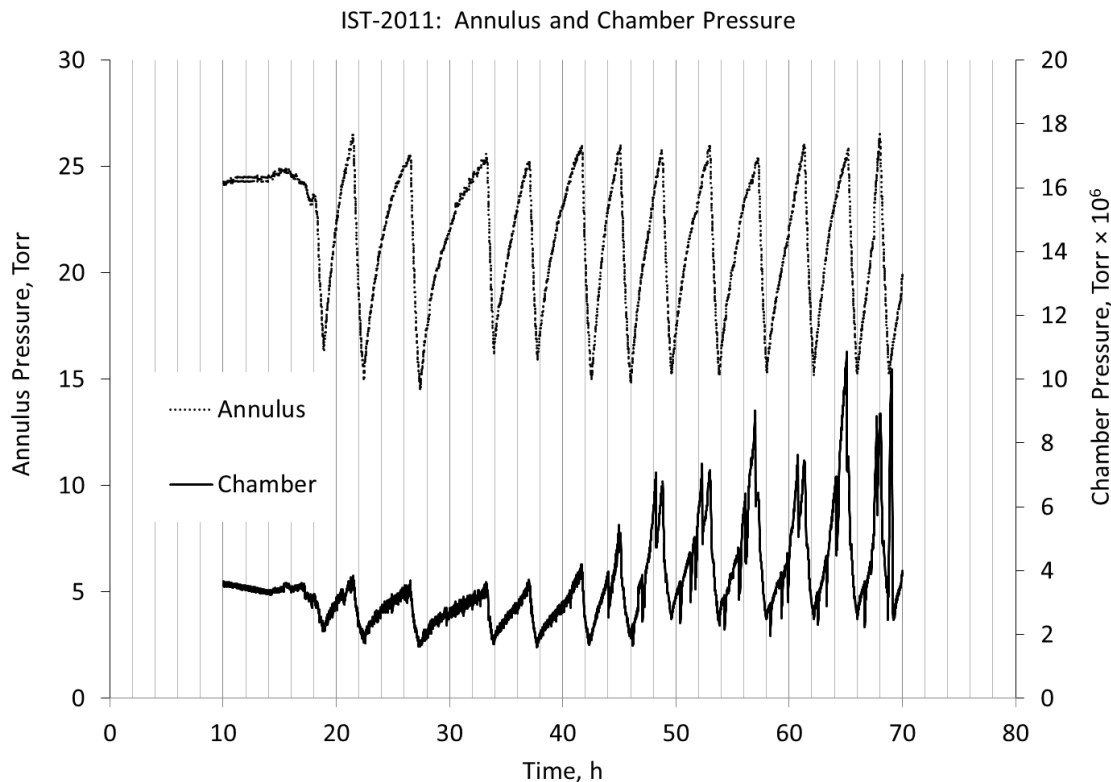
Figure 15.—Correspondence between IST-2011 annulus and test-chamber pressures.

such as existed during the IST-2010. The continual GN₂ flow put an increased burden on the roughing system. A number of Beech-Russ pumps were required to be operated continuously to restrict the rate of annulus pressure rise, and when the annulus pressure approached the upper acceptable limit, a number of Roots blowers were brought on line to reduce the pressure to the lower limit. Thus, there occurred over the IST-2011 a large number of annulus pressure swings, each represented by a fast pressure drop followed by a more gradual pressure rise. The N₂-trend line and N-trend line track in phase with the annulus pressure. Additional data shows that the peaks in these two trend lines correspond with peaks in the annulus pressure, which occurs just before the additional annulus pumping is activated. The trend lines given in the last figure correspond to direct leakage between the annulus and the chamber. This was established by direct correspondence between annulus and chamber pressures, which is presented in Figure 15. Another less noticeable feature can be seen from the trend lines shown in Figure 14. The trend lines for H₂O, O₂, and O are not in phase with the two nitrogen trend lines. To reveal this phase difference, the trend lines are scaled individually so that they may be placed on a linear scale, as presented in Figure 16. Although this scaling does not preserve measured values, it allows the phase difference to become evident. The adjusted trend lines are ordered such that relative abundance is maintained. The AMUs corresponding to H₂O, O₂, O, OH, AR, and CO₂, listed here in descending order of abundance, are out of phase with the AMU corresponding to N₂. Why this is the case is discussed next.

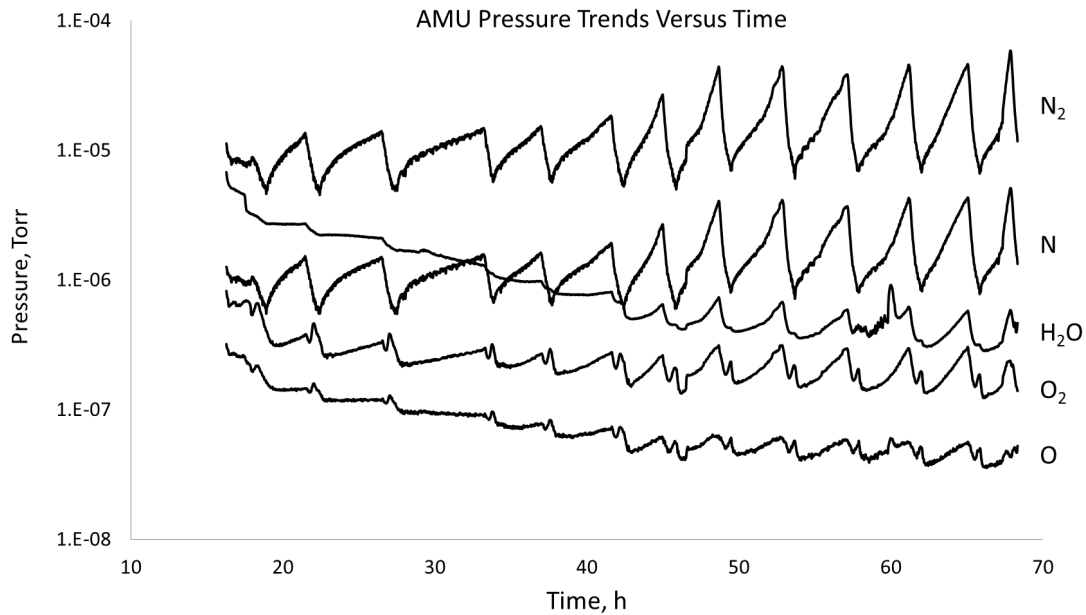
Figure 16.—IST-2011 RGA scans for several constituents. Not to scale.

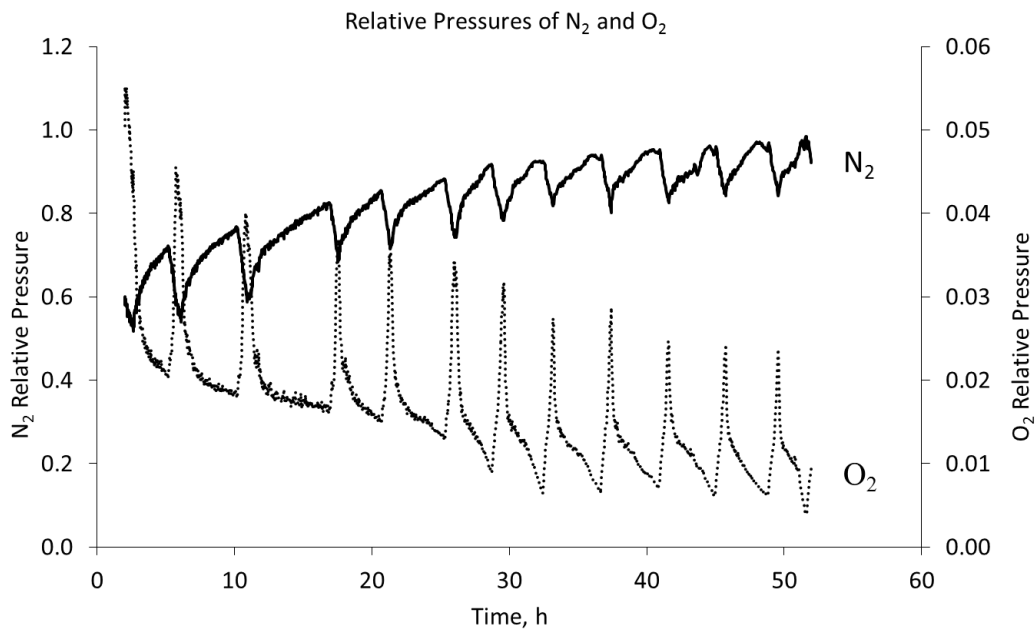
The relative pressures of N₂ and O₂ are plotted in Figure 17, each with respect to different scales. Again, the phase difference is clearly visible, as a maximum in one component corresponds to a minimum in the other component. At all times the abundance of N₂ in the chamber is greater than the abundance of O₂. After 50 h, the ratio of a maximum in N₂ to a minimum in O₂ approached 200:1. The reason for the phase difference can be better understood by examining three tendencies. The first tendency is deduced from knowing that the nitrogen leak source was located a short distance from the inlet piping of the annulus roughing line pipe compared to the diameter of the annulus. With increased annulus pumping, the annulus pressure is decreased. A decrease in annulus pressure resulted in a disproportionate decrease in nitrogen compared to respective decreases of the minority constituents.

Figure 17.—IST-2011 RGA scans for N_2 and O_2 relative pressures.

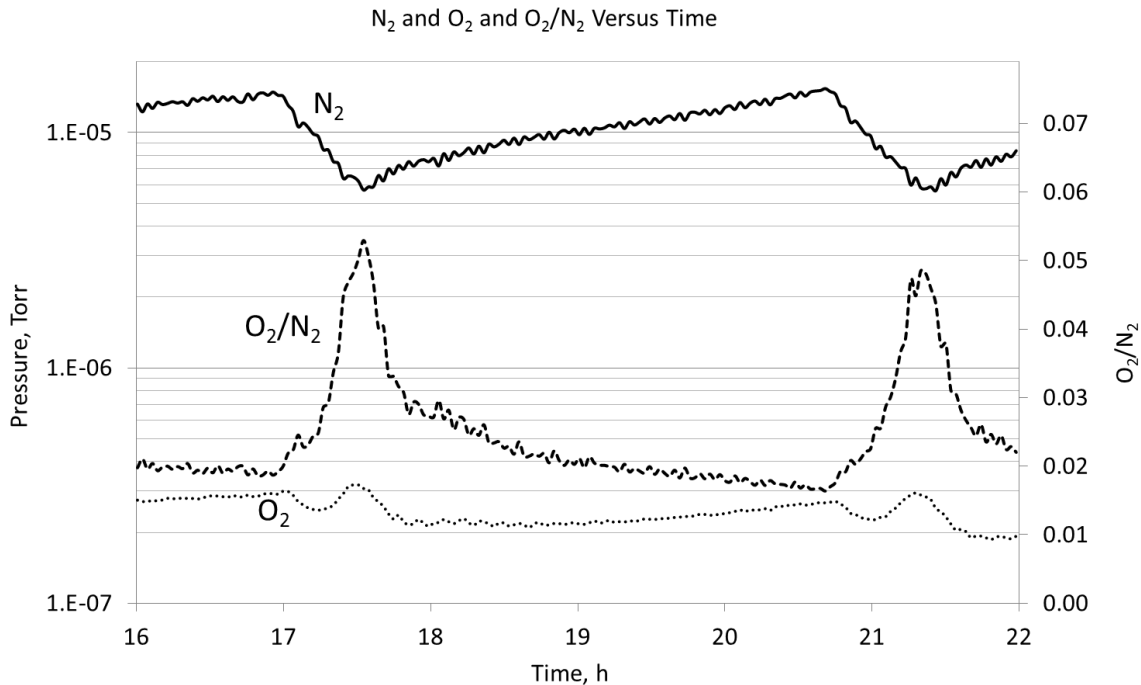
The second tendency is due to the variation in outgassing with pressure. As the annulus pressure decreases, general outgassing increases. Third, the leak rate of ambient air into the annulus from outside also increases with decreasing annulus pressure. Due to these tendencies, the concentration of minority constituents increases with decreasing annulus pressure. Although total leakage to the chamber decreases as the annulus pressure decreases, the relative concentrations of the minority constituents can increase in the chamber to the extent that a given chamber partial pressure can reach a local maximum near a minimum in the total pressure. This can be seen by referring again to Figure 14, and closely examining the trend line for O_2 . Figure 18 shows the trend lines for N_2 and O_2 and the quotient trend line, O_2/N_2 , for a few cycles of annulus pressure. This figure clearly illustrates that as the N_2 pressures falls to a minimum, the quotient O_2/N_2 reaches a maximum. The increase in O_2/N_2 is sufficient in this case that the

Figure 18.—IST-2011 RGA scans for N₂ and O₂ relative pressures and their ratio.

O₂ pressure reaches a maximum. Thus, a relative increase in a given annulus partial pressure, such as is the case for O₂, is sufficient to cause the leak rate of that constituent to increase even though the total leak rate is reduced due to a drop in annulus pressure. The implications of this and how it relates to chamber contamination levels is discussed in the following presentation of TQCM data.

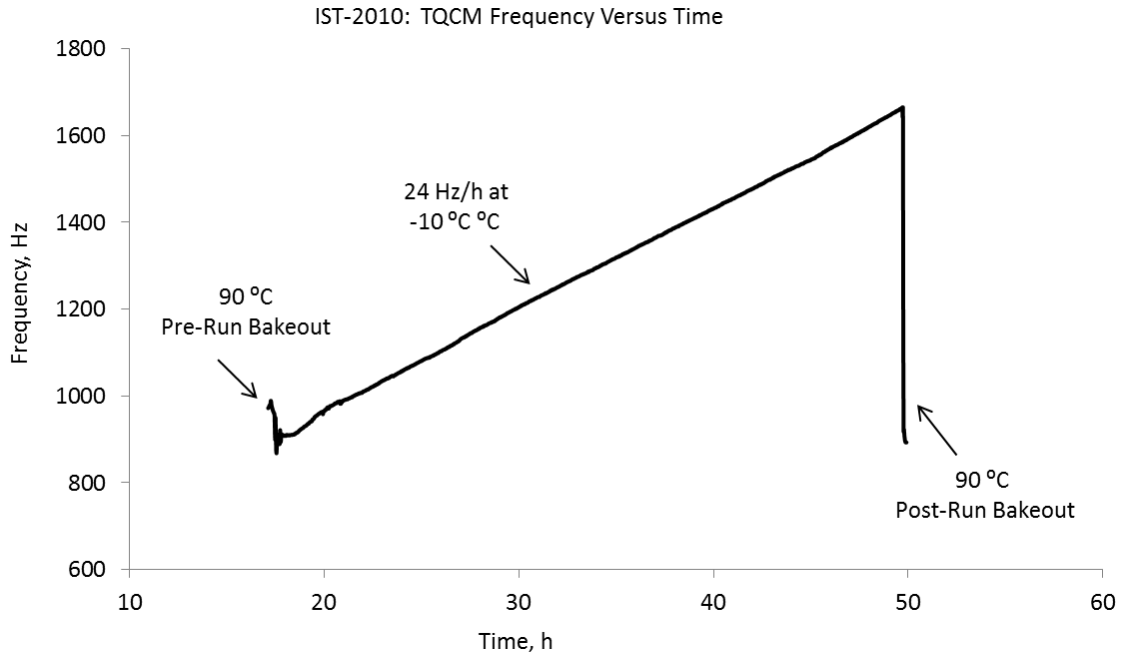
TQCM data were taken during each IST. The data presented in Figure 19 show the variation of TQCM frequency with time over a period of 31.9 h of operation during IST-2010. The abrupt declines in frequency at each end of the curve are due to changes in the TQCM's sensor temperature. The initial decline reflects the temperature change as the TQCM finished baking out at 90 °C and approached the set temperature for operation, which was -10 °C. The final decline reflects the temperature change as the TQCM was sent again to its bake-out temperature of 90 °C to avoid condensation at the end of the high vacuum operation. The average rate of increase in frequency during the 31.9-h interval at -10 °C is 24.1 Hz/h. For the final 24 h, 8-h interval rates, given for each successive period, are as follows: 1) the first 8-h interval averaged 24.1 Hz/h; 2) the second 8-h interval averaged 22.8 Hz/h; and 3) the third 8-h interval averaged 24.3 Hz/h. The frequency rate remained very constant over the course of the run.

Figure 19.—IST-2010 TQCM data at -10°C .

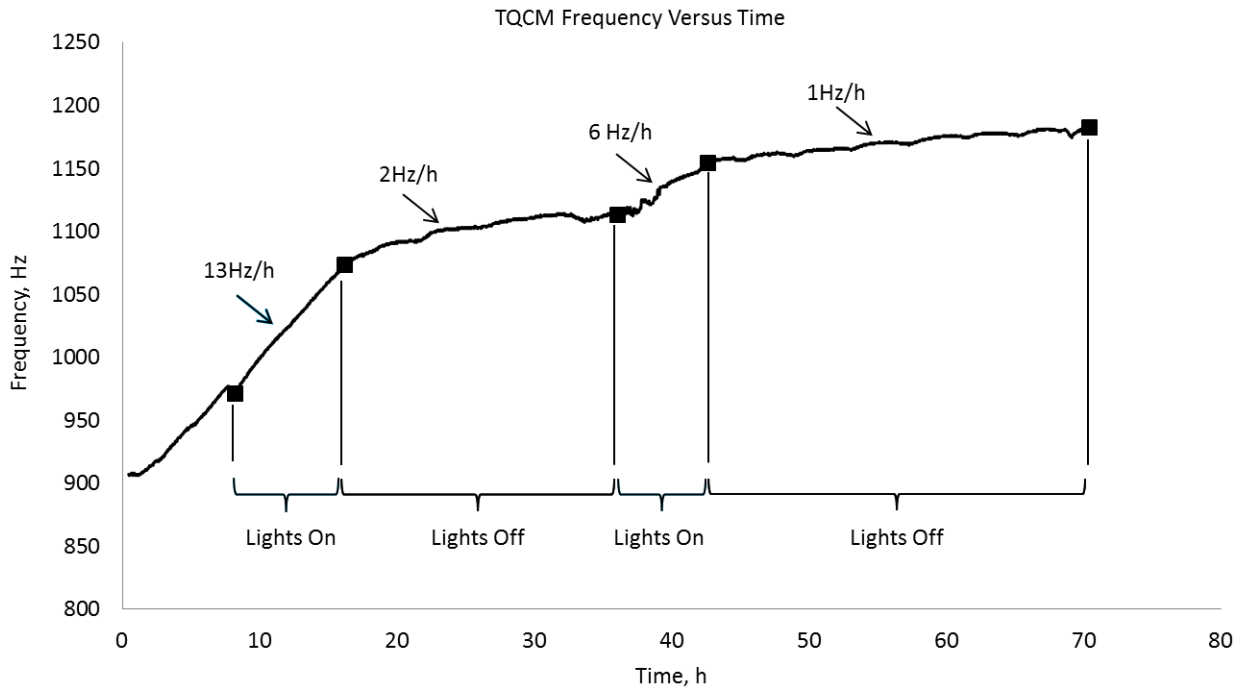
The data presented in Figure 20 shows the variation of TQCM frequency with time, over a period of 70.4 h of operation during IST-2011. The set temperature for operation was -10 °C, as in the previous IST. The drop in frequency seen to occur approximately 8 h into the run is due to a loose cable connection at the TQCM's controller. This cable interruption caused the sensor temperature to rise from -10 °C. The temperature rise caused the sensor to decline in frequency as accumulated contaminants desorbed. Once the cable connection was secured, the sensor obtained its operation point of -10 °C shortly afterward. While this interruption caused a sharp discontinuity in frequency, only a slight discontinuity in slope is seen. This is somewhat significant to what follows. From the point of interruption, the curve can be divided into four time intervals corresponding to whether the chamber lights were operated or were shut off. The intervals are denoted in the figure along with the slopes, which signify Hz/h, listed above the corresponding intervals. The frequencies and times corresponding to these interval endpoints are listed in

order: 1) 971 Hz at 8.22 h; 2) 1073 Hz at 16.17 h; 3) 1113 Hz at 36.05 h; 4) 1154 at 42.67 h; and 5) 1182 at 70.4 h. The rates of increase in frequency during the intervals are: 1) lights on 12.8 Hz/h; 2) lights off 2.0 Hz/h; 3) lights on 6.2 Hz/h; and 4) lights off 1.0 Hz/h. As done for IST-2010 TQCM data, rates for the final 24 h, 8-h interval rates, are given for each successive period, as follows: 1) the first 8-h interval averaged 1.1 Hz/h; 2) the second 8-h interval averaged 1.0 Hz/h; and 3) the third 8-h interval averaged 0.6 Hz/h. Compared to the IST-2010 data, the rates over the last 24 h are significantly lower for the ITS-2011 data. The average rate for the final 24-h period for the IST-2011 is 0.9 Hz/h.

Figure 20.—IST-2011 TQCM data at -10°C .
