Prepared for the
2010 National Space and Missile Materials Symposium (NSMMS)
sponsored by General Dynamics Information Technology
Scottsdale, Arizona, June 28–July 1, 2010

An Investigation of Stress Dependent Atomic Oxygen Erosion of Black Kapton Observed on MISSE 6

Abstract

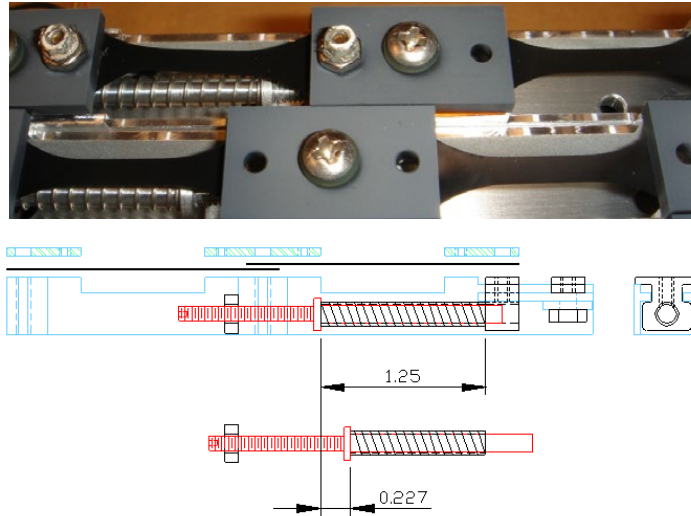
Figure 1.—Photo of stressed (left) and unstressed (right) sample holders from above, and a side view drawing of a holder showing the unstressed sample position on the left and the stressed on the right. (Dimensions are in inches.) The stressed sample is fixed on the left side and allowed to move to the right by having the mount hole on the right slotted. Tension is supplied by compression of the spring.

The flight experiment was designed to allow some of the polymer dog-bone type samples to be exposed under a tensile load typical of expected conditions for the James Webb Space Telescope sunshield. The tensile load of approximately ~2.22 N (0.5 lb) was applied by mounting the sample in a holder similar to that shown on the left side of the photo in Figure 1 and then compressing a spring with a spring constant of ~385 N/m (2.2 lb/in.) by approximately ~0.0058 m (0.227 in.) to put the sample under an approximately constant tensile load. The drawing in Figure 1 shows a double sample holder where the sample on the left did not have an applied tensile stress and the one on the right did. For the samples exposed under stress, the resulting stress was dependent on the polymer film thickness per Equation (1) with an average gage width of approximately 0.0032 m (0.126 in.). For the Black Kapton XC samples, the applied stress was $\sim 2.76 \times 10^7$ N/m² (~4000 psi) as the films were 2.54×10^{-5} m (0.001 in.) in thickness.

For the ground based testing, the same sample holders were used but slightly modified to allow other spring compression lengths to achieve a wider variety of tensile stress on the samples. This was accomplished by modifying the rod underneath to allow greater travel of the spring and through the use of copper u-shaped shims to compress the spring and place the sample under a fixed tensile load.

The stressed and unstressed samples of Kapton XC flown on the wake side did appear very different from each other. The two unstressed samples appeared slightly textured while the two stressed samples were very dark matte black in appearance. A photo of the two sample pairs is shown in Figure 1. The stress level during exposure was $\sim 2.76 \times 10^7 \text{ N/m}^2$ ($\sim 4000 \text{ psi}$) and the strain was ~ 0.008 which represents about 3 percent of the maximum strain. The stress on the sample was about 24 percent of the tensile strength. This does not appear to be a significant amount of strain on the material but is enough to cause a difference in the appearance of the erosion of the material due to oxidation by atomic oxygen. Figure 4 shows side-by-side SEM images at 45° tilt of the stressed (UV-S-2) sample of Kapton XC on the left and the unstressed (UV-U-2) sample of Kapton XC on the right. There is more surface texturing occurring on the stressed sample than the unstressed sample as can be seen in the top 2/3rds of the image. The bottom 1/3 was under the sample mount and protected from erosion by atomic oxygen. The unstressed sample is only slightly different in appearance to the unexposed surface, while the surface of the stressed sample has undergone very noticeable erosion.

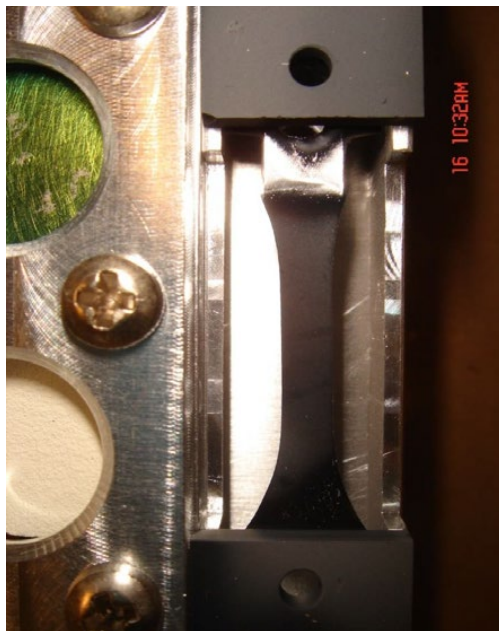
Figure 2.—Kapton XC flown on ram side of MISSE 6 (AO-S-1) showing stretching of the sample at the silver area at the top of the sample in the photograph

Two unstressed samples of black Kapton (XC) were exposed on the ram side of MISSE 6. Both samples appeared to show evidence of texturing of the surface with a darker appearance near each end of the dog-bone sample. One of these samples designated AO-S-1 was inadvertently put under stress when one end of the sample holder was moved, which changed the overall sample length by ~ 0.0017 m (~ 0.068 in.). This sample was installed in a sample holder initially designed for putting the sample under a tensile load so the holder on the top side of the sample had a slotted mount hole. It appears that the sample was inadvertently bumped and the one end of the holder moved putting the sample under a high tensile stress even though it was not initially intended to be stressed. There was a cable that was passed up between this sample tray (G3) and the neighboring tray very close to AO-S-1 which may have provided the opportunity for inadvertent bumping of the one end of the sample holder during experiment installation. The movement put a strain on the sample (for an undetermined length of time) of ~ 0.07 . This represents approximately 26 percent of the maximum strain for Kapton XC. The resulting stress on the sample was 2.32×10^8 N/m² (33,600 psi) which is greater than the yield strength of Kapton XC. The sample had a silvered appearance on the end that was stretched and distorted which is evident from the photograph in Figure 2.

The appearance of the sample raises two questions. The first is why the stretched end appears silver and the second is why the black Kapton appears to be darker in the region of higher stress? In order to try to answer these questions, SEM and EDAX analysis was performed on the sample at selected locations shown in Figure 3, SEM images in Figure 3 show a significant change in surface morphology from the center to the edge. The center portion has a smooth lumpy appearance typical of black Kapton which progresses to an area which looks as if it had a thin film gossamer coating on it with many cracks perpendicular to the pull direction. There are fine cone-like peaks in areas where there is cracking which progresses to almost all peaks with thin wisps of film on the surface nearer to the silver area. At the edge where the sample separated, there are only a few short peaks remaining. EDAX scans indicate mostly carbon and oxygen signals in the central region progressing to a high concentration of aluminum near the stretched end. This sample was originally intended to be put under stress and wired so there was a vapor deposited aluminum coating on the back side. It appears that as the stress on the sample is increased, the erosion rate of the black Kapton increases which results in first development of surface texture cones and a thin film of ash from oxidation of the black Kapton. This progresses to loss of ash and erosion of the mostly carbon cones to the point at which the vapor deposited aluminum is predominantly what is left looking like a blanket of snow at the base of the remaining carbon peaks. If erosion of the Kapton XC is dependent on the level of stress, then there should be an observable difference between the stressed and unstressed samples of Kapton XC that were flown on the wake side of MISSE 6.

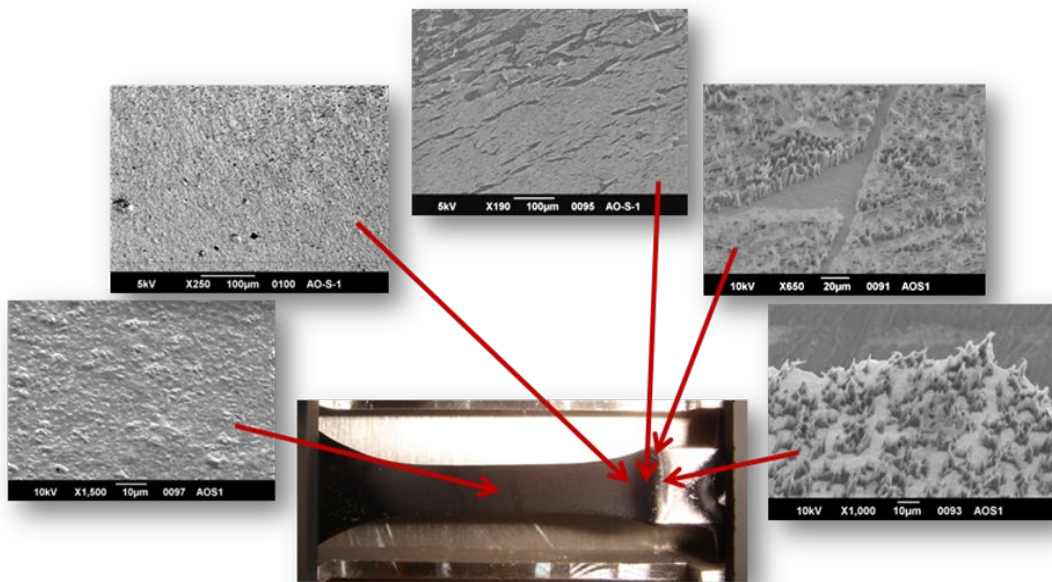
Figure 3.—SEM images of selected positions on sample AO-S-1 exposed on the ram side of MISSE 6.

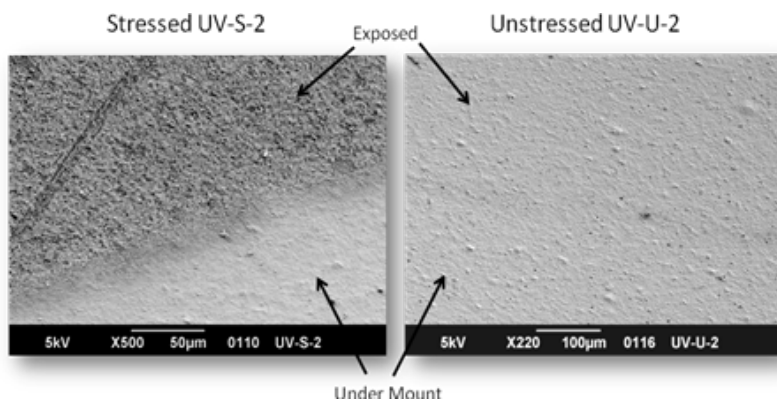
Figure 4.—Scanning electron microscope images of stressed (left) and unstressed (right) Kapton XC at 45° tilt. Top approximately 2/3 was exposed to the space environment on the wake side of MISSE 6 while the bottom ~1/3 was protected by the clamp holding the sample in place.

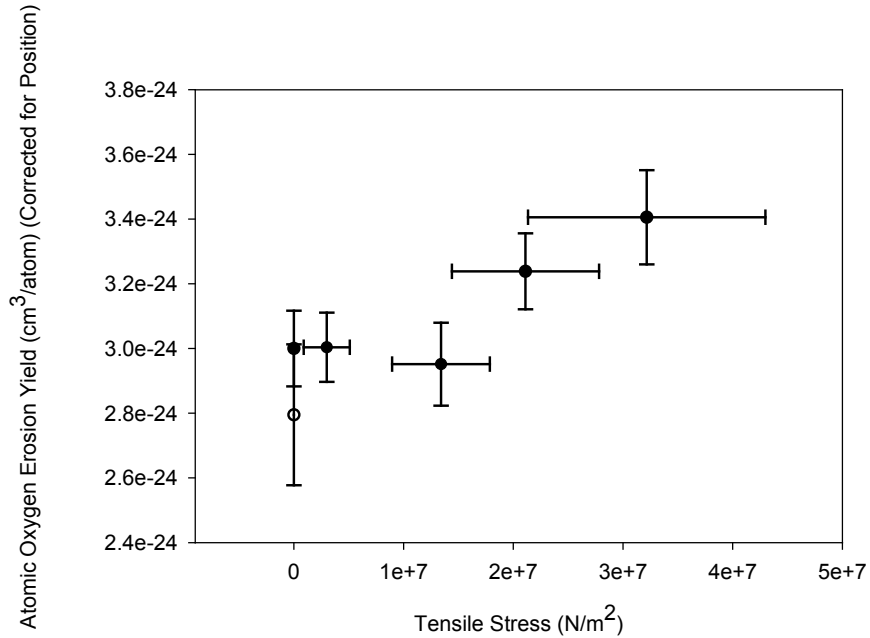
Figure 5.—Atomic oxygen erosion ratio as a function of stress for Kapton HN exposed to ground based thermal energy atomic oxygen.

Kapton HN samples were installed in the same sample holders and four of the samples were loaded to varying stress levels with two unstressed samples included for fluence witnesses. The atomic oxygen arrival ratio for the two unstressed samples was within error of that observed for the flux map so the fluence at the locations of the stressed samples was estimated using the flux map and fluence measured at the control locations. Figure 5 contains a graph of the resulting erosion yield (cm^3 removed per incoming atom) as a function of tensile stress for Kapton HN. As can be seen from the graph, at stress levels above $2 \times 10^7 \text{ Pa}$, the erosion yield exhibited a slight increase with increasing stress.

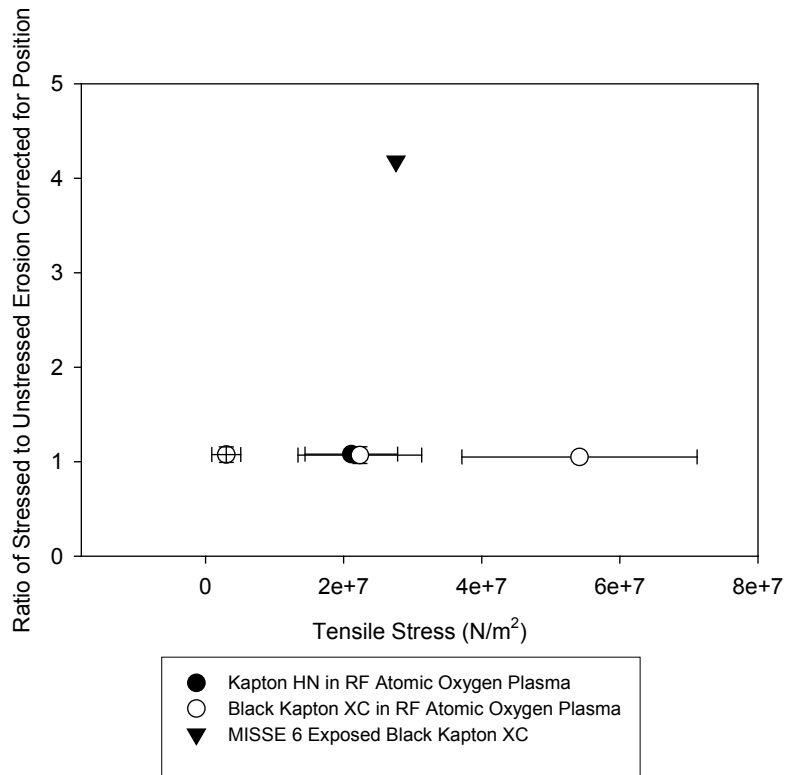
Figure 6.—Ratio of stressed to unstressed erosion yields for Kapton HN, and Black Kapton XC exposed to a ground based thermal energy atomic oxygen plasma as a function of tensile stress compared to that for Black Kapton XC exposed on MISSE 6.

The erosion yield for two stress levels of Kapton HN normalized with respect to the unstressed erosion yield for that material was compared with that obtained for two Black Kapton XC samples exposed in the ground based atomic oxygen plasma chamber in the same positions and with the same spring compression level as that of the Kapton HN. The resulting stressed to unstressed erosion ratios shown in Figure 6 were within error of each other but much lower than the erosion ratio for the stressed to unstressed Black Kapton XC exposed on MISSE 6. The error in the flight data is not shown but is expected to be large in comparison to that for the ground based atomic oxygen exposure data. However, there was very little difference in the surface appearance of the ground test data compared with that observed on MISSE 6.
