# Treatment of PCB Contaminated Caulking Using AMTS

NASA Kennedy Space Center

University of Central Florida Orlando, FL

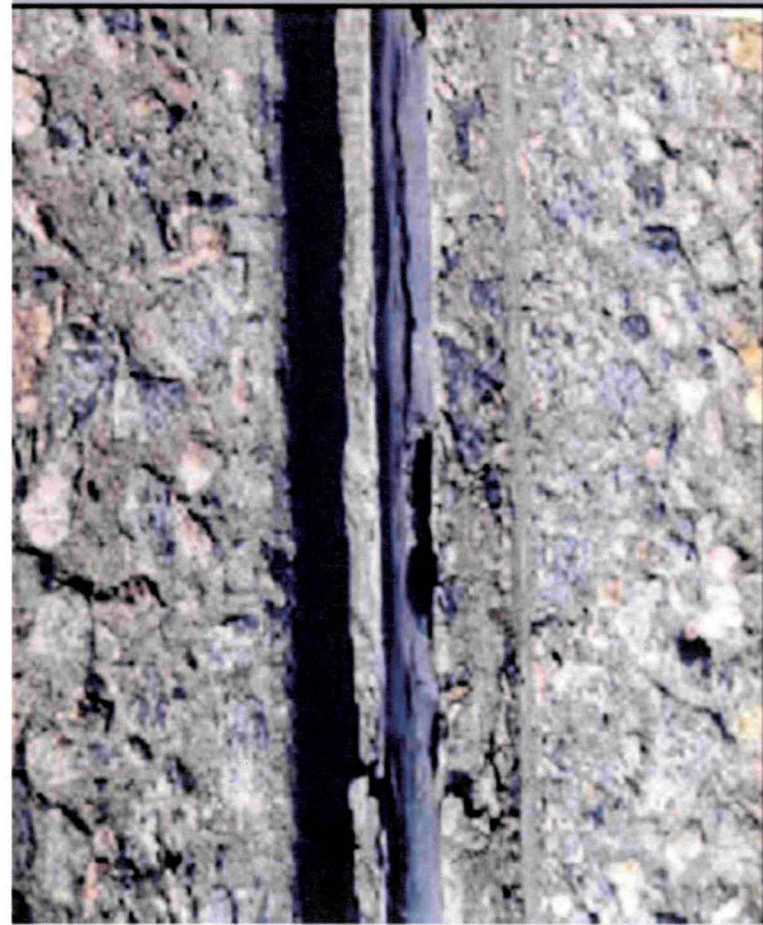
- Found in masonry buildings and concrete structures built between the 1940's and late 1970's
- Used in concrete expansion joints
- Caulk can contain up to 15% PCBs (by mass)

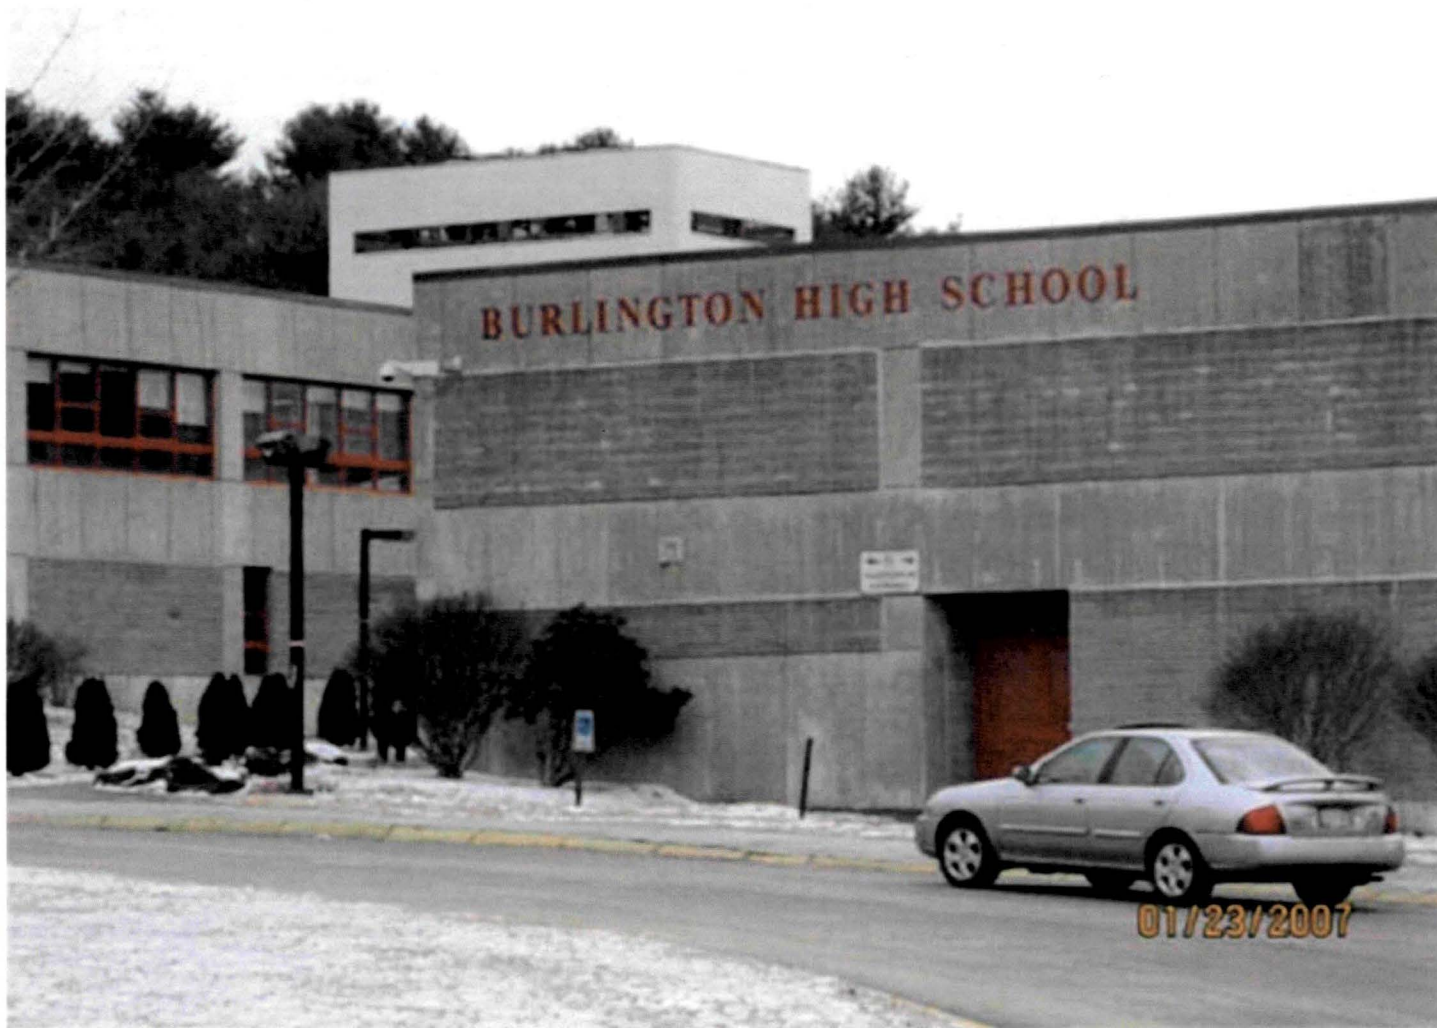
Burlington High School, Burlington, Massachusetts, 2006  
Masonry Caulk 106,611ppm Arochlor 1260

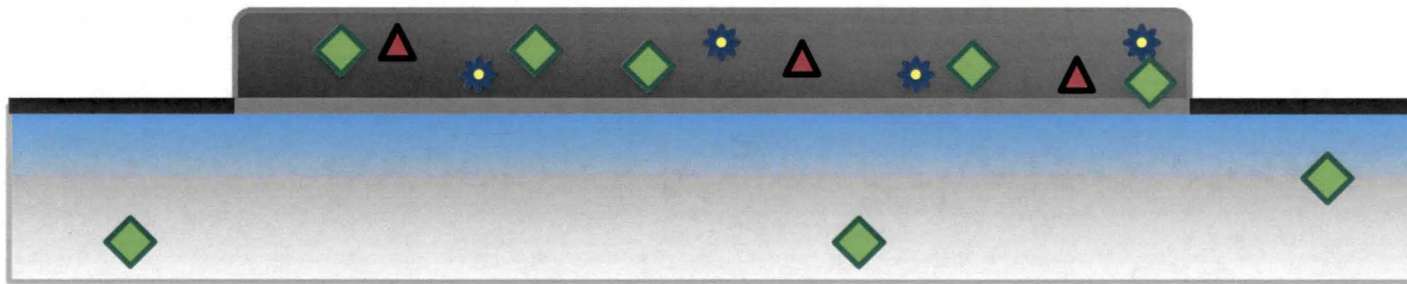
- \* Magnesium and acidified ethanol dechlorinate absorbed PCBs

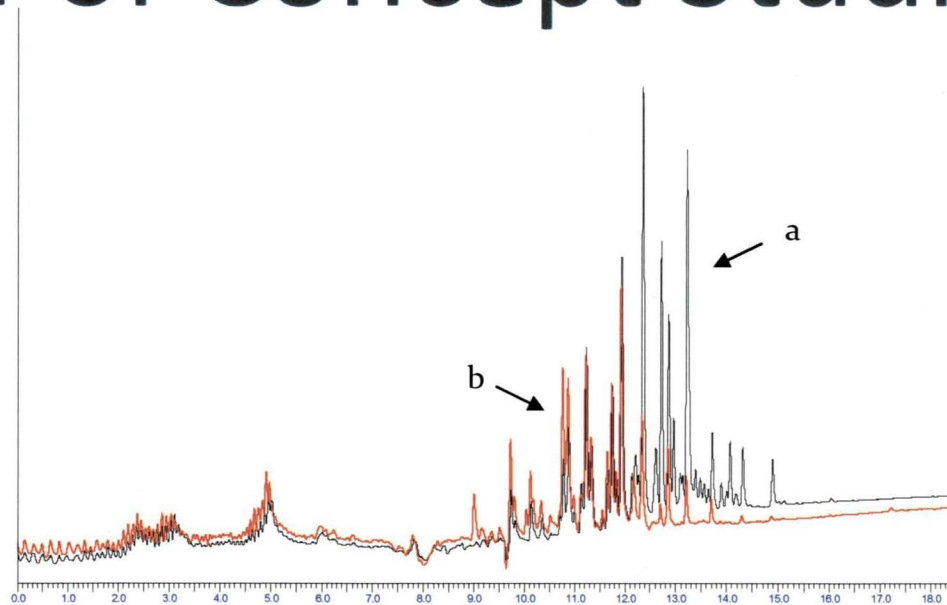
Overlaid chromatograms of AMTS paste spiked with Aroclor 1254 before activation (a) and one week after activation with Mg and acidified ethanol (b)

- Envelope shift from higher to lower chlorinated congeners again rules out a sorption-only process within the AMTS paste when activated

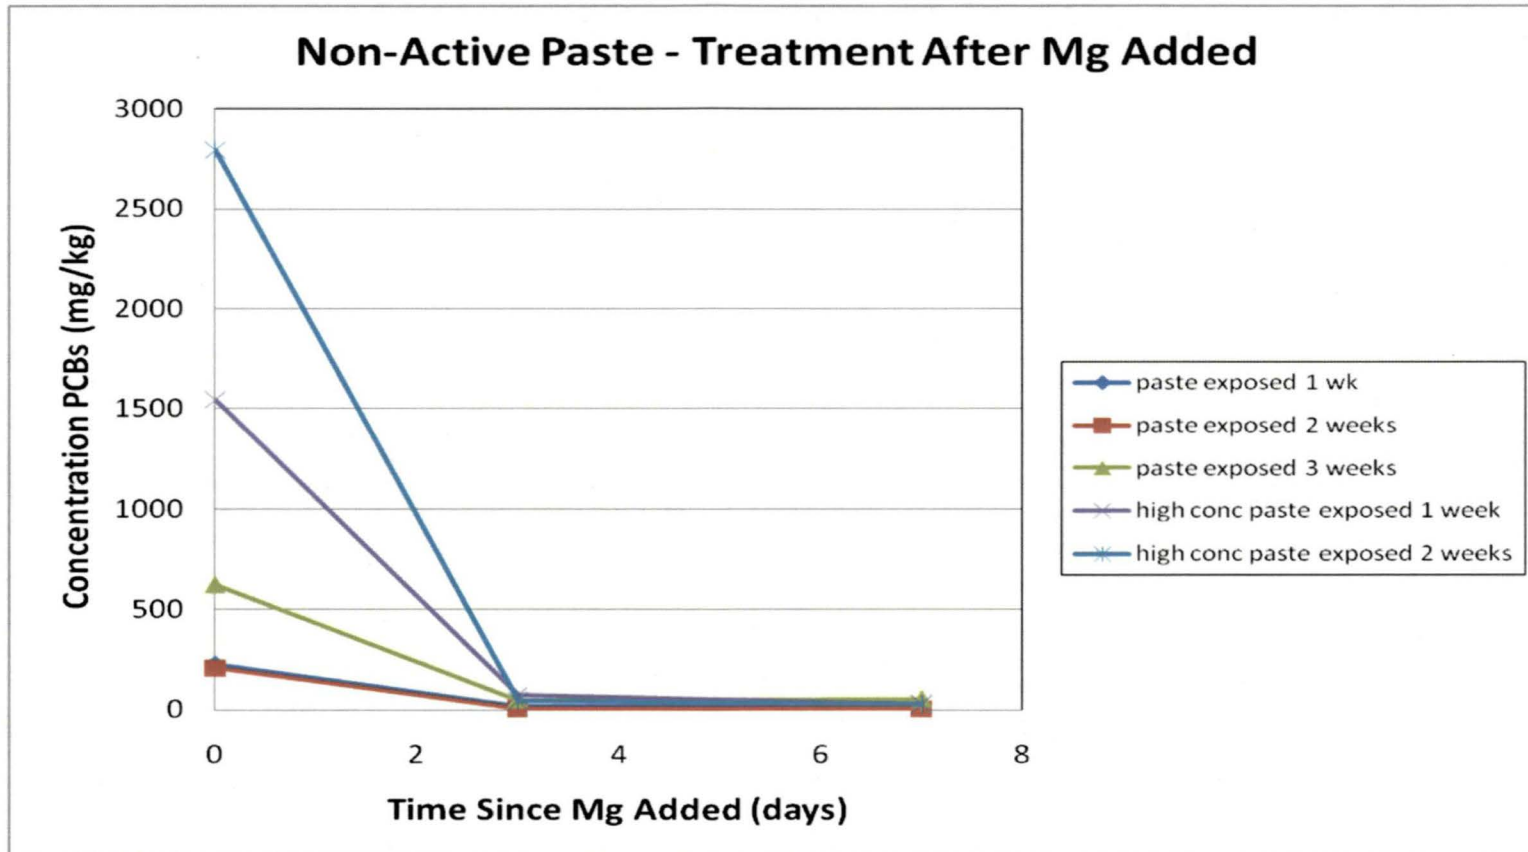
10% of activated Mg added to paste after removed from painted structures and successful treatment to below 50 mg/kg even with high starting concentrations

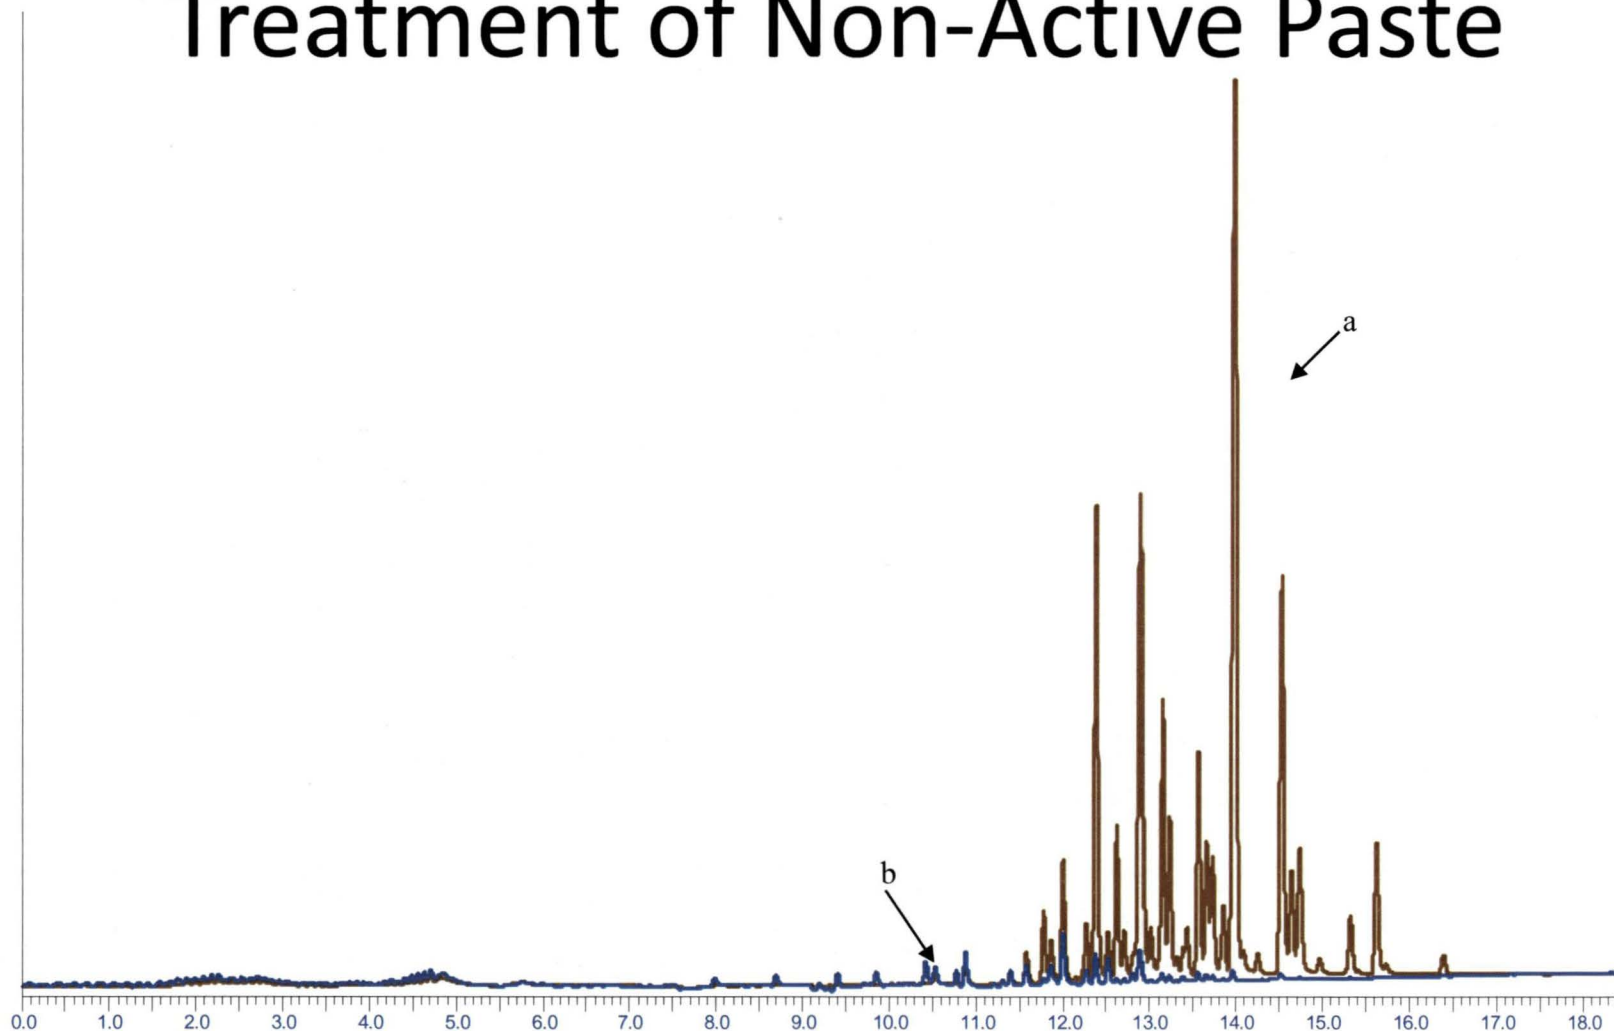
Chromatograms of the original paste and after 7 days of treatment. Data showing (a) NM 6810-36 1wk (original) 226 mg/kg = **brown** and (b) after 7 days reacting with Mg metal 11 mg/kg = **blue**.

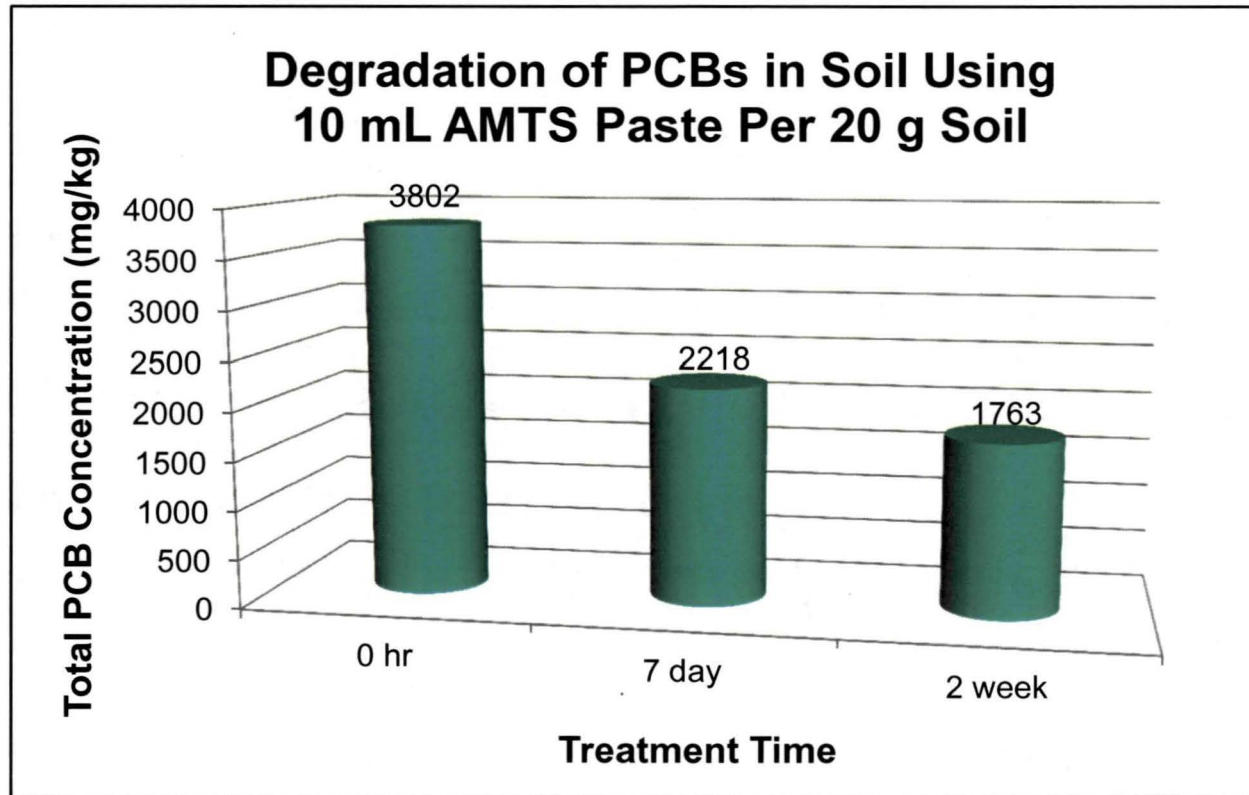
- Soil sieved and air-dried prior to experiments
- Mixed with AMTS and allowed to react in jars (single treatment)

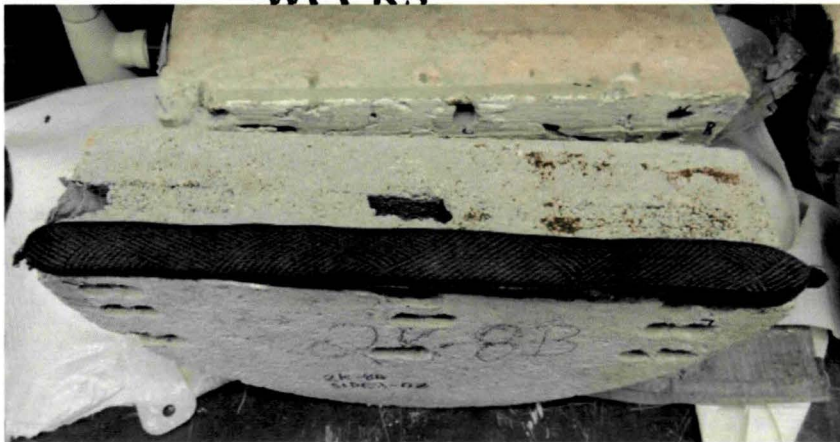
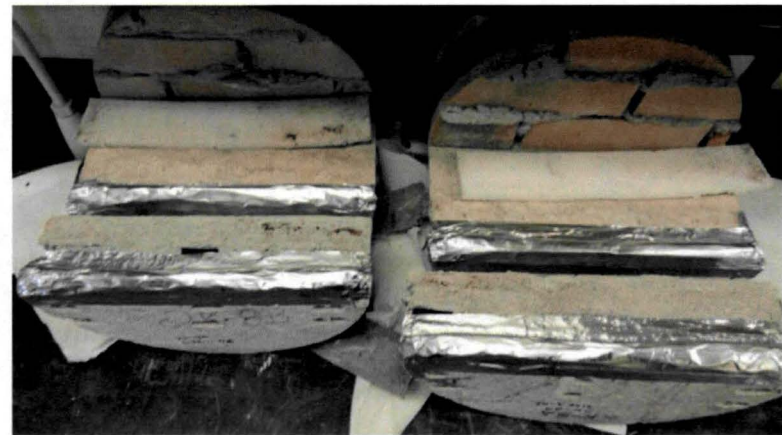
- “Sock” - nylon delivery system filled with NMTS applied to the area of the removed caulk
  - Sealed airtight with aluminum tape
  - Left in contact with contaminated concrete for 2 weeks

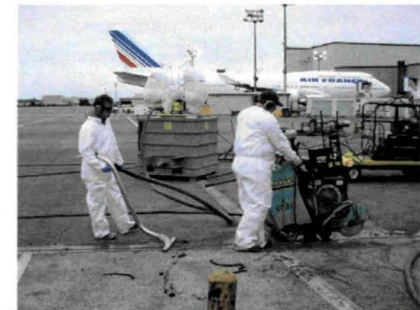
- Expansion Joints used to relieve heat-induced stress
  - Found in building faces, roads, etc...
  - Filler material can be contaminated

with PCBs  
**50 miles of joints with PCBs**

Garson, McCormack, Sugino and Molinari, 2004. Airport Flightline Expansion Joints – Unexpected Source of PCB Contamination. *Fourth International Conference on Remediation of Chlorinated and Recalcitrant Compounds*, Monterrey CA., May 2004.
