ISS Exercise Equipment Highlights

HRP NSBRI Evening Topic
February 11, 2013

Presented by:
NASA/JSC/ER Cherice Moore
Advanced CMS Technology Development Manager
(281) 483-8780
cherice.moore-1@nasa.gov

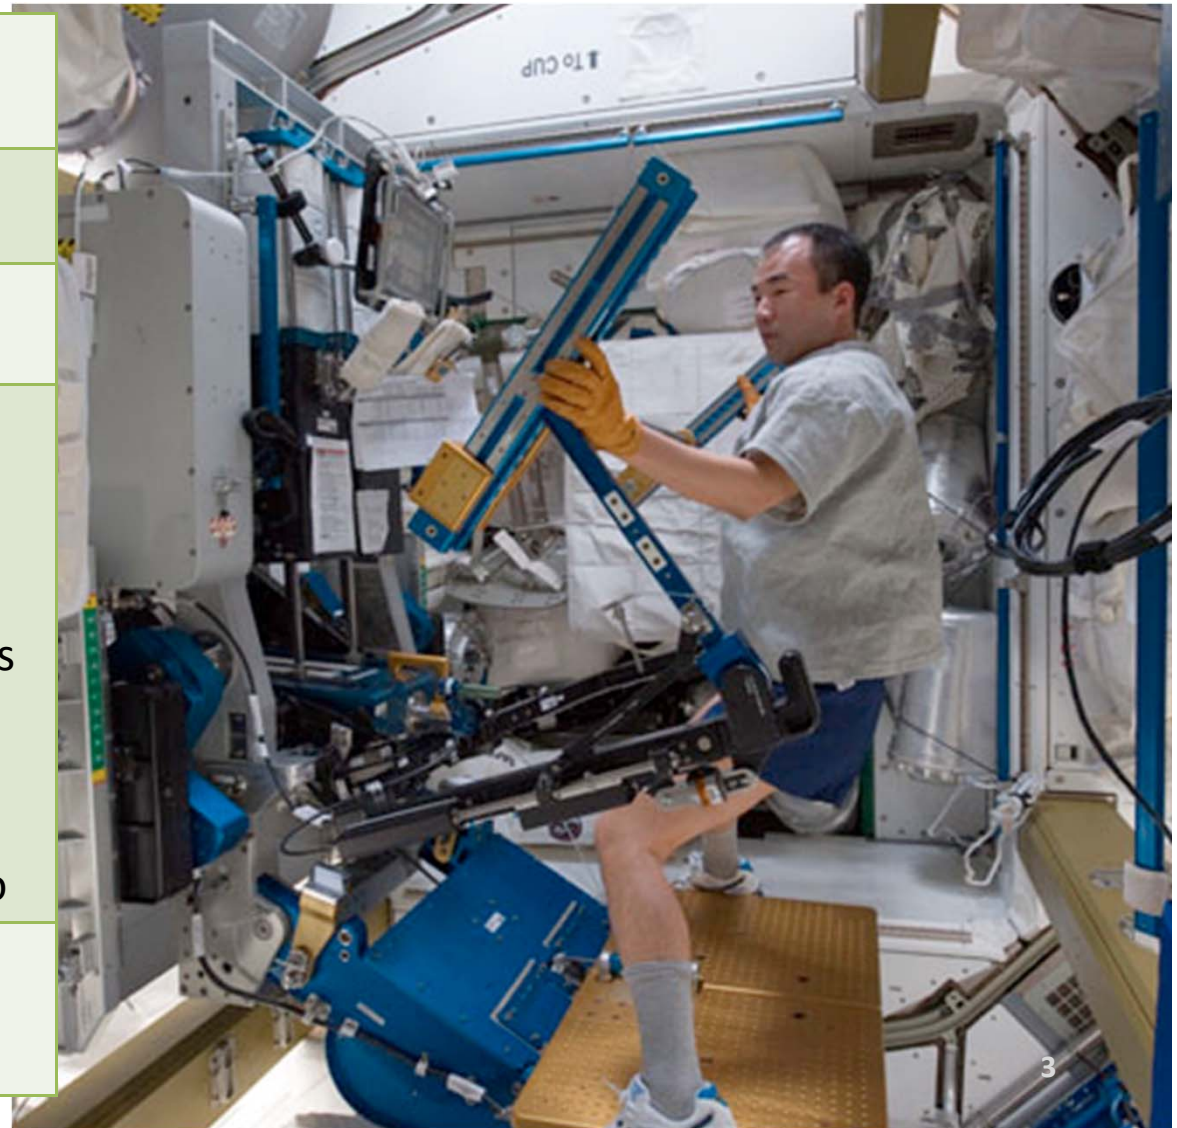
Advanced Resistive Exercise Device - ARED

Years On-Orbit	4.1 years (1.5 hrs/crew/day)
Total Cycles	932,853 (through July 2012)
Maximum Load Capability	600 lbs.
Data Captured (manually captured in Excel since 6/1/11)	<ol style="list-style-type: none">1. Cycles2. Exercise Time3. Exercise Performed4. Weight/Exercise5. Sets/Exercise6. Crew ID7. Example video
Yearly Maintenance Time Required	Approx. 14 hours

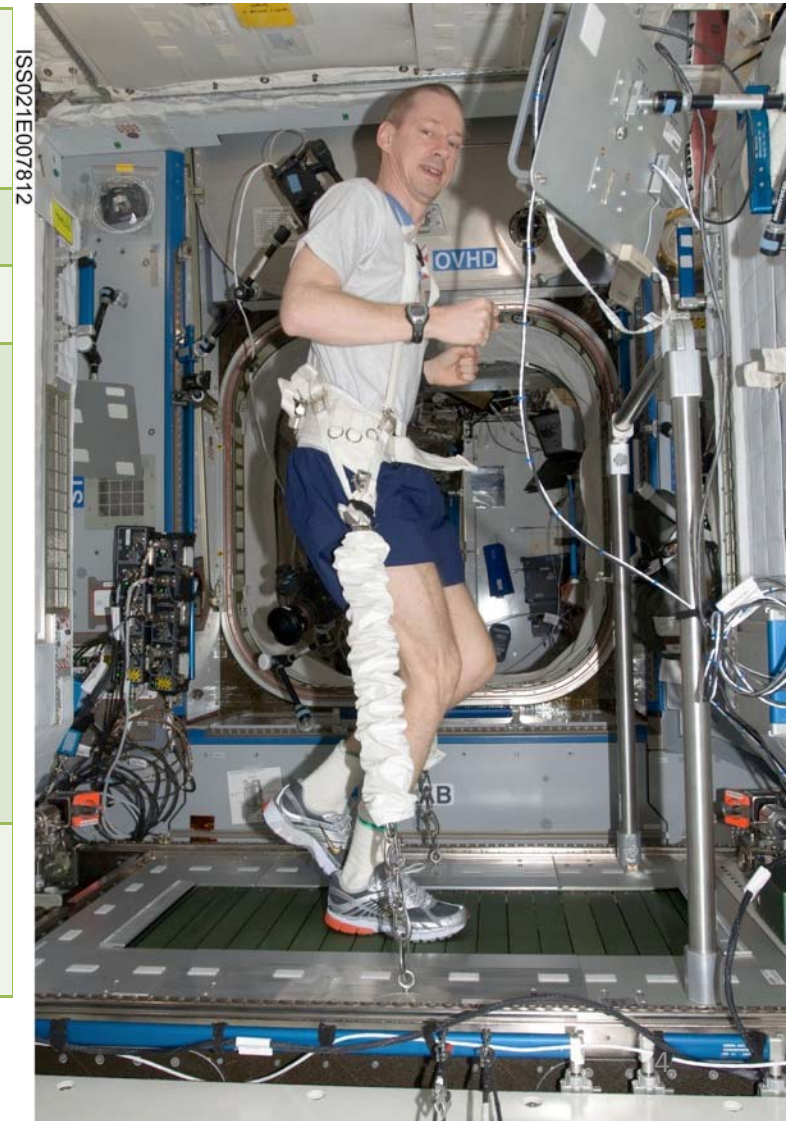
Treadmill – T2

Years On-Orbit	2.3 years (inst. Oct 2010) (1 hr/3 crew/day)
Total Hours Used	Approx. 1,000 hours
Maximum Speed	12 mph
Data Captured	1. Session Time/Total Time used 2. Accelerometer Data 3. Load Cell Data 4. Motor Speed 5. Electronics Sensor Data (e.g. current, voltage, temperatures, water flow rates) 6. Heart Rate 7. Example video
Yearly Maintenance Time Required	Approx. 11 hours

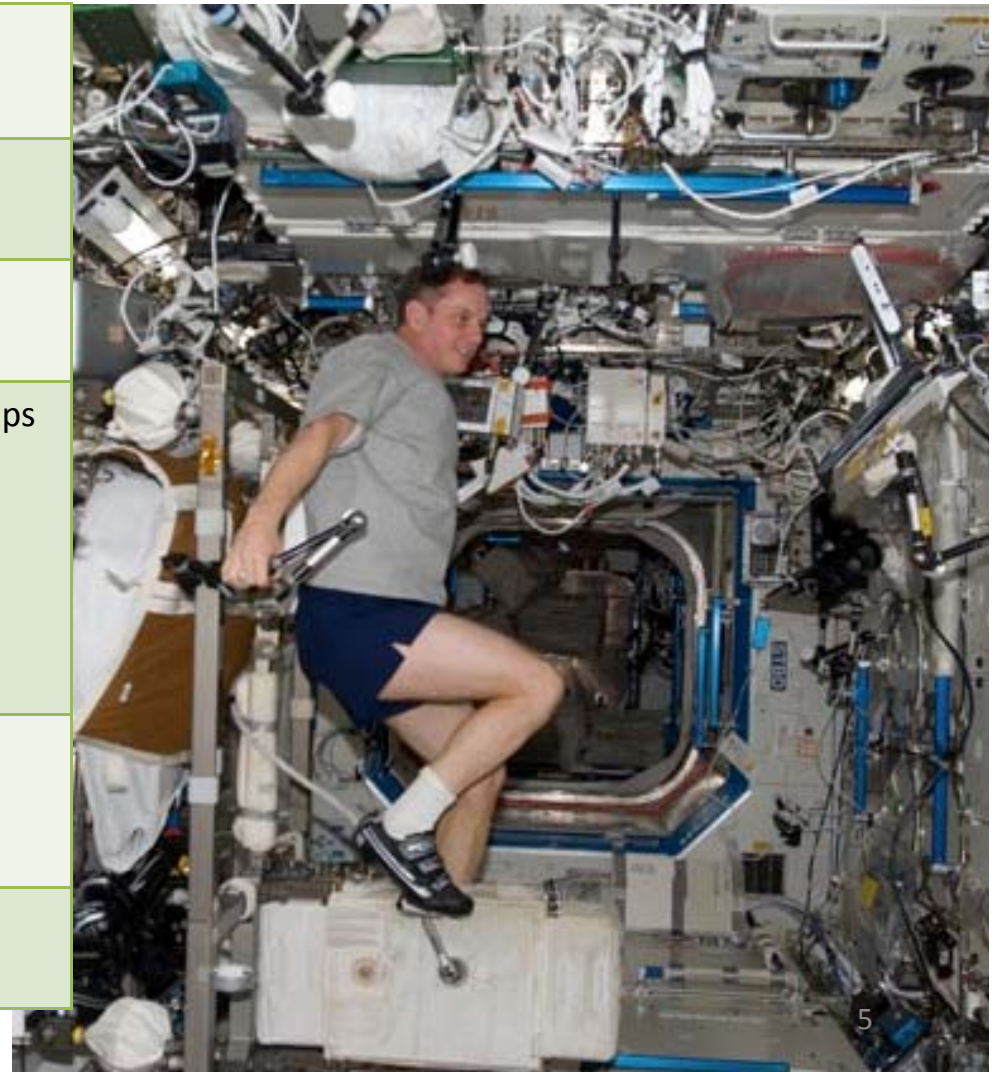
Cycle Ergometer with Vibration Isolation & Stabilization (CEVIS)

Years On-Orbit	12 years (inst. Mar 2001) (~ 30 min/day)
Total Hours used	2,037 hours (through Feb 2013)
Maximum Load Capability	350W
Data Captured	<ol style="list-style-type: none"> 1. Exercise Duration & Time Stamps 2. Speed (Planned & Actual) 3. Workload (Planned & Actual) 4. Heart Rate 5. Crew ID 6. Protocol Name 7. Example video
Yearly Maintenance Time Required	Maximum of 2.5 hours
External Interface	Operable through RS-232 Port

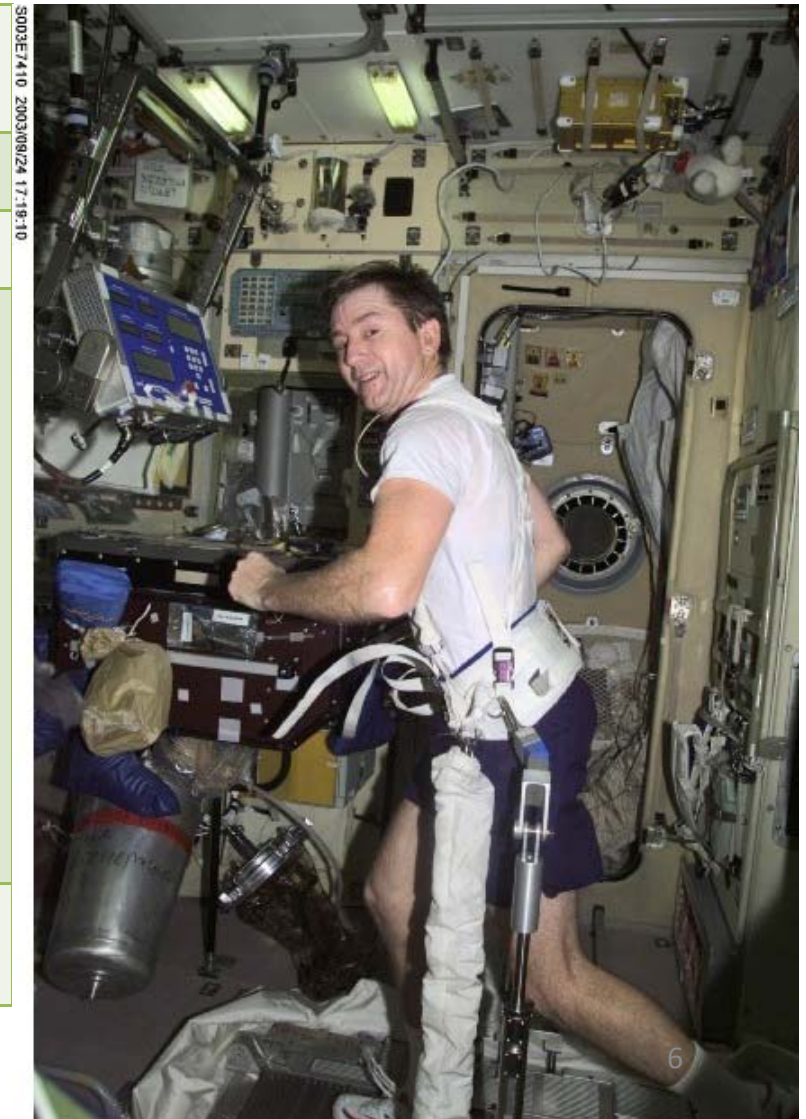
Treadmill with Vibration Isolation & Stabilization (TVIS)

Years On-Orbit	12 years (1 hr/crew/day)
Total Hours Used	Approx. 4,100 hours
Maximum Speed	10 mph
Data Captured	<ol style="list-style-type: none"> 1. Exercise Duration & Time 2. Session Distance 3. Belt Speed 4. Subject Loading 5. Gyroscope Speed 6. Temperatures 7. Voltages/Currents 8. Heart Rate 9. Crew ID 10. Example videos
Yearly Maintenance Time Required	Approx. 30-35 hours

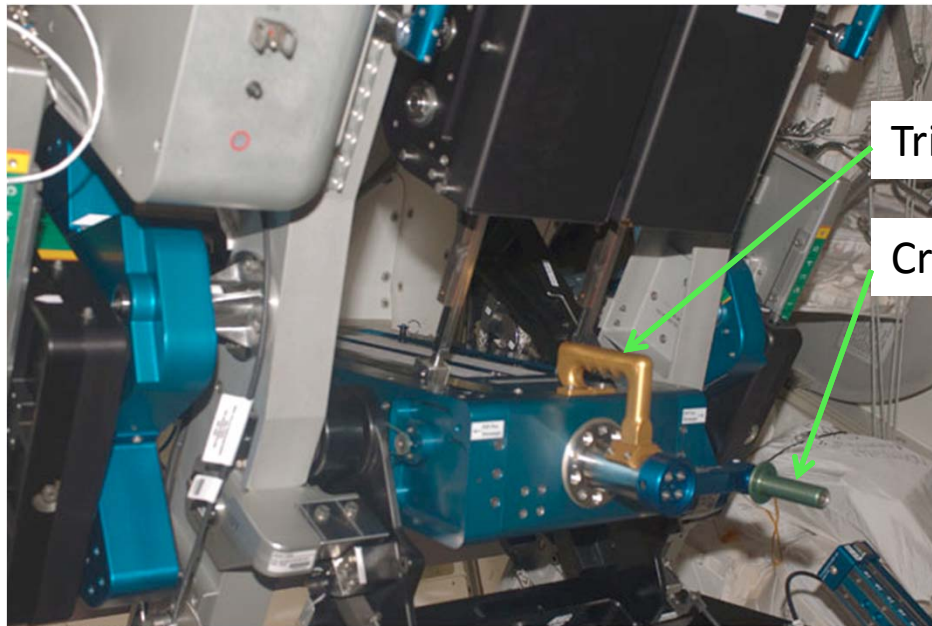
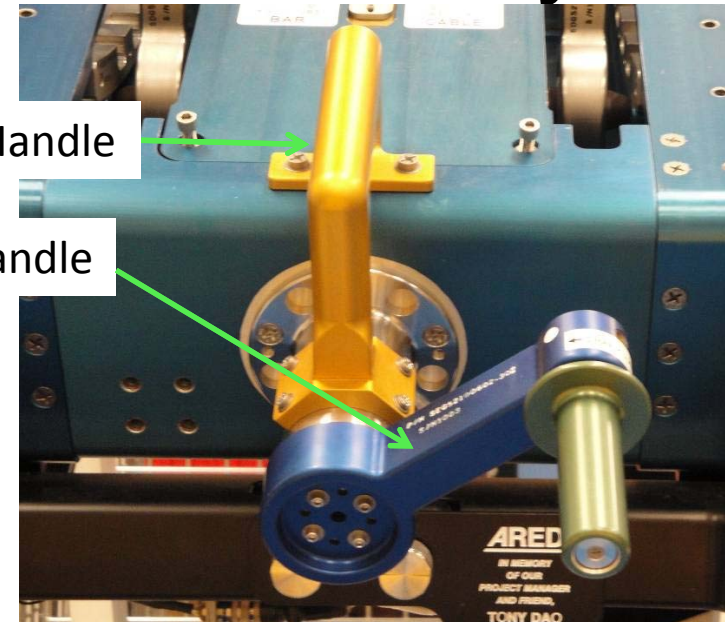
ARED Crank Handle Anomaly

- Jan 2012 Crew experienced the load jump when they would adjust it and during exercise.
- Investigation identified 2 issues preventing further ARED use:
 1. A keyed connection pin between the load adjustment unit (LAU) and the crank handle had walked out resulting in the decoupling of the LAU from the handle.
 2. Unexpected use of the handle and release mechanism had worn down the locking pin and the ratcheting mechanism
- Short Term repairs (see next page)
 1. A Snap-On Deep Socket was used as spacer to push the key back into position and secure it
 2. A Fastener was used to act as the locking pin for the ratcheting mechanism
- Replacement components were flown within a few weeks and installed about 3 months later.

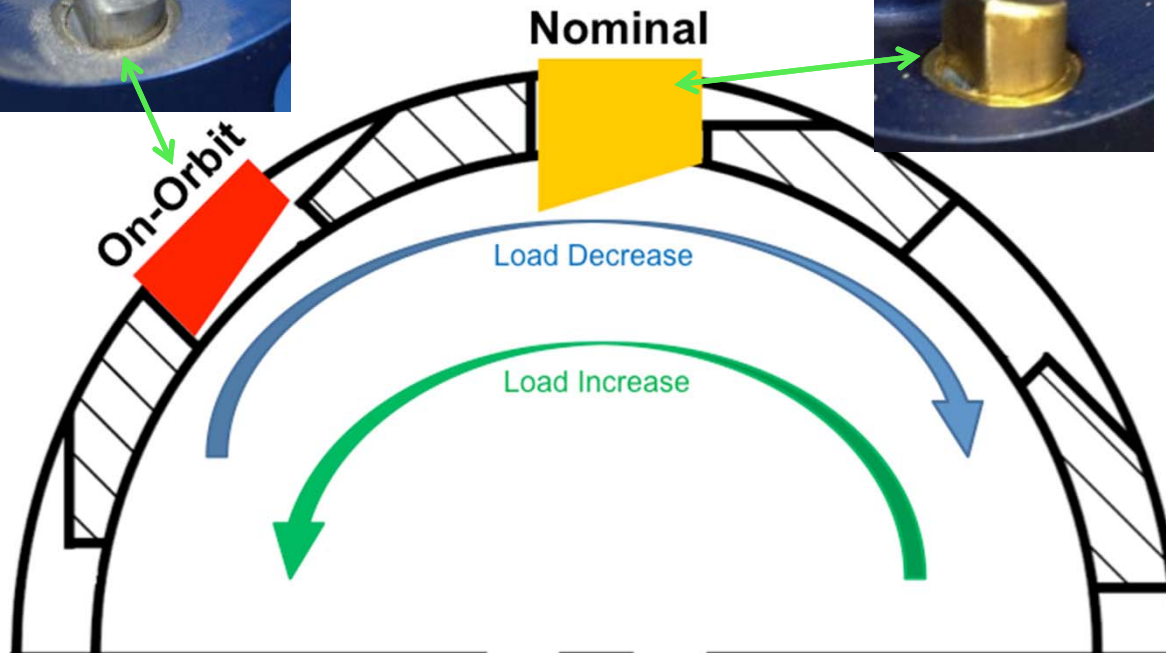
ARED Crank Handle Anomaly

Not to scale

Locking Design
Repair limited load
adjustments to 7-
10 lb. increments
until replaced.

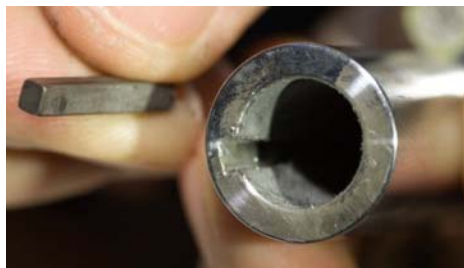
Keyed connection pin

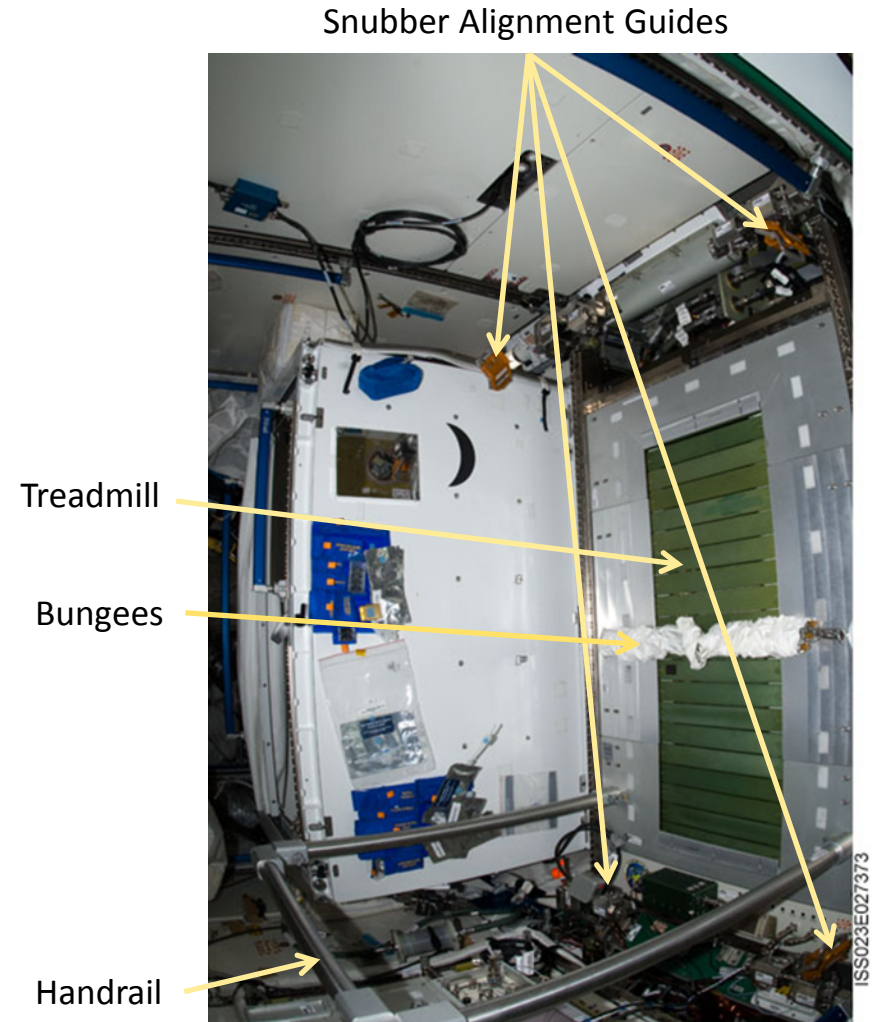
T2 Power Avionics Unit (PAU) Anomaly

- Data signatures in April 2010 pointed to a failure of the Power Avionics Unit (PAU) secondary 120 Volt circuit.
- Short term recovery turned off the power to the damaged circuits which limited the maximum speed on T2.
- PAU was replaced several months later and full capability was restored.

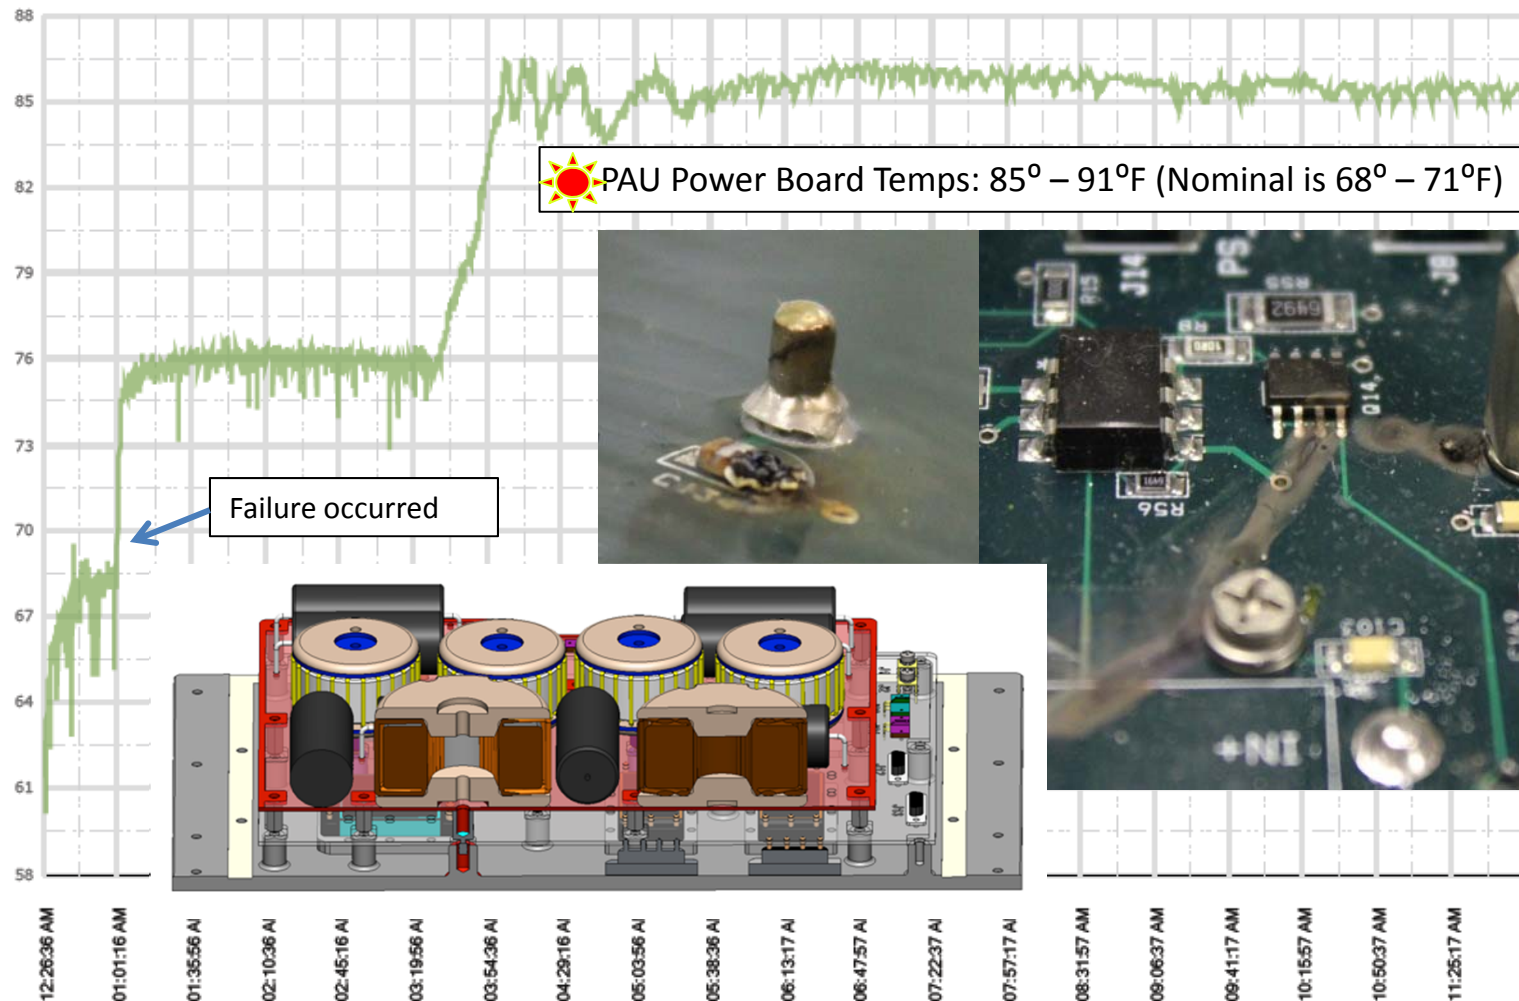
T2 Power Avionics Unit (PAU) Anomaly

PAU Power Board Temp beginning on 4/10/2010 00:00:00 for 12 hours
