Self Diagnostic Accelerometer Ground Testing on a C-17 Aircraft Engine

Abstract—The self diagnostic accelerometer (SDA) developed by the NASA Glenn Research Center was tested for the first time in an aircraft engine environment as part of the Vehicle Integrated Propulsion Research (VIPR) program. The VIPR program includes testing multiple critical flight sensor technologies. One such sensor, the accelerometer, measures vibrations to detect faults in the engine. In order to rely upon the accelerometer, the health of the accelerometer must be ensured. Sensor system malfunction is a significant contributor to propulsion in flight shutdowns (IFSD) which can lead to aircraft accidents when the issue is compounded with an inappropriate crew response. The development of the SDA is important for both reducing the IFSD rate, and hence reducing the rate at which this component failure type can put an aircraft in jeopardy, and also as a critical enabling technology for future automated malfunction diagnostic systems. The SDA is a sensor system designed to actively determine the accelerometer structural health and attachment condition, in addition to making vibration measurements. The SDA use

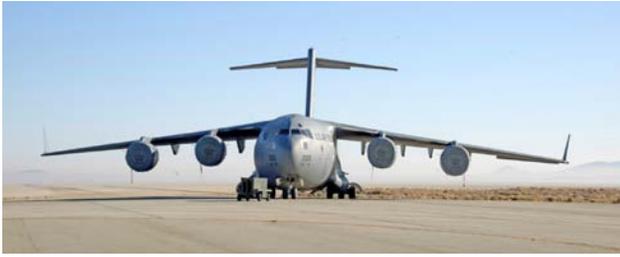
Figure 1. C-17 Aircraft used in VIPR testing of the SDA.

further by installing SDAs in an operating turbojet engine installed on a grounded aircraft. For this work, the SDAs were installed on a C-17 aircraft engine as part of the Vehicle Integrated Propulsion Research (VIPR) engine tests in 2011.

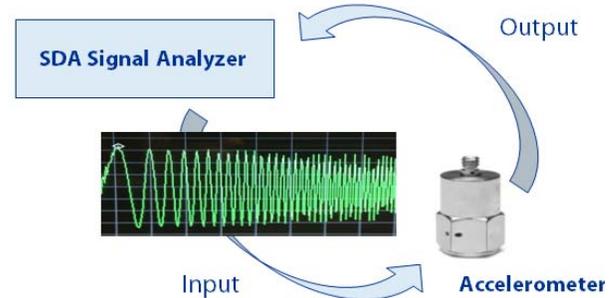
By sending an electrical chirp to the accelerometer and measuring the response (output/input), as seen in Fig. 2, the signal analyzer can monitor for any changes in the response. The changes in the response pattern depend on the mechanical and electrical impedance of the SDA system. The mechanical and electrical impedance is related to the health and attachment of the accelerometer.

Figure 2. Model of the SDA system.

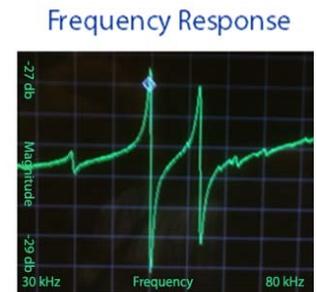
The SDA diagnostic response, measured in the frequency domain, is unique to each accelerometer and its base attachment condition. The diagnostic response takes the form of a series of resonant antiresonant pairs that shift and change according to the health and attachment condition of the accelerometer. A baseline reference signal is taken for each SDA in the tightly attached condition. Deviation from this reference signal may be used as an indicator of the health and attachment condition of the accelerometer. An example of the frequency response (output signal divided by input signal) of a healthy accelerometer is shown in Fig. 3. The resonant frequencies of the system stand out as spikes in the signal. The SDA diagnostic chirp ranges between 30 and 80 kHz. This is outside and thus doesn’t interfere with the typical signal bandwidth (< 25 kHz) of the accelerometer used as a vibration sensor.

Figure 3. SDA frequency response example of a healthy sensor.

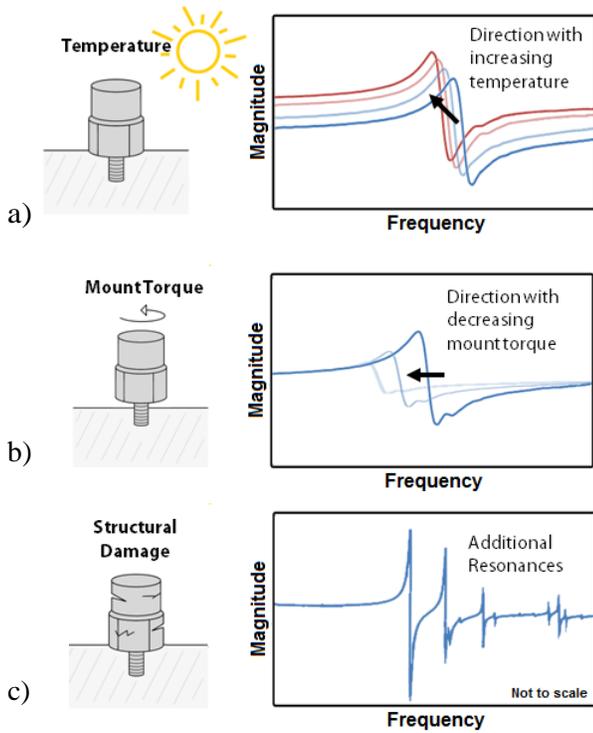
Empirical models have shown a predictable change in the accelerometer diagnostic response caused by a change in the accelerometer’s environment [7] as shown in Fig. 4. These changes include changes in temperature, mount torque, and structural integrity.

Temperature increase causes the frequency response pattern to shift up and to the left in the magnitude vs. frequency plot as seen Fig. 4a. The frequency response pattern generally remains the same with the number of resonances and the separation between them remaining unchanged.

Mounting torque decrease (loosening the attachment condition) causes existing resonances to shift to the left and become smaller in the magnitude vs. frequency plot as seen in Fig. 4b. As the attachment condition transitions from tight to loose, the resonances disappear entirely and new resonances may spontaneously appear elsewhere in the diagnostic band. The number of resonances and the separation between them changes so much that the frequency response pattern for the tight and loose condition are completely different and can, as a result, be used to determine the sensor attachment condition.

Accelerometer structural damage results in a change in the frequency response pattern inconsistent with the reference healthy condition frequency response pattern. Typically a damaged accelerometer will have additional resonances. If the piezoelectric crystal is critically damaged, the electrical connection could be disconnected resulting in an entirely unresponsive accelerometer.

Figure 4. SDA Resonant frequency changes due to a) temperature, b) mount torque and c) structural damage.

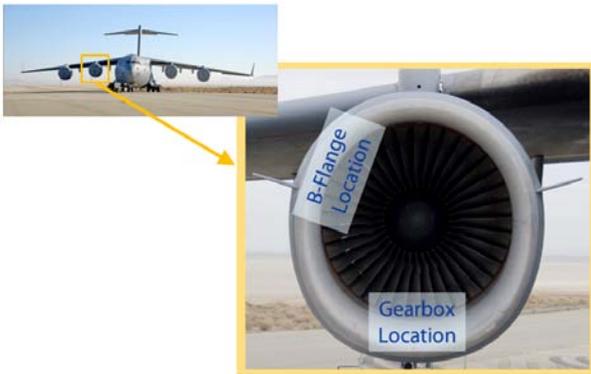
Four SDAs were installed on the engine under the cowl at two locations: the B-Flange and Gearbox as indicated in Fig. 5. Each location had one SDA tightened

Figure 5. SDA installations located inside the C-17 engine at the B-Flange and Gearbox.

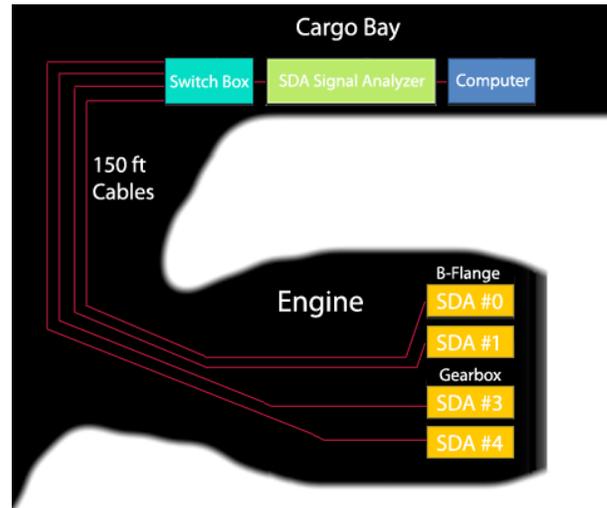
A schematic of the installation of the SDA system on the C-17 aircraft is shown in Fig. 7. The four accelerometers, labeled as SDA #0, #1, #3 and #4, were installed on the engine. SDAs #0 and #1 were installed in the B-Flange location. SDAs #3 and #4 were installed in the Gearbox location. The accelerometers were connected to 150 ft cables. The cables passed through an opening in the engine framing, traced along the aircraft wing, and then entered the fuselage/cargo bay where they connected into a switch box. The switch box was used to select which accelerometer was connected to the signal analyzer. The computer controlled the signal analyzer and saved the resulting diagnostic data with the aircraft time tag. The researcher was located in the cargo bay with the switch box, SDA signal analyzer, and computer. The researcher observed the SDA data in real time to

Figure 7. A model of the SDA system and connections installed on the C-17.

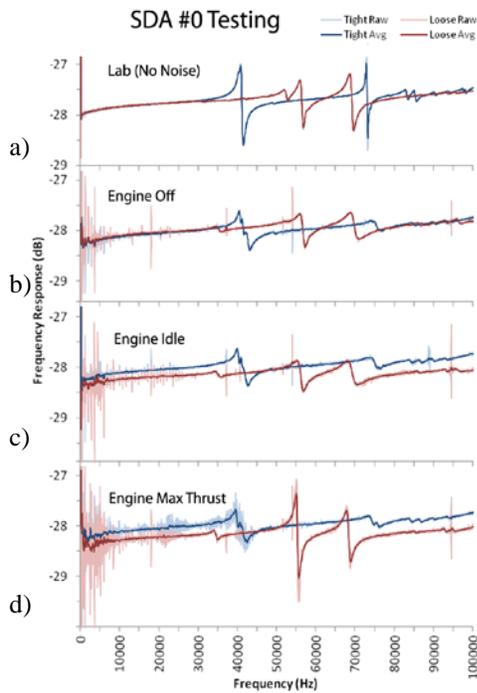
The results from VIPR testing of four SDAs are shown in Figs. 8-11. The B-Flange SDA datasets are shown in Figs. 8 and 9. The Gearbox SDA datasets are shown in Figs. 10 and 11. The blue and red plots represent the tight and loose accelerometer attachment conditions, respectively. The lighter color plots, labeled as raw, are the unprocessed cumulative plots of approximately 10 datasets from the named tight or loose attachment condition. To better visualize the noise in the raw datasets, the average of the raw datasets is plotted as a darker color plot and labeled as average. The average is calculated by averaging the 10 datasets and then smoothing using boxcar averaging with a width of 5 data points.

Figure 8. SDA #0 tight and loose results from the a) laboratory, b) B-Flange engine off, c) B-Flange engine idle, and d) B-Flange engine maximum thrust.

The laboratory datasets were collected at room temperature, without any vibrations, and with minimal interfering setups (no cable or EMI noise concerns). The mounting hardware and safety wire used in the lab were identical to the configuration used in the C-17 testing. The ideal environment in the lab resulted in stable and consistent SDA signals. For this reason, the laboratory datasets for each SDA were used as the reference signals in the Eqs. 3 and 4 calculation of the *Health Index* values.

The engine off datasets were taken in the C-17 engine with the engine off during a cool day. The plots show the presence of minor noise in the SDA system. Although the engine was off, vibrations in the low frequency range are present (<10 kHz). The vibrations were most likely caused by the auxiliary power unit located in the lower portion of the aircraft fuselage. The auxiliary power unit was on to provide power to the SDA. Higher frequency noise spikes, most notably seen at frequencies 18 kHz, 37 kHz, 54 kHz, and 95 kHz, are present most likely from electrical interference from nearby cables used in other aircraft systems. This electrical interference is also present when the engine is on such as for idle and maximum thrust.

The engine idle datasets were taken in the C-17 engine with the engine at idle. The plots show increased levels of noise present in the SDA system (<10 kHz). Due to the close proximity of the SDA to the engine, engine noise is expected.

The engine maximum thrust datasets were taken in the C-17 engine with the engine at maximum thrust. These plots also show increased noise levels (<50 kHz)

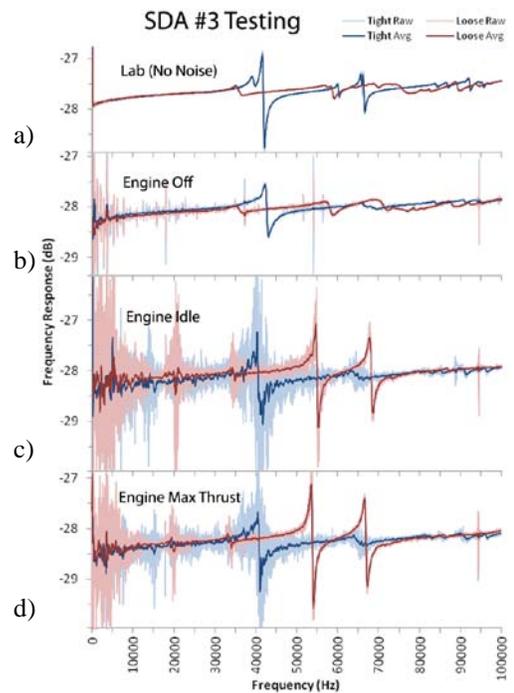
Figure 10. SDA #3 tight and loose results from the a) laboratory, b) Gearbox engine off, c) Gearbox engine idle, and d) Gearbox engine maximum thrust.

For the engine idle and engine maximum thrust conditions the Gearbox location shows a significant increase in noise over the engine off datasets. This broadband noise (<100 kHz) attenuates at the higher frequencies. This noise was not present in the B-Flange datasets.

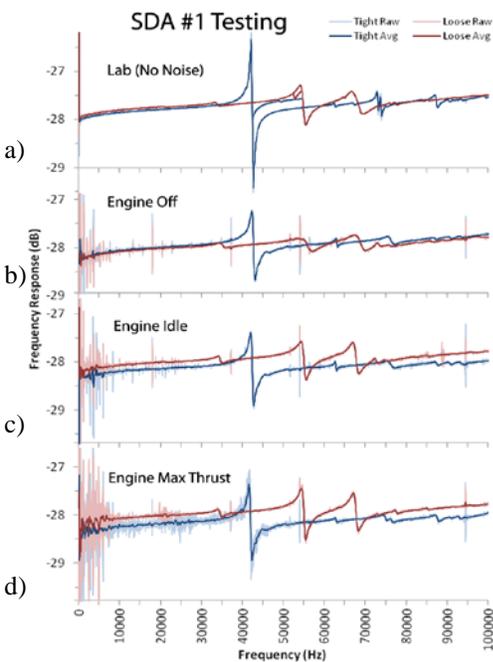
Figure 9. SDA #1 tight and loose results from the a) laboratory, b) B-Flange engine off, c) B-Flange engine idle, and d) B-Flange engine maximum thrust.

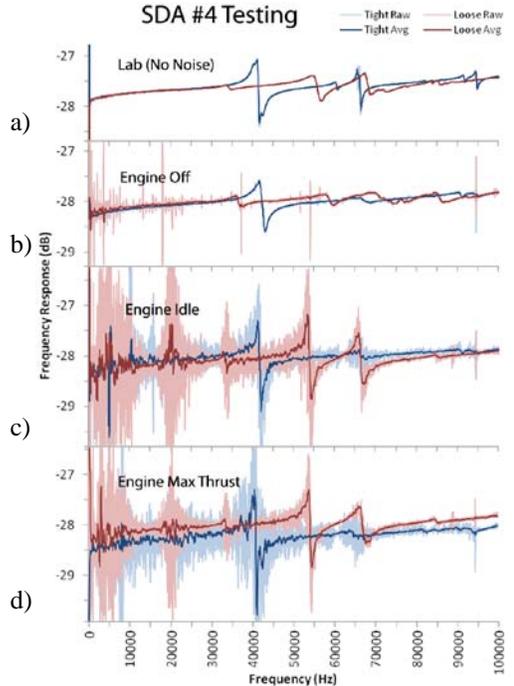
Figure 11. SDA #4 tight and loose results from the a) laboratory, b) Gearbox engine off, c) Gearbox engine idle, and d) Gearbox engine maximum thrust.

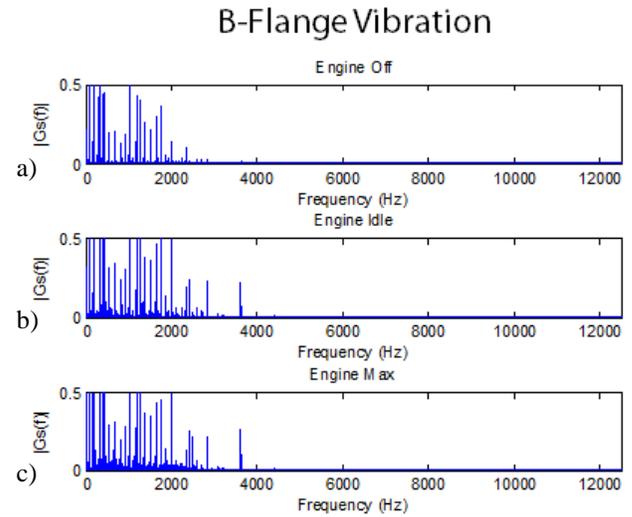
Vibration measurements were collected from nearby legacy 25 kHz sampling rate B-Flange and 50 kHz sampling rate Gearbox accelerometers. The vibration measurements were taken over 1 minute with the engine off, engine idle, and engine maximum thrust. The Fast Fourier Transforms (FFTs) of this data were calculated for the B-Flange and Gearbox accelerometers and are shown in Figs. 12 and 13 respectively. The FFT vibration results show that the vibrations drop off beyond 5 kHz. The acceleration root mean square, a_{rms} , values are displayed in Table 1. The results show a consistent relationship between the increase in vibrations and the increase in SDA noise except for the Gearbox engine idle and engine maximum thrust data. The large amount of noise present in the data from SDA Gearbox engine idle and maximum thrust levels did not show up in the vibration measurements.

Figure 12. B-Flange legacy accelerometer vibration measurements for 1 minute with the engine a) off, b) idle and c) maximum thrust.

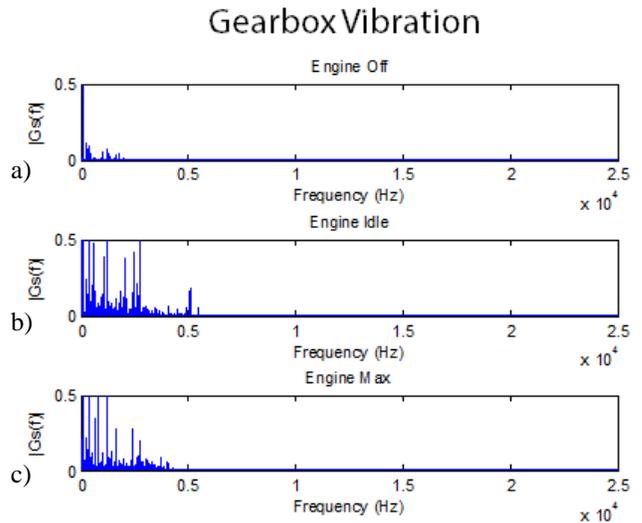
Figure 13. Gearbox legacy accelerometer vibration measurements for 1 minute with the engine a) off, b) idle and c) maximum thrust.

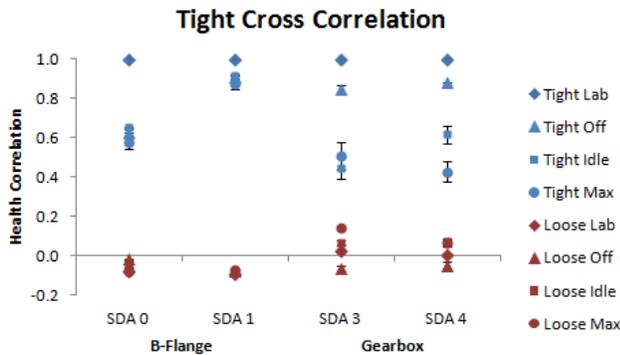
Using the entire collection of raw VIPR data, the *Health Index* values were calculated using Eqs. 3 and 4 for each dataset. Ten datasets for each condition are averaged together and plotted in Figs. 14 and 15. The average is plotted with 2 standard deviations used as the error bar width.

The tight reference signal, from the SDA in the laboratory, cross correlated with the experimental signal from the same SDA with the various attachment conditions and environments determines the *Health Index* values shown in Fig. 14. These results positively identify the tight condition with a high correlation.

Figure 14. *Health Index* calculated by using the tight reference correlated with the corresponding SDA for the tight and loose attachment conditions in the laboratory, engine off, idle, and maximum thrust levels.

The SDA cross correlation pattern recognition health algorithm successfully discriminates the healthy SDA from the faulty SDA for all tests. The tight reference cross correlated with the tight experimental condition has a minimum correlation of 0.43 ± 0.05 which is significantly higher than the maximum correlation of 0.14 ± 0.01 for the tight reference cross correlated with the loose experimental condition. If the datasets are first averaged before the cross correlation, the minimum correlation of 0.43 value improves to 0.63, while the 0.14 value goes to 0.15. The significant difference in the correlation numbers strengthens the argument that cross correlation pattern recognition can successfully determine whether the SDA is in a healthy tightly attached condition. The SDA system was successful in determining the tightly attached condition even when significant amount of noise was present, as seen in the Gearbox SDA data in the engine idle and maximum thrust levels.

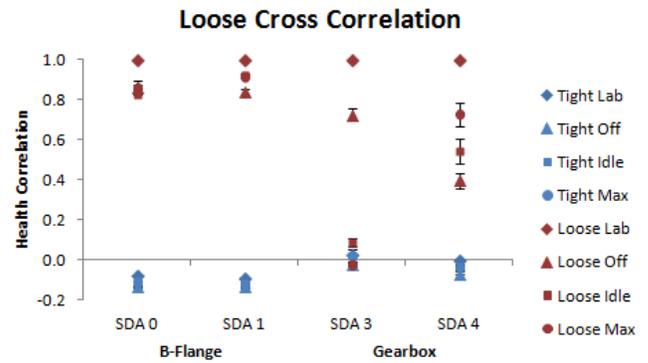
The loose reference signal, from the SDA in the laboratory, cross correlated with the experimental signal from the same SDA with the various attachment conditions and environments determines the *Health Index* values shown in Fig. 15. These results positively identify the loose fault with a high correlation except for the SDA 3 experimental loose attachment condition with the engine idle and maximum thrust levels. At these two conditions the *Health Index* was lower than expected because the reference resonance extrema were not as pronounced as the experimental resonance extrema. This exemplifies the lack of consistency in the loose fault and correspondingly makes it difficult to develop a reliable loose fault reference.

Figure 15. *Health Index* calculated by the loose reference correlated with the corresponding SDA for the tight and loose attachment conditions in the laboratory, engine off, idle, and maximum thrust levels.

noisy Gearbox datasets for the engine idle and engine maximum thrust, the worst case tight correlation improved from approximately 0.4 to 0.8. The worst case loose correlation improved from approximately 0.4 to 0.5. Cross correlating the average data did not improve the lower than expected results for the loose attachment conditions for SDA 3 engine idle and engine max thrust.

Using the loose cross correlation to confirm the loose fault was successful in all but two test cases: engine idle and max thrust levels for SDA 3. For these two test cases, the resonant frequencies were greater in magnitude than the loose reference SDA 3 in the lab. This exemplifies the lack of consistency in the loose fault. This inconsistency

makes it difficult to save a reliable loose fault reference for use in the cross correlation pattern method. With the exception of these anomalies the results confirmed the loose fault. The loose reference cross correlated with the loose experimental condition has a minimum correlation of 0.39 ± 0.04 which is higher than the maximum correlation of 0.02 ± 0.00 for the loose reference cross correlated with the tight experimental condition. If the datasets are first averaged before the cross correlation, the minimum correlation of 0.39 improves to 0.47, while the 0.02 value goes to 0.04. The difference in the correlation numbers supports the argument that cross correlation pattern recognition can successfully determine the fault of the SDA. Even so, confirming a specific fault type through cross correlation can be difficult because the resonant frequency pattern in a faulty system may not always be consistent, as it is for the healthy tightly attached condition.
