# KSC Electrostatic Discharge (ESD) Issues

**Dr. Charles Buhler\***

**Electrostatics and Surface Physics Laboratory**

**NASA Kennedy Space Center, FL**

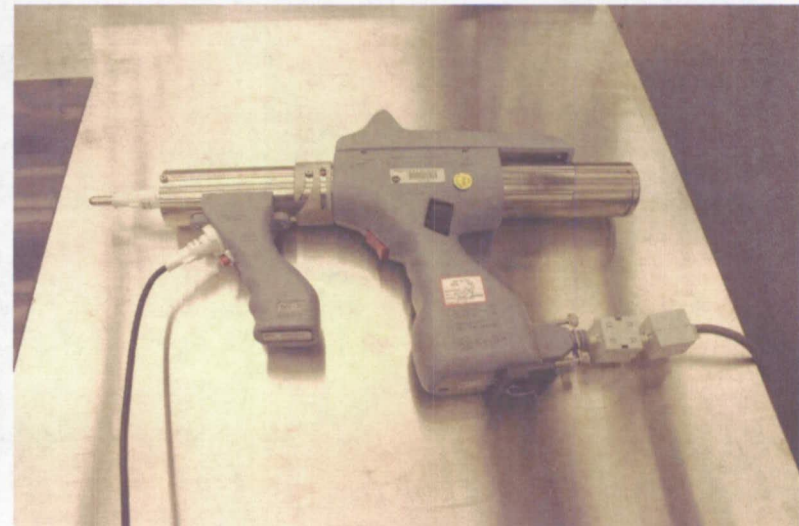
# Shuttle Crew Escape Equipment Life Preserver and Life Raft Inflator

- Concern: Human body discharge could set off explosive and inadvertently deploy units
- Tests performed using IEC 61000-4-2 test standard using 25,000 volts to simulate human generated spark.

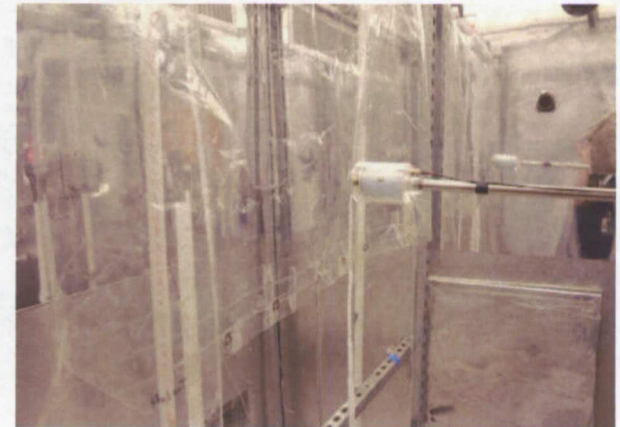
# Tail Service Mast Aclar Purge Barrier Curtain

- Concern: Triboelectric charging of curtain during operations
- Measurements showed large potentials reached when deploying
- Aclar failed Spant Incendivity Testing
- Solution: Simple wet wipe to dissipate charge

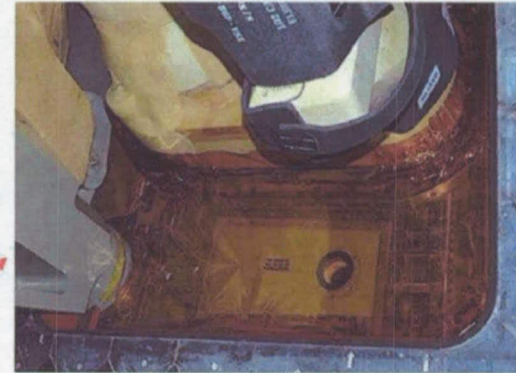
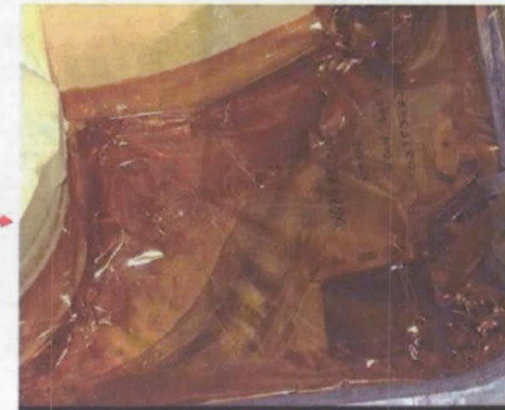
# Kapton Purge Barrier Baggie

- Concern with triboelectric charging of baggie during installation and during launch
- Kapton fails standard Spark Incendivity Test

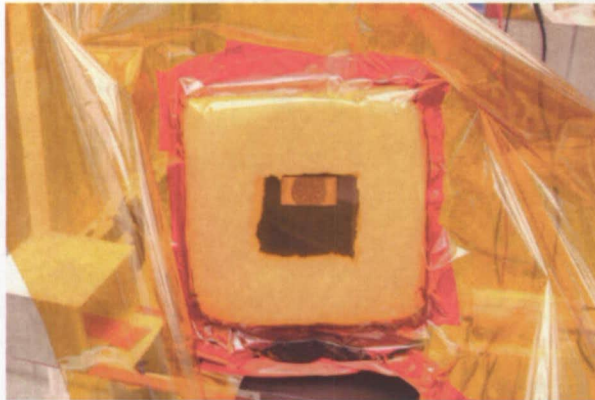
# Kapton Purge Barrier Baggie

Hundreds of realistic Spark Incendivity Tests showed that charge levels obtained with internal components reached -55 kV but were not capable creating ignitions (67 KV needed for ignition)  
Charge induced during installation dissipates at 70% RH (Kapton is hydrophilic)  
Future launches: Lowest recorded RH: 7% - Tests are ongoing

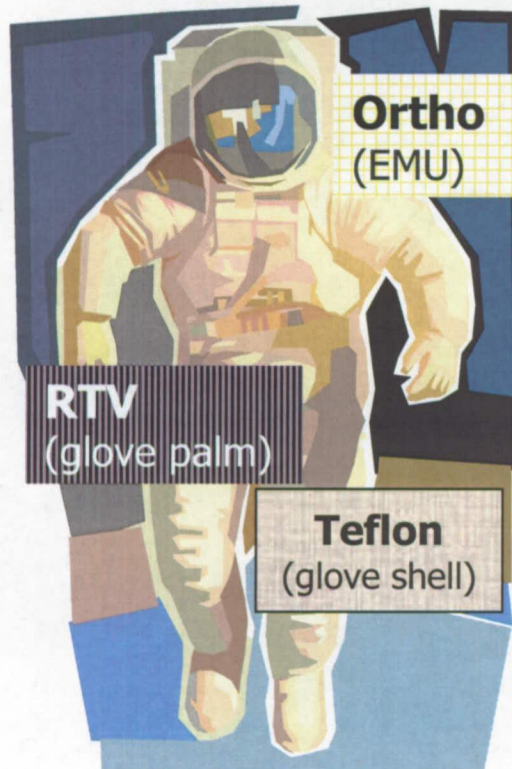
# HST STIS Repair

- Testing and evaluation of the ESD threat due to triboelectric charging of ST Infrared Spectrometer electronic boards to be replaced

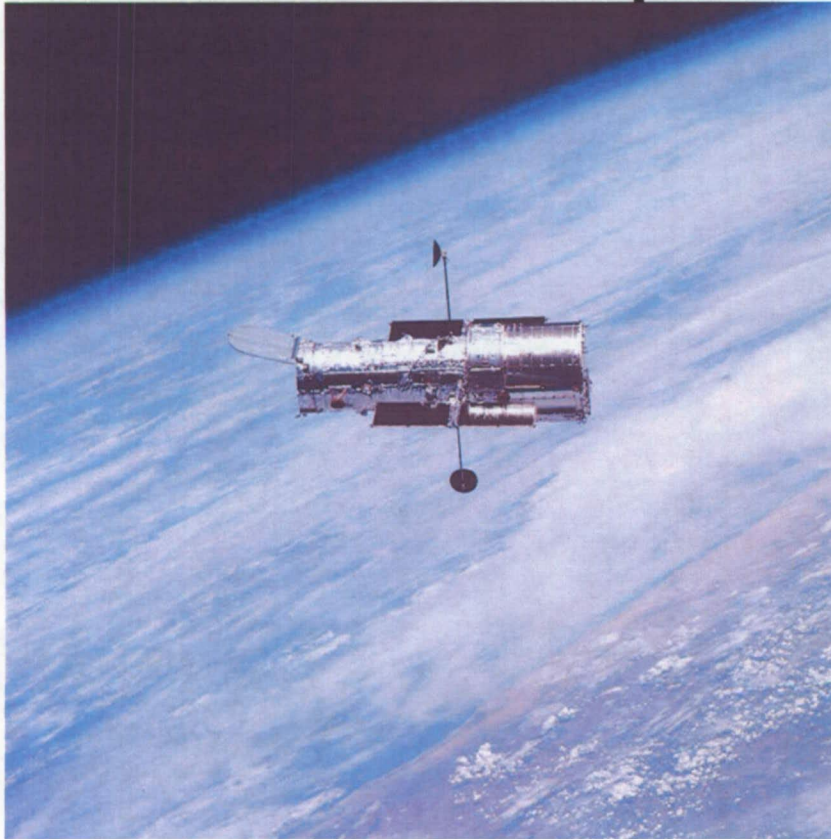
# HST Repair Mission: ACS

- Electrostatic evaluation of Advanced Camera for Surveys electronic card replacement unit
