Evaluation of a Microwave Blade Tip Clearance Sensor for Propulsion Health Monitoring

Mark R. Woike

NASA Glenn Research Center

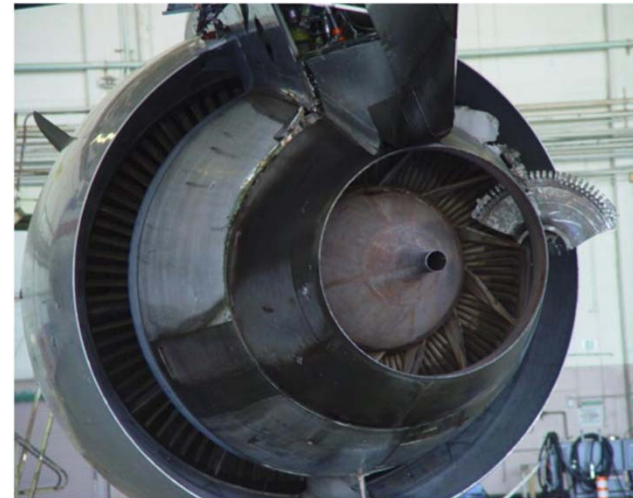
Turbine Disk Failure – June 2, 2006

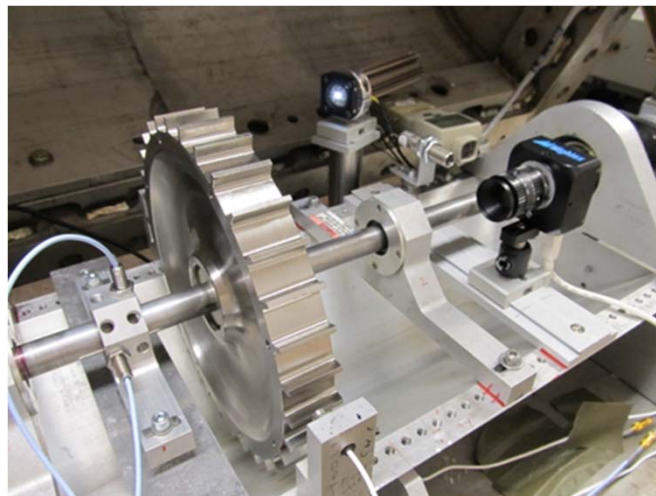
Crack Detection Experiments in GRC Rotordynamics Lab

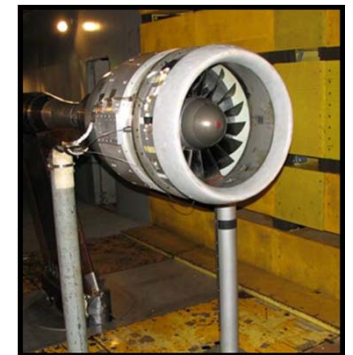
Rotordynamics & Fault Detection in Lab Testing

- Microwave tip clearance sensors and measurement developed by **Radatec, Inc (now Meggitt)** through the NASA Small Business Innovation Research (SBIR) Program and other commercial contracts
 - Phase III SBIR commercialization contract 2006-2007
 - First generation (5.8GHZ) production probes delivered in 2008
 - Second generation (24GHZ) probes delivered in 2009
- The use of microwave sensors for making tip clearance and tip deflection measurements is an emerging technology
 - Techniques on their use and calibration need to be developed
 - The sensor's overall accuracy and ability to make clearance measurements need to be evaluated
- Several evaluation experiments were accomplished from 2006 to now as a means of building toward primary goal of using these sensors on an actual engine

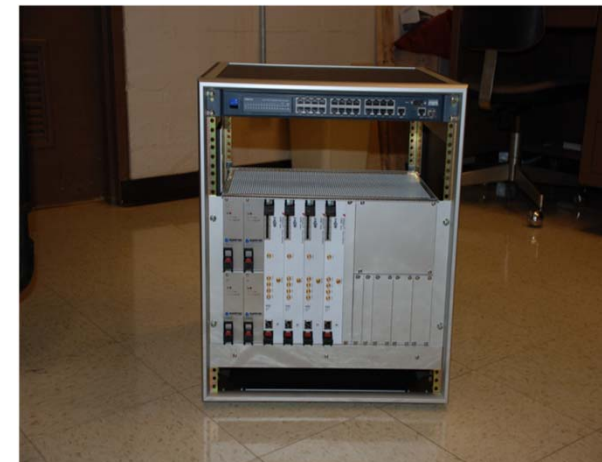
Microwave Sensor Electronics

- Sensor Electronics
 - Contains the microwave generator and detector
 - Data acquisition & display computer
 - Located off board of test article or engine
 - Connected to sensors via co-axial cable

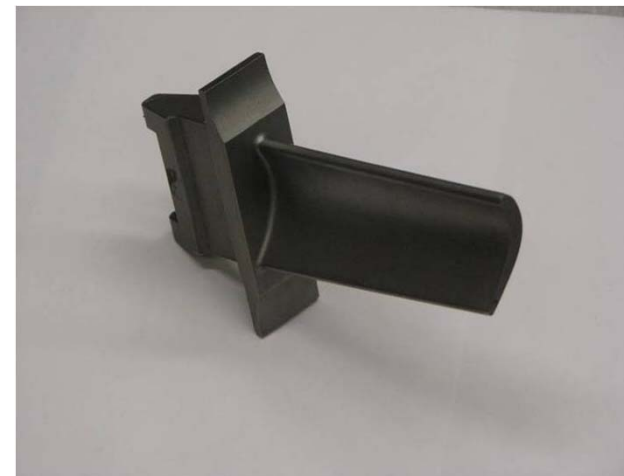
"Thin" Compressor Blade

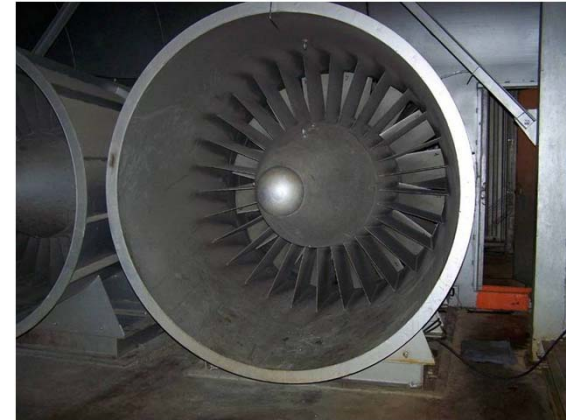
Axial Vane Fan at the Glenn Research Center's 10x10 Wind Tunnel

- Axial Van Fan
 - 1.8 M Diameter, operates at 1200 RPM
 - 16 Blades, ~26 mm thick (~1"), ~362 mm (~14") long, ~267 (~10.5") mm chord length
 - One 5.8GHZ probe installed

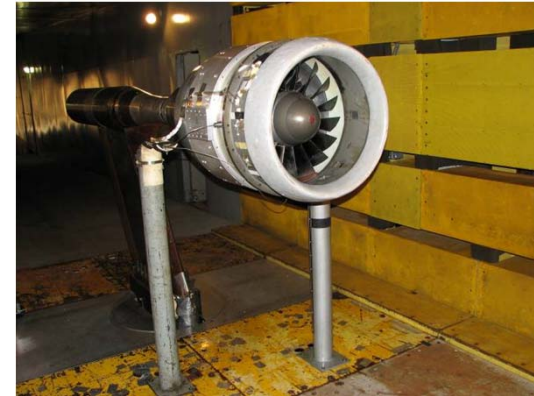
NASA Turbofan at the Glenn Research Center's 9x15 Wind Tunnel

- Objectives:
 - Demonstrate the microwave sensors ability to acquire blade tip clearance measurements on an aero engine size test article and blades
- NASA Turbofan:
 - Subscale turbofan propulsion simulator
 - 2 probes (5.8GHZ) installed, 90° apart
 - 18 Composite Blades
 - Blade tips were coated with nickel to allow measurement by microwave probes
- Outcome / Results:
 - Acquired tip clearance data for several test runs of the turbofan
 - ***The change in tip clearances measured during fan operation was in-line with previous data acquired with capacitive probes on earlier test entries***
 - ***Demonstrated the sensor's ability to make measurements on "aero" engine size hardware***

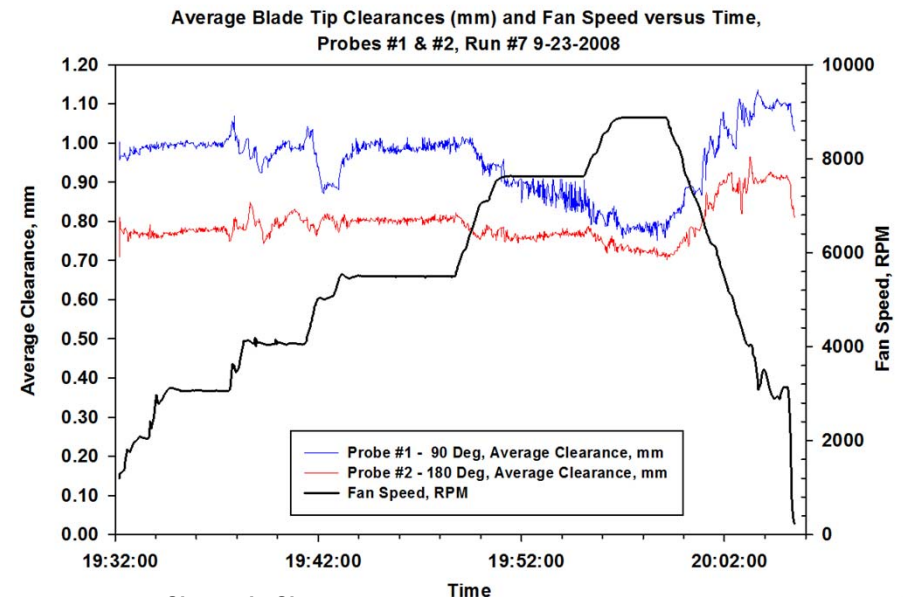
Change in Clearance
Probe #1 $\Delta = 0.22$ mm ($\sim .009$ "")
Probe #2 $\Delta = 0.06$ mm ($\sim .002$ "")

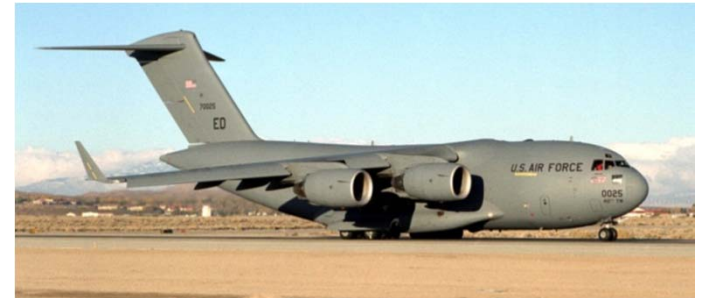
- VIPR I test was conducted in December 2011 at NASA Dryden / Edwards Air Force Base
- Test vehicle:
 - Boeing C-17 Globemaster III
 - Equipped with Pratt & Whitney F117 turbofan engines
- VIPR 1 EHM ground tests included:
 - A series of nominal and faulted engine test cases
 - Data collected over a range of power settings including quasi-steady-state and transient operating conditions
