Engineered Polymer Composites Through Electrospun Nanofiber Coating of Fiber Tows

Lee W. Kohlman
Glenn Research Center, Cleveland, Ohio

Abstract

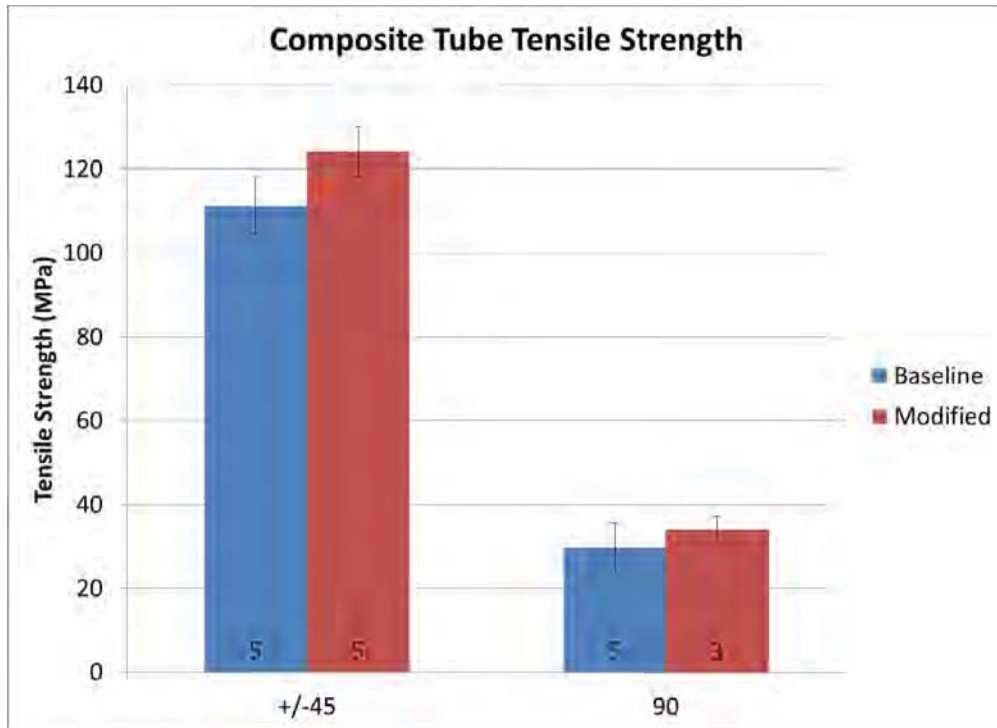
Figure 26.—Average peak stress for tension specimens, error bars represent two times standard deviation, the number of specimens appear in the bottom of each bar, baseline (blue) and modified (red).

The lack of change in the 90° tension specimens may imply poor bonding of the nanofiber to the matrix material or that an insignificant quantity is present to appreciably affect the transverse tensile strength of the composite. Additional testing is needed to further investigate the adhesion of the epoxy matrix to the polymer nanofiber.

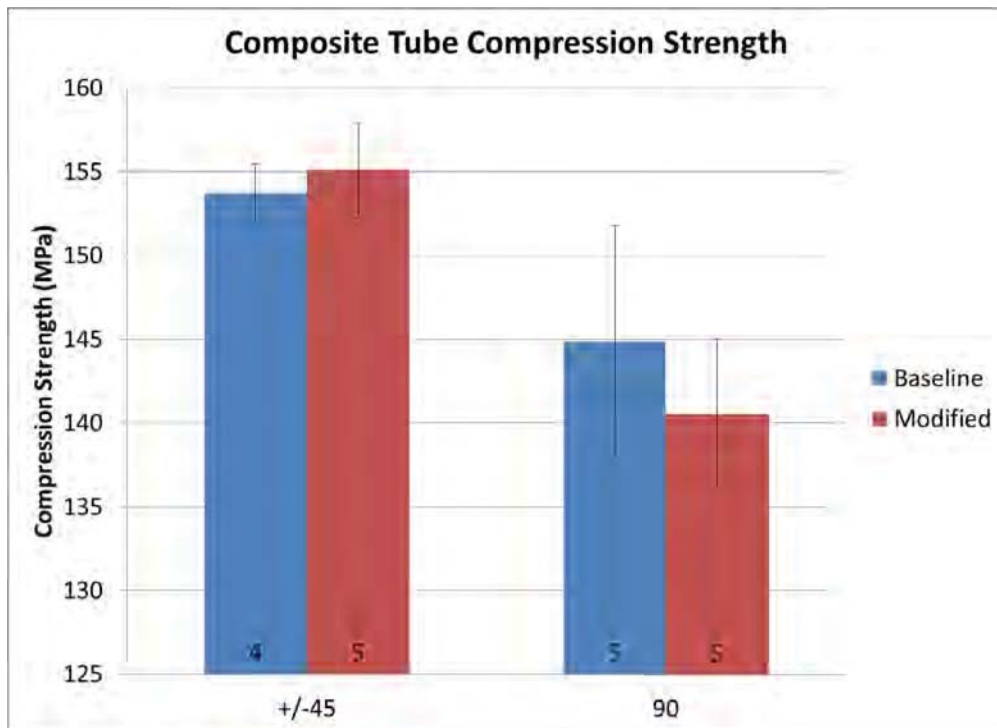
Figure 27.—Average peak stress for compression specimens, error bars represent two times standard deviation, the number of specimens appear in the bottom of each bar, baseline (blue) and modified (red).

Figure 27 shows the measured compression strengths with error bars representing two times the standard deviation. The baseline values are shown in blue and the modified tube values shown in red. The numbers in the bottom of each bar indicate the number of specimens used in the computations. The $\pm 45^\circ$ tension tubes with the added nanofiber toughener shows an increase in average strength of 11.6 percent over baseline with two times the standard deviation of baseline and modified set not showing an overlap. The average strengths of the remaining modified test sets show no significant difference as compared to the baselines when the standard deviation overlaps are considered. This is true not only for two times standard deviation but one standard deviation as well. This is because the main driver for ultimate failure of the $\pm 45^\circ$ tension tube is interlaminar shearing of the tow to tow interface, whereas the other specimens undergo different failure mechanisms including in-plane shear and transverse tension that are less affected by the nanofiber toughener.

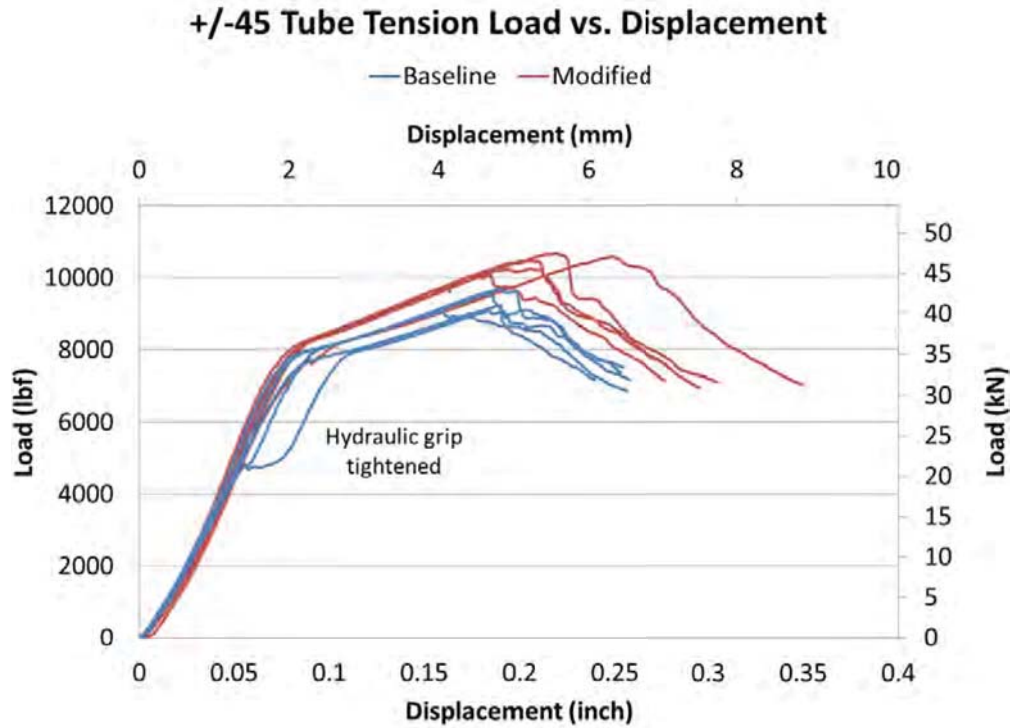
Figure 28.—Load vs. displacement curves for all tubes with the $\pm 45^\circ$ wind angle loaded in tension.

The $\pm 45^\circ$ tensile specimens deformed significantly (radial contraction) following the onset of nonlinearity above 8000 lb (35.6 kN) load (Appendix C). Ultimate failure was characterized by a peak in load followed by an extended unloading (negative load/displacement curve slope) resulting from progressive delamination of the tows. The 90° tensile specimens failed at the end cap bond line at relatively low load with no nonlinear deformation as anticipated. Figure 23 shows a $\pm 45^\circ$ tensile specimen after failure, still mounted in the load frame.

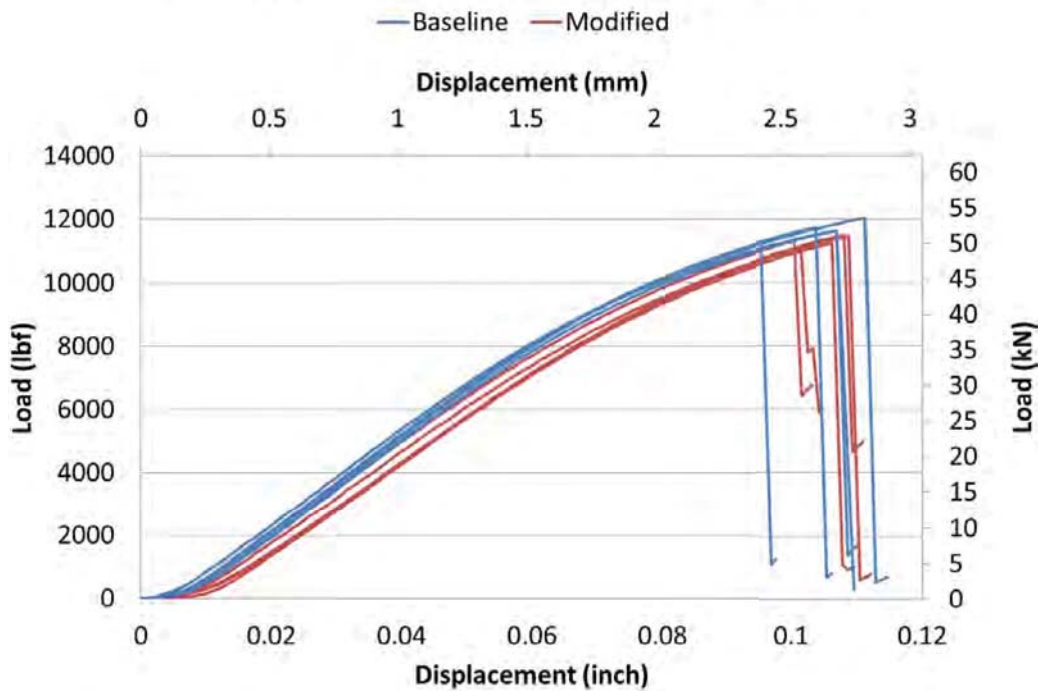
90 Tube Compression Load vs. Displacement

Figure 31.—Load vs. displacement curves for all tubes with the 90° wind angle loaded in compression.
