# **Calcium-Magnesium-Aluminosilicate (CMAS) Infiltration and Cyclic Degradations of Thermal and Environmental Barrier Coatings in Thermal Gradients**

Dongming Zhu, Bryan Harder, Jim Smialek, Robert A. Miller

**38th International Conference and Expo on Advanced Ceramics and Composites  
January 26-31, 2014**

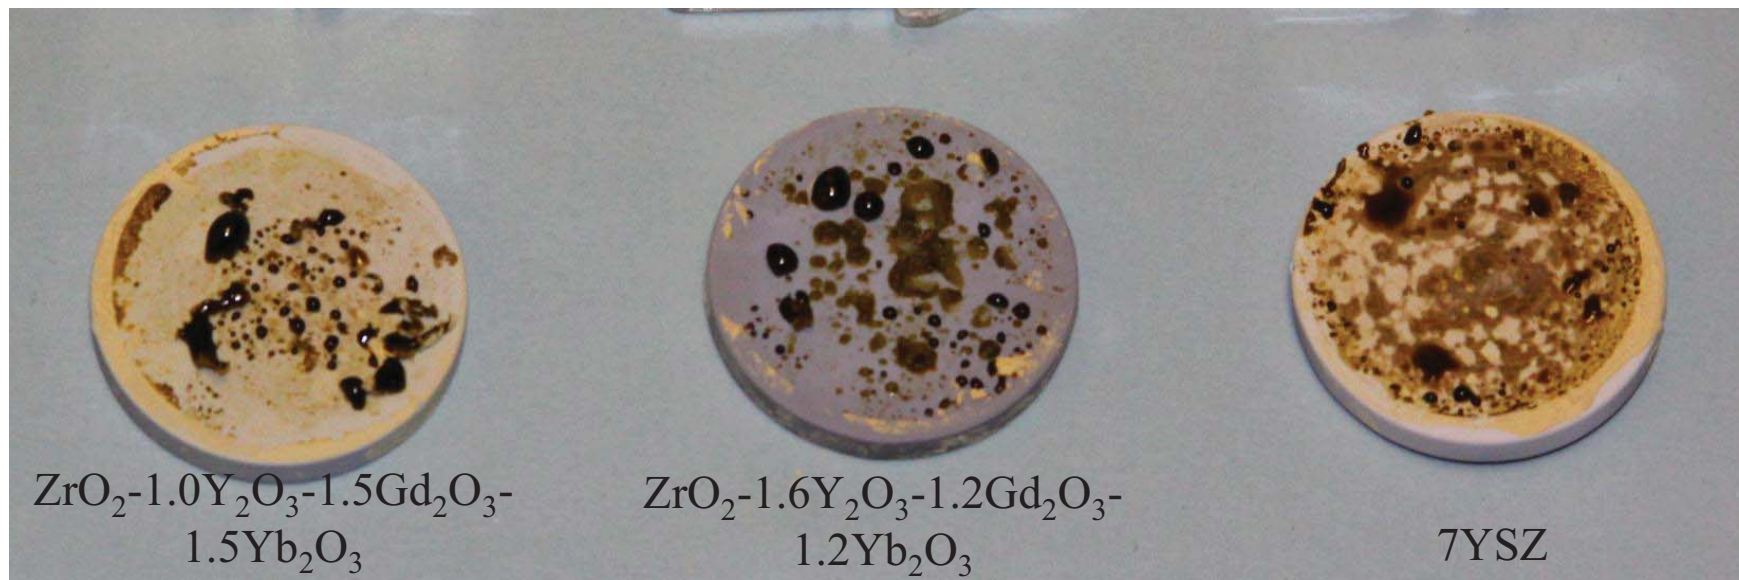
- Direct Laser heat flux infiltrated thermal barrier coatings (Conventional CMAS)

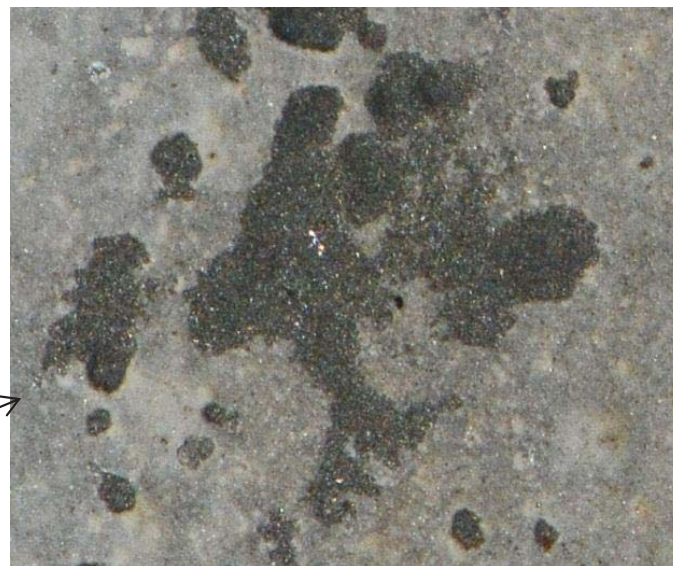
- Mach 0.5 gas velocity
- Specimen testing temperature 2100°F

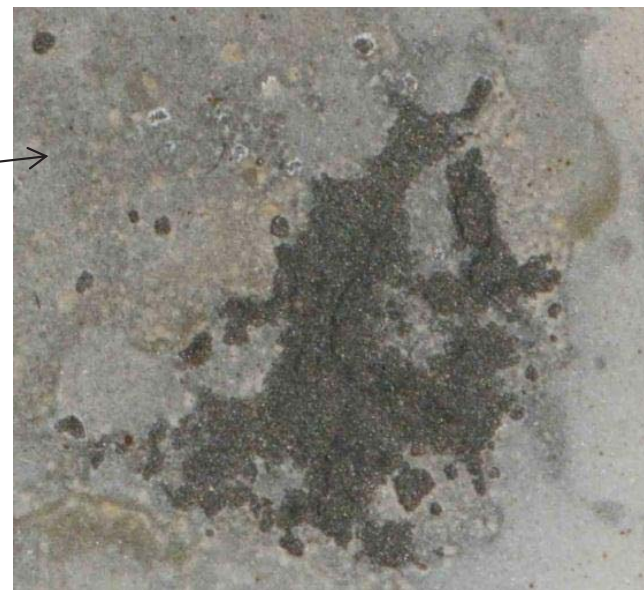
- CMAS infiltrated and erosion tested Specimen

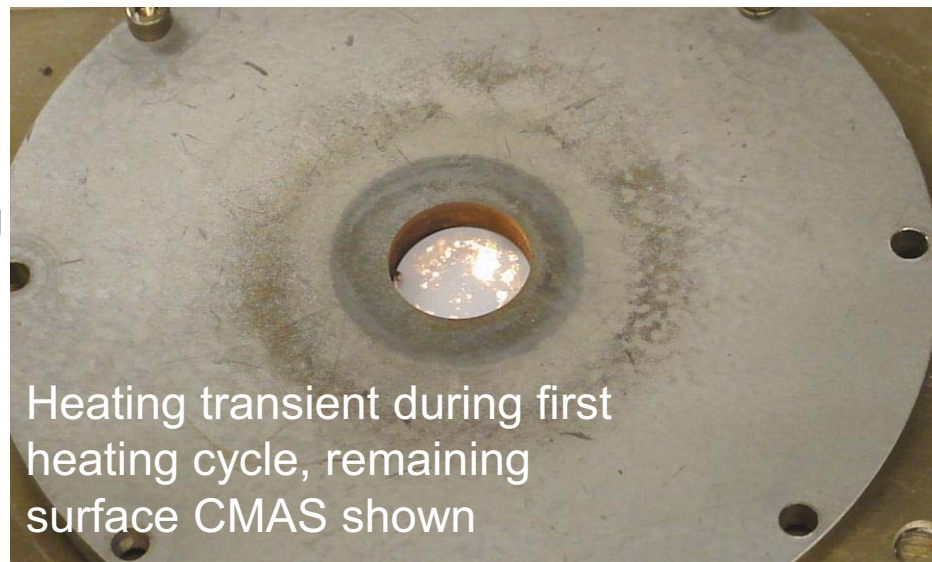
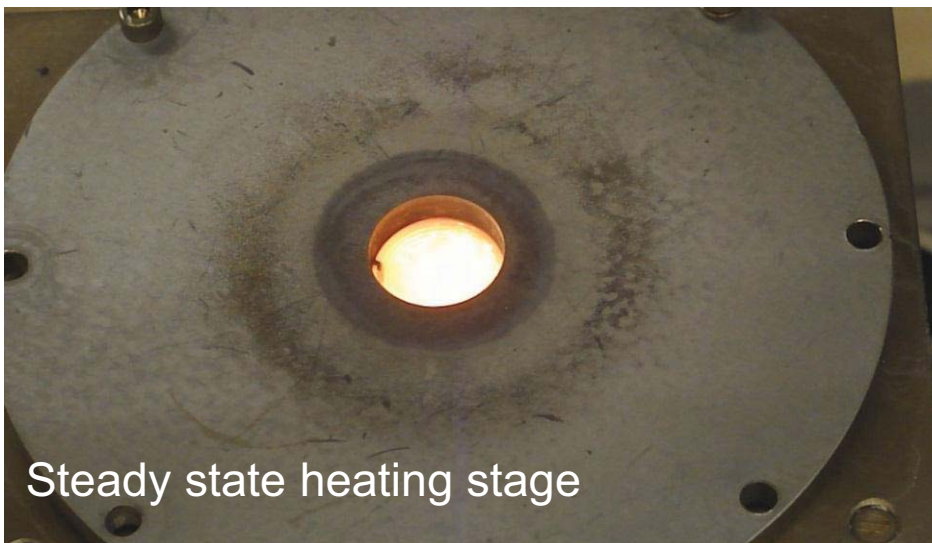
- An EB-PVD  $ZrO_2$ -2mol% $Y_2O_3$ -1.5mol% $Gd_2O_3$ -1.5mol% $Yb_2O_3$  TBC (PtAl/Rene N5 substrates) furnace tested at 1150°C 20 hr, then laser thermal gradient 2-cycle CMAS infiltration
- Continued laser thermal gradient cyclic tested at  $T_{surface}$  1280°C and  $T_{interface}$  1150°C for 38, 1 hr cycles with CMAS
- The specimen survived the test without spalling

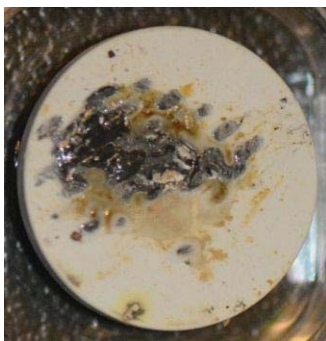
YSZ 01 laser + receptor  
heat flux “pressure”  
infiltrated: C+Si dopants

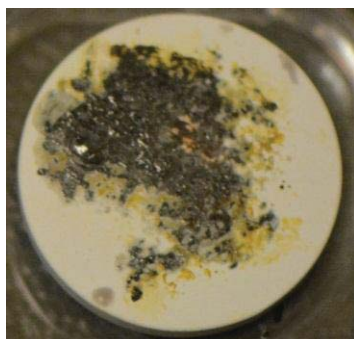
YSZ 02 laser + receptor  
heat flux “pressure”  
infiltrated: C, Si dopants

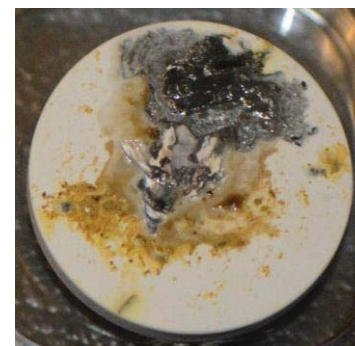
YSZ 03 laser + receptor  
heat flux “pressure”  
infiltrated: YSZ added

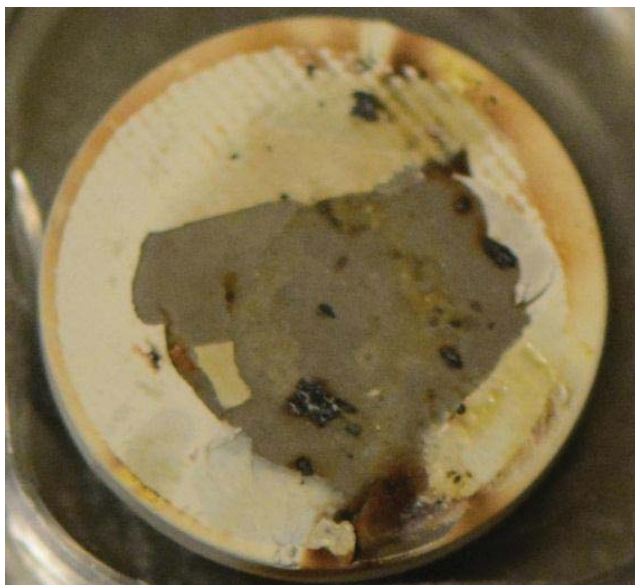
YSZ 02 laser rig cyclic tested  
and spalled, after 50 hr test at  
 $T_{\text{surface}} 1230^{\circ}\text{C}$  and  $T_{\text{interface}} 1170^{\circ}\text{C}$

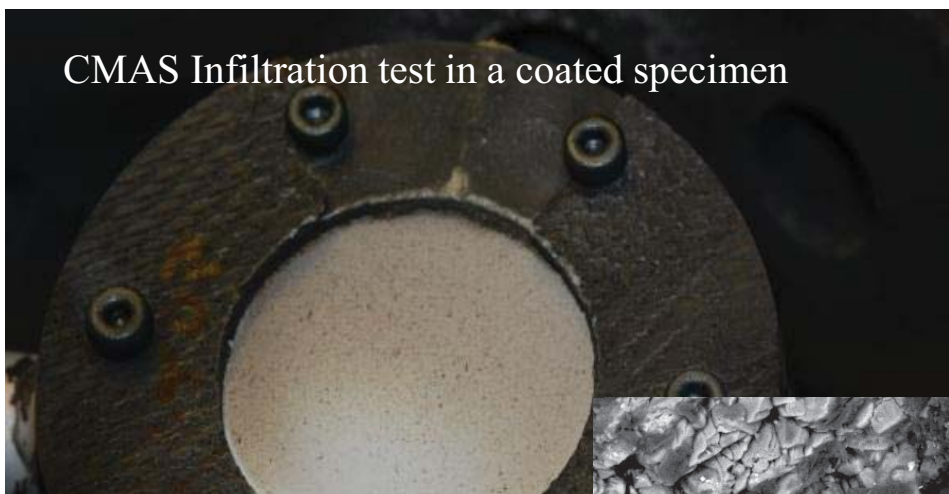
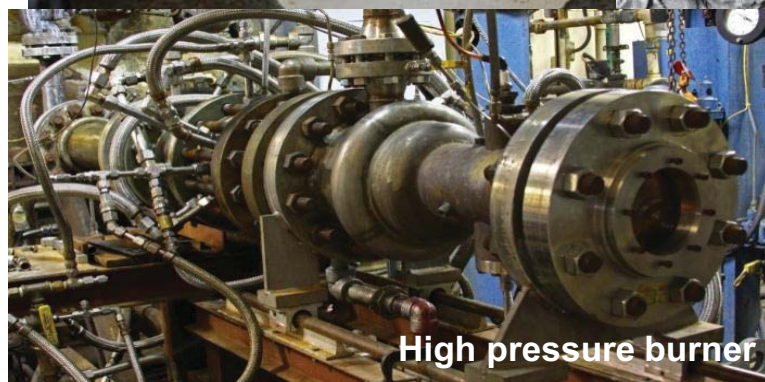
- A 2" diameter thermal barrier coated disc (back cooled) used for the initial test
- Thermal barrier coating temperature at 1250°C
- Rig conditions:
  - Jet fuel & air combustion with mass air flow 1.5 lbm/s
  - 10 atmospheres (160 psi) pressure
  - CMAS injected after the burner nozzle but not fully melted and infiltrated

CMAS Infiltration test in a coated specimen
