# Analysis of Particulate and Fiber Debris Samples Returned from the International Space Station

NASA, George C. Marshall Space Flight Center, Huntsville, Alabama, 35812

During the period of International Space Station (ISS) Increments 30 and 31, crewmember reports cited differences in the cabin environment relating to particulate matter and fiber debris compared to earlier experience as well as allergic responses to the cabin environment. It was hypothesized that a change in the cabin atmosphere's suspended particulate matter load may be responsible for the reported situation. Samples were collected and returned to ground-based laboratories for assessment. Assessments included physical classification, optical microscopy and photographic analysis, and scanning electron microscopy (SEM) evaluation using energy dispersive X-ray spectrometry (EDS) methods. Particular points of interest for assessing the samples were for the presence of allergens, carbon dioxide removal assembly (CDRA) zeolite dust, and FGB panel fibers. The results from the physical classification, optical microscopy and photographic analysis, and SEM EDS analysis are presented and discussed.

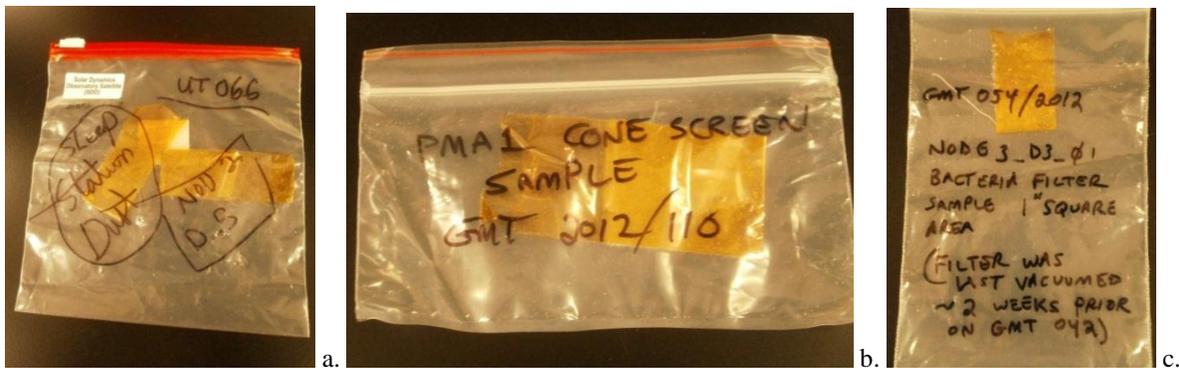
**Figure 1. Kapton<sup>®</sup> tape samples returned aboard 28S.** Depicted are tape samples collected from a.) the sleep station, b.) the PMA1 cone screen, and c.) a Node 3 bacteria filter element face.

These Kapton<sup>®</sup> tape samples were folded upon themselves making analysis difficult. Some loose particulate matter was found in the bags containing the tape samples. These loose particles were collected for SEM EDS analysis. The sleep station dust sample bag contained two tape samples. One was removed and used for the allergen analysis and one was delivered to NASA MSFC for physical and chemical characterization. Figure 1 shows the samples returned aboard Soyuz vehicle 28S.

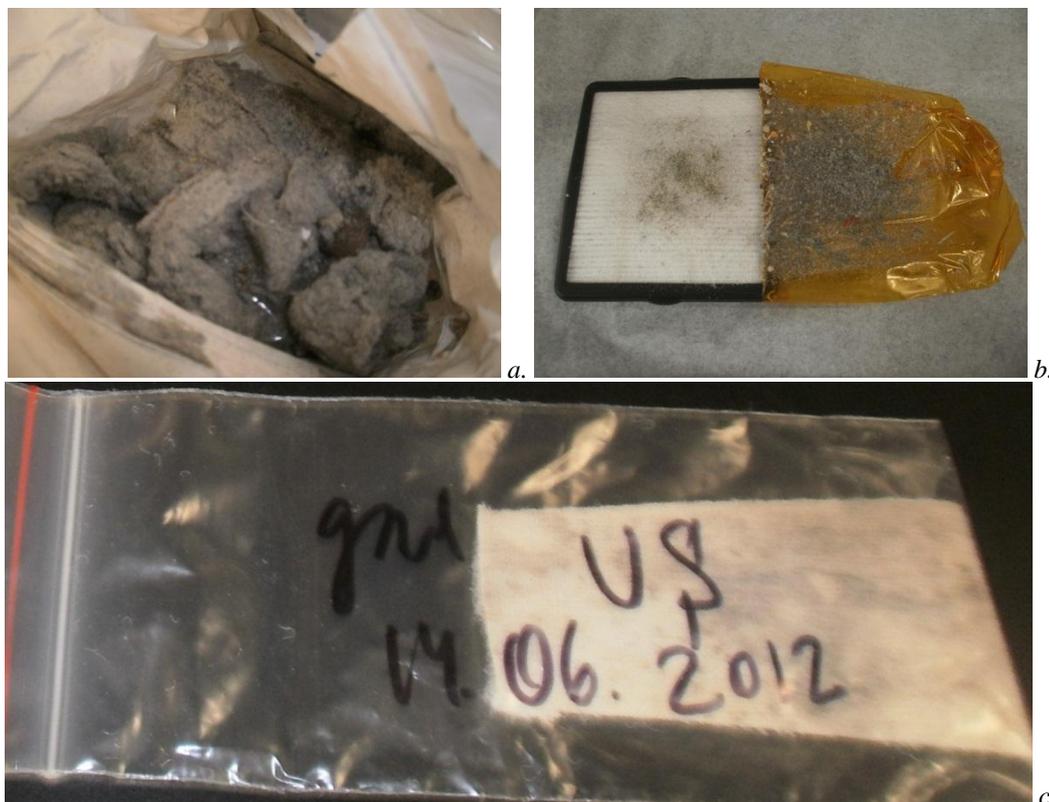
**Figure 2. Debris samples and fabric material returned aboard 29S.** Views of a.) the mixed debris in the vacuum cleaner bag, b.) the vacuum cleaner HEPA filter, and c.) the FGB panel material swatch.

The tape over the vacuum cleaner HEPA filter inlet face removed most of the debris from the face so analysis had to be approached similarly to the Kapton<sup>®</sup> tape samples returned aboard Soyuz vehicle 28S. The vacuum cleaner bag as received had been cut open to collect materials for the allergen study. Blue-grey lint was the predominant material in the vacuum bag. The FGB panel fabric swatch measured approximately 3.8 cm wide  $\times$  9.5 cm long. A portion measuring approximately 1.9 cm wide  $\times$  3.8 cm long was removed for the allergen study before delivery to NASA MSFC. The FGB panel fabric swatch appeared to be a "dirty white" color with the appearance of dark mildew-like stains. A "yellowing" pattern within the fabric appears to indicate that water may have "wicked" into the fabric and then evaporated leaving a "water stain" pattern. Figure 2 shows the samples returned aboard Soyuz vehicle 29S.

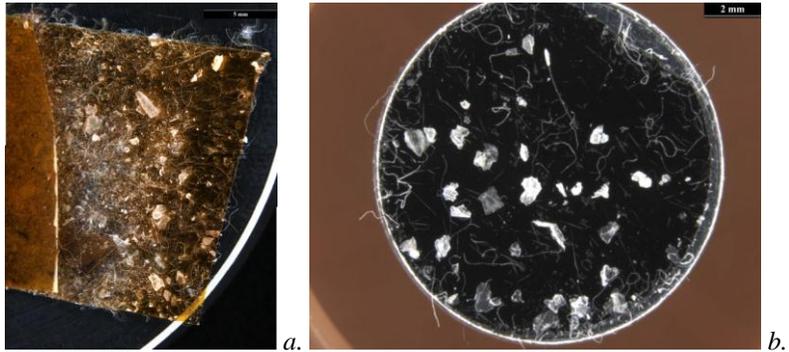
**Figure 3. Node 3 bacteria filter tape sample and SEM stub containing debris.** Typical for the tape samples returned aboard Soyuz vehicle 28S.

Evaluation of the tape samples returned aboard Soyuz vehicle 28S focused on visual observations via optical microscopy and whether particles exhibiting chemical composition similar to CDRA zeolite pellets might be present based on SEM EDS methods. Visual observations noted a variety of granular and fibrous material on the tape. As shown by Fig. 3, the tape sample from the Node 3 bacteria filter contains various fiber colors, however, white fibers predominate. Granular material appears to be composed of human skin, nail clippings, and food debris. This sample was typical of all the tape samples. It was noted that the tape sample from the sleep station contained more human hair strands while the pressurized mating adapter-1 (PMA1) cone screen sample had more blue-grey lint than the other tape sample locations. Individual particles were collected from the tape samples and placed on SEM stubs for analysis with attention given to elemental composition that may indicate the presence of CDRA zeolite pellet material.

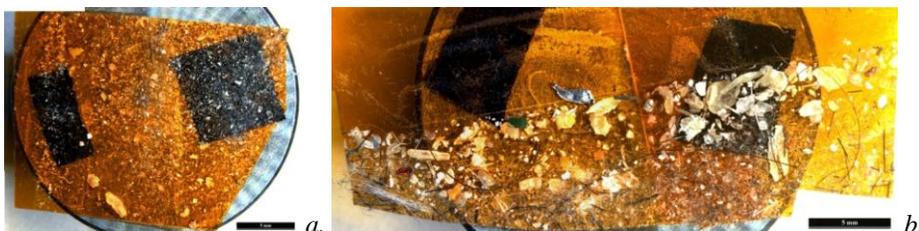
**Figure 4. Cut sections of Kapton® tape covering the vacuum HEPA filter element.** Significant quantities of skin fragments, nail clippings, granular debris, hair, and fibrous debris are evident.

analysis were conducted on both sections of tape. Seventeen individual particles were selected for targeted SEM EDS analysis. Figure 4 shows the tape cutout samples mounted for SEM EDS analysis. Skin fragments, nail clippings, granular debris, and a variety of hair and fibrous debris are

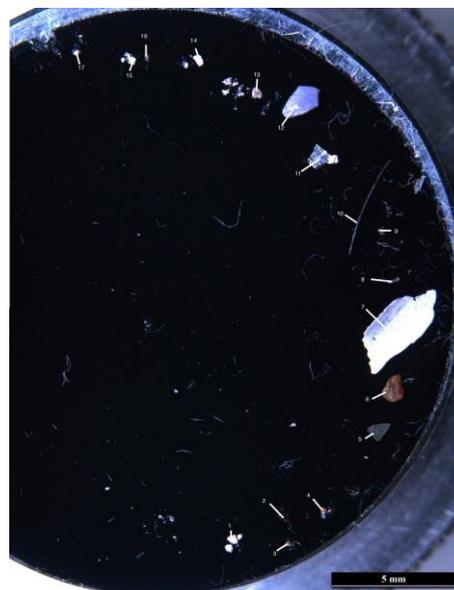
**Figure 5. Selected particles from the vacuum cleaner HEPA filter.** Individual particle composition was found to be primarily carbon and oxygen.

visible. The EDS analysis of seventeen targeted particles shown by Fig. 5 found the elemental composition to be dominated by carbon and oxygen. Some observation to note were particle number seven which contained zinc (31 wt%), titanium (6.7 wt%), aluminum (2.4 wt%), magnesium (1.5 wt%), silicon (2 wt%), phosphorus (12.3 wt%), oxygen (28.7 wt%), carbon (14.5 wt%), and lesser amounts of iron, nickel, potassium, sulfur, and chlorine. Particle number eleven was reported to contain aluminum (86 wt%), magnesium (4.8 wt%), and zinc (3.7 wt%) with lesser quantities of nickel, silicon, chromium, iron, copper, oxygen, and carbon. Analysis of particle number nine found high quantities of iron, carbon, and oxygen. Comparison of all SEM EDS results found no spectral signatures consistent with CDRA zeolite pellet material.

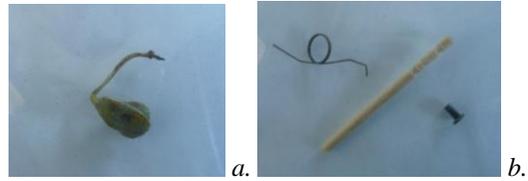
**Figure 6. Interesting items retrieved from the vacuum cleaner bag debris.** Items that were different from the typical debris included a.) a plant seedling, and b.) a toothpick fragment, a small screw, and a wire spring.

The material retained on the No. 14 test sieve consisted of large blue-grey lint balls with hair and long fibers interspersed within it. Food, paper, and plastic debris were also observed. Unusual items found in this debris included a small plant seedling, a slender wooden dowel that may be a toothpick fragment, a small screw that possibly came from eyeglasses, and a thin wire spring. These items are shown by Fig. 6. The material retained on the No. 14 test sieve was classified into four fractions shown by Fig. 7 — lint and hair (38.55 grams), paper and

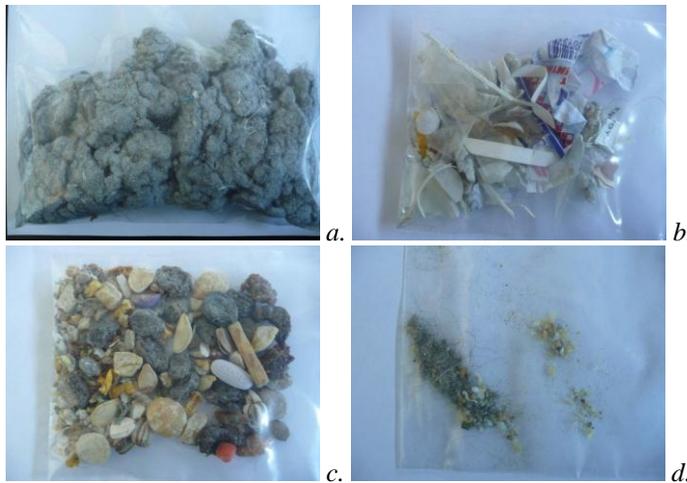
**Figure 7. Debris retained on the No. 14 standard test sieve.** Debris classifications include a.) lint and hair, b.) paper and plastic, c.) food debris, and d.) granular and fibrous residue.

The material retained on the No. 14 sieve ( $>1,400\ \mu\text{m}$ ) shown by Fig. 7 consisted of four classifications—fiber and hair, food, paper and plastic, and residue. The fiber debris was blue-grey lint with human hair dispersed throughout it. The lint retained particles of various sizes which can be dislodged by handling the bulk material. The appearance demonstrates that lint accumulation can, in itself, serve as an effective particulate filter. The food debris consisted of dried raisins, nut shells (e.g. pistachio and sunflower), nut fragments (e.g. peanut, macadamia, sunflower), dried vegetables (e.g. carrot, corn, pea, and potato), leaf fragments, a multivitamin tablet, a pretzel or potato stick fragment, large cookie or brownie fragments, a candy-coated chocolate fragment, and a large array of granular crumbs. The granular crumbs are difficult to ascertain their origin and a detailed forensic analysis may be beneficial. The paper and plastic debris consisted of bandage wrapper fragments, labels, personal care product wrapper fragments, plastic packaging fragments, elastic seal material fragments, and a variety of other debris. The residue consisted of material similar to the granular food crumbs mixed with fibers and hair.

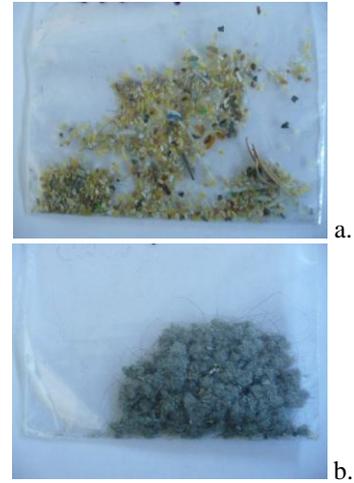
**Figure 8. Debris retained on the No. 18 standard test sieve.** Material fractions include a.) granular debris and b.) fiber and hair debris.

The material (8.19 grams) that passed through the No. 14 test sieve consisted of granular material, smaller fibrous debris, and smaller hair fibers. This material was transferred to a No. 18 test sieve which has 1,000  $\mu\text{m}$  apertures. The sieve was agitated gently by hand. The material retained on the No. 14 sieve and the material that passed through the sieve weighed 1.63 grams and 6.33 grams, respectively. There was 97.2% mass accountability for this sieving operation. The material that passed through the No. 18 test sieve was similar in appearance to the material retained on the sieve. Both fractions consisted of granular material, fibrous debris, and hair fibers but of different sizes. The granular and fibrous debris fractions for the material retained on the No. 18 test sieve, shown by Fig. 8, weighed 0.98 grams and 0.65 grams, respectively.

The material retained on the No. 18 sieve ( $>1,000\ \mu\text{m}$  and  $<1,400\ \mu\text{m}$ ) shown by Fig. 8 consisted of two classifications—granular and fibrous debris. The granular debris consisted primarily of large dried skin fragments and nail clippings. A stem, possibly from a cherry, was found. A mechanical pencil lead fragment was also found. Figure 11 shows some typical granular debris in this size fraction. Small plastic fragments were observed. The fibrous debris consisted of smaller blue-grey lint fibers and human hair.

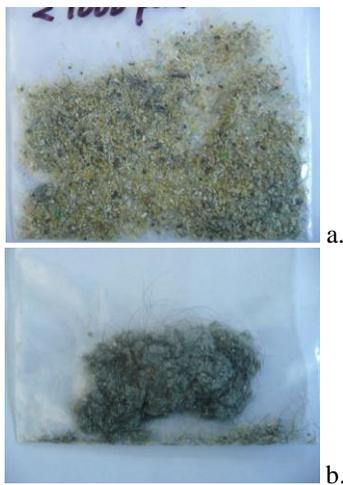
**Figure 9. Debris retained on the No. 35 standard test sieve.** Material fractions include a.) granular debris and b.) fiber and hair debris.

The material retained on the No. 35 test sieve ( $>500\ \mu\text{m}$  and  $<1,000\ \mu\text{m}$ ) shown by Fig. 9 consisted of two classifications—granular and fibrous debris. The granular debris consisted of smaller dried skin fragments and nail clippings. Small mechanical pencil lead fragments were also found. Figure 12 shows detailed views of the granular material retained on the No. 35 test sieve. The fibrous debris consisted of fine blue-grey lint and short human hair fragments.

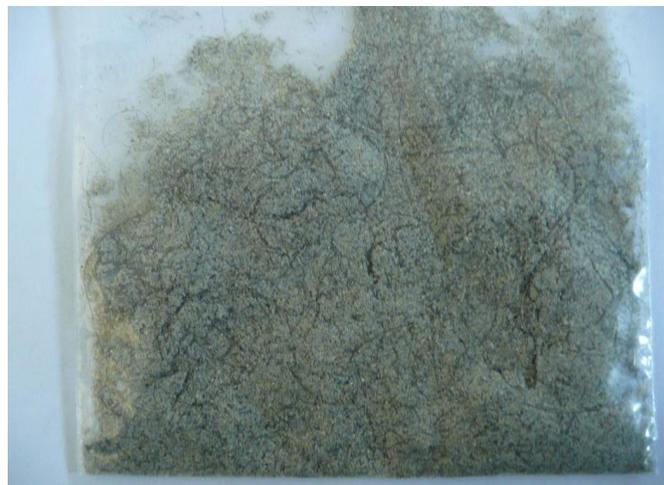
**Figure 10. Debris that passed through the No. 35 standard test sieve.** Mixed granular, fiber, and hair debris.

The material that passed through the No. 35 test sieve ( $<500\ \mu\text{m}$ ) shown by Fig. 10 consisted of a uniform tan-colored, powdery mixture of granular material and short human hair fragments. The granular material was similar in color to the dried skin fragments and nail clipping found in the larger sized granular material fractions; therefore, it may be concluded that this fine granular material may be fine skin and nail clipping fragments. Figure 13 shows a more detailed view of the material that passed through the No. 35 test sieve.

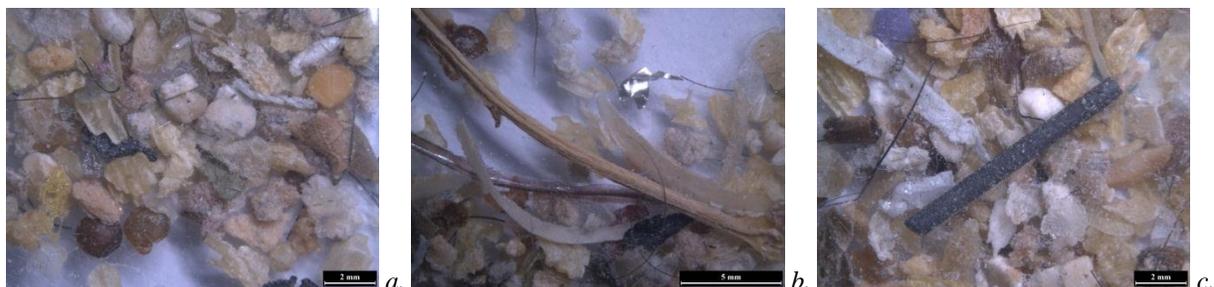
**Figure 11. Granular debris retained on the No. 18 test sieve.** a.) Typical debris showing dried skin and other unidentified debris at 10X magnification b.) a view showing a fruit stem and a large nail clipping at 8X magnification c.) a view showing a mechanical pencil lead fragment at 10X magnification.

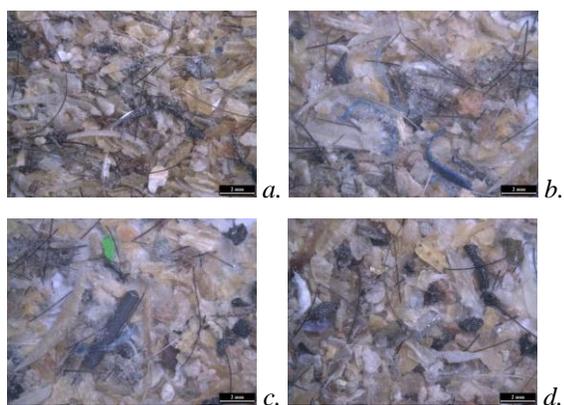
**Figure 12. Granular debris retained on the No. 35 test sieve.** Views at 10X magnification showing a.) debris with dried skin and nail clippings, b.) blue fibers possibly from Velcro® closures, c.) mechanical pencil lead, blue fibers, and nail clippings, and d.) metal turnings.

Fibrous debris was found to be predominantly clothing lint and human hair. Other fibrous debris was observed as shown by Fig. 12. Scanning the granular debris from all the size fractions indicated some white fibers of interest shown by Fig. 17. These fibers strongly resembled the multi-strand fiber found in the FGB panel fabric (Fig. 17, view a.) as well as the white fiber loops on the back of the FGB panel fabric and the white fibers on the vacuum cleaner HEPA filter face. The fibers on the back of the FGB panel fabric and the fibers on the vacuum cleaner HEPA filter face are very similar in appearance as shown by Figs. 14b and 16b. While Fig. 17 shows that there are fibers in the vacuum cleaner bag debris which are similar in appearance to FGB panel materials, the similarity between the FGB panel and vacuum cleaner HEPA filter face fibers confounds a source determination based strictly on appearance. More detailed chemical and physical analysis by forensic science fiber analysis experts.

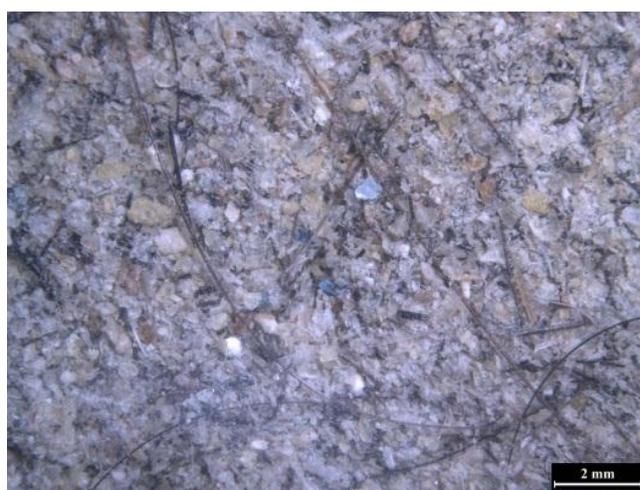
**Figure 13. Debris that passed through the No. 35 test sieve.** The debris at 10X magnification shows mixed granular material and human hair.

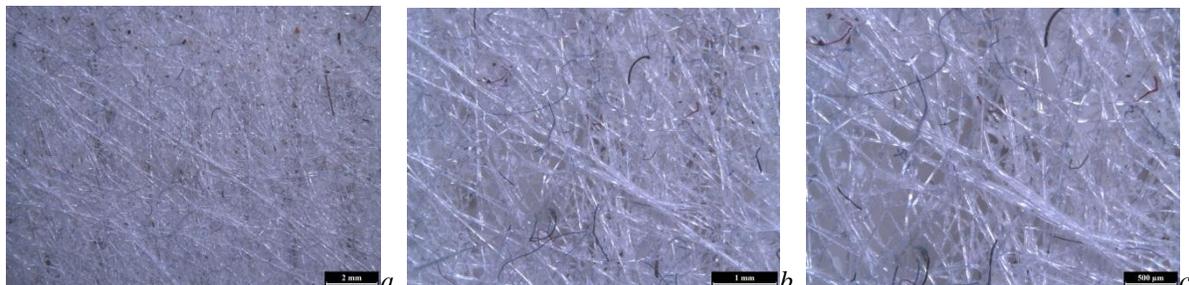
**Figure 14. Vacuum cleaner bag filter optical microscopy photographs.** Views at a.) 10X, b.) 25X, and c.) 40X magnification show white to clear fibrous material composition with some captured granular and fibrous debris. The Kapton<sup>®</sup> tape covering the filter face removed the major portion of accumulated debris from the filter face.

The vacuum cleaner filter was assessed using optical microscopy and photography. Figure 14 shows a view of the filter inlet face. The white to clear fibers comprising the vacuum cleaner filter's pre-filter media are interesting because they appear very similar to white fibers observed in the vacuum cleaner bag debris.

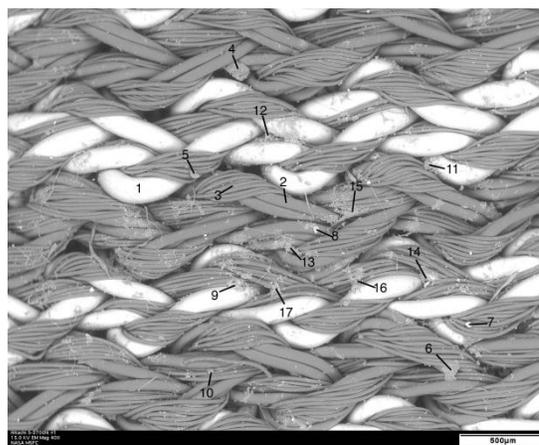
**Figure 15. FGB panel fabric swatch SEM image showing seventeen EDS probed locations.** Three fiber types are evident at 40X magnification of the smooth side of the FGB panel fabric. Fibrous and particulate debris adhering to the surface are visible.

The FGB panel fabric swatch was evaluated by SEM EDS, optical microscopy, and photography. Seventeen areas shown by Fig. 15 were probed using SEM EDS. Both fibers and debris adhering to the fibers were targeted. The fabric consisted of three types of fibers. Each fiber was targeted as well as fourteen areas where debris adhered to the fabric. The targeted fibers were found to have an elemental composition to consist primarily of fluorine (32.8 wt% average), carbon (51.5 wt% average), oxygen (11.3 wt% average), and nitrogen (4.7 wt% average). Lesser quantities (0.2 wt% to 1 wt% range) of calcium, sodium, magnesium, aluminum, silicon, chlorine, potassium, and titanium were observed. These observations may be indicative of a fluoropolymer and acrylic fiber materials. The elemental composition of the debris was found to consist of fluorine (22 wt% average), carbon (44.8 wt% average), oxygen (15.8 wt% average), and nitrogen (5.9 wt% average). Lesser quantities (0.5 wt% to 2.6 wt%) of calcium, sodium, magnesium, aluminum, silicon, phosphorus, sulfur, chlorine, potassium, iron, and titanium were observed. The particle probed at location number 8 contained 4.1 wt% zirconium. Similarities are noted in the primary elements observed for all seventeen probed locations. This is likely due to the dominant fiber background of the debris adhering to the fibers.

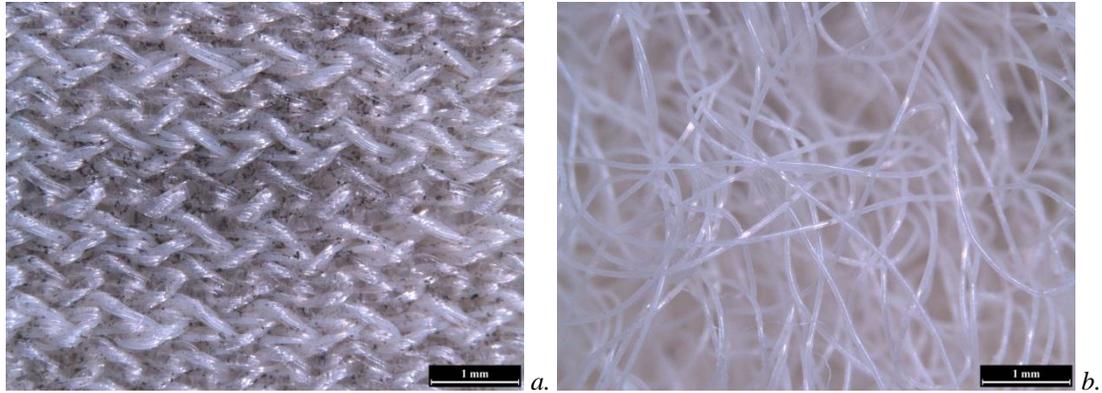
**Figure 16. FGB panel fabric swatch optical microscopy images.** Views at 25X magnification showing a.) three fiber types consisting of a clear fiber, thin white fiber, and a multi-strand twisted fiber are visible on the fabric smooth side. Dark spots in the image are the mildew-like stain on the fabric, b.) white fiber loops are visible on the fabric back. These fibers are visible in the weave on the fabric's smooth side.

Both sides of the fabric were evaluated using optical microscopy. Figure 16 shows views of the fabric's smooth side and backing side. The three fiber types are visible on the fabric's smooth side. These fibers consist of a clear fiber, a multi-strand twisted fiber, and a thin white fiber. The backing side consists of a single type of fiber that appears to be the thin white fiber visible in the smooth fabric side weave. Physical inspection found the fabric to be flexible with no indication of brittleness and no tendency to produce dust. A few white backing fibers were found loose in the sample bag but the number of loose fibers was  $<50$  and may have been shed from the cut edges. No dust or other debris was found in the sample bag. The fabric was inspected by hand and abraded by vigorously rubbing the back with the fingers. Less than 20 fibers were shed from the material after a minute. Based on these observations it may be concluded that fibers originating from the FGB panel fabric material would be released only when the material is cut or subjected to repeated mechanical abrasion rather than spontaneously generated.

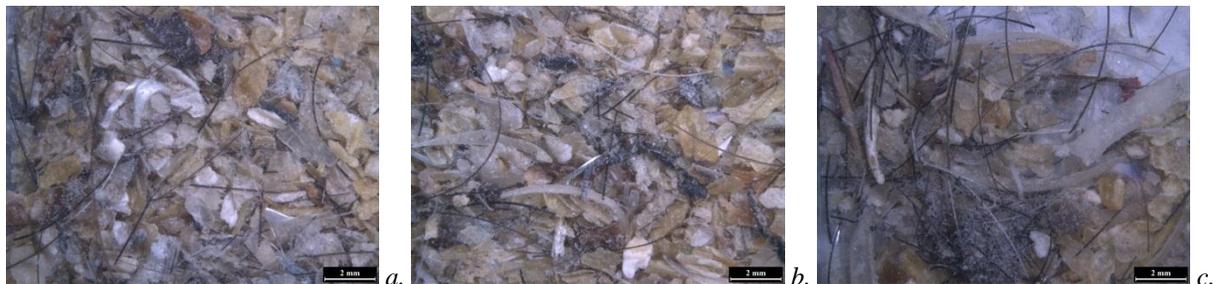
**Figure 17. Vacuum cleaner bag debris showing fiber debris of interest.** Views at 10X magnification showing a.) a multi-strand fiber having similarity to an FGB panel fabric multi-strand fiber, b.) white fibers similar to those observed on the FGB panel fabric back or the vacuum cleaner bag HEPA filter face, and c.) more white fibers similar to those observed on the FGB panel fabric back or vacuum cleaner bag HEPA filter face.
