# Vehicle Integrated Propulsion Research Tests

Propulsion Controls and  
Diagnostics Workshop  
December 11, 2013  
Cleveland, OH

John Lekki, Gary Hunter, Don Simon, Roger Meredith, John Wrbanek, Mark Woike, Roger Tokars  
NASA Glenn Research Center  
Marianne Guffanti  
United States Geological Survey  
Captain Eric Lyall  
Air Force Research Lab

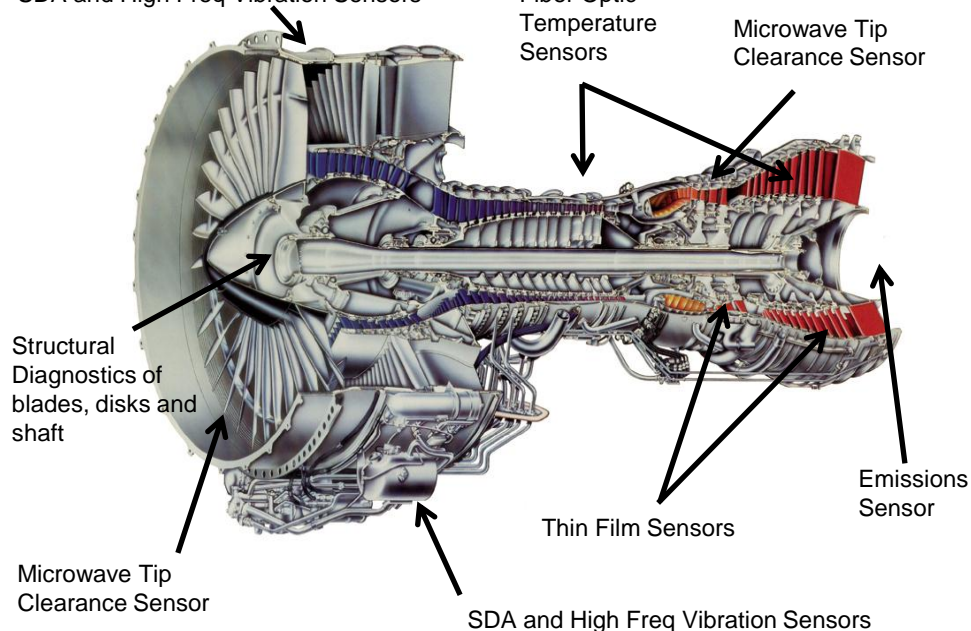
SDA and High Freq Vibration Sensors

Fiber Optic Temperature Sensors

Microwave Tip Clearance Sensor

Model-based gas path diagnostic architecture

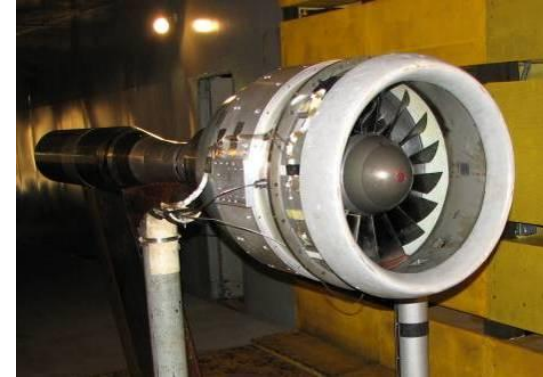
*Microwave sensors installed on the NASA Turbofan Test Rig at the GRC's 9x15 LSWT*

- Targeted for use in hot sections of turbine engines (High Pressure Turbine section)
  - Rated for use in high temperature environment, ~1200 °C
  - Highly accurate, current goal of ~25um for this technology
  - Able to see through contaminants that exist in the engine flow
- MWBTCS successfully tested in engine test in October 2013. First known test of integrally cooled tip clearance sensor in the high turbine.

- Microwave blade tip clearance sensor technology for use in turbine engines
  - Structural health monitoring – tip clearance and tip timing
  - Active closed loop clearance control - tip clearance

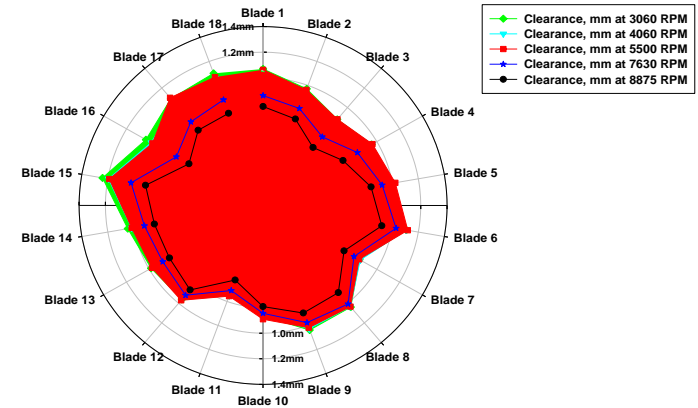
Polar Plot, Clearance vs Speed  
Blade Tip Clearances in mm, Probe #1, 90 Degree Position  
Run #7 9-25-2008

*Clearance data acquired on the NASA Turbofan Test Rig*

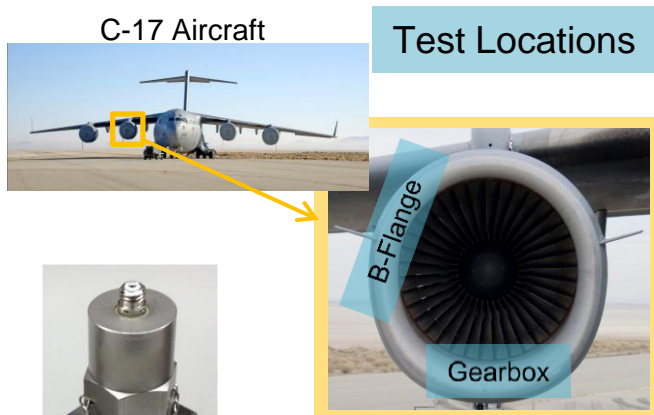
The Self Diagnostic Accelerometer (SDA) was mounted and tested on the C-17 engine in order to demonstrate the SDA's flight worthiness and robustness.

Accelerometer mount

Secured with safety wire

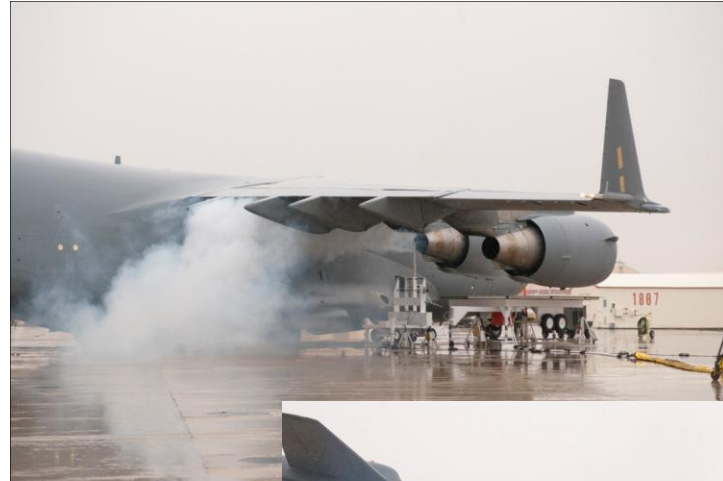
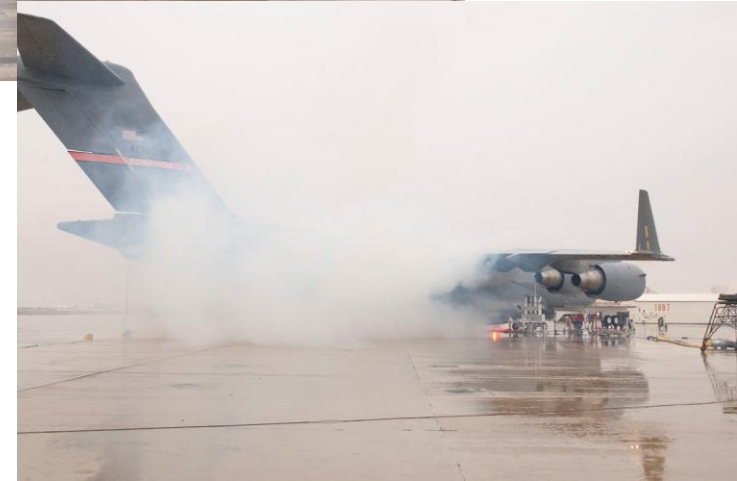
ESS Rig

- Day 1 of VIPR testing was a “green engine run” (first time the test engine was run post-overhaul)
- Provided an opportunity to evaluate the Emission Sensor System (ESS) during preservation oil burn-off

Preservation oil burn-off!
