# The International Space Station 2B Photovoltaic Thermal Control System (PVTCS) Leak: An Operational History

Anthony N. Vareha<sup>1</sup>

NASA Lyndon B. Johnson Space Center, Houston, Texas, USA

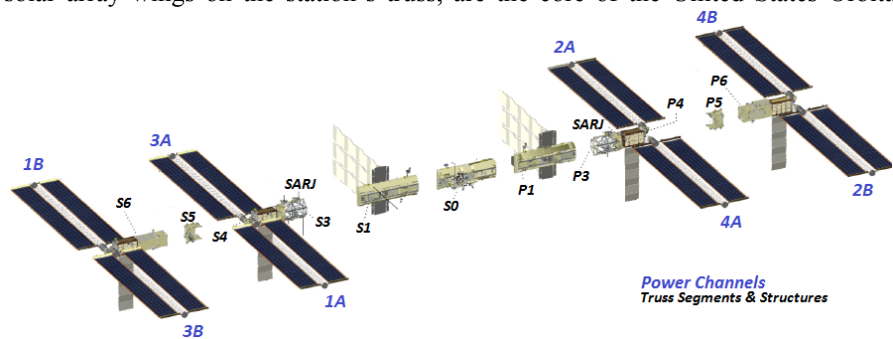
Figure 1. ISS Truss Schematic.

modules, and each supports two power channels as shown in Figure 1. Each PVM contains the components needed to provide 150-160V DC power to downstream systems and payloads, and batteries to allow uninterrupted power through the ISS's orbital eclipse/insolation cycle. All USOS EPS and NH<sub>3</sub> cooling is the operational responsibility of the Station Power, ARticipation, Thermal, and ANalysis (SPARTAN) officer within NASA's Mission Operations Directorate (MOD), located at the Mission Control Center in Houston (MCC-H).

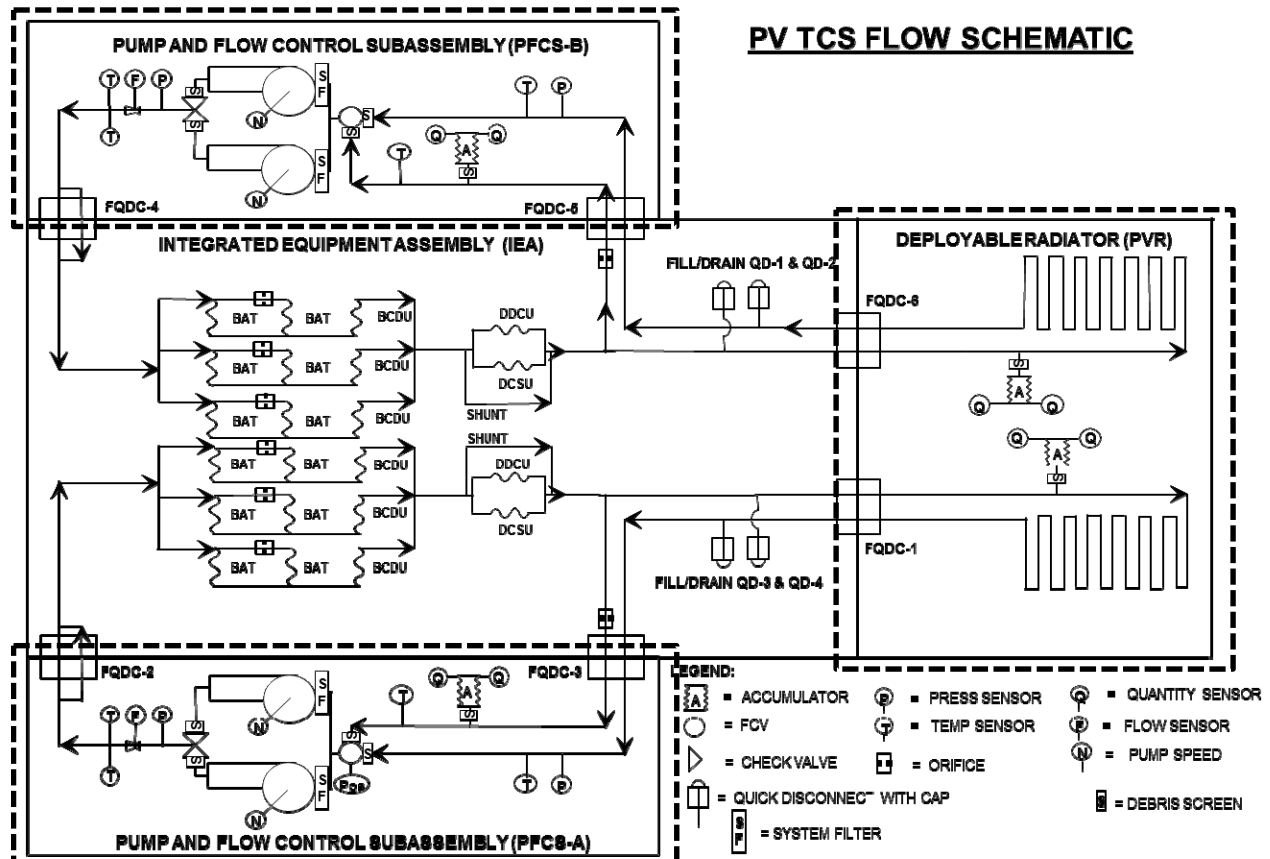
As battery discharge is an exothermic reaction, active cooling is necessary to keep batteries below upper operating temperature limits. Cooling is also necessary for the various electrical components on the PVM involved in power routing and DC-to-DC voltage conversion. This active cooling is provided by the circulation of NH<sub>3</sub> in the Photovoltaic Thermal Control System (PVTCS), which uses a Pump Flow Control Subassembly (PFCS) orbit replaceable unit (ORU) to circulate coolant through the Integrated Equipment Assembly (IEA) onto which the EPS ORUs are attached. The PFCS contains two pumps for redundancy, with only one pump active at a time. The PFCS also contains a Flow Control Valve (FCV) for temperature control. The FCV rotates as needed to force NH<sub>3</sub> to either bypass or flow through the Photovoltaic Radiator (PVR) based on the battery temperatures. Though each channel's PVTCS loop is independent, both loops on a given PVM flow through the same PVR ORU. At time of launch, each PVTCS contains approximately 53lbm of NH<sub>3</sub>, of which approximately 13lbm is surplus to provide for some amount of leakage. Figure 2 shows a schematic of the PVTCS.

Figure 2. PVTCS Schematic.<sup>1</sup> For the P6 PVM, the 2B PVTCS would be the upper loop as shown, with 4B below. Orbit Replaceable Units (ORUs) are denoted by dashed lines.

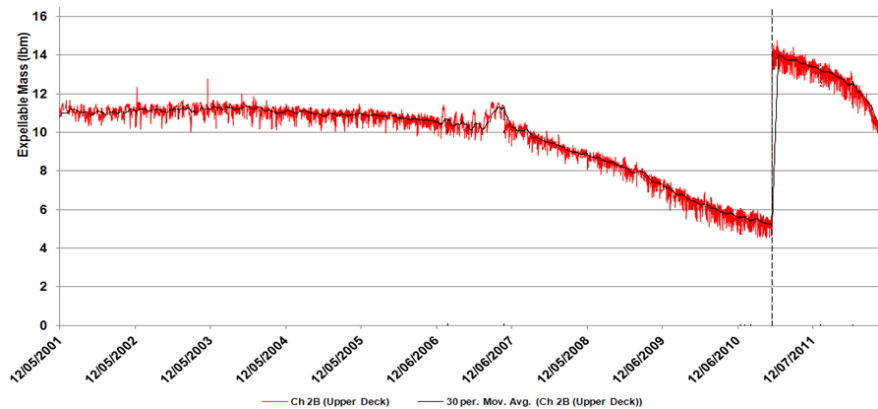
A leak of this size was far too small to be detected visually, as the orifice associated with such a massflow would be microscopic. Therefore, a "feed the leak" strategy was agreed to by the ISS Program, whereby spacewalks would occur every few years for the purpose of topping off the NH<sub>3</sub> reserve. By the middle of 2009 the ISS Program determined that the first such refill would occur during the STS-134 mission, also known as ISS flight ULF-6, which at the time was scheduled for mid-2010. This would allow the refill to be completed ahead of the 2B PVTCS reaching its automated FDIR shutdown point due to low quantity levels, which was estimated to occur in the middle of 2013.

**Figure 3. Expellable PVTCS 2B fluid mass (lbm), 2001-2012.** *Expellable mass of 0 represents the point at which the 2B PVTCS would need to be shut down to prevent pump cavitation. Mass is calculated based on a small set of temperature, pressure, and fluid quantity sensors located within the PVTCS, and can be biased by thermal environments, attitude, and whether or not the PVTCS is unpowered (as it was for a time in late 2007 when the P6 truss was relocated). The dotted line is the STS-134 PVTCS refill described in section III. Note rate increase in 2012 as described in section IV.*

This would allow the refill to be completed ahead of the 2B PVTCS reaching its automated FDIR shutdown point due to low quantity levels, which was estimated to occur in the middle of 2013.

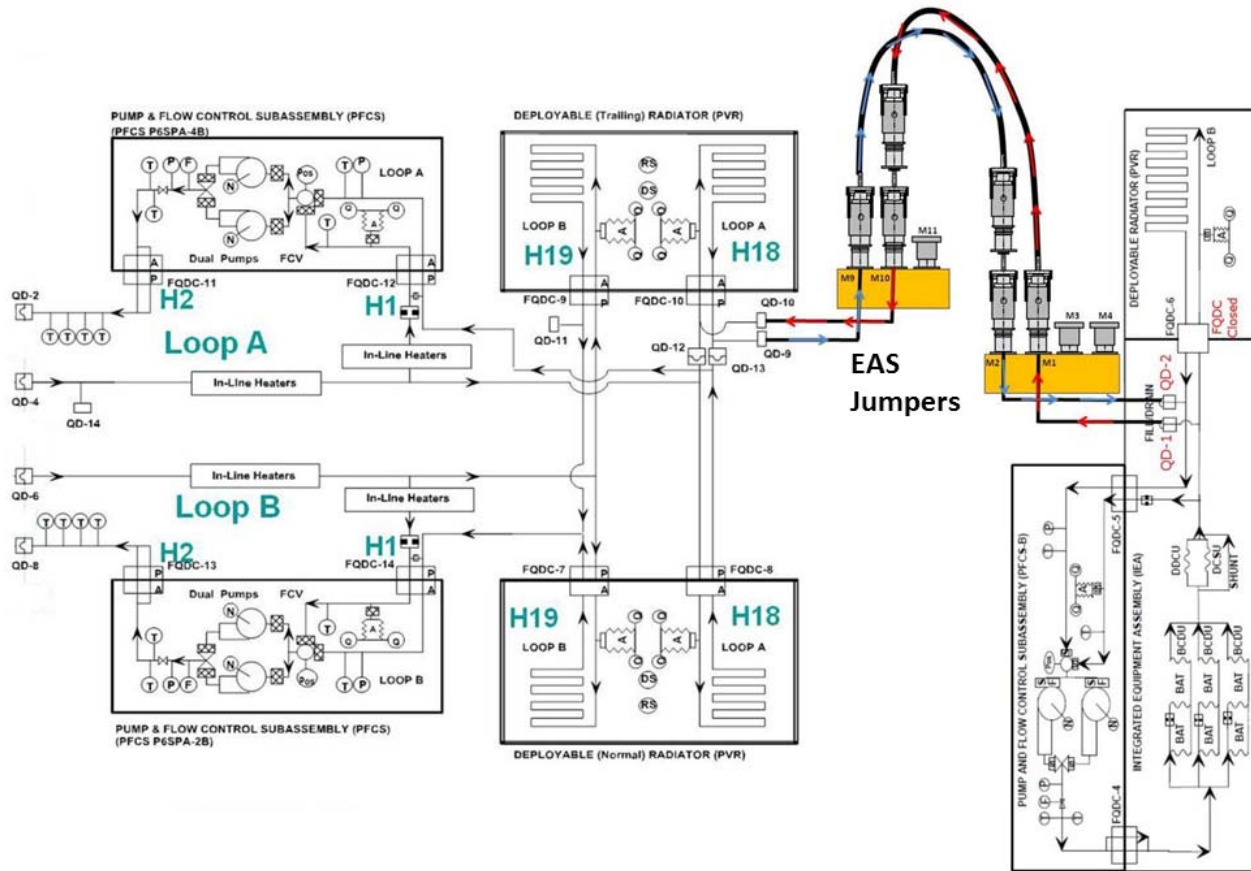
To allow the channel 2B PVTCS to keep running while attempting to isolate the leak source, ISS engineers and operations personnel crafted a plan to utilize a unique capability of the P6 truss segment. The 2B PVTCS would be cross-connected with the adjacent decommissioned EETCS via two EAS jumpers, and one of the EETCS radiators would be redeployed after 6 years of dormancy. In this configuration, the 2B flowpath within the P6 PVR could be isolated while the Trailing Thermal Control Radiator (TTCR) of the EETCS provided cooling to channel 2B. This configuration is shown in Figure 5.

**Figure 5. Schematic of PVTCS/EETCS “Hybrid Config”.** The 2B lines of the P6 PVR, shown top right, are isolated. Warm  $NH_3$  leaves the 2B PVTCS out of QD-1, through one of the EAS jumpers, and enters EETCS Loop A via QD-10. From here, the  $NH_3$  arrives at a T-junction. Half of the  $NH_3$  flows through the deployed Trailing Thermal Control Radiator (TTCR, shown at top), while half flows through the retracted Starboard Thermal Control Radiator (STCR). Note that the radiator naming convention is based on its original position atop the station centerline. The 2B PFCS, at right, contains the only running pump – the EETCS Loop A and B PFCSs are powered, but their pumps are off. All of EETCS Loop B is stagnant.

US EVA 20 was executed to put the above plan into action. First, a fluid connector valve was closed to isolate the channel 2B flowpath within the P6 PVR. Next, the EAS jumpers were configured so that PVTCS  $NH_3$  which would normally flow to the PVR would be routed out through the jumper over to the EETCS with its to-be-deployed TTCR. Finally, the TTCR insulation shroud was removed and the TTCR was uncinched. Once the crew was clear of the radiator, SPARTAN successfully commanded deployment of the TTCR. The STCR remained retracted and covered by insulation; deployment was not an option due to interference with one of the solar arrays of the P4 truss (which was not an issue when P6 sat atop the vehicle centerline).

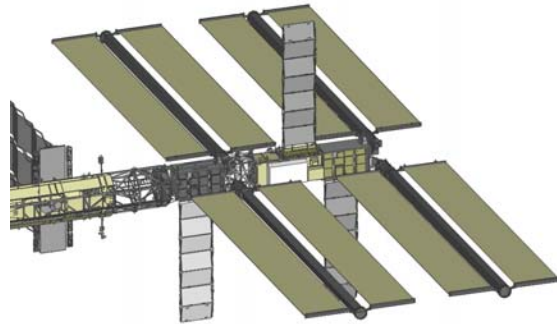
**Figure 6. Overview of ISS port truss post EVA 20.** *The EETCS TCR is shown upwardly deployed, while the P4 and P6 PVRs are deployed downwards.*

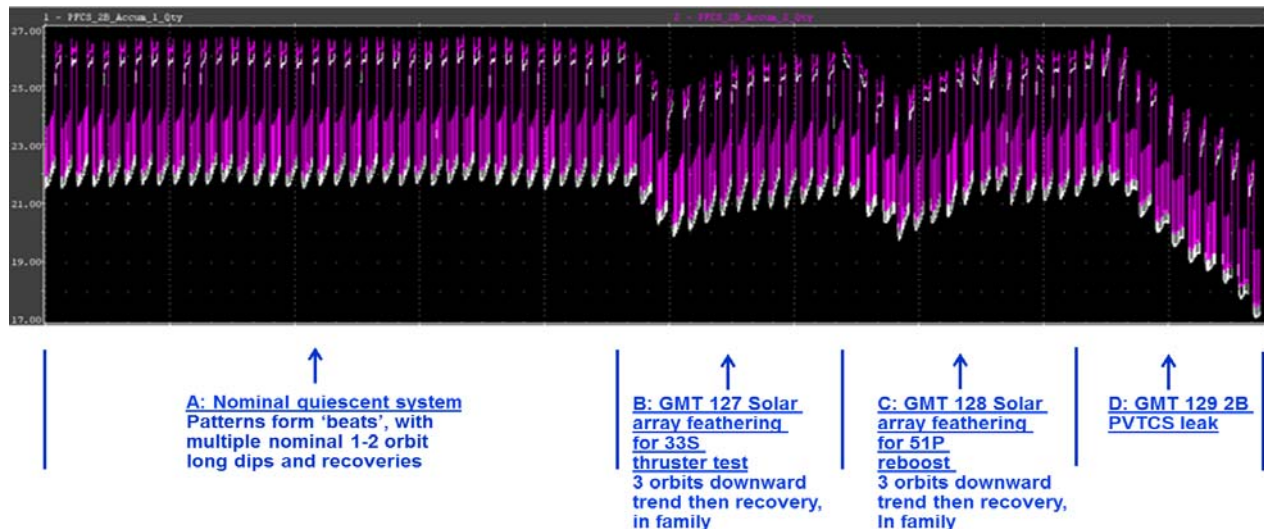
Telemetry indicated a 5lbm/day leak, with automated shutdown action expected to occur within 24-48 hours when the 2B PFCS quantities would fall below 4%. The Timeliner bundle discussed previously was not yet onboard and therefore EETCS quantities were not a part of the leak shutdown algorithm.

**Figure 7. 2B PFCS Fluid Level (GMT 2013/124-129).** Y-axis is the fluid quantity as measured by two sensors within the 2B PFCS accumulator. Each ‘beat’ is approximately an orbit. Within an orbit, quantity is highest when the FCV is in full-radiator flow, due to the effects of line resistance across the hybrid system. Note the similarity of the pattern of the GMT129 leak to the two SARJ feathering events prior.

personnel) stated that the goal of the team would be to perform an EVA on May 11th. The EVA crew would replace the channel 2B PFCS, as this was the only possible remaining leak source in the 2B system having isolated the PVR on EVA 20. The only caveat was that a pump replacement would not be performed if it appeared to the crew that the leak source was obviously from the irreplaceable hardlines underneath the PFCS and EPS equipment.

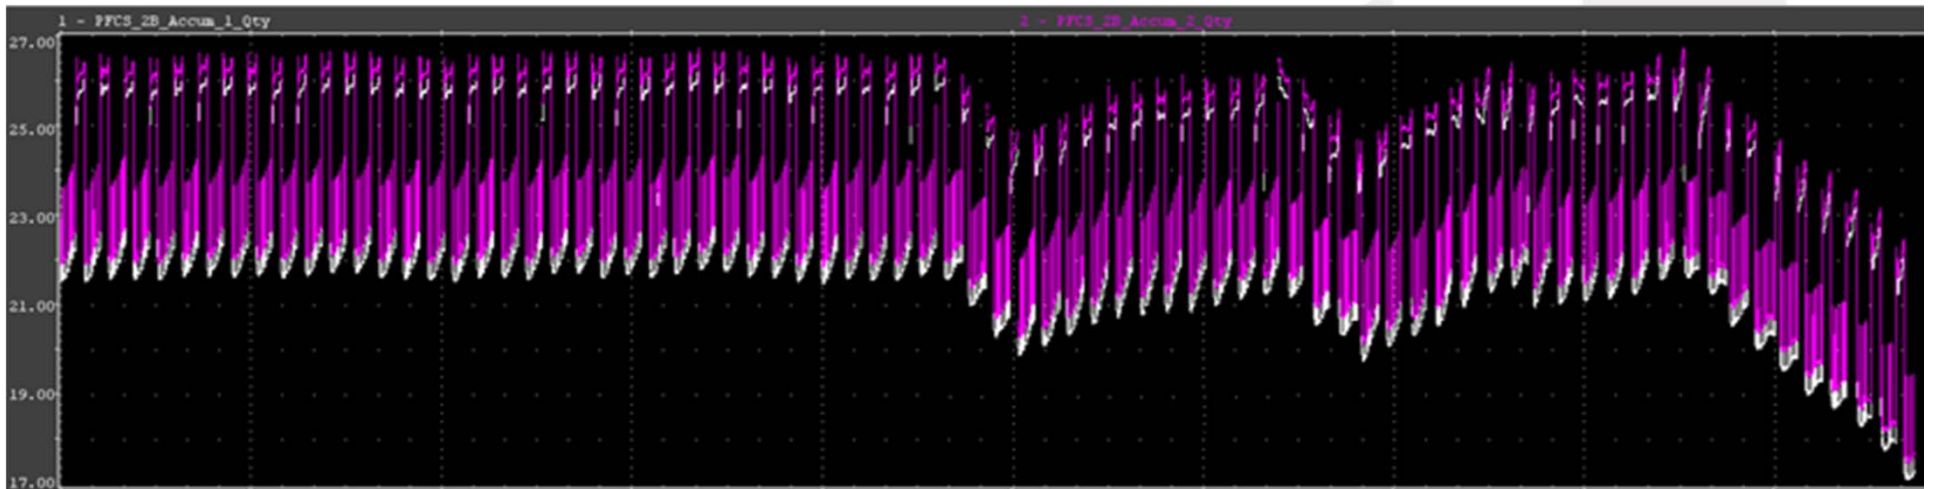
2B PVTCS NH<sub>3</sub> Qty vs. Time (~5 days in May 2013)

**A: Nominal quiescent system**  
Patterns form 'beats', with multiple nominal 1-2 orbit long dips and recoveries

**B: GMT 127 Solar array feathering for 33S thruster test**  
3 orbits downward trend then recovery, in family

**C: GMT 128 Solar array feathering for 51P reboost**  
3 orbits downward trend then recovery, in family

**D: GMT 129 2B PVTCS leak**

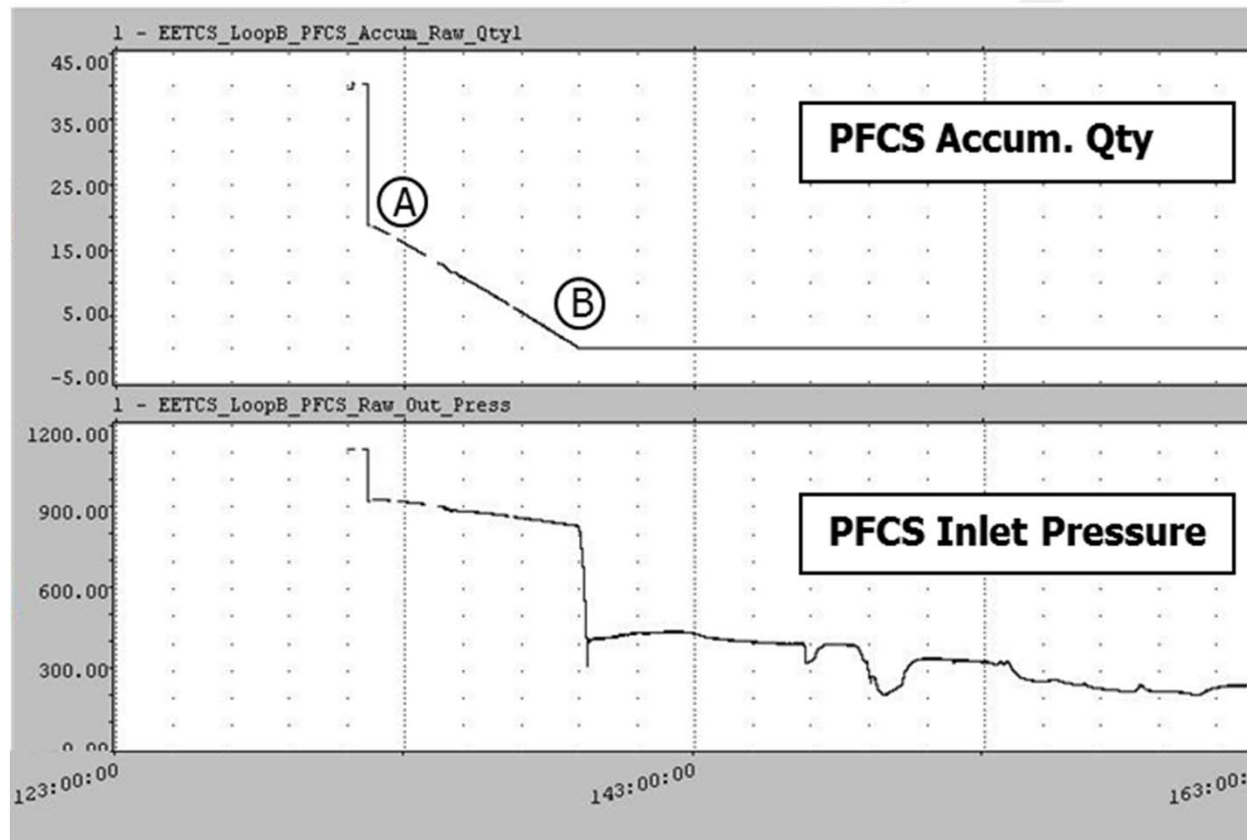
'Mr. Leaky' – PFCS S/N 0004 After EVA 21 Removal

- Leak Status:
  - The 2B PVTCS leak was isolated to PFCS S/N 0004
  - Since May 2013, system mass has not appreciably changed
  - An EVA may occur as early as this summer to retract the TTCR and return 2B PVTCS to design configuration
- Conclusion:
  - ISS PVTCS leak mitigation capabilities were crucial to continuing successful operation
  - An operations mindset during the design process is a necessity
