# Tank Applied Testing of Load-Bearing Multilayer Insulation (LB-MLI)

Wesley Johnson<sup>1</sup>, Juan Valenzuela<sup>2</sup>, Jeff Feller<sup>3</sup>,  
Dave Plachta<sup>1</sup>

2014 Propulsion and Energy Forum

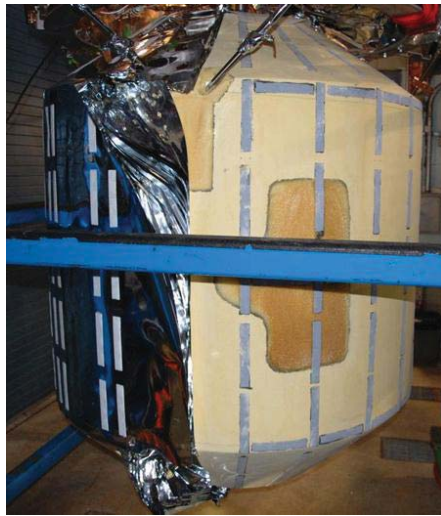
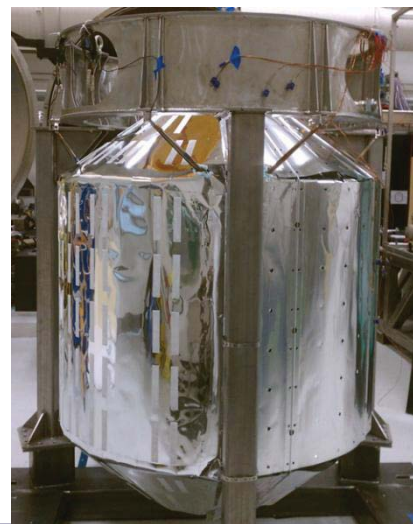
Two tanks were fabricated to be as close to identical as possible

- Nearly identical insulation systems were installed on each tank
- One tank was tested with liquid hydrogen for thermal performance
- The other was tested with liquid nitrogen to determine the acoustic environmental effects on the cooled shield/MLI.

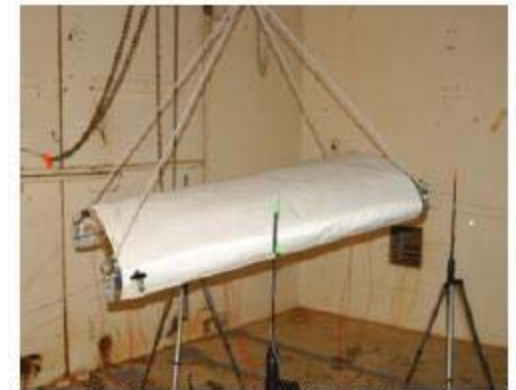
- In order to demonstrate structural integrity of the blanket, acoustic testing was selected over vibration testing
  - Insulation systems are large area, lightweight systems that respond more to acoustically input energy than vibrationally input energy
- Testing on coupons
  - Unloaded flat panel
  - Loaded curved panel
  - Post test examination for changes (damage)
- Testing on a Tank
  - Thermal testing before and after
  - Post test examination for changes (damage)
- All actual acoustic testing done when system was a room temperature

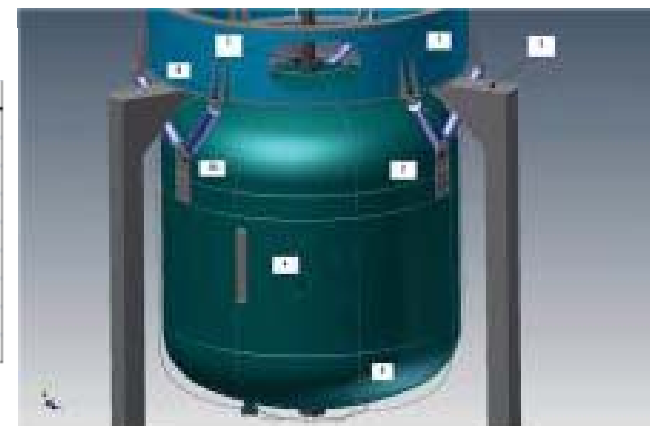
Accel #	Description	Type
1	On gusset, near strut attach point	Triax
2	On tank, near strut attach point	Triax
3	On support column, top surface	Triax
4	On tank surface, mid-barrel section	Uniaxial
5	Same as #4, clocked 120 degrees around tank	Uniaxial
7	On top of tank	Uniaxial
8	On bottom of tank	Uniaxial
9	On gusset, near strut attach point	Triax
10	On tank, near strut attach point	Triax

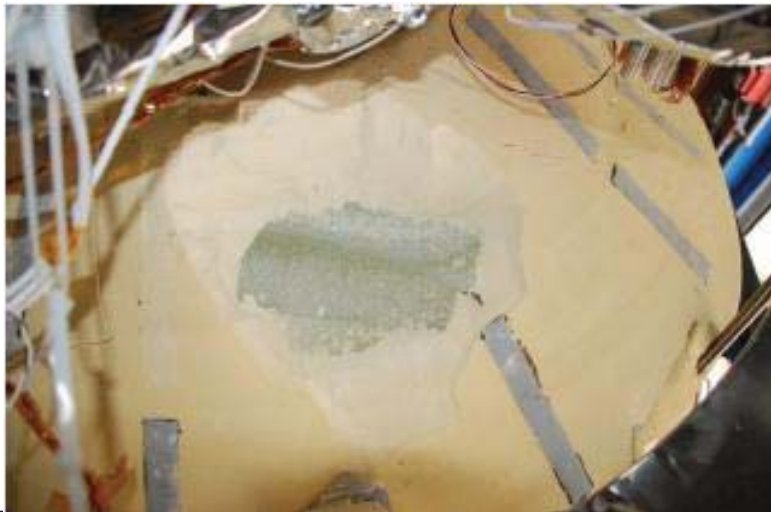
- Post test evaluation showed divoting and cracking of the SOFI, further investigation yielded:
  - Tank was stainless steel, not aluminum, SOFI shrinkage optimized for aluminum
  - SOFI was up to 4" thick in some places, recommend not greater than 1.5" to 2" thick in future
  - Velcro may have added extra stresses to cause more cracking
