NASA/TM—2014-218396

# Test Facility Simulation Results for Aerospace Loss-of-Lubrication of Spur Gears

*Robert F. Handschuh and Lucas J. Gargano  
Glenn Research Center, Cleveland, Ohio*

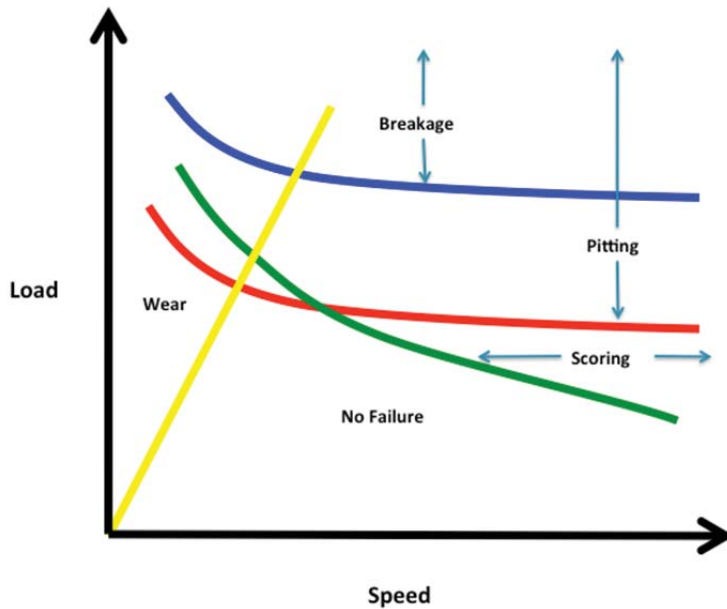
Figure 1.—Effects of speed and load on gear wear mechanisms.

Failure mechanisms of gear contacts can be summarized by Figure 1 (Ref. 2). In Figure 1, two of the mechanisms are of most importance for loss-of-lubrication. The first is the wear region where extreme loading at slower sliding speeds under starved lubrication conditions generates sufficient heat to expedite wear. The other region is the scoring region where high relative sliding of the teeth influences the heat being generated. In either case, the friction coefficient increases due to the loss of the full elastohydrodynamic fluid film, thus increasing the heat generation rate.

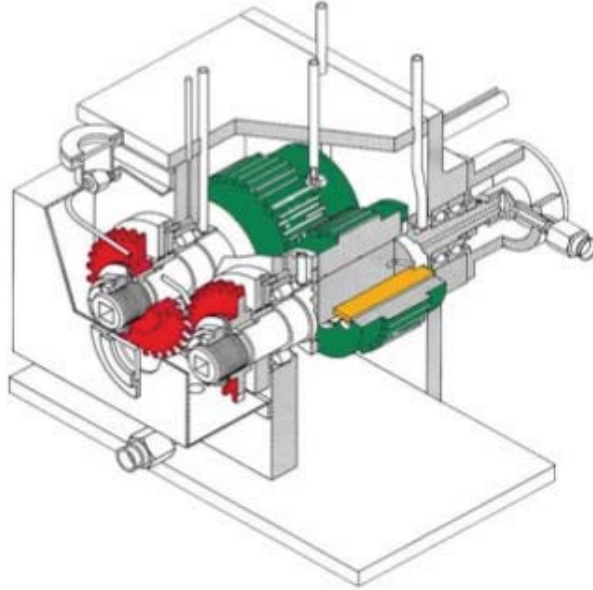
Figure 2.—Cross-sectional sketch of the test gearbox used for loss of lubrication testing.

The test facility used for conducting all loss-of-lubrication simulation tests is the NASA Glenn Contact Fatigue Test Facility (Refs. 6 to 8). The facility is shown in the sketch illustrated in Figure 2. The facility is a torque regenerative test rig that locks torque in the loop via a rotating torque applier. The test gears have a 1:1 ratio. Facility speed and torque can be varied as needed during a test. The basic gear design information of the tested gears is listed in Table 1.

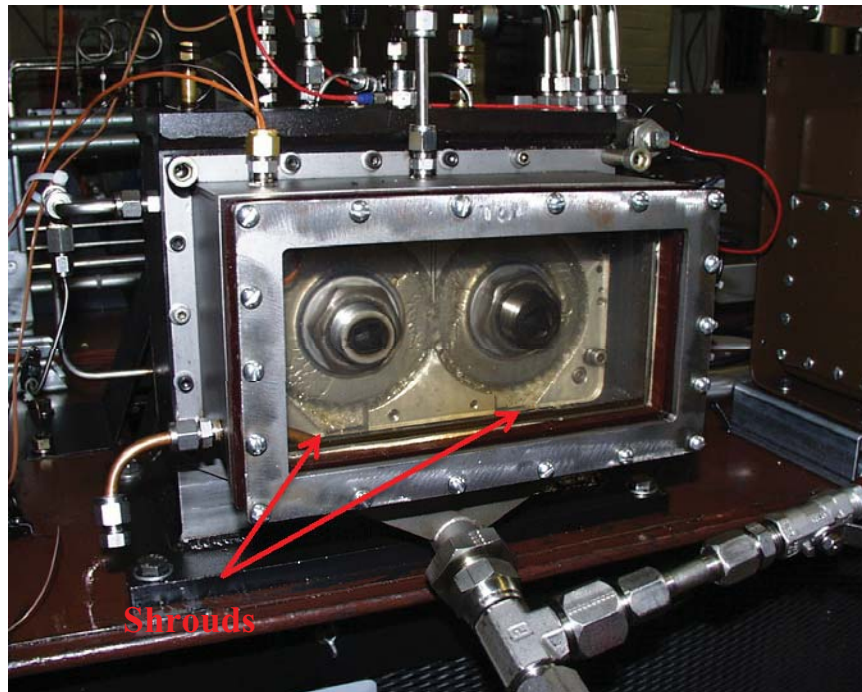
Figure 3.—Current test gearbox arrangement utilizing shrouds (bottom exit shown).

As previously mentioned, the facility went through an evolutionary period (Ref. 5) where shrouding, visual access, gearbox lubricant removal, and instrumentation were added to the test section. A photograph of the current test gearbox arrangement is shown in Figure 3.

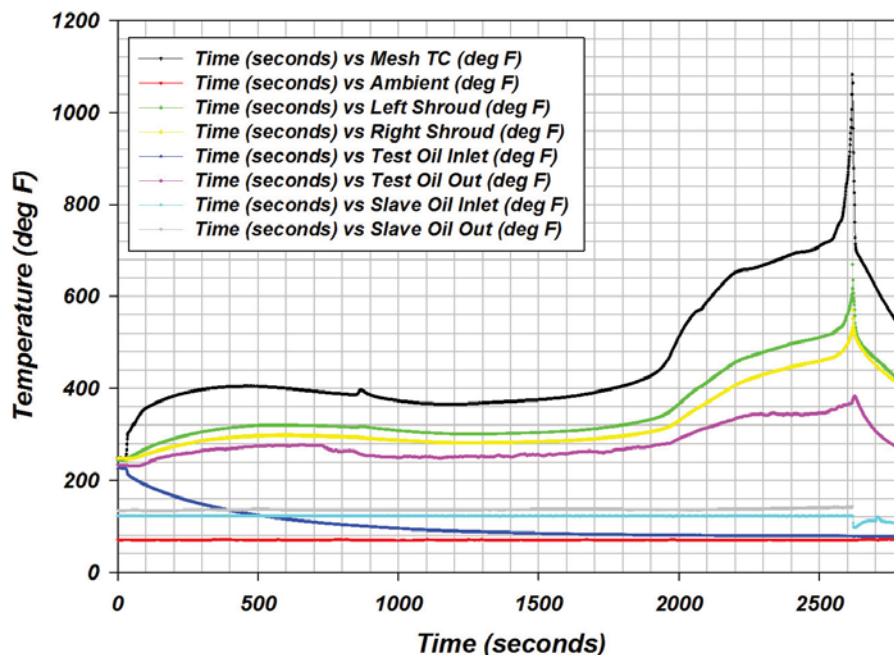
Figure 5.—LOL data for 1.72 kPa (250 psi) load pressure ~59.3 N\*m (540 in\*lb) torque tested at 10000 rpm.

An example of each of the two load levels will now be described. At the lower level of the two loads, two tests were conducted with the loss-of-lubrication time of 40.8 and 43.1 min in length. The data from the static thermocouples imbedded in the shrouds along with other facility temperatures is shown in Figure 5.

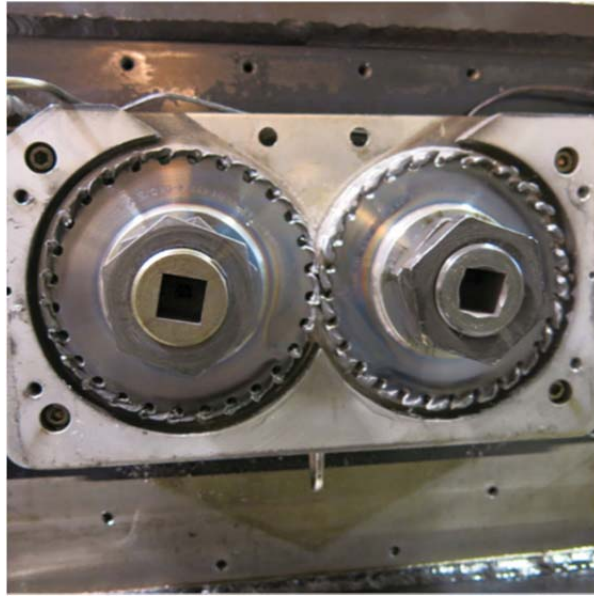
Figure 6.—Post-test condition of the gears (gearbox cover and outer high temperature glass removed).

The gears in the post-test condition are shown in Figure 6. Note that the test was conducted until the gear tooth meshing heat generation and resultant temperature was high enough to plastically deform the gear teeth. This type of post-test condition occurred whenever the test was permitted to continue until total loss of torque delivery was achieved. A typical loss of lubrication failure at this condition is shown in Figure 7.

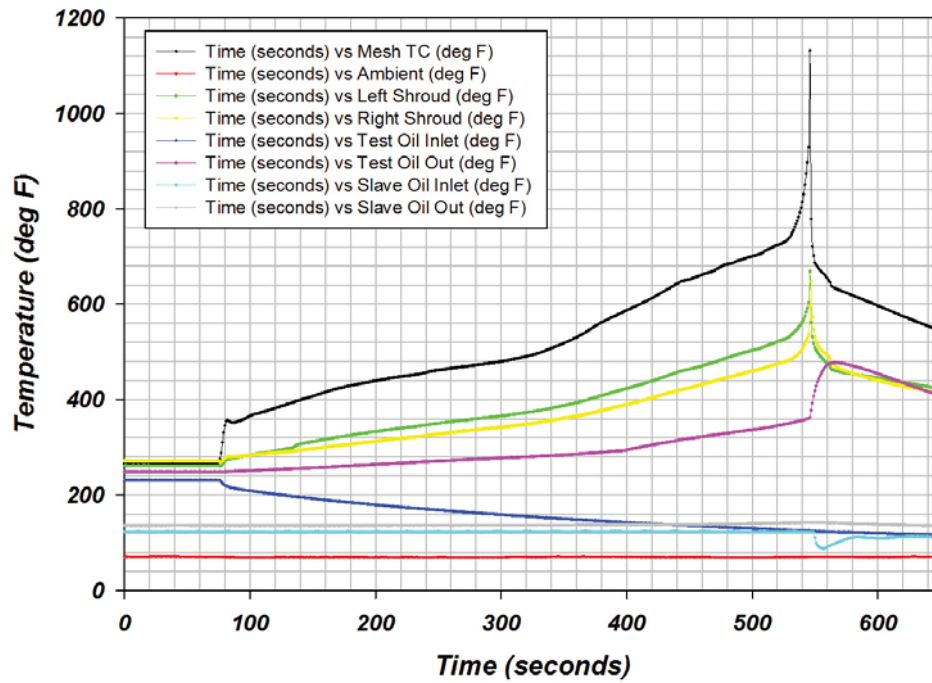
Figure 8.—Loss-of-lubrication data from higher load test 83.6 N\*m (740 in\*lb).

Two other tests were conducted at an elevated level of load (~83.6 N\*m (740 in\*lb)). These two tests, in the loss-of-lubrication mode, produced failures in 7.9 and 9.2 min. The test temperature data from the 7.9 min loss-of-lubrication test is shown in Figure 8. As can be seen from this data, the temperature did not reach an increased steady-state condition prior to increasing to failure as it did in the test shown in Figure 5. After the primary lubrication system was disconnected the temperature just continued to rise. The post-test condition of the test gears is shown in Figure 9 with the gearbox cover removed.

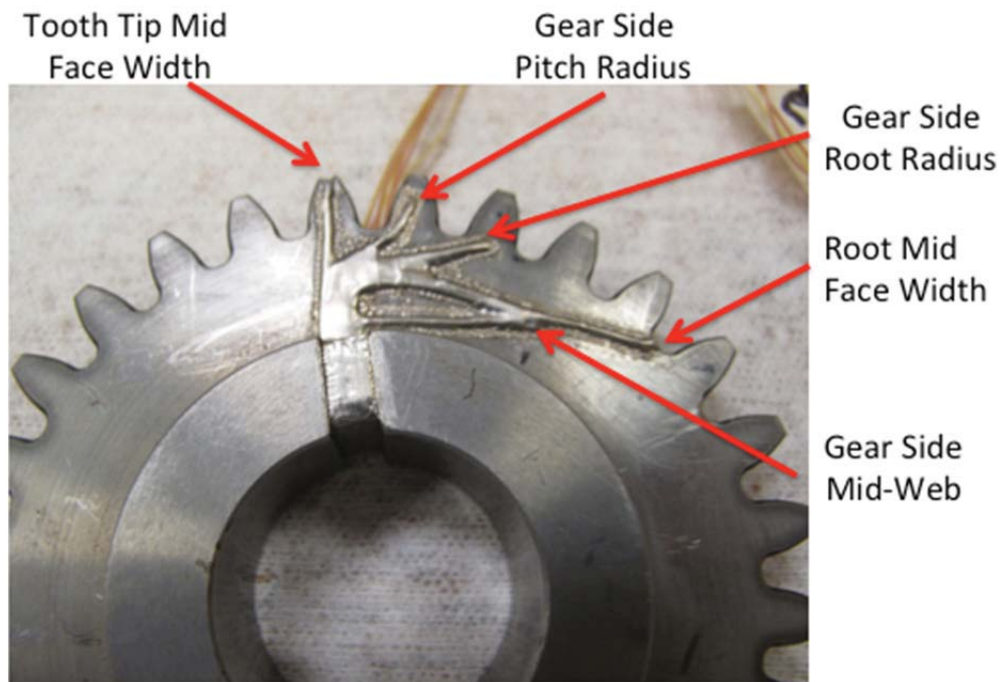
Figure 10.—Instrumented LOL test specimen before testing.

The gear used in these tests is shown in Figure 10. It was the gear installed in the left side of the gearbox. The left side gear acts as the driving gear of the test section of the facility. A total of five thermocouples were attached to the gear at the tooth tip mid-face width, root mid-face width, and on the side of the gear at the pitch radius, root radius and mid-web locations. As shown in Figure 10, the thermocouple wires were covered by a thin metal foil that was spot welded to the side of the gear to protect the instrumentation during operation. The rest of the required hardware is shown in Figure 11 prior to installation in the test rig. The assembly in the test rig is shown in Figure 12.

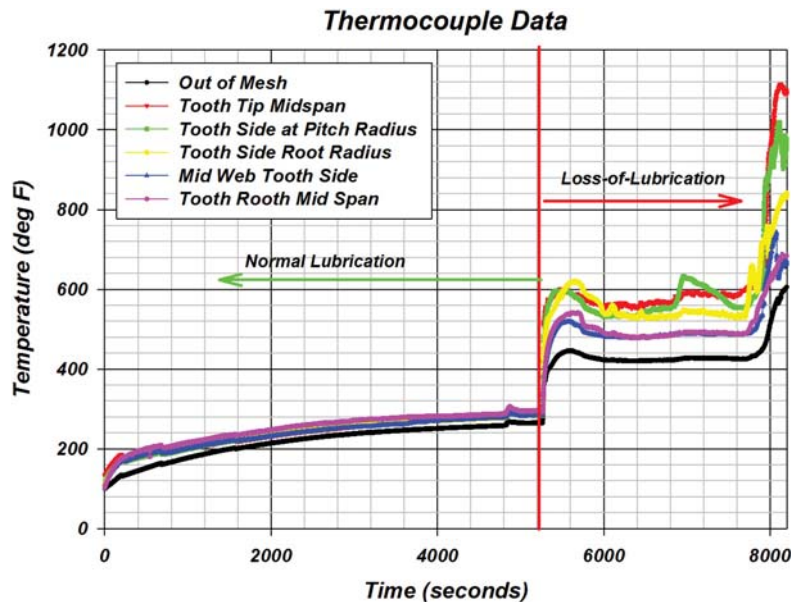
Figure 13.—On-gear and out-of-mesh thermocouple data from star-up to instrumentation failure during loss-of-lubrication.

The initial data for warm-up and operation of the facility in the normal to loss-of-lubrication mode is shown in Figure 13. During this same test the lubricant was shut off and the test run until failure. The data from loss-of-lubrication initiation to failure for the shroud (static) and other facility thermocouples is shown in Figure 14.

The data in Figures 13 and 14 indicate that the bulk temperatures of the gear were exceeding the temperature that was found from the static shroud thermocouples. In the normal lubrication condition this value was 20 to 40 °F depending on the location. In the loss-of-lubrication mode, this amount was as high as 500 °F higher on the gear than that of the static shroud thermocouples. In Figure 13, the data beyond 8200 sec is believed to be invalid due to post-test inspection of the thermocouple wiring that was melted together at the common locations through the shaft. The thermocouple wiring coating was exposed to bulk temperatures in the gear beyond the melting point of the wire coating.

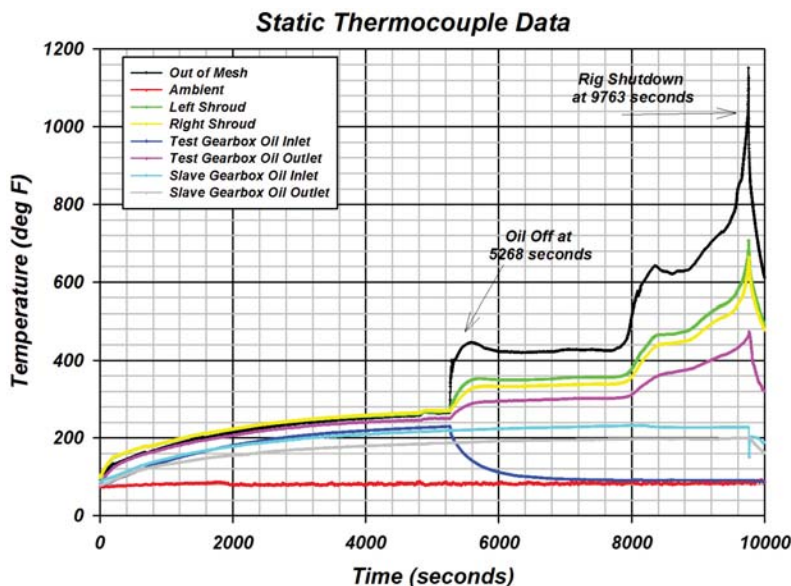
Figure 14.—Data from shroud and facility (static) thermocouples.
