Validation Ice Crystal Icing Engine Test in the Propulsion systems Laboratory at NASA Glenn Research Center

NASA Glenn Research Center

2014 AIAA Aviation, Jun 16 - 20, 2014, Atlanta, GA

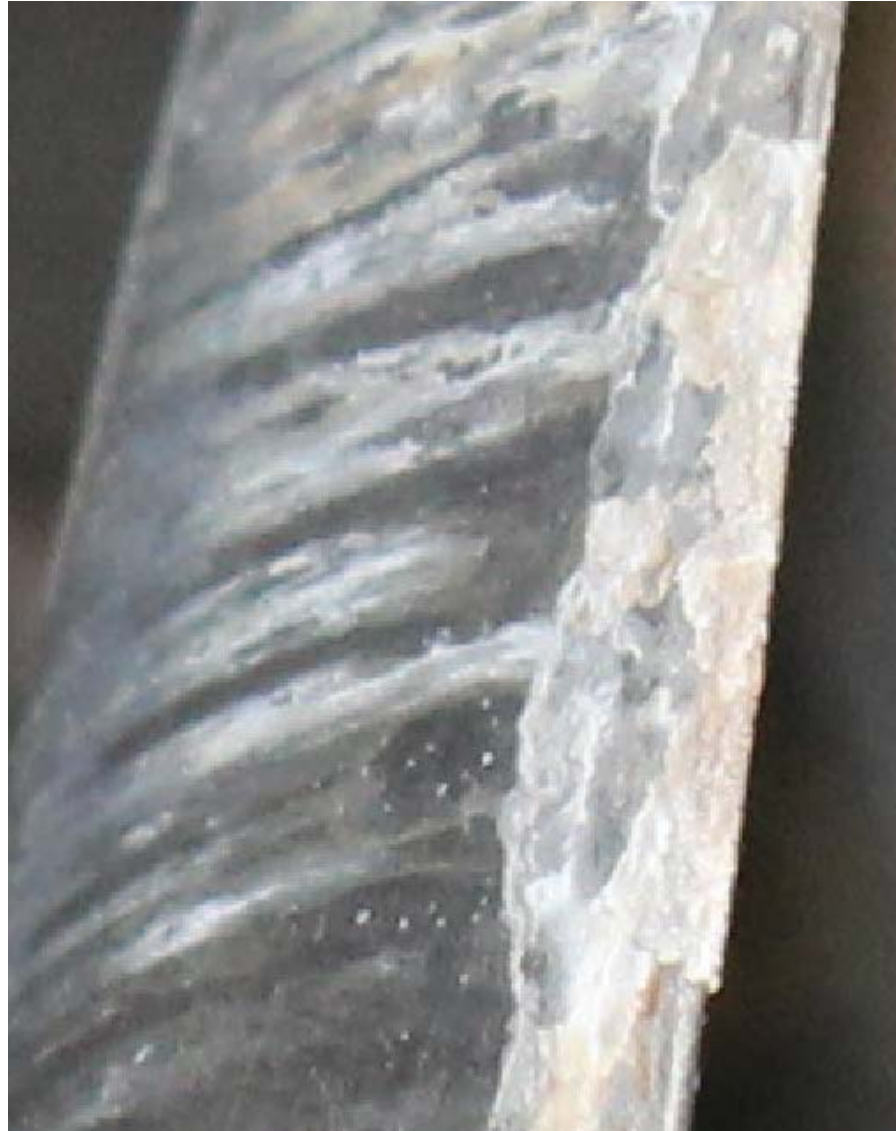
Mineral Deposits on flow path hardware

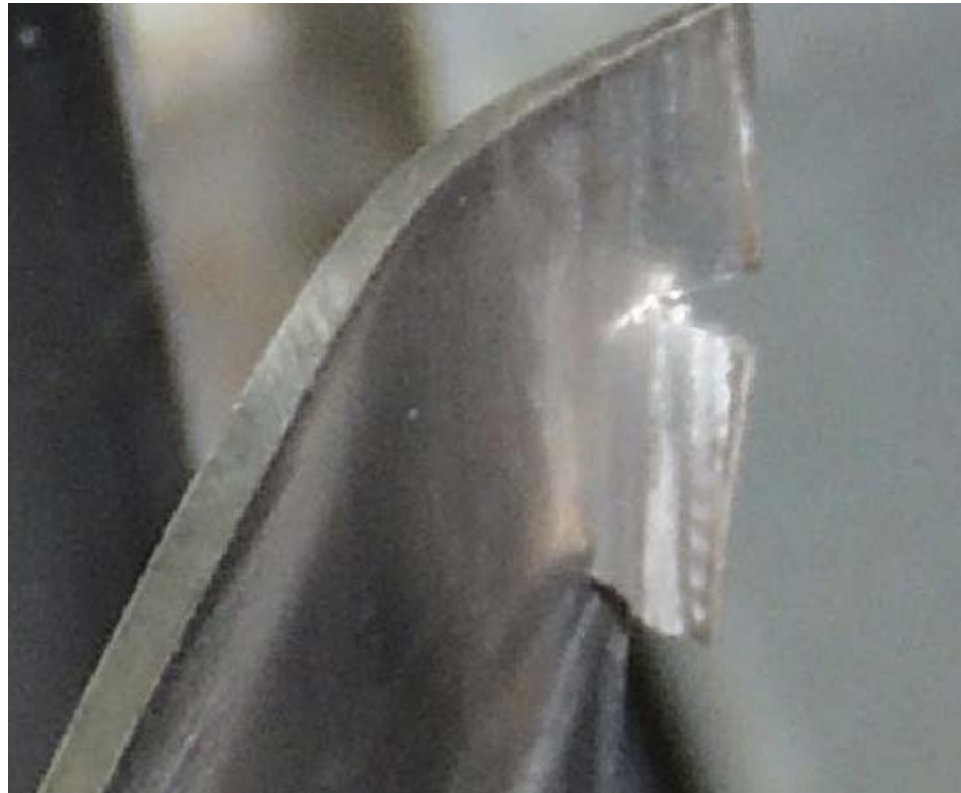
Hardware damage that occurred during a full roll back PSL test point

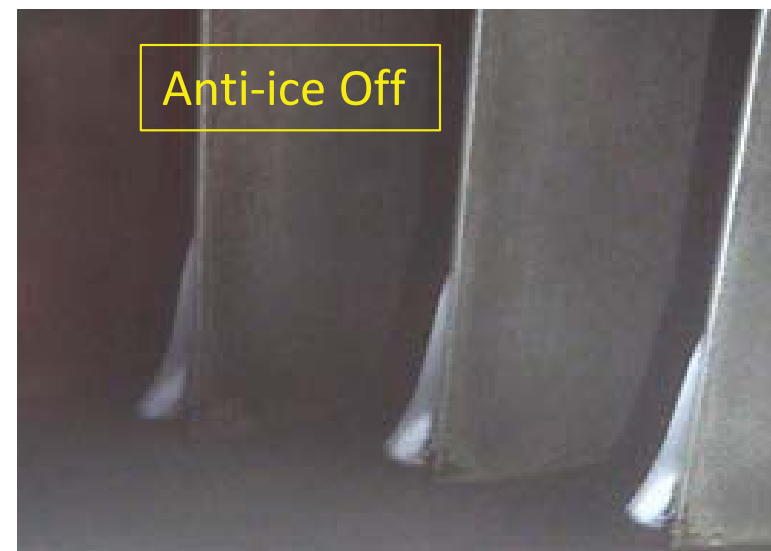
Liquid Water Layer off of heated spinner

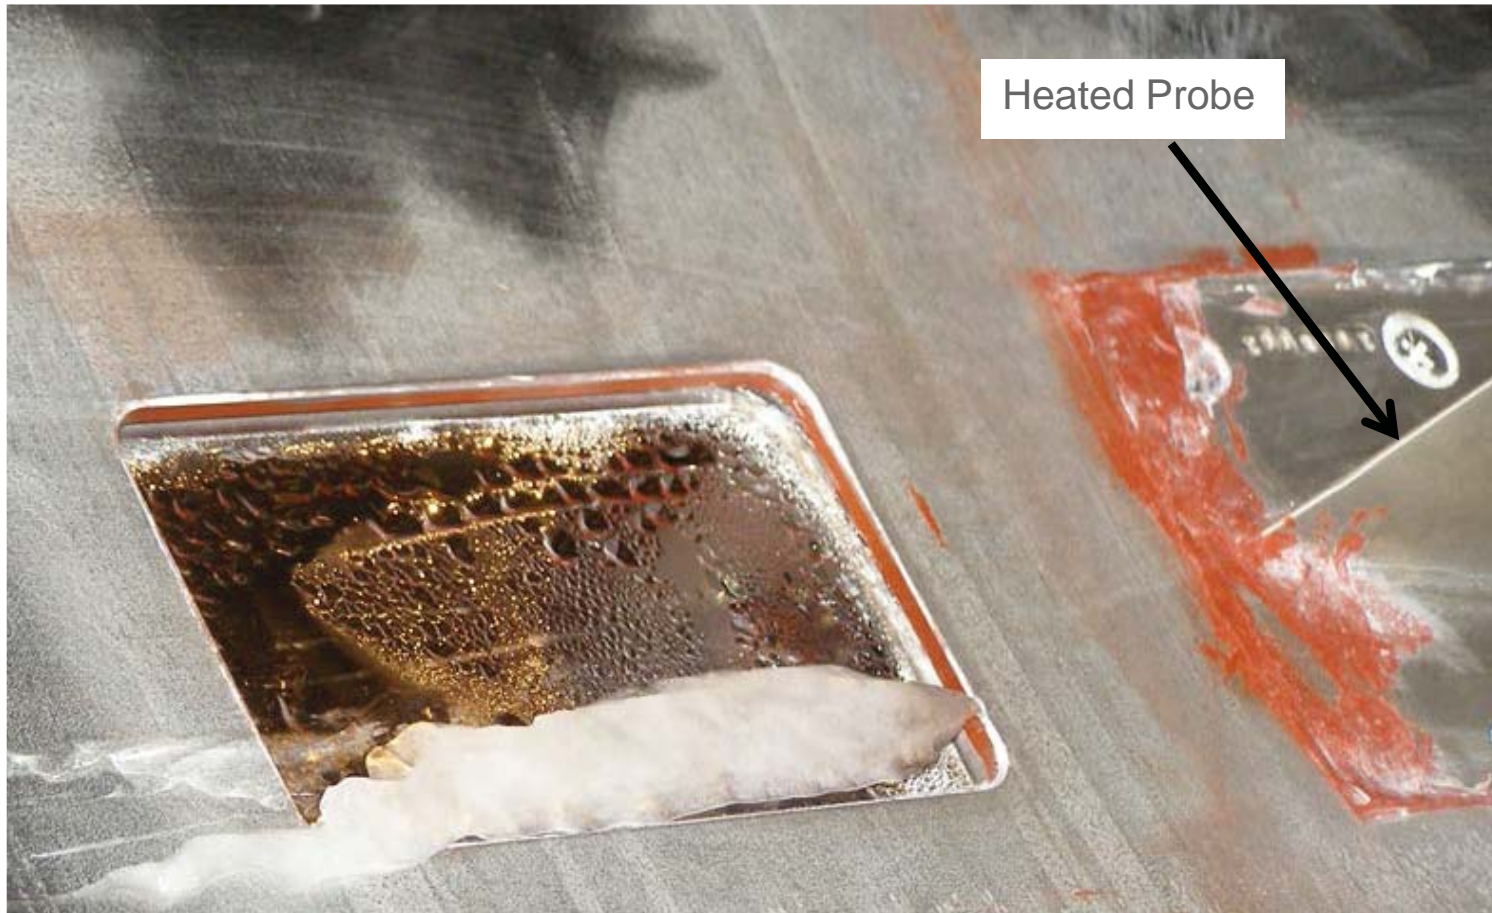
Ice forms aft of heated probes in the flow path

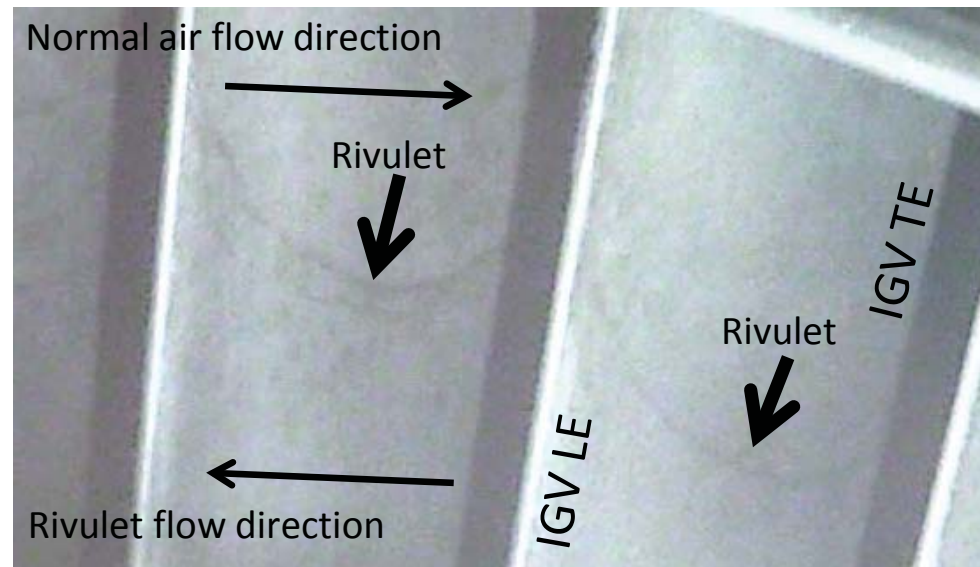
Reverse flow rivulet
