Accelerated Testing of UH-60 Viscous Bearings for Degraded Grease Fault

An accelerated aging investigation of critical aviation bearings lubricated with MIL-PRF-81322 grease was conducted to derive an understanding of the mechanisms of grease degradation and loss of lubrication over time. The current study focuses on UH-60 Black Hawk viscous damper bearings supporting the tail rotor driveshaft, which were subjected to more than 5800 hours of testing in a heated environment to accelerate the deterioration of the grease. The mechanism of grease degradation is a reduction in the oil/thickener ratio rather than the expected chemical degradation of grease constituents. Over the course of testing, vibration and temperature monitoring of bearings was conducted and trends for failing bearings are presented.

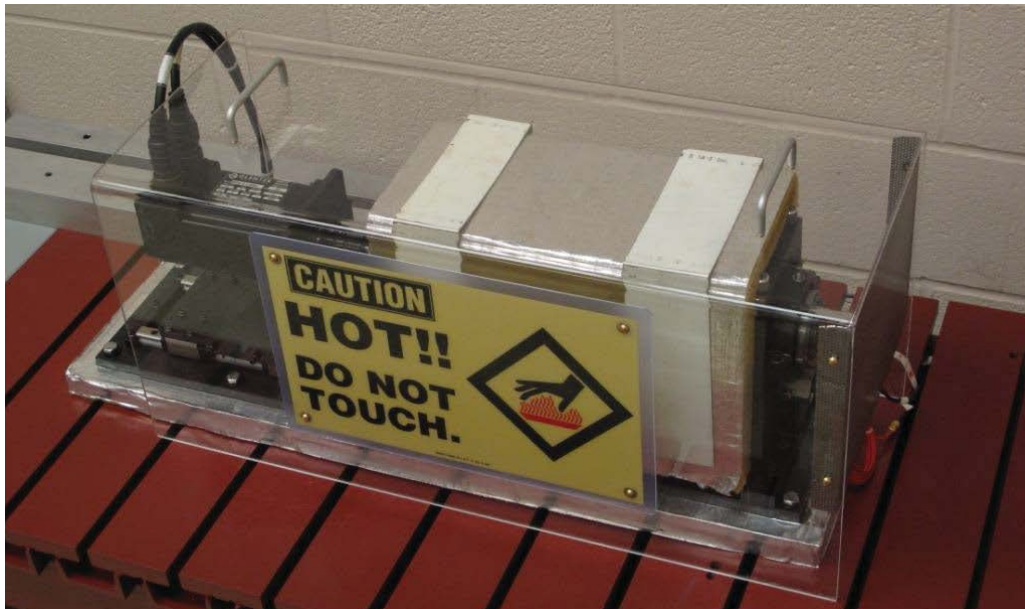
Figure 1 – Grease Degradation Rig Setup with Insulation and Guard Shield Installed

The test rig comprises an electric motor driving a rotating shaft assembly on which test bearings are mounted and operated within a heated test section. Eight test bearings are housed within the test section, with inner races fixed to the rotation of the test shaft and with stationary spring-loaded posts engaging slots machined in the outer race to constrain rotation. Four of these spring plungers engage from below and the other four engage from above. This alternating attachment provides a small radial load on each test bearing, while minimizing the total net radial load on the shaft and rig bearings and overall deflection. Two "rig bearings" on either end of the test section are mounted within the chamber structure and support and constrain the test shaft relative to the static rig structure. The arrangement constrains the rotation axis of the test bearing inner races more rigidly while allowing their outer races some freedom of movement in both axial and radial directions. The two rig bearings are identical to the test bearings, but operate at considerably lower temperatures. Other test bearings are accommodated by this rig with only minor configuration changes, but only the UH-60 viscous damper bearing is considered in this paper.

The rotating shaft assembly is attached to a motor through a flexible coupling. The eight bearings are encased in an insulated heated test chamber having sheet metal walls, with the heater located directly below the test bearings. A plastic guard is placed around the test chamber and motor to obstruct access to hot and rotating parts. Heater set points to 190 °C (375 °F) or higher can be achieved with the current configuration, although bearing temperatures may remain somewhat lower due to heat sinking to the outside environment through the solid bearing shaft. Proportional-integral-derivative (PID) control is used to regulate chamber temperature based on a thermocouple measurement, and while the chamber temperature can vary cyclically up to ± 10 °C (18 °F) the bearing race temperature does not reflect temperature oscillations greater than 0.5°C (1 °F). In later experiments, air flow has been introduced within the chamber encourage a more isothermal chamber environment, but that technique was not incorporated here and significant temperature gradients are observed between test bearings.

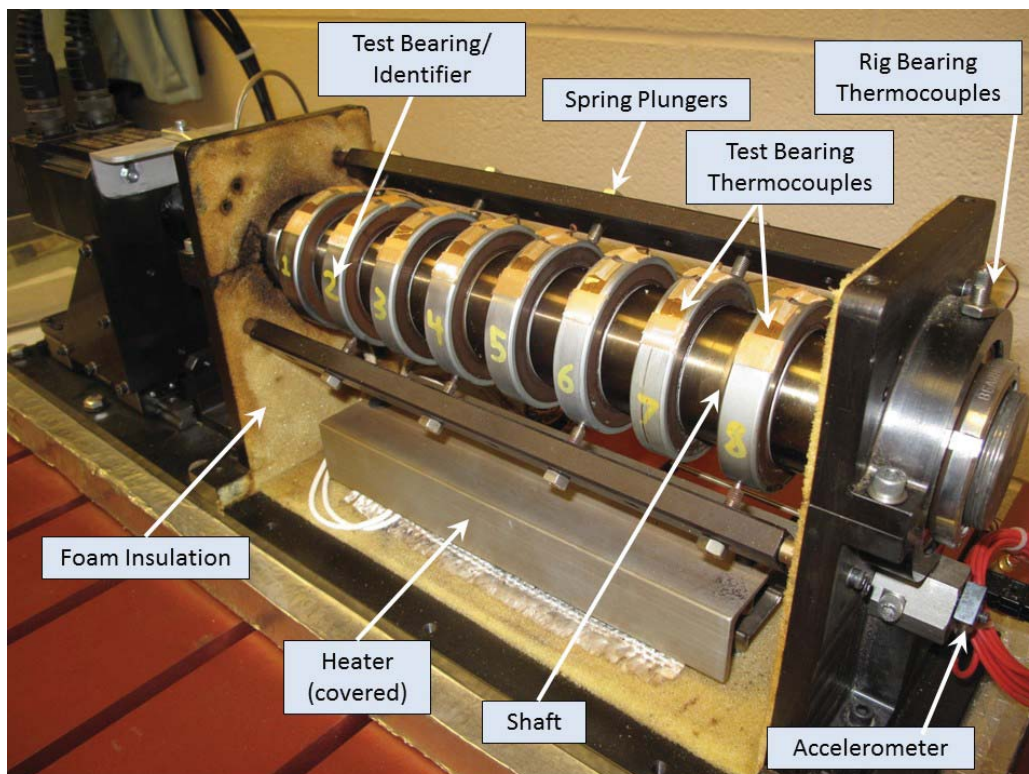
Figure 2 – Grease Degradation Rig with Test Package Chamber Exposed

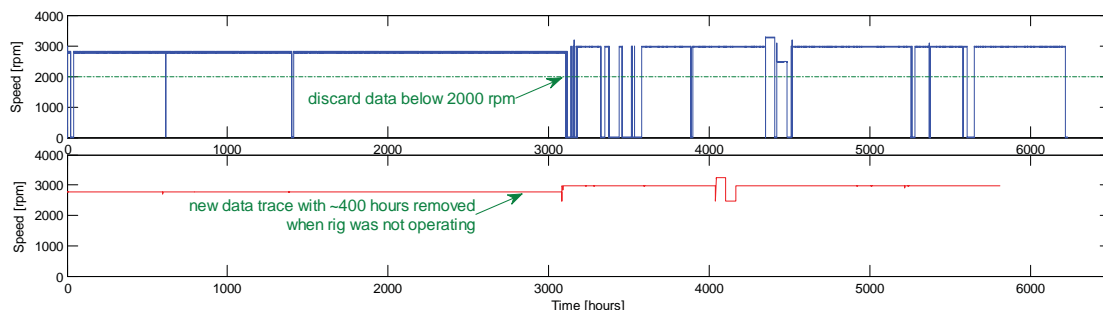
Figure 3 – Filtered and unfiltered speed signal for (a) all 6200 hours of recorded test data, and (b) only 5806 hours of test time when grease was aging

During the course of the tests, several shutdowns of the test rig occurred due to either user intervention or limit exceedance on one of the instrumentation signals. When analyzing and presenting the test data, portions of the time trace were omitted where the motor speed fell below a threshold of 2000 rpm, as this was indicative of rig shutdown and no significant degradation of the lubricant is taking place. As shown in Figure 3, this resulted in slight compression of the time traces presented from about 6200 hours of elapsed time where data was being taken, to about 5806 hours of relevant aging time.

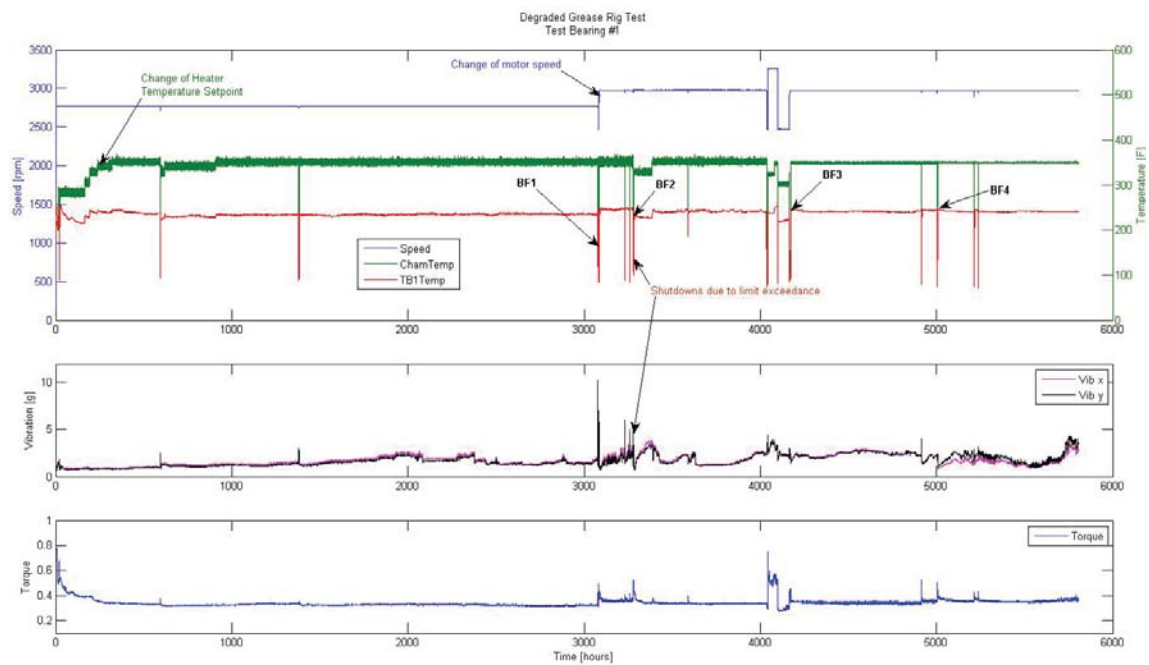
Time traces of significant signals are shown in Figure 4 for the entire 5800 hours of test time. The speed and chamber temperature profiles show the operational conditions to which the test bearings were exposed. The temperature of test bearing #1 only is shown to more clearly illustrate the response of a typical bearing temperature to changes in the operational conditions. Two channels of rms vibration and the motor current signal are also plotted, and trends over time can be seen along with responses to defined bearing failures and changes in operating conditions. Figure 5 provides time traces of the test bearing temperatures for approximately 120 hours of the test, and illustrates typical temperature stability behavior and reaction to set point changes.

*Figure 4 – Signal plots for Test Bearing #1
(BF1: RB#2/a, BF2: TB#6/a, BF3: TB#5, BF4: TB#4)*

Over the course of the aging test, five bearing failures were identified and resulted in removal of a bearing. These are labeled in Fig. 4 as “BF1,” “BF2,” “BF3,” and “BF4,” with the fifth failure noted after the completion of testing. The specific bearings associated with these failures along with their circumstances are detailed in later sections.

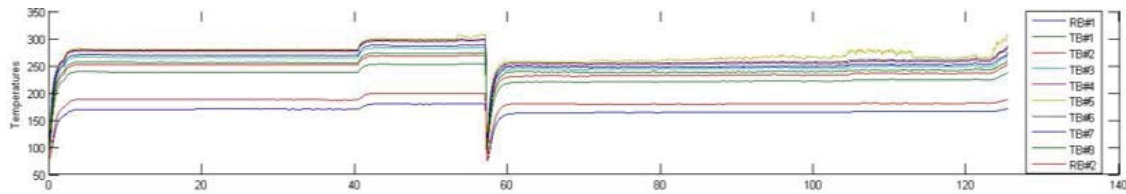
Figure 5 – Measured time traces of bearing outer race temperature for 120+ hours

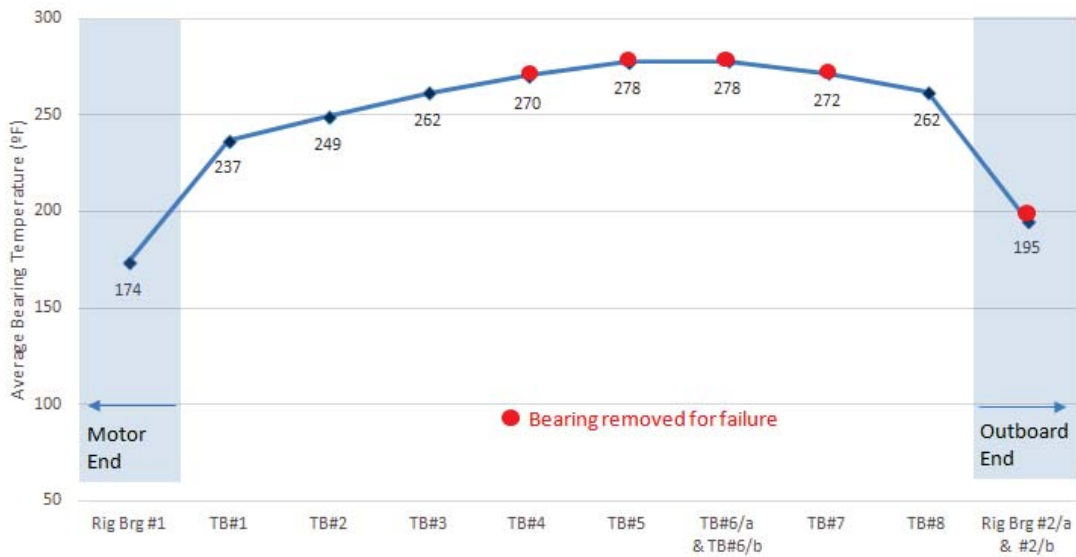
Figure 6 shows the average temperature profile of the test and rig bearings over the duration of the test. The bearings marked in red are the ones that failed during testing. The outer race temperature averages fall within a total range of approximately 40 °F.

Figure 6 – Mean outer race temperatures of test and rig bearings

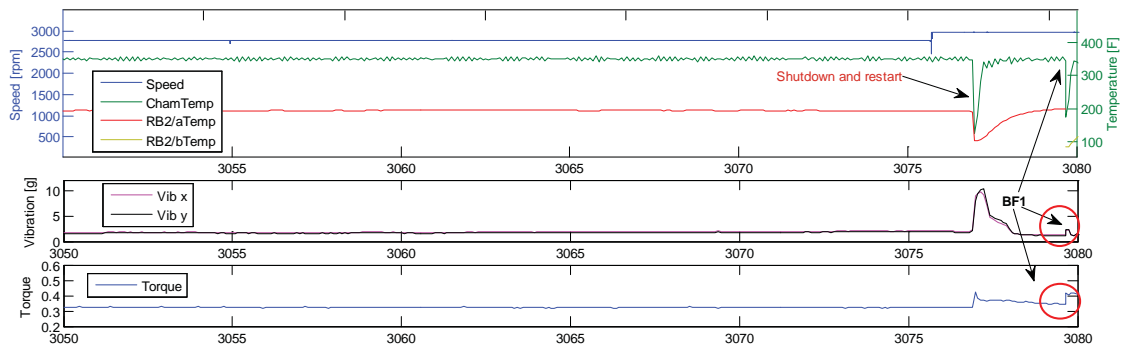
The failure of the rig bearing RB#2/a (bearing failure #1, or “BF#1”) appeared to be the most conservative removal, as this was done mostly as a precaution since it was not specifically identified as a test bearing and a rig bearing failure was to be avoided. At approximately 3077 hours of elapsed test time, a limit exceedance on rms vibration of 3.0 g was recorded and the test stopped automatically (denoted “SD5” in Fig. 7). After restart, vibration and torque started considerably higher than their previous steady values, although decreasing. This behaviour is quite typical for a cold restart of the test rig. Following the restart, the rig bearing temperature triggered a shutdown at 200 °F after only a few hours of additional runtime, even though the vibration by this time had dropped to a lower value than before the first shutdown. It was thought that the temperature exceedance so soon after the rms vibration exceedance could be indicative of an impending failure of this rig bearing, and so it was removed and replaced with a new bearing.

After removing the seal from this rig bearing (S/N B626-25677), the grease appeared dry and depleted though still somewhat pliable. Grease remaining on the seal had a slight appearance

of cracking like dried mud, and detailed chemical studies are reported separately. Turning by hand, excessive clearance or substantially rough turning was not noted when compared to another bearing, but the rotation was somewhat noisy. By comparison, a control bearing turned more slowly due to the increased grease drag. Little grease was present in the bearing but it remained in small clumps on the inner diameter of the between the balls. Fig. 7 shows the behaviour of torque, vibration, and the rig bearing temperature prior to removal. Subsequent attempts to restart the rig caused the new bearing to trip the temperature limit, perhaps as the new bearing had initially higher torque during break-in. Exceedance limits were set higher to allow the test to run longer.

Figure 7 – Detail of bearing failure BF1 on Rig Bearing RB#2/a, with a conservative shutdown around 3077 hours and then another shutdown at 3079 hours with a precautionary removal of the rig bearing

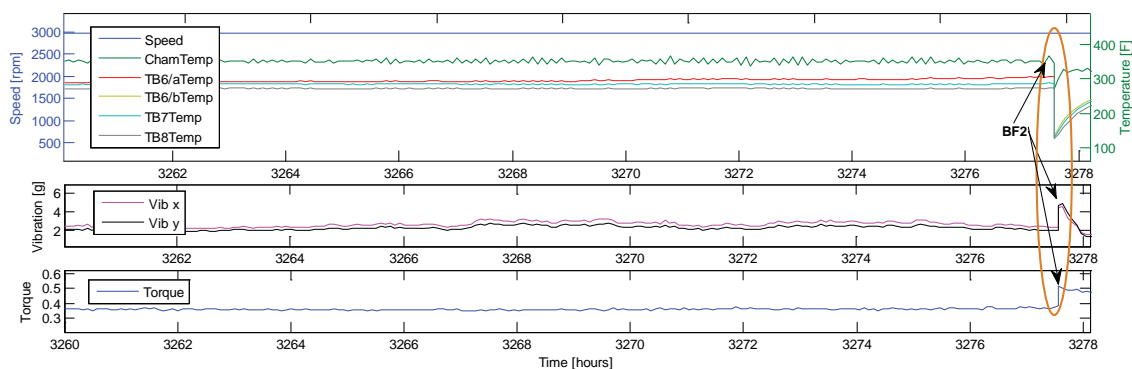
The second failed bearing was removed from the rig following a series of shutdowns that occurred not long after the replacement of rig bearing #2. At approximately 3230 hours of test elapsed time, the test stopped on an exceedance of rms vibration at 4.0 g. After restarting the test with slightly higher limits, the test again stopped about 17 hours later due to an exceedance of the TB#6 outer race temperature of 300 °F. After another restart with higher temperature limits, another shutdown was triggered approximately 21 hours later due to the temperature of TB#6 exceeding 310 °F. Earlier quasi-steady readings from this race thermocouple were between 270-280 °F, so this final limit exceedance corresponded to a 30 – 40 °F increase. The bearing was declared to have failed and was removed and replaced. At this point it was noted that the bearing was very difficult to turn by hand, though it had not completely seized. Figure 8 show time traces of approximately 80 hours of test time around the point where the bearing was deemed to have failed, “BF2” at approximately 3278 hours.

Figure 8 – Detail of bearing failure BF2 on Test Bearing TB#6/a, showing slight trending upward of TB#6/a temperature prior to shutdown and removal

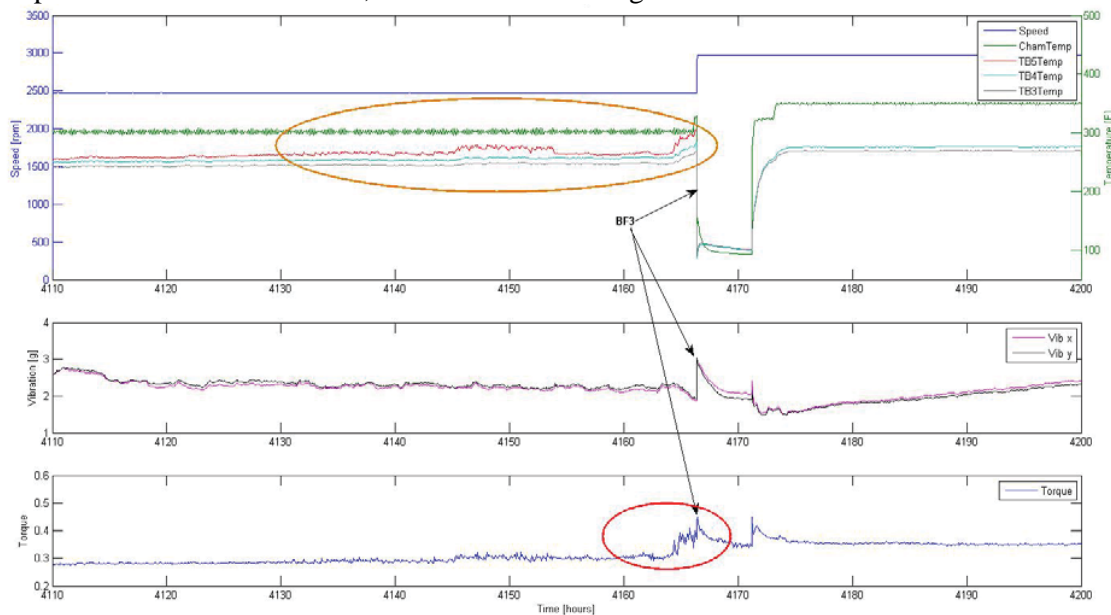
After approximately 4000 hours, the test was interrupted and the rig was moved to a new location. There was a resulting period of approximately one year during which the rig remained in conditioned storage with the test specimens left installed. The test was then resumed, and within the first 150 hours of operation after storage, the third bearing failure occurred on test bearing #5. As shown in Fig. 9, the race temperature for this bearing showed some signs of excursion for a period of at least 35 hours prior to failure. Since restarting the test following storage, speed set points were varied from 2500 rpm up to 3250 rpm to determine noise and vibration characteristics in the new location. This departure from the usual steady test conditions result in some uncertainty in the contribution to aging rate and appropriate threshold criteria for rig shutdown. Although race temperature and torque variations preceded the bearing failure by at many hours, the test shutdown occurred immediately following an increase in speed set point from 2500 rpm to 3000 rpm, and chamber temperature set point from 300 °F to 325 °F. The bearing (SN #B626-56171) was removed for inspection, but due to a lack of additional test specimens it was replaced with spacers.

Figure 9 – Detail of bearing failure BF3 on Test Bearing TB#5, showing significant test bearing temperature excursions and torque increase prior to shutdown and removal

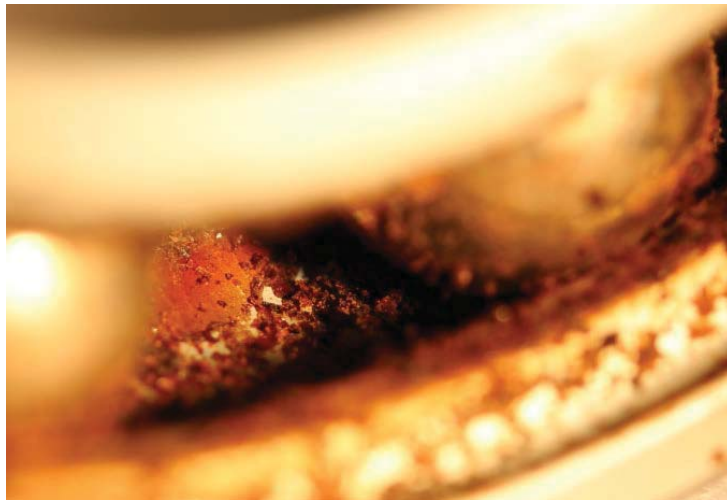
At the initial inspection the bearing seals appeared darkened. After its removal from the test rig the grease had a dried appearance with almost a granular texture, and was adhered to the cage. Some areas along the seal lip at the inner race had darkened, brittle and continuous sections of grease. The rivets were pressed out of the cage and the cage removed for inspection of the race surfaces, which is shown in Fig. 10.

Figure 10 – Photograph of failed test bearing #5 after removal of cage, showing visual condition of grease on the outer race in different locations

The specimens declared to have failed were inspected to determine the failure mechanism. The seals were found to remain intact and functional, although the seal material was found to have become brittle from the exposure to elevated temperature. With the seals removed, the grease in the failed bearings was found to have a dry, brown and cracked appearance and was retained on the seals or clinging to the cage. When pried with a pick, the grease flaked off in small dry clumps or flakes in some cases, while in others it remained slightly pliable. On some of the more advanced failures, small mounds of dried caked grease were noted on the outer race between rolling elements. When the remaining grease products were washed from

the bearings with solvent, corrosion damage was not observed despite what may appear similar to corrosion in the above photographs. When turning by hand, there was a very large periodic torque variation notable as each successive ball attempted to overrun those grease deposits. In some instances this torque variation was large enough to trip an overcurrent protection in the motor controller.

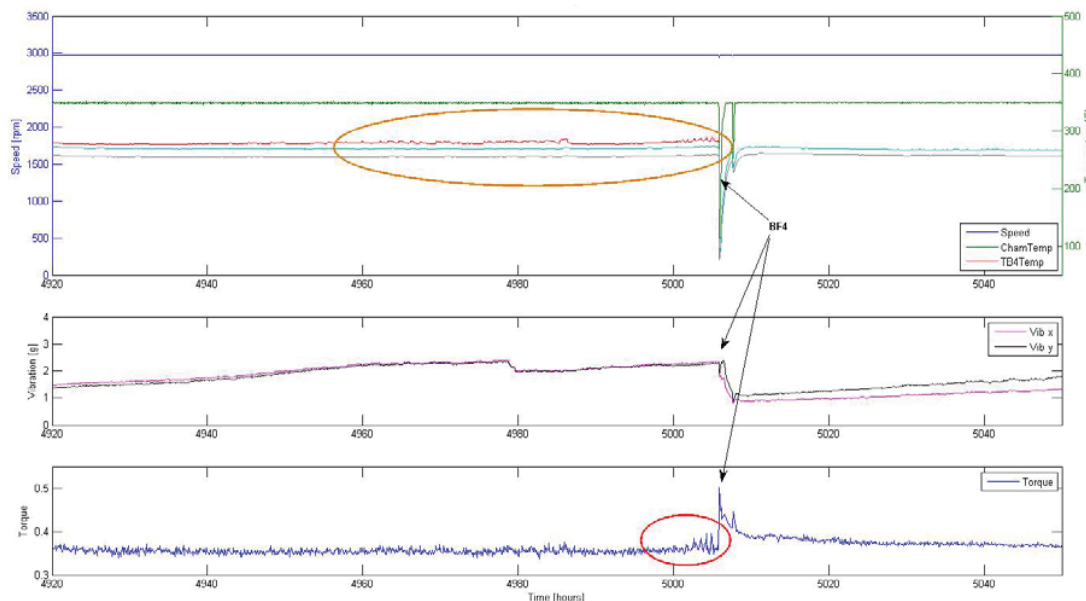
The fourth bearing deemed to have failed was removed following an exceedance of torque. An attempt to restart the test with higher torque shutdown limits resulted in the outer race breaking loose from the spring plunger and ripping the thermocouple open, so the bearing was deemed to have failed and removed from the rig to be replaced with spacers. The final 100 hours of the bearing operation is given in Fig. 11, showing upward trends in vibration somewhat erratic torque in the final hours prior to failure, and some fluctuations in temperature, though not as substantial as in the previous test bearing failures. The bearing had seized with a few degrees of rotational freedom, where dried grease pockets had settled on the outer race between rolling elements and were not easily overrun. Fig. 12 shows the visual condition of the bearing after it was removed for failure.

Figure 11 – Detail of bearing failure BF4 on Test Bearing TB#4, with temperature, vibration and torque signals showing deviations in the hours preceding failure

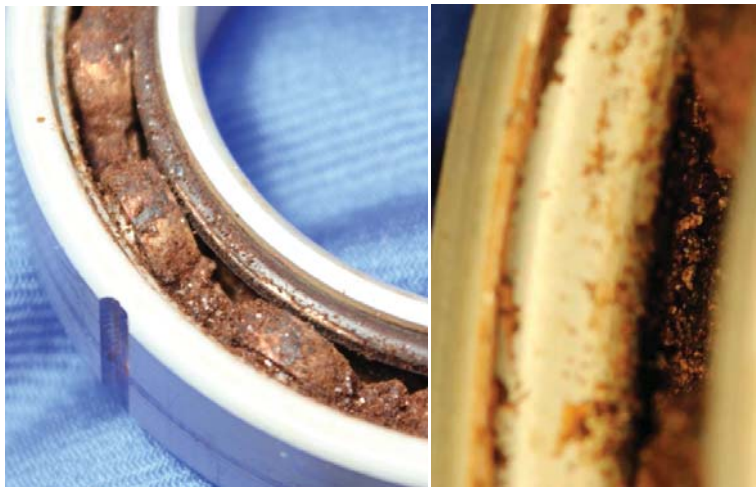
Figure 12 – Photographs of failed test bearing #4, (left) showing cage areas and (right) showing outer race surface between rolling elements

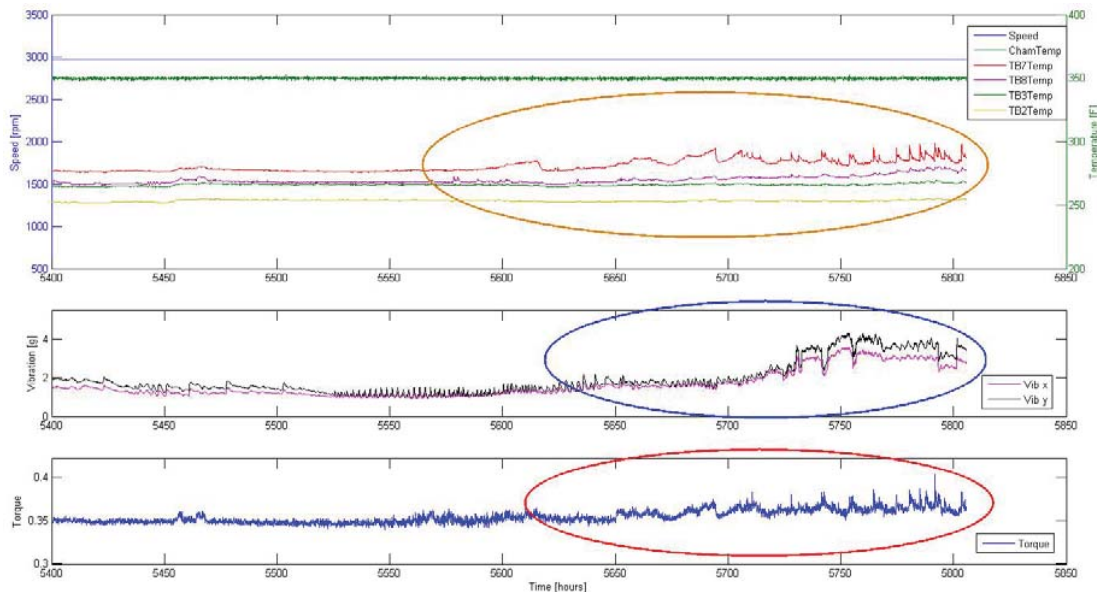
Finally, near the end of the recorded data at 5800 hours, indications of high vibration, torque, and temperature of test bearing #7 (SN # B626-55880) indicate potential impending failure, with the values of these signals trending upward and exhibiting seemingly erratic behavior for at least 200 hours prior to the termination of the test. This behavior is shown in Fig. 13.

Figure 13 – Final hours of rig testing, showing erratic temperature, vibration and torque
