A Study on the Effects of Ball Defects on the Fatigue Life in Hybrid Bearings

Ching-Yao (Tony) Tang*, Chad E. Foerster*, Michael J. O'Brien*, Brian S. Hardy*, Vinay K. Goyal*, Benjamin A. Nelson*, Ernest Y. Robinson**, Peter C. Ward* and Michael R. Hilton*

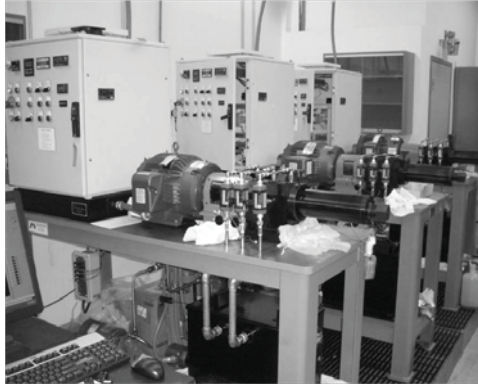
Figure 1. Rolling contact fatigue testers at The Aerospace Corporation.

Fatigue testing was performed on full-scale bearings using a standard bearing tester (Figure 1). The bearings were thrust loaded to either 330 ksi (2.3 GPa) or 400 ksi (2.8 GPa) mean contact stress between the Si_3N_4 balls and the inner race, rotated at 5000 rpm (524 rad/s), and lubricated with a continuous flow of MIL-L-7808 oil at 0.95 l/min/bearing. The oil was maintained at 60 °C (140 °F) and filtered to the 3- μm level. These conditions resulted in $\lambda = 1$, where λ is the ratio of the calculated lubricant film thickness to the mean surface roughness of the races.

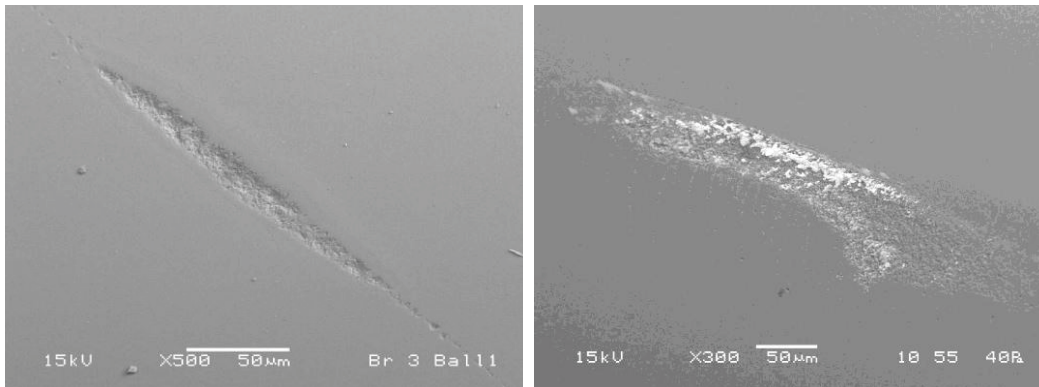
Figure 2. A typical scratch found on Si_3N_4 ball (left), and a distinctive feature observed by contractors (right).

A technique was created to generate scars with dimensions and morphology that are comparable to the distinctive features observed from contractors and in as-manufactured Si_3N_4 balls (Figure 2). The technique involves controlled back-and-forth sliding contact of two Si_3N_4 balls. This ball-on-ball apparatus is shown in Figure 3. The apparatus consists of a linear stage to enable precise relative translational motion between the balls, and two ball holders with conforming hemispherical sockets. The balls rest inside the sockets and their rotational movement is constrained by rubber-tip set screws.

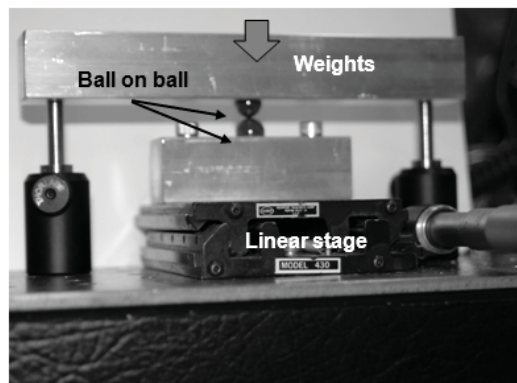
Figure 3. Ball-on-ball test fixture used in generating artificial scars on Si_3N_4 balls.

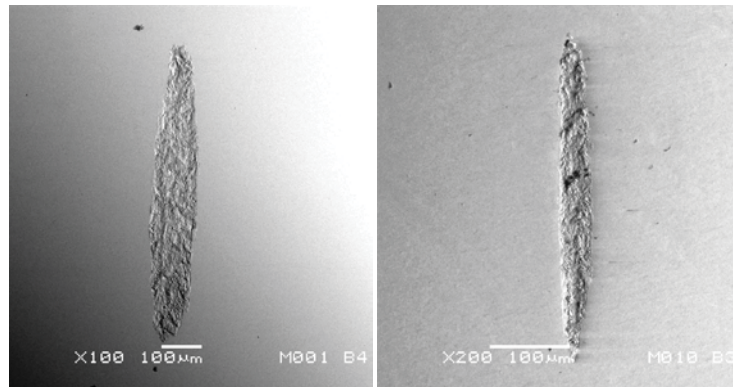
Figure 4. Examples of artificially-generated scars: “large” scar (left) and “small” scar (right).

“small” scars with a width of approximately 40 μm . The mean depth of the scars, for all scar sizes, was kept constant at approximately 2 μm . Representative images of the “large” scar and the “small” scar are shown in Figure 4.

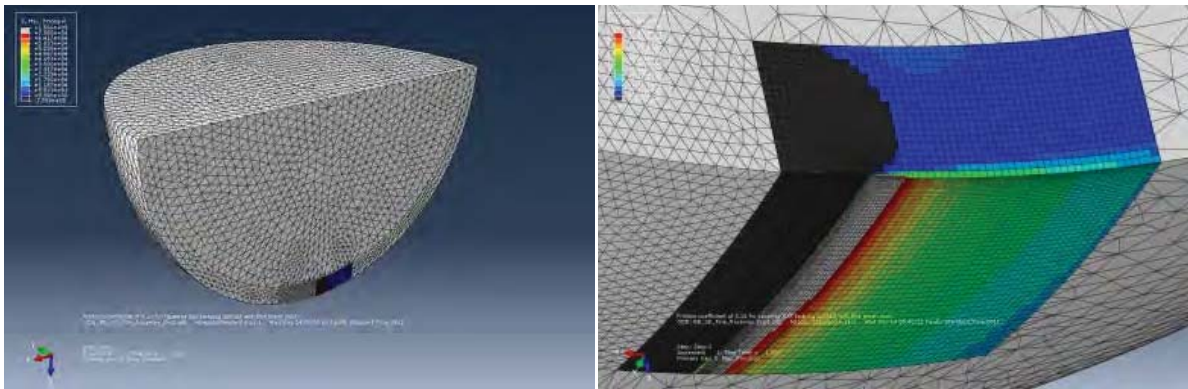
Figure 5. Micron element size FEM (left) and whole model (right) region of interest showing the high tensile stresses created by the traction load.

Three-dimensional finite-element models (FEMs) of Si_3N_4 balls contacting steel raceways were developed and compared against the analytical Hertzian contact stress solution. The FEM results for the elliptical contact patch size and parabolic contact stress distribution on the surface of the ball within the contact zone matched the Hertzian solution. Similar partial validations were completed for ball bearings contacting a flat surface. In addition, a subroutine was written to simulate the normal and traction loads generated from a ball bearing contacting either a curved or flat surface. This subroutine allowed the non-linear contact conditions present in the original FEMs to be replaced, significantly reducing the solve time for the models. These prior FEMs were leveraged and improved upon in preparation for the numerical FEM validation (Figure 5).

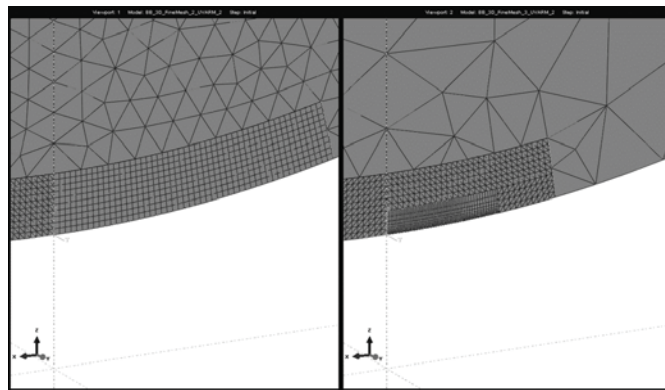
Figure 6. Close up views of two parametric models showing the tie command regions with one significant mesh size transition (left) and two significant mesh size transitions (right).

The high fidelity models included elements in the grain-size level (microns). These models were enhanced to provide more flexibility for future parametric studies. The FEMs were split into regions of varying mesh density based on the required stress resolution. Therefore, a large portion of the quarter symmetry model was changed to quadratic tetrahedral elements that could rapidly reduce in size in the contact region. Constraint equations were developed using the “tie” command in ABAQUS to enforce surface to surface continuity and facilitate coarse-to-fine mesh transitions. This strategy allowed for multiple model variations with different element sizes in the contact region, as shown in Figure 6.

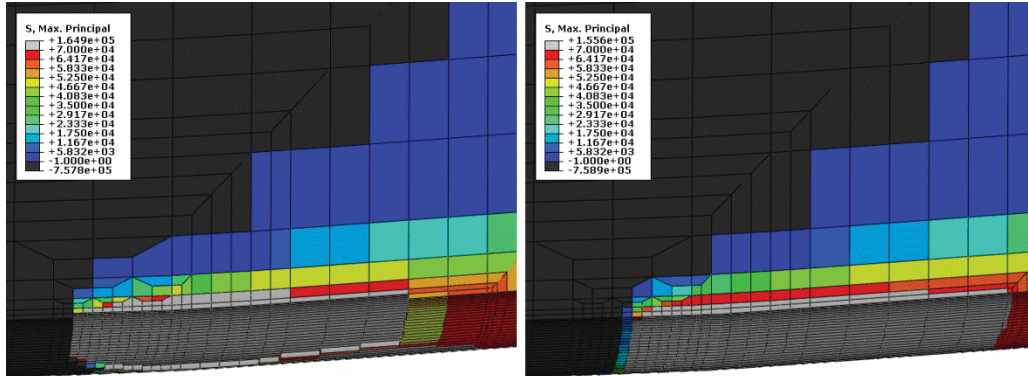
Figure 7. Maximum principal stress of contact with a scar (left) and without a scar (right).

a typical lab generated scar. The scar was placed in the high tensile region of the FEM caused by the traction load because that was the most probable failure initiation region. A raceway contact simulation was run and the FEM results demonstrated little change in the Si_3N_4 ball's stress field around the contact region due to the presence of the scar (Figure 7). Therefore, a scar was deemed benign in terms of the effect on the life of the Si_3N_4 ball.

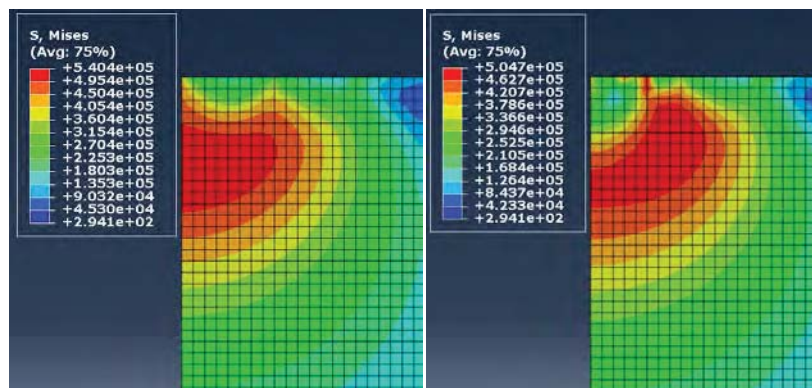
Figure 8. Stress contours in the steel from pristine ball contact (left) and contact with a 100- μm wide ball scar (right).

A pristine contact condition produced high von Mises stresses in the steel raceway directly under the contact patch (Figure 8). This high stress region did not extend to the surface of the raceway. The ball scars changed the shape of the stress field, shifting the high von Mises stress region closer to the surface while creating a low stress region directly under the scar. In addition, at the scar edge a local stress concentration appeared in the steel raceway and connected with the high stress region.

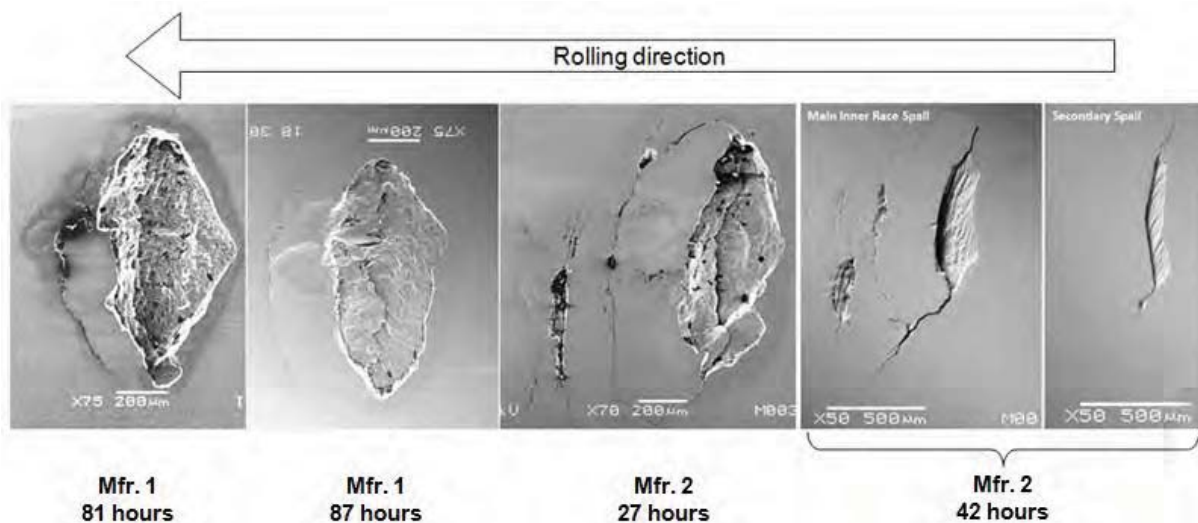
Figure 9. Inner race spalls of hybrid bearings with "large" scars on every ball.

All RCF tests resulted in inner race spalls with a similar characteristic "surface initiation site" pattern (Figure 9). The spalls were most likely caused by the stress riser from rolling over the scar features on the Si_3N_4 balls.

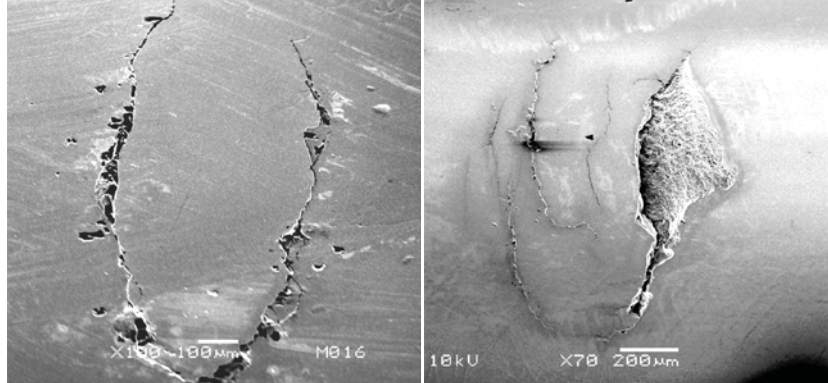
Figure 10. Inner race spalls of hybrid bearings with “large” scars on only 2 balls in each bearing. First failure occurred after 120 hours (left), and second failure occurred after 668 hours (right).

The reduction in the number of scars by 75% (64 scars to 16 scars) delayed, but did not eliminate, the onset of damage leading to inner race spall. Figure 10 shows the SEM images of the resulting damage that occurred after 120 hours and 668 hours of operation. The failure after 120 hours is perhaps the earliest initiation of a spall that has ever been captured before any significant material had been expelled. Our experience in setting the vibration limit of the RCF testers enabled us to capture the initiation stage. The feature that caused the second failure after 668 hours resembles the spalls previously discussed. Scanning electron microscopy coupled with our experience in setting the vibration limit of the RCF testers enabled us to capture the progression of damage leading to inner race spalls in a RCF test.

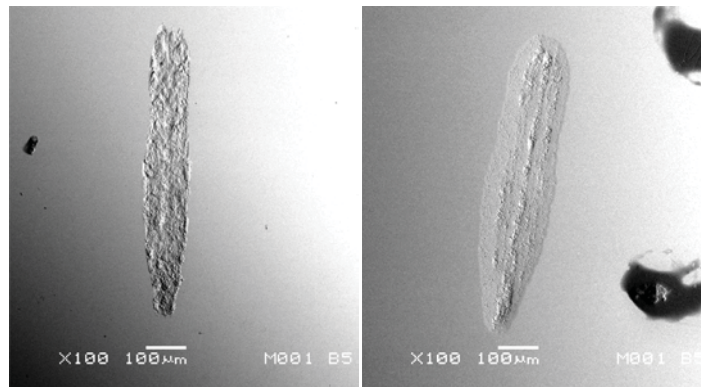
Figure 11. Representative artificially-generated scar: before (left) and after (right) RCF testing. This particular test lasted 28 hours at 5000 rpm with a mean contact stress of 330 ksi (2.3 GPa).

Figure 11 shows the typical progression of a scar after testing, which provides two significant findings. First, all the scars on the Si₃N₄ balls (64 scars in 4 bearings) had been run over, as evidenced by the apparent halo around and widening of each scar. This key finding suggests that, contrary to initial assumption, balls with scars do not track or maintain their orientation inside a bearing. This finding is further supported by the lack of a wear band on each ball, regardless of the number of hours in operation, which is typically observed in unscarred balls after RCF testing. The reason for the lack of ball tracking could be due to the ball being pivoted each time the scar enters the contact patch. Another reason could simply be because at such a high rate of rotation, any minute change in an otherwise pristine surface of the ball creates a misalignment between the ball’s center of mass and its axis of rotation, leading to rotational imbalance.

The second finding is the burnishing of the scars during testing. From Figure 11, it is apparent that the peaks within the scars have either been flattened or completely removed, leaving behind only the valleys and remnants after material removal.

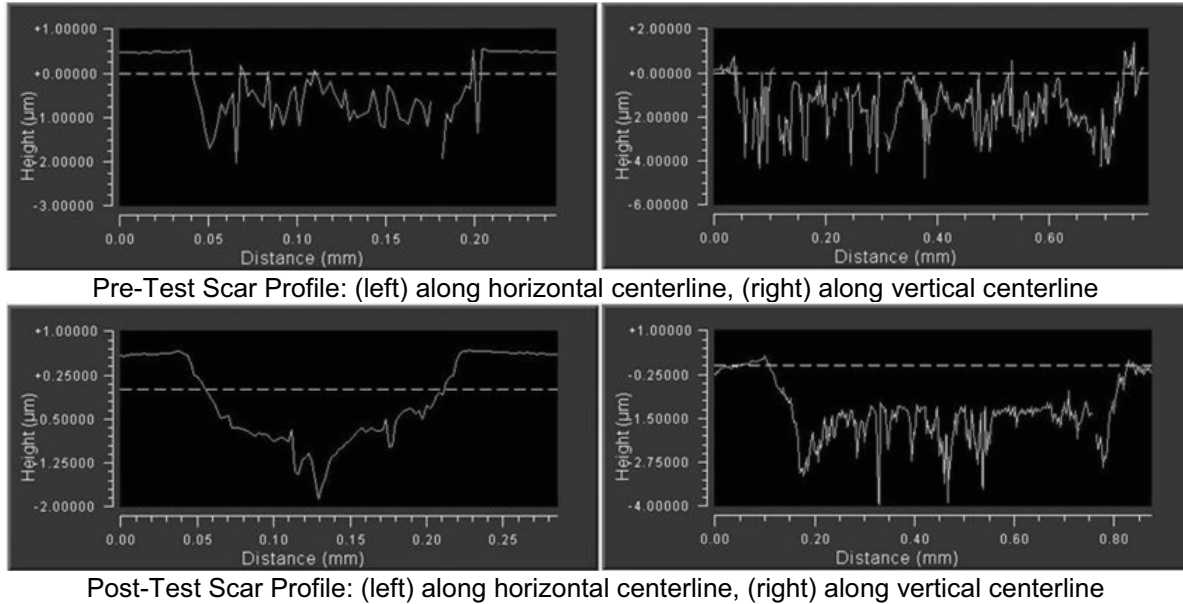
Figure 12. Optical surface profilometry trace of a scar before (top) and after (bottom) RCF testing

Further investigation of the apparent burnishing of the scars was conducted using optical (white-light) surface profilometry before and after testing (Figure 12), which provides a quantitative comparison of the roughness and morphology. Traces were taken near the major and minor axes of the scar ellipse, and the corresponding profiles are shown in the plots in the left column and right column, respectively. As the roughness decreased, the scar effectively became more benign, which could suggest that most of the raceway damage occurred very early in testing.

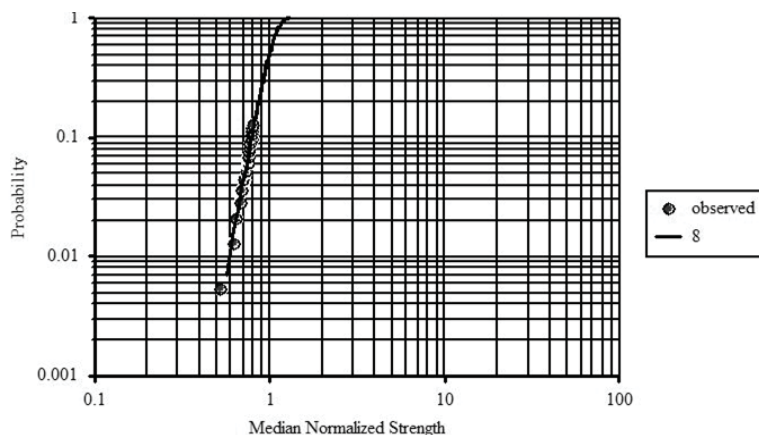
Figure 13. Strength distribution of Si_3N_4 balls

The strength distribution shape factor estimate, m , was obtained from experimental data using Aerospace-developed strength tester [10] of Si_3N_4 balls. Although based on a partial sample of the first 17 out of 131 specimens, this $m = 8$ is a very good data fit, especially since it conforms to the weakest data (Figure 13). The estimated median strength is 725 ksi (5.0 GPa).

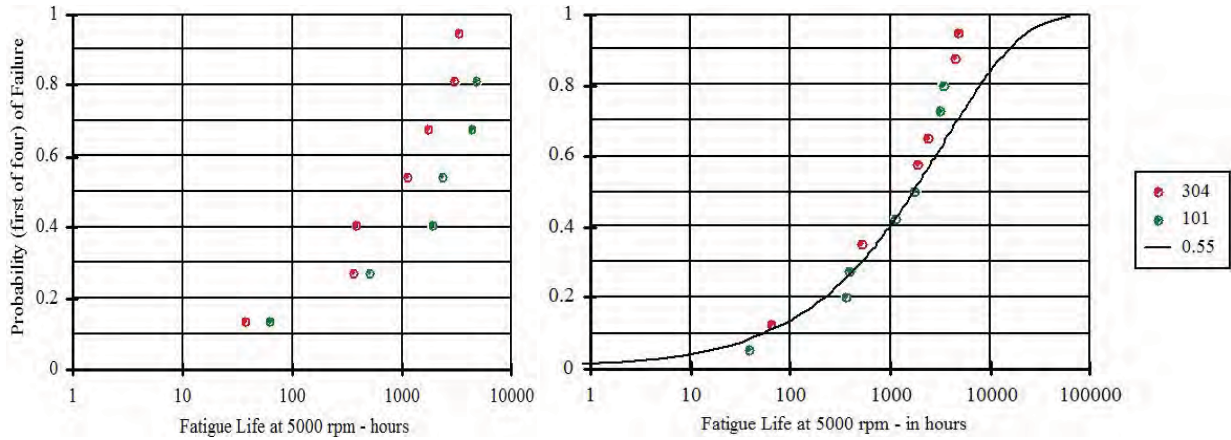
Figure 14. Individual probability distributions (left) and combined RCF lifetime distribution (right) of as-manufactured hybrid bearings for 101H and 304H sizes

The individual data (first of four) for sizes 101 and 304 are collected and shown in Figure 14. The similarity of the distribution shapes allows these data to be pooled, forming a mixed population distribution. Unlike the expected inflection near the central values of life, these data show a monotonic increase in failure probability to the longest observed life. Fortunately the service life design is defined by the short observed lives, and, while the distribution at long life is of academic interest, it has little impact on the practical design operating life. The strength shape factor, $m = 8$, and life shape factor $b = 0.55$ were combined to create a Reliability Forecast Chart shown in Figure 15, that gives a projected view for the combination of load, life, and reliability at very long service lives.

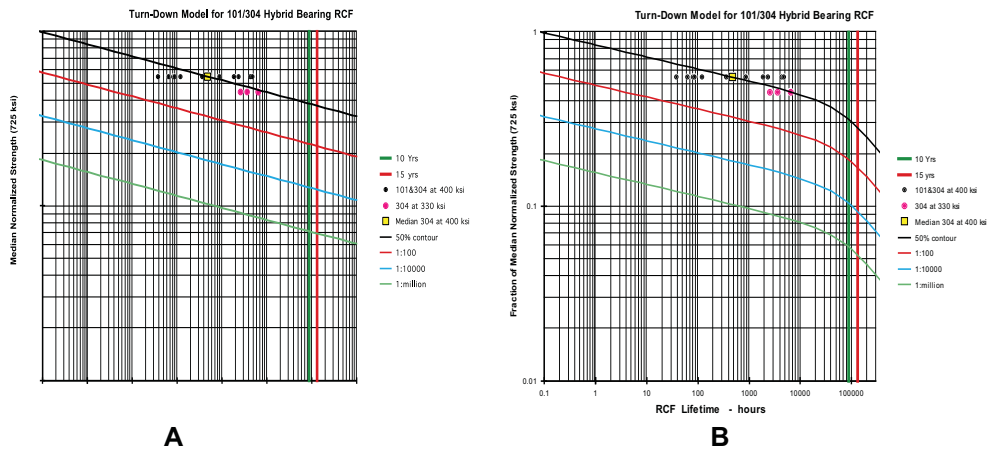
Figure 15. Turn-down model for as-manufactured 101H and 304H bearings. A) No turn down, B) Notional turndown for one particular set of parameters shown here. More data would be needed to confirm or refute if a turn down effect is present in these materials.

Equation (3) produces a family of straight lines as shown in Figure 15A, constant reliability contours, of slope $-b/m$ on $\text{Log}(R)$ versus $\text{Log}(t)$ coordinates, provided that the distributions of strength and fatigue life are each consistent with Weibull distributions having time-invariant shape factor. However, this is not the case for the RCF data examined here, and some modification of the model is explored.

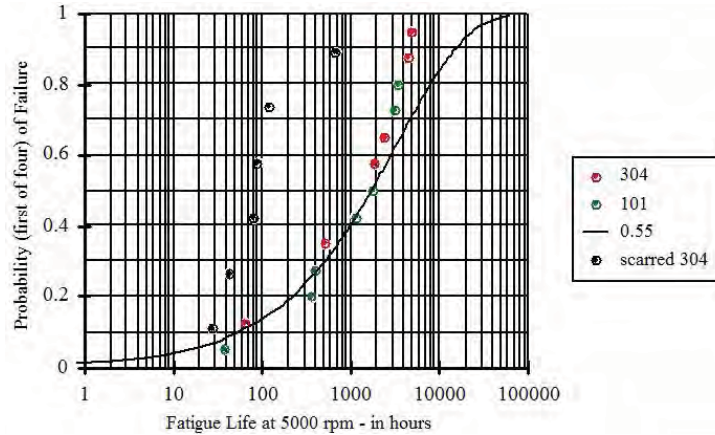
Figure 16. Combined lifetime distribution of mixed as-manufactured 101H and 304H bearings and 304H bearings with scarred Si_3N_4 balls.

Figure 16 shows the pronounced reduction of fatigue life and lowered life scatter. However, the monotonic increase of failure probability seen with the pristine bearings is not present with the damaged bearings. The median life of the scarred bearings was about 5% of the pristine bearing life, and there was no similarity observed in the distribution plots
