# **Creep Behavior and Durability of Cracked CMC**

**R.T. Bhatt<sup>#</sup>, Dennis Fox, and Craig Smith**  
**NASA Glenn Research Center**  
**Cleveland, OH**  
**<sup>#</sup>Ohio Aerospace Institute**

**Prepared for Presentation at the 39<sup>th</sup> Annual Conference on Composites, Materials, and Structures, Cocoa Beach/Cape Canaveral, Florida, January, 2015**

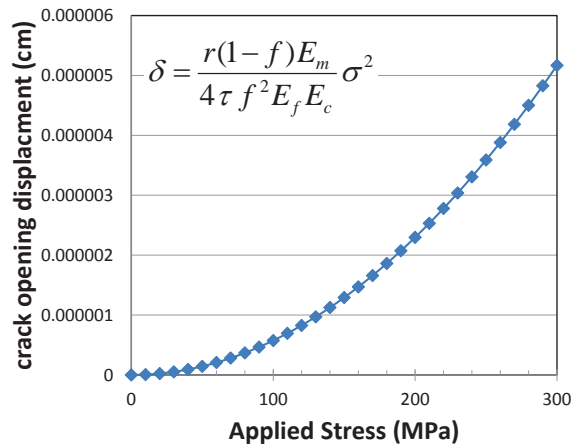
## Predicted Crack Opening Displacement (COD) With Applied Stress for Fiber Reinforced CMCs

- $\delta$  = Crack opening displacement
- $r$  = Fiber radius
- $f$  = Fiber fraction
- $E$  = Elastic modulus of the matrix
- $E$  = Elastic modulus of the fiber
- $E$  = Elastic modulus of the composite
- $\sigma$  = Applied stress
- $\tau$  = Interfacial shear strength between the fiber and the matrix

- Matrix crack opening displacement
- Extant of crack
- Matrix crack healing capability
- Crack tip intensity
- Diffusivity/ permeability of oxygen
- Temperature
- Environment
- Creep/slow crack growth
- Stress
- Time
- Gas velocity
- Location of the primary crack
- Crack spacing

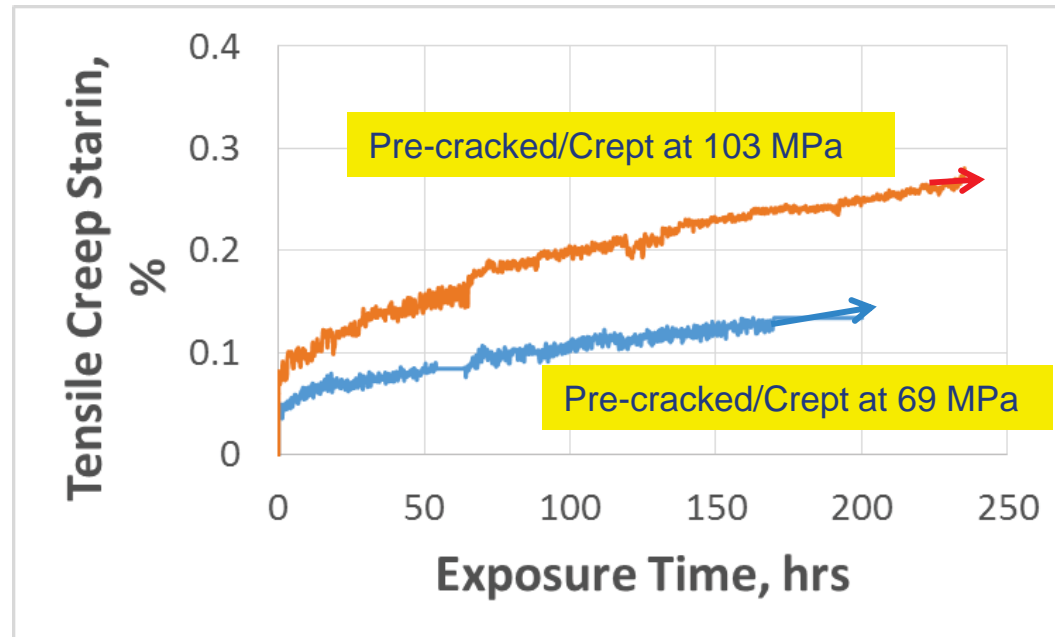
# Tensile Creep Behaviors of Pre-cracked 2D Balanced MI SiC/SiC Composites with Sylramic-iBN Fibers

(Creep Conditions: 1315°C/69 or 103 MPa /Air)

***Matrix cracks in the pre-cracked MI SiC/SiC composites healed during creep testing and significantly reduced fiber oxidation. The creep curves follow fiber creep data.***

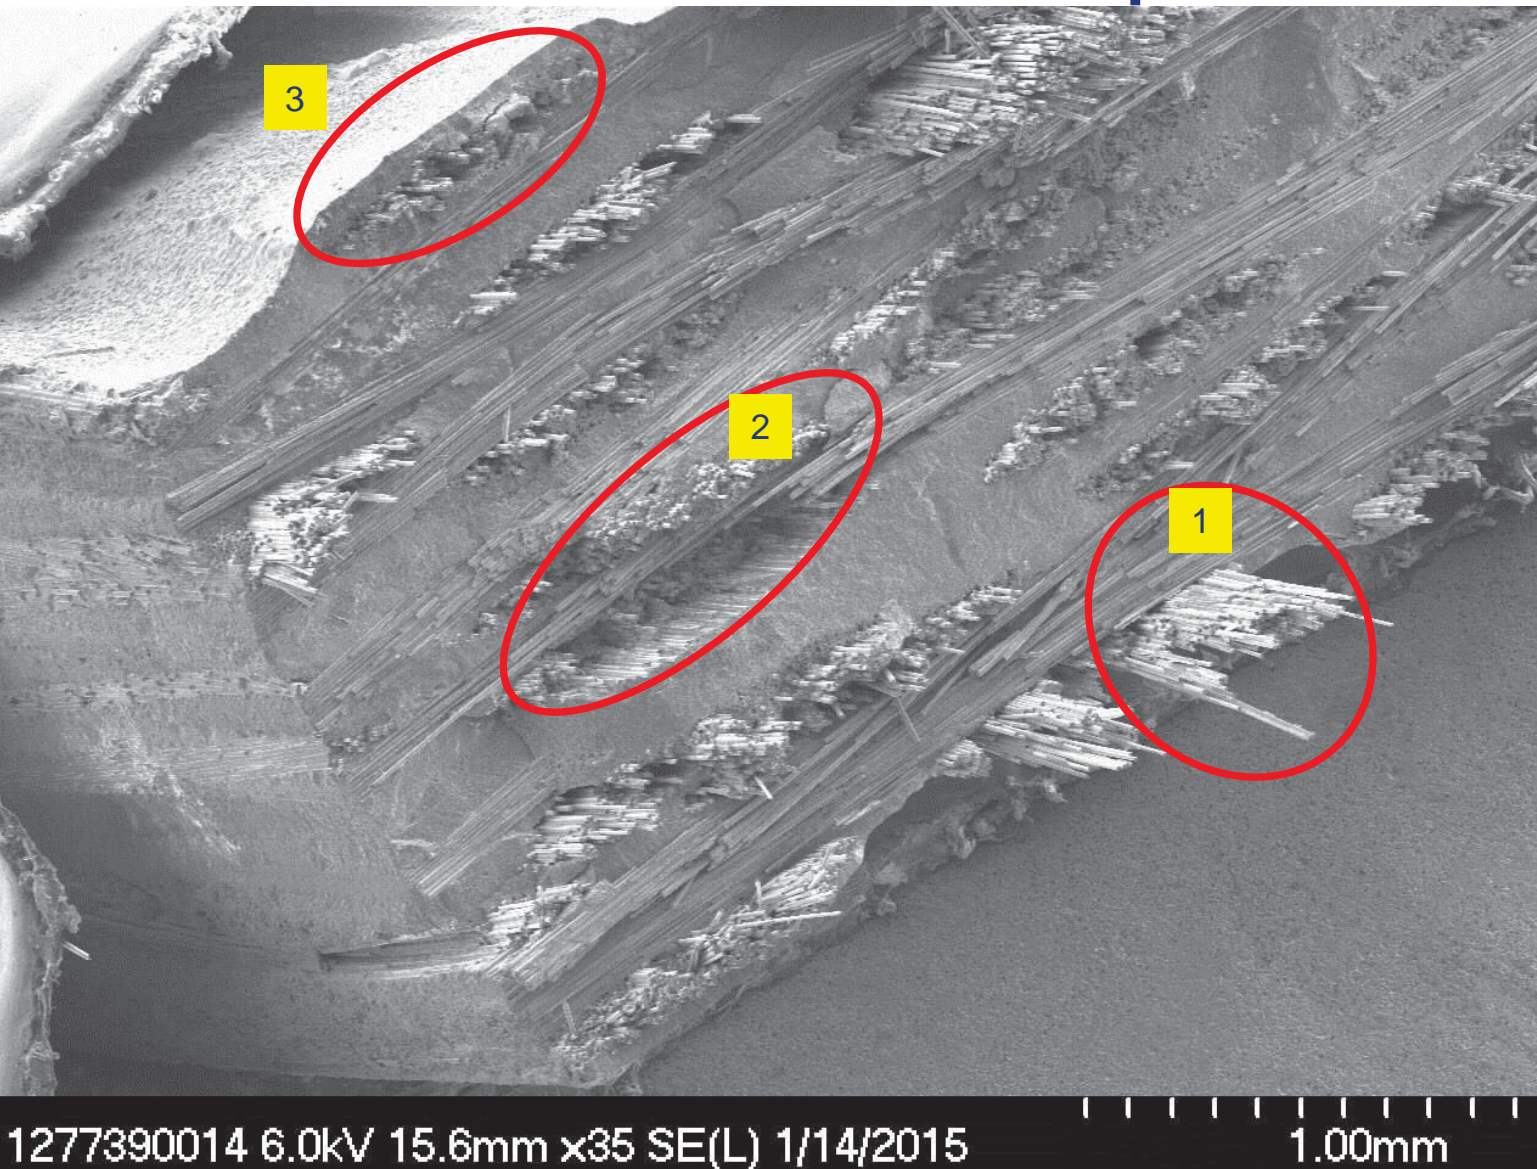
# SEM Photographs of a Pre-cracked Uncoated MI Sylramic-iBN SiC/SiC Composite Specimen Creep Tested at 1315<sup>0</sup>C/103MPa/235hrs and Then Tensile Tested at Room Temperature

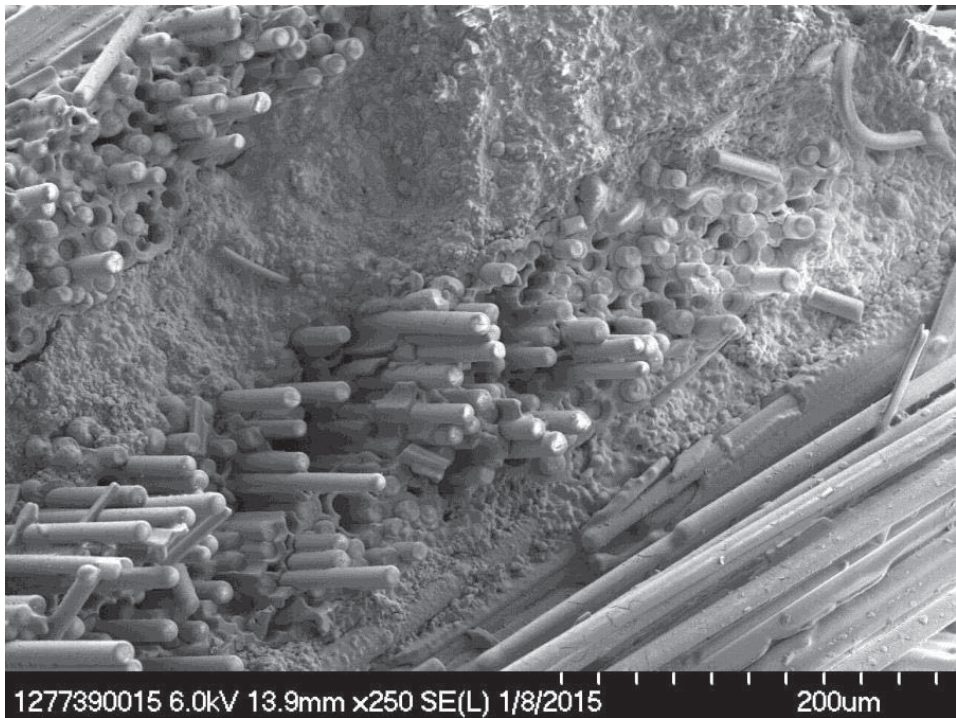
# SEM Photographs of the Fractured Surface of a Pre-cracked Uncoated MI Sylramic-iBN SiC/SiC Composite Specimen SPLCF Tested at 35MPa, 1315°C for 157hrs in Air

***Pre-cracked and SPLCF tested MI SiC/SiC composites failed by extensive interface oxidation followed by fiber fracture.***

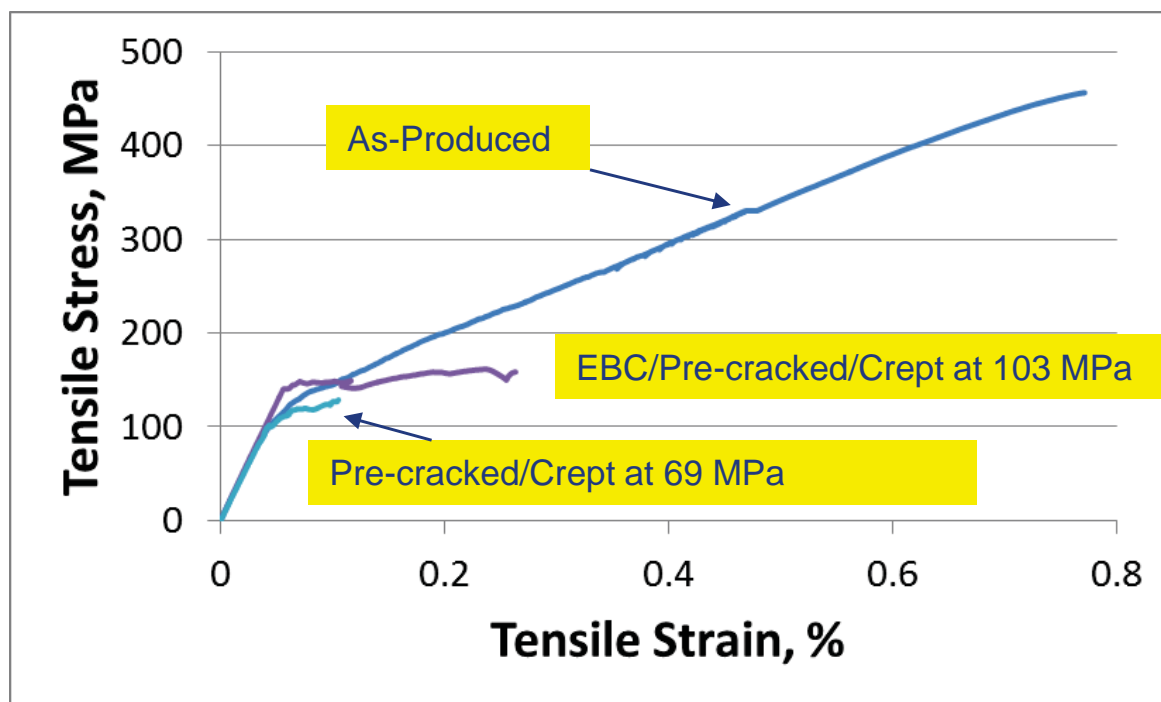
# Room Temperature Tensile Stress-Strain Behaviors of Pre-cracked 2D Balanced MI SiC/SiC Composites With Hi-Nicalon-S Fibers Before and After Creep Test

(Burner Rig Creep Conditions: 1315<sup>0</sup>C/69 and 103MPa/100hrs)

***Pre-cracked full CVI Hi-Nicalon-S SiC/SiC composites crept under burner rig conditions survived 100hr exposure, but residual room temperature tensile fracture strengths were low.***

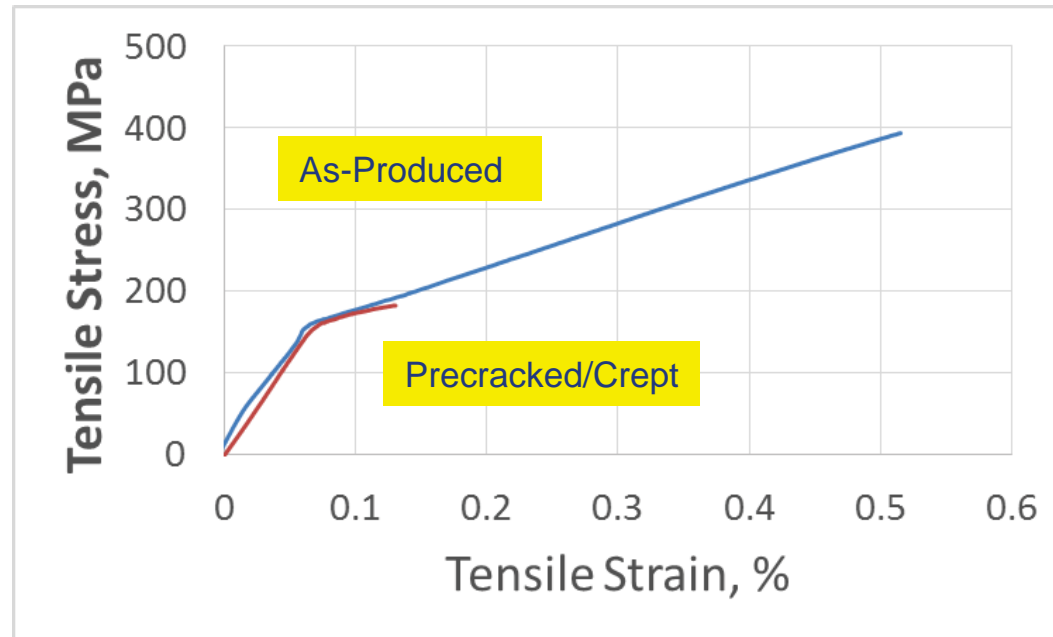
# Room Temperature Tensile Stress-Strain Behavior of Pre-cracked 2D Balanced Full CVI SiC/SiC Composites With Sylramic-iBN Fibers After the Creep Test

(Burner Rig Creep Conditions: 1315<sup>0</sup>C/69MPa/100hrs)

***Pre-cracked full CVI Sylramic-iBN SiC/SiC composites crept under burner rig conditions survived 100hr exposure, but residual room temperature tensile fracture strengths were low.***

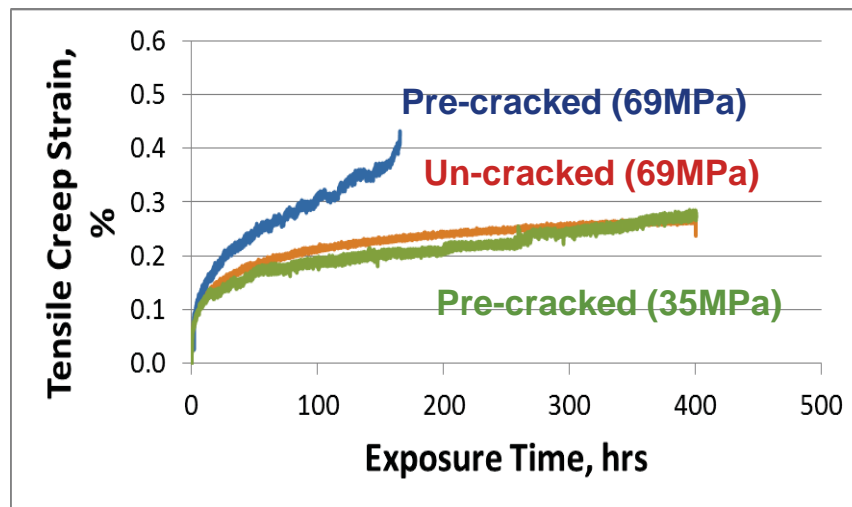
Hi-Nicalon-S Fibers

# Tensile Creep Behaviors of Un-cracked and Pre-cracked 2D Balanced Full CVI SiC/SiC Composites with Hi-Nicalon-S and Sylramic-iBN Fibers

(Creep Conditions: 1450°C/35 or 69 MPa /Air)

***Under cracked conditions, the durability of 2D full CVI SiC/SiC composites is significantly reduced irrespective of the type of SiC fiber reinforcement. Also durability of cracked composites depends upon crack opening displacement, extent of crack and the location of the critical crack.***

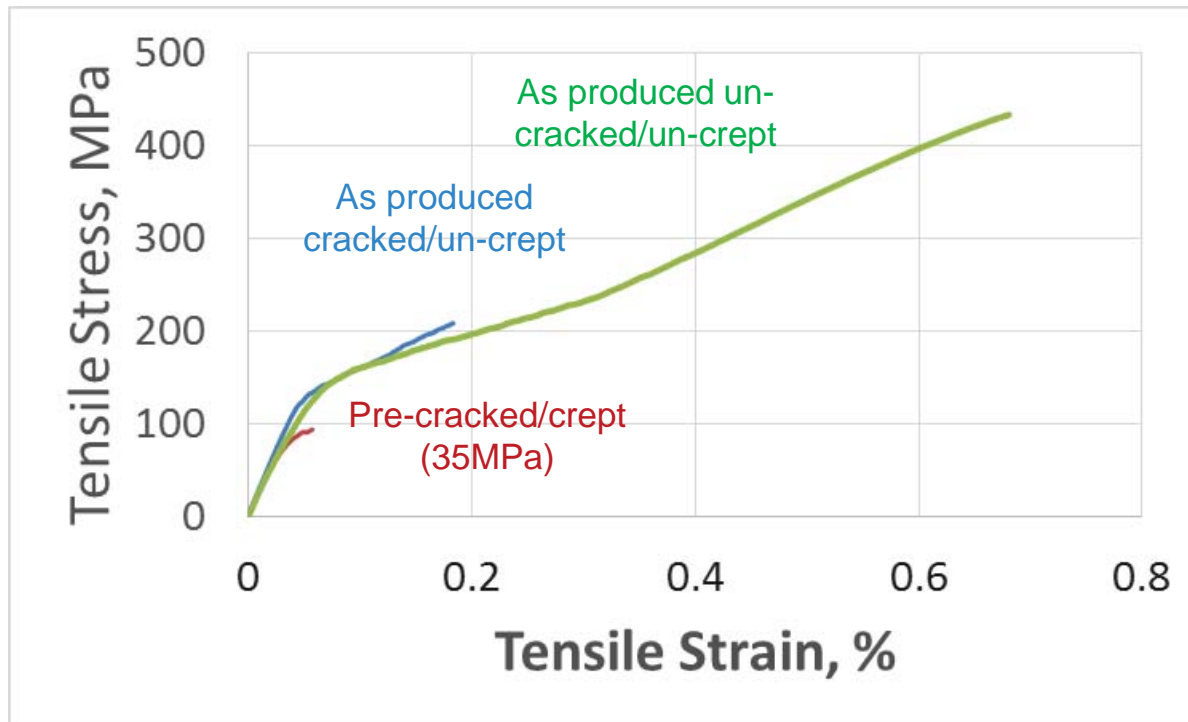
# Room Temperature Tensile Stress-Strain Behaviors of Pre-cracked 2D Balanced Full CVI SiC/SiC Composites With Hi-Nicalon-S Fibers Before and After Creep Test

(Creep Conditions: 1450°C/35 or 69 MPa /Air)

***In-plane tensile properties of pre-cracked/crept composites are significantly lower compared to those of un-cracked composites. The dominant crack outside the hot section.***
