# **SPACE STATION SOLAR ARRAY JOINT REPAIR**

# Solar Alpha Rotary Joint (SARJ)

# The Problem

# Failure Investigation

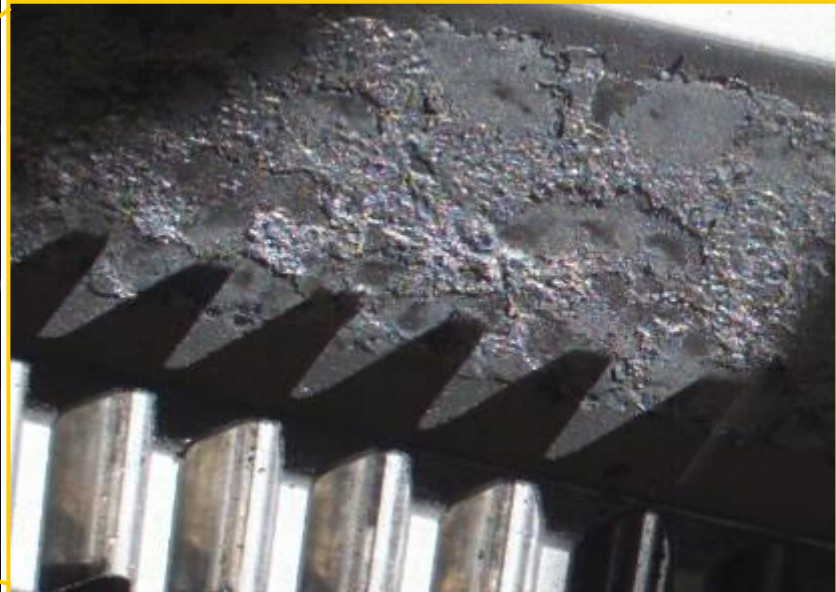
# Outer 45 Deg Race Shows Significant Damage

- Outer 45 deg race damaged
- Nitrided case spall fragments and ground up fine particles collected

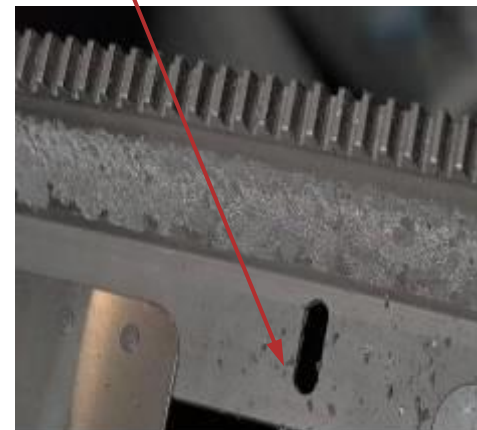
fragments

Intergranular networking  
in nitrided case

- Government –Industry team formed to determine root cause
- Root cause found to be roller misalignment (aka mistracking) coupled with high contact friction
  - generates tipping and high roller edge contact stresses
  - edge stresses high enough to crack/fatigue the nitrided case
  - intergranular networking (crack-like separations) likely contributed to damage
- Least difficult repair would be to lubricate the SARJ tracks with grease
- How do we validated this fix and how long will it last between regreasing?
  - build a high fidelity SARJ life test rig

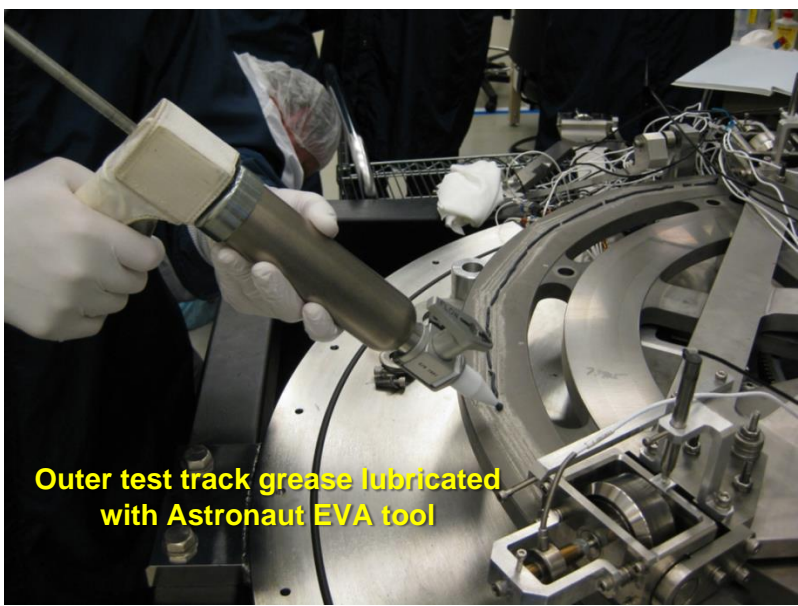
Outer test track grease lubricated with Astronaut EVA tool

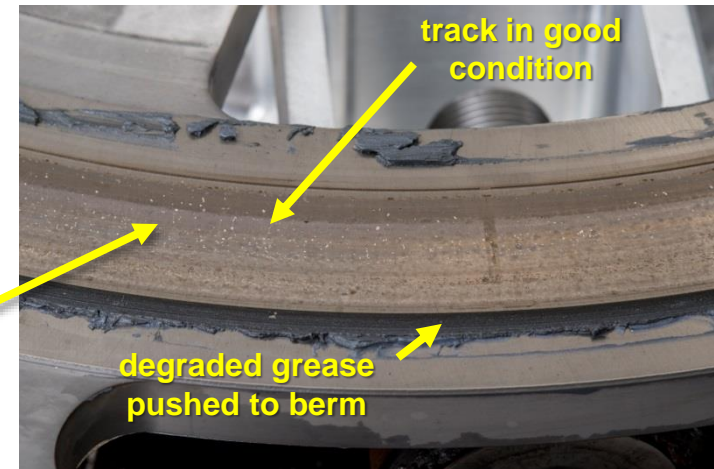
Datum A inner track

**Both Tracks showed Minor Wear after  
36+ Equivalent On-orbit Years**

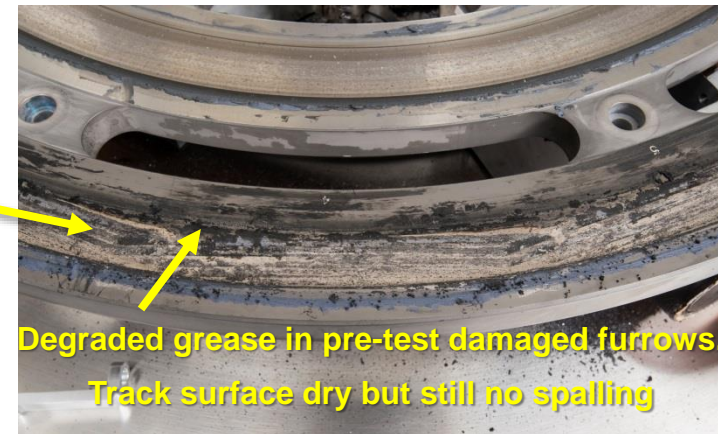
45 deg outer track

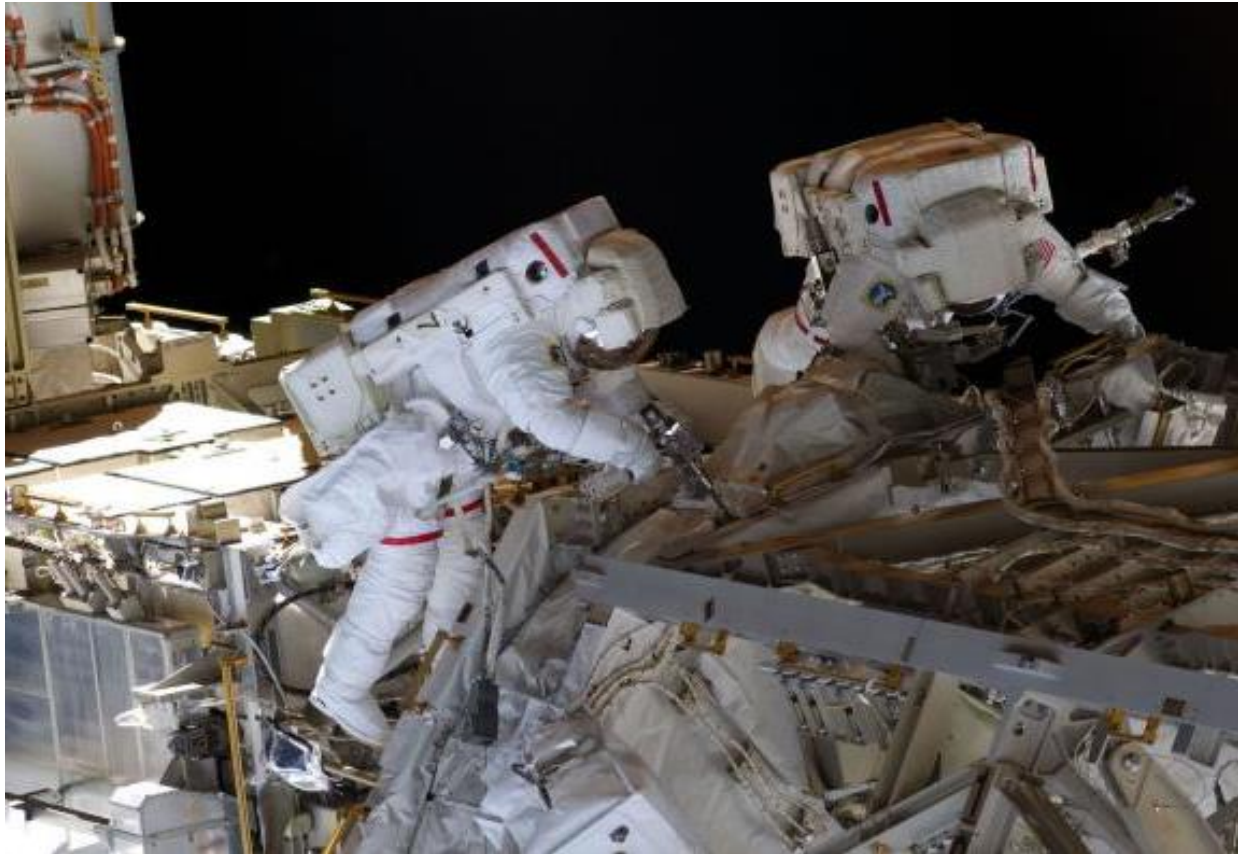
# Post Script: *SARJ Races Greased (STS-126 Nov 2008)*

***Motor current and vibe levels returned to near normal***

- rose slightly through the years but still well below safe levels

- Rollers replaced on damaged SARJ
- Starboard & Port Races cleaned & greased.
