## Paper Number: 1856

# Title: Failure Predictions of Out-of-Autoclave Sandwich Joints with Delaminations under Flexure Loads

## ABSTRACT

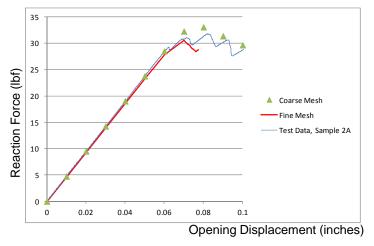
Figure 4. Structural response of DCB for test and model.

Two panels were fabricated to measure the Mode I interlaminar fracture toughness using the double cantilever beam (DCB) test, per ASTM D5528-0. Finite element modeling was used to size the stacking sequence on either side of the crack, to ensure that the bending stiffness of each cantilever arm was nearly equal. Panels were fabricated with 0-degree 30-ply unidirectional IM7/977-3 substrate (0.16 inch thick) and 0-degree 26-ply T-40-800/5320-1 woven fabric doubler (0.21 inch thick). The IM7/977-3 was first autoclave cured and the surface was abrasion treated prior to out-of-autoclave bonding of the T-40-800/5320-1. The joint doubler was cured to the IM7/977-3 substrate using vacuum bag pressure only, per manufacturer's recommendation: 12 hour cure at 200°F followed by a freestanding post cure at 350°F. Three coupons were tested with a 2.5 inch long flaw (Figure 1) and three coupons with a 3.5 inch long flaw. A displacement gauge was used for accurate measurement of crack opening displacement. Keyence digital microscope images were taken every 15 seconds for instantaneous crack length measurements. The Mode I average energy release rate ( $G_{IC}$ ) was measured as 1.3 lbf/inch, as shown in Figure 2, and it was consistent between the panels with 2.5 inch flaw and the panels with 3.5 inch flaw. The load-displacement response from the finite element simulations using cohesive elements, shown in Figure 3, were in good agreement with experimental response, shown in Figure 4.

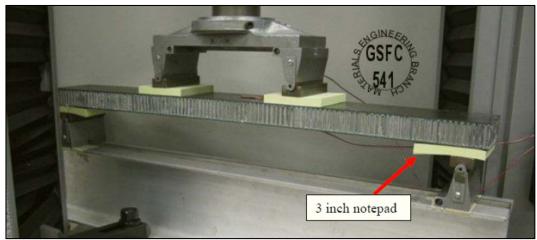
Figure 13. Four-Point-Bend Test.

For the actual test, notepads were used at the supports and load point to prevent local stresses from failing the composite core before the joint in the constant shear region could be properly loaded. The 4PB test setup can be seen in Figure 13.

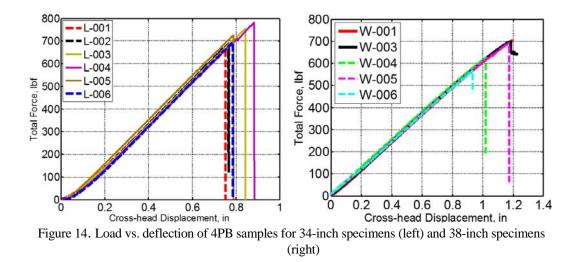
\*Max displacement does not apply. Core shear failure occurred. Max displacement not relevant (see Figure 15). \*\*Problem with Instron® crosshead data acquisition. Max load and displacement reported from DIC. No plot possible for W-4PB-002 in Figure 14.

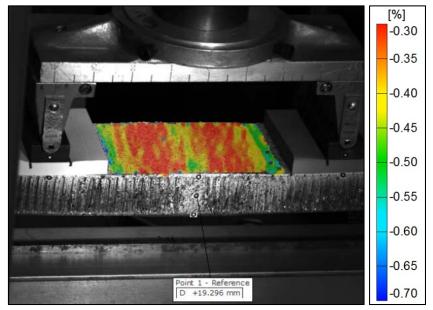
Figure 17. Axial strain of joint for 34-inch specimen with flaw.

In addition to measuring maximum centerline deflection and reaction load, surface strains were measured in the joint region using DIC as shown in Figure 17. A stochastic

pattern was applied to the surface of the materials using black and white spray paint to provide tracking points for the full-field strain measurement. Figure 18 compares 34-inch 4PB specimens with and without a flaw. The location of the flaw is shown in the figure with a circle. Axial strain fields were captured digitally at the last frame before failure. Strain limits were set identically from -3000  $\mu\epsilon$  to -7000  $\mu\epsilon$ . It can be observed that the influence of the Teflon® insert increases the strain field on the joint seam.

The last metric for comparison between the performed tests and the analyses is that of surface strains at the joint. Figure 17 and Figure 18 showed test results for axial surfaces strains by DIC. Shown below in Figure 30 and Figure 31 are axial surface strains just before joint failure for test and analysis of 34-inch and 38-inch specimens, respectively. For the 34-inch specimens, strain in the circular debond region are 5 to 10 percent higher in analysis than in test, which corresponds to the roughly 11 percent higher peak load that the analysis predicted over the tests. For the 38-inch specimens, strains in the joint region match very well to the tests (approximately within 1 percent). The influence of the Teflon® inserts on the strain fields are noted in the figures.

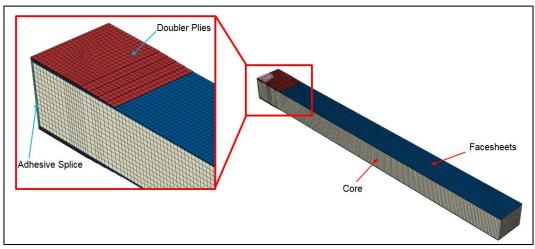
Figure 19. Isometric view of 34-inch 4PB specimen FEM.

To reduce analysis time, two-way symmetry was utilized for all 4PB models discussed here. In order to improve convergence of the solution, all models are displacement-controlled. Figure 19 illustrates the general model setup and mesh of the 34-inch specimen and Figure 20 shows the same model with dimensions and boundary conditions (BCs) labeled. Note that the symmetric boundary conditions for X-symmetry and Z-symmetry are labeled as  $U_x = 0$ " and  $U_z = 0$ ", respectively.

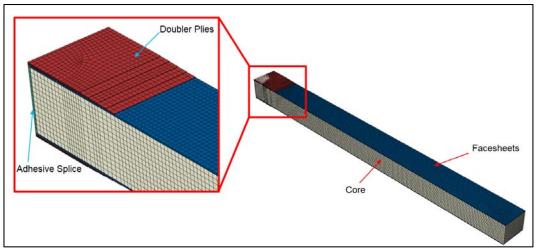
Figure 21. Isometric view of 38-inch 4PB specimen FEM.

Figure 21 illustrates the general model setup and mesh of the 38-inch specimen and Figure 22 shows the same model with dimensions and BCs labeled. For the 38-inch specimen, note that the global coordinate system (CSYS) remains the same, but a new local coordinate system was defined for the material orientation since those specimens were cut transverse to zero degrees.

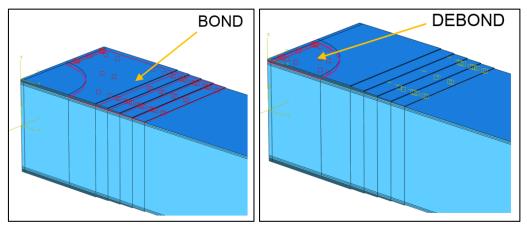
Figure 23. FEM schematics showing locations of bond (left) and debond (right).

Figure 23 shows the bond and debond regions in the models. Table II summarizes the cohesive bond and debond properties.

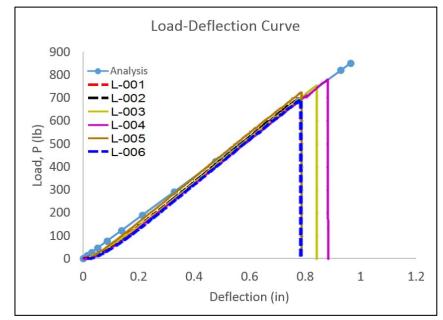
Figure 25. Test vs. Analysis Load-Deflection Results for undamaged 34-inch 4PB specimen.

Finite element results for 34-inch and 38-inch specimens without a flaw (i.e., undamaged) were first compared to test data. A graphical representation of this data is shown in Figure 25 and Figure 26, respectively. For the 34-inch specimen only L-003, L-004, and L-005 were the undamaged samples. For the 38-inch specimen only W-001 and W-003 were the undamaged samples.

The 34-inch analysis predicted joint failure would occur at a peak load of 852 lbf while the maximum load seen in test for that specimen was 781 lbf, so the model prediction was within 10 percent. The 38-inch analysis predicted that core shear failure would occur at a peak load of 882 lbf while the maximum load seen in test for that specimen was 702 lbf, so the model prediction was within 26 percent. This could indicate that the core strength properties were lower than the strength used in the analysis.

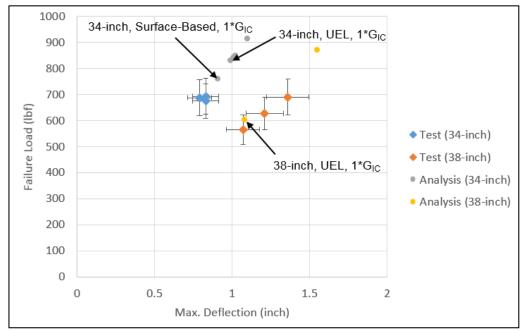
Figure 27. Failure load vs. max deflection of flawed 4PB tests and analyses.

A summary of the analysis results for 34-inch and 38-inch flawed specimens is shown in Table IV. For comparison, a new summary of the test results as originally seen in Table I is shown below in Table V with only the flawed specimens shown. For the 34-inch specimens, the best match to tests is the surface-based cohesive elements with a  $G_{IIC}$  value equal to  $1 \cdot G_{IC}$ . For the 34-inch specimens, the peak load of 759 lbf is within 11 percent of the average test peak load. For the 38-inch specimens, the peak load of 604 lbf is within 4 percent of the average test peak load. The failure load versus maximum deflection of all the tests and analyses summarized in Tables IV and V are shown graphically in Figure 27, with +/-10 percent error bars on the test data. It was found through the analyses that the UEL bond methodology had a better rate of convergence, but the surface-based cohesive methodology typically was closer to test results when it converged.  $G_{IIC}$  is typically two or three times that of  $G_{IC}$ , but since  $G_{IIC}$  was not measured this assumption could not be validated. A  $G_{IIC}$  value of  $1 \cdot G_{IC}$  was closer to tests in all analyses.

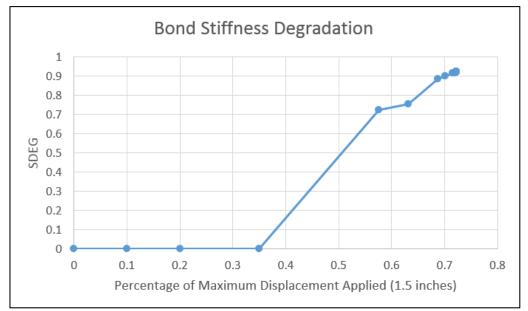
Figure 28. Scalar stiffness degradation as a function of maximum displacement applied for 38-inch specimen analysis (UEL) with flaw.

The analysis that proved closest to tests was the 38-inch W specimen, with UEL flaw and  $G_{IIC} = 1 \cdot G_{IC}$ , and was inspected for damage propagation at the joint doubler interface to the panels. The scalar stiffness degradation (SDEG) variable, a measure of an element's residual stiffness, was monitored at the interface through the analyses. The SDEG has a value from zero to one where a value of one corresponds to a fully damaged bond element. A plot of this variable through the analysis step is shown in Figure 28 for the element where bond failure is first initiated. From Figure 28 it can be concluded that bond failure initiates at 308 lbf, which is approximately 35 percent of the maximum displacement applied. Figure 29 shows a contour plot of SDEG in the region of the specimen where bond failure is occurring.
