Carolyn Atkins^a, Kiranmayee Kilaru^b, Brian D. Ramsey^b, David M. Broadway^b,
Mikhail V. Gubarev^b, Stephen L. O'Dell^b, William W. Zhang^c

Differential deposition correction of segmented glass x-ray optics

9603-46

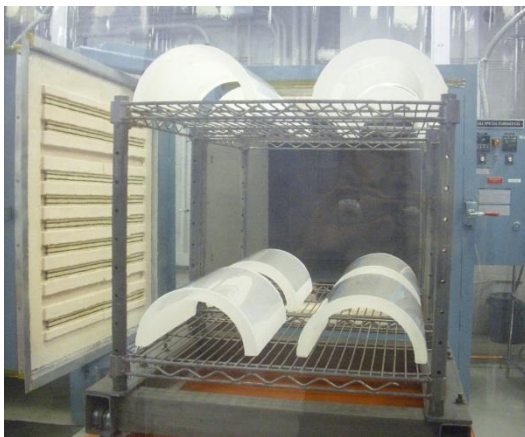
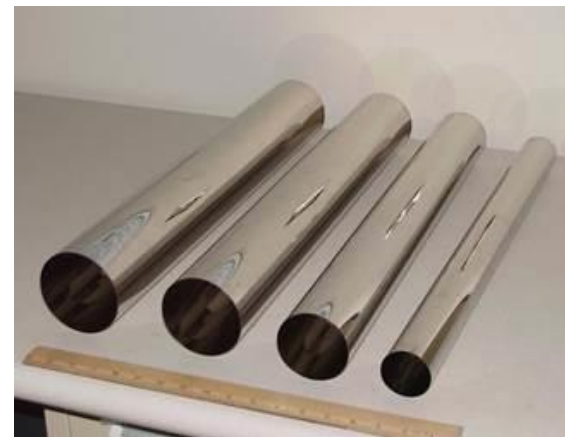
Introduction - challenges

- Shape – segmented, leading to a less rigid structure.
- Material – borosilicate, lightweight, but easily deformed.
- Mounting – point fixture, where the optics are held at discreet points.

- Shape – full shell, rigid structure.
- Material – Ni-Co alloy, heavier but less prone to deformation.
- Mounting – collet fixture, where the optic is held uniformly around its circumference.

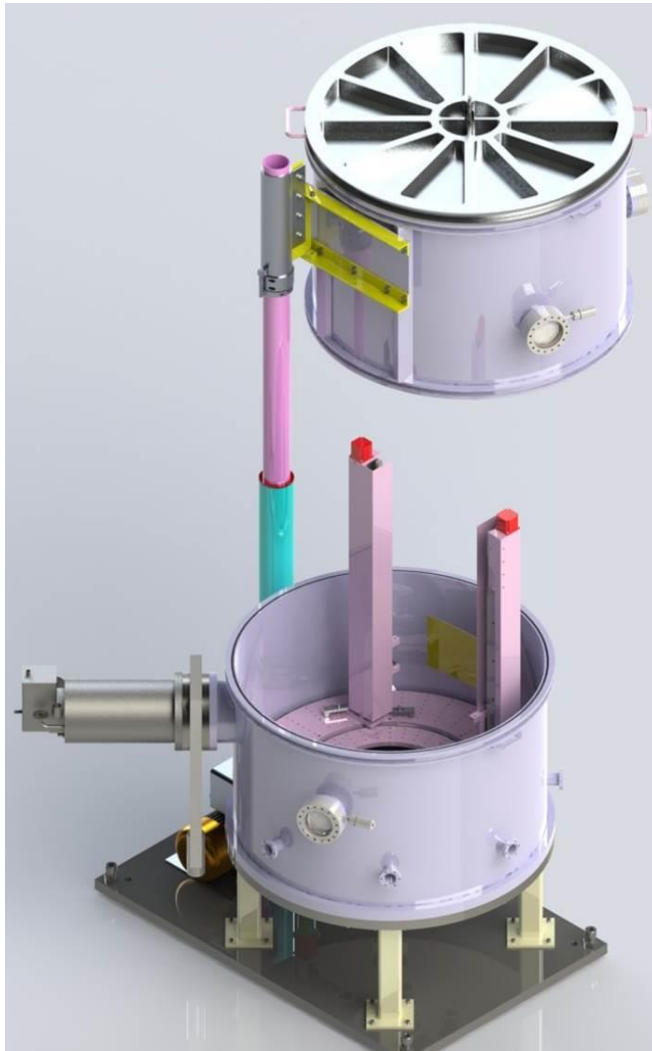
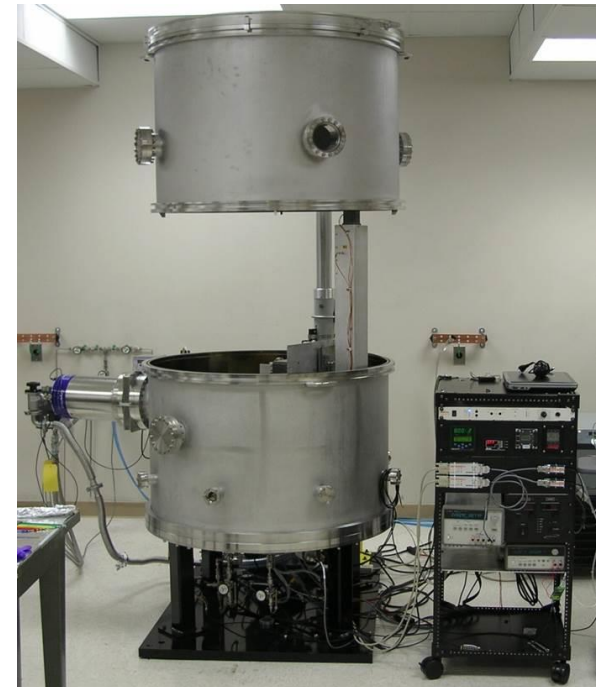
Hardware – vacuum chamber

- 1m in diameter, 1.3m in height.
- Vertical translation provided by a portable tower which has a travel of ~680mm in the vertical direction.
- The 360° rotation is provided by an annular platform.
- Optical encoders are used on both the translation and rotation to ensure accurate positioning and feedback.
- A 1 inch DC magnetron is to sputter the material for the differential deposition process.

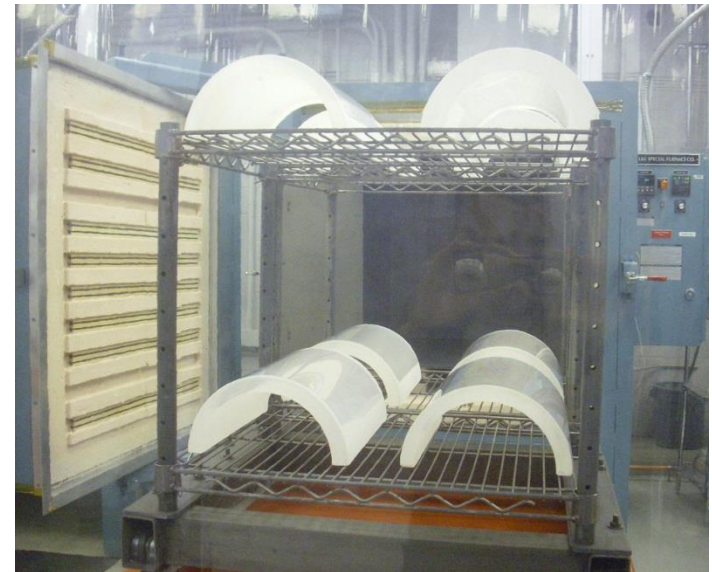
Introduction – segmented glass optics

The slumped glass optics used for differential deposition are those fabricated by NASA's Goddard Space Flight Center (GSFC).

Glass: Schott D263
30° segments, ~200mm long, ~400μm thick.
