Optic Nerve Sheath Mechanics in VIIP Syndrome

Julia Raykin¹, Andrew Feola¹, Rudy Gleason¹, Lealem Mulugeta², Jerry Myers³, Emily Nelson³, Brian Samuels⁴ and C. Ross Ethier¹

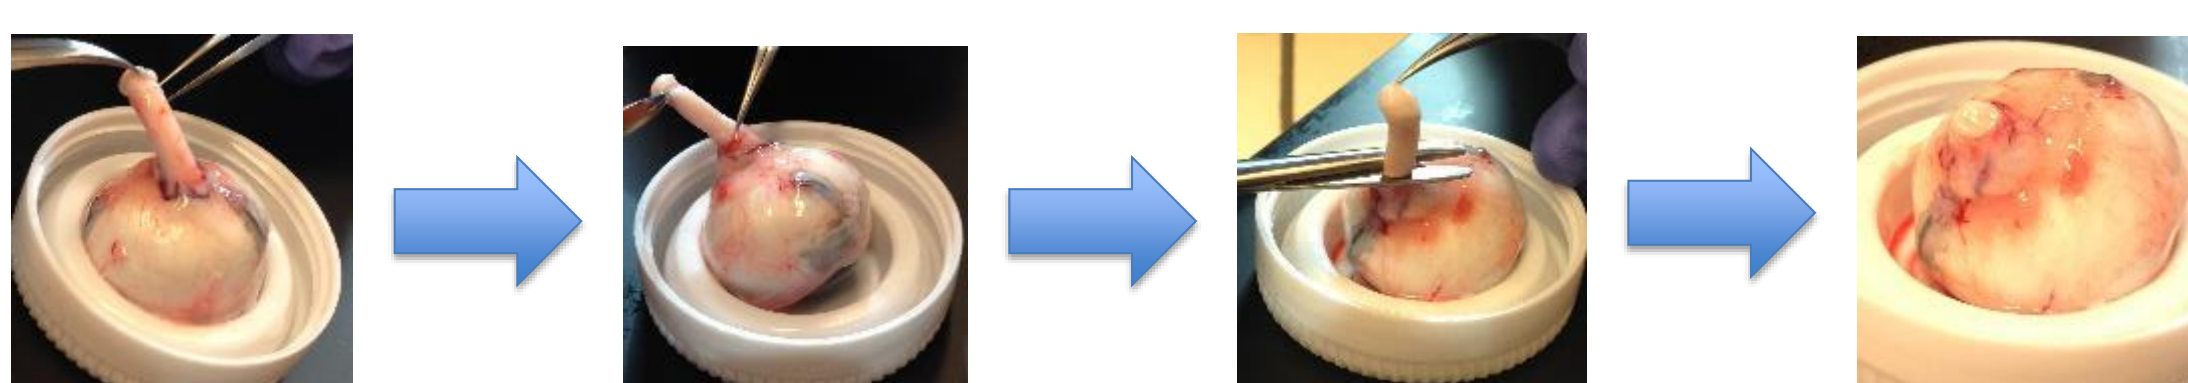
- Fresh porcine eyes obtained from local abattoir
- The optic nerve sheath was peeled away from the optic nerve proper then cut away from the globe and attached to a pressure control system (to simulate CSF pressure)
