Calcium-Magnesium Aluminosilicate (CMAS) Interactions with Advanced Environmental Barrier Coating Material

Valerie L. Wiesner and Narottam P. Bansal
Materials & Structures Division
NASA Glenn Research Center

*11th International Conference on Ceramic Materials and Components for
Energy and Environmental Applications*

June 18, 2015

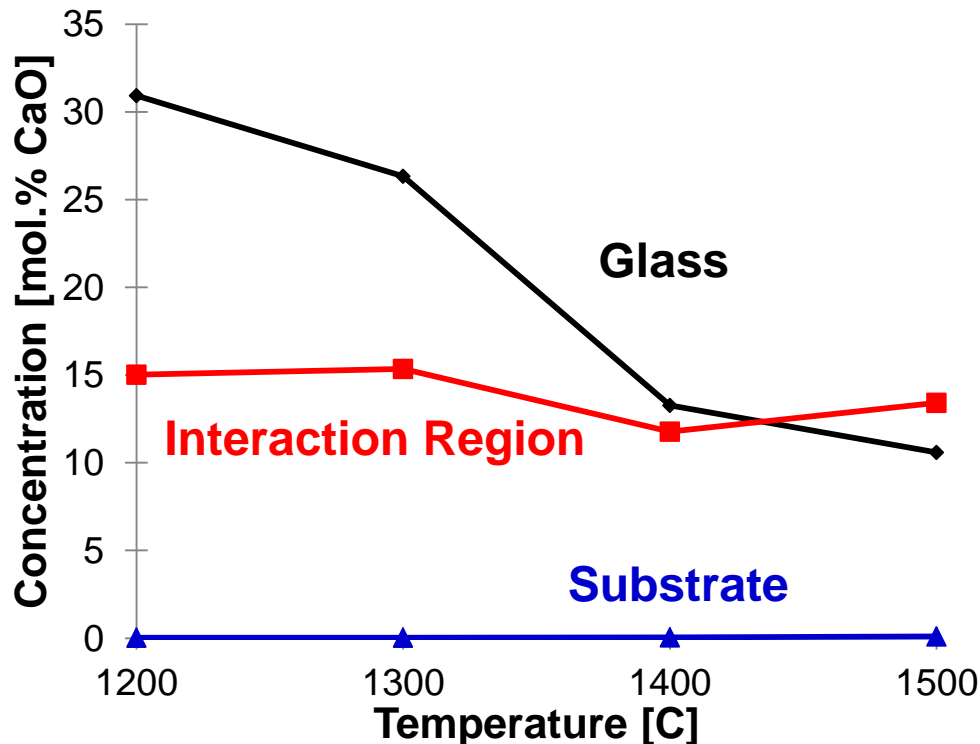
Average CaO Content by EPMA

- CaO content in glass decreases with temperature
- CaO content in interaction region constant
 - Depth of interaction region increases with temperature
- No CaO detected in substrate

BSE image of CMAS glass/Y₂Si₂O₇ substrate after 1500°C-20h
