# International Space Station (ISS) Environmental Control and Life Support (ECLS) System Overview of Events: 2010 - 2014

Gregory J. Gentry<sup>1</sup>

John Cover<sup>2</sup>

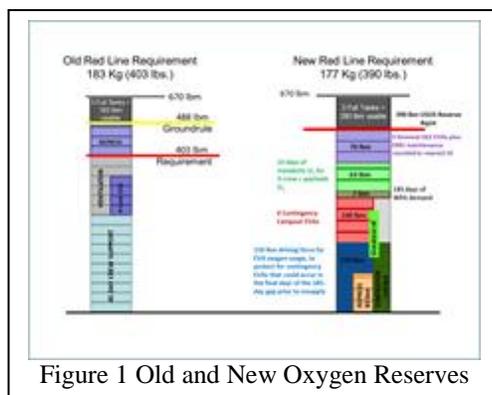
As Ops and Engineering teams learn more about how to operate the ISS, some things evolve, and recently the amount of reserve oxygen was re-vamped to reflect this experience. Figure 1 shows old and new oxygen reserve amounts and their make-up.

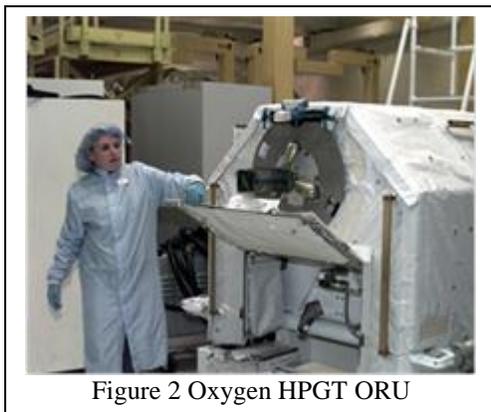
A High Pressure Gas Tank (HPGT) ORU (see Figure 2) was delivered to ISS on STS-134 mounted to Express Logistics Carrier #3 (ELC-3) configured for and filled with oxygen. Once delivered the ELC-3 was parked on the starboard truss. As the last ground unit was designed for Shuttle transport, ISS program management decided to store the HPGT on ISS where it could be used on ISS rather than stranding it on the ground after Shuttle retirement. All five of the “HPGT parking spots” on the Airlock are full (three oxygen HPGTs and two nitrogen HPGTs) so a structural mounting location

had to be built on the ISS truss. Since it was never envisioned that a HPGT would reside on a truss, there isn’t any health monitoring of the ORU, which unfortunately leaves no method for verifying the HPGT integrity.

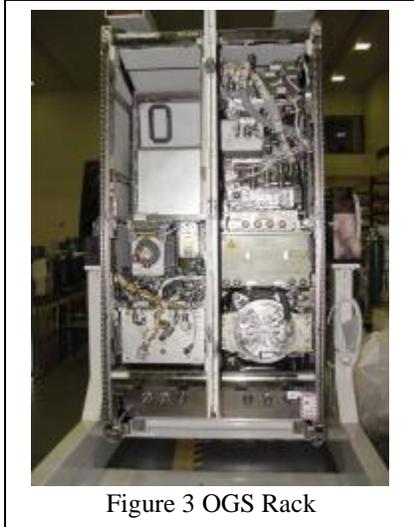
Figure 3 OGS Rack

The OGA, residing in the Oxygen Generation System (OGS) Rack (see Figure 3), has produced 3806 kg (8373 lbs.) of O<sub>2</sub> and 488 kg (1047 lbs.) of H<sub>2</sub> through 3/22/2015. With the rack plus spares weighing in at under 1,400 kg (3,000 lbs) water electrolysis has provided a large logistic advantage especially when the additional mass of tanks required to deliver oxygen to ISS is considered. Using the recently developed Nitrogen/Oxygen Resupply System

The OGS rack was launched on STS-121/ULF1.1 in July 2006 and initially installed in the U.S. Lab module for operation. After Node 3 arrived on STS-130/20A in 2010, the OGS rack (along with WRS 1 & 2 racks) was moved into Node 3 accumulating ~38,000 hours of operational run time (through March 2015) with an *average* production rate of 2.4 kg /day (5.3 lbs/day) oxygen.

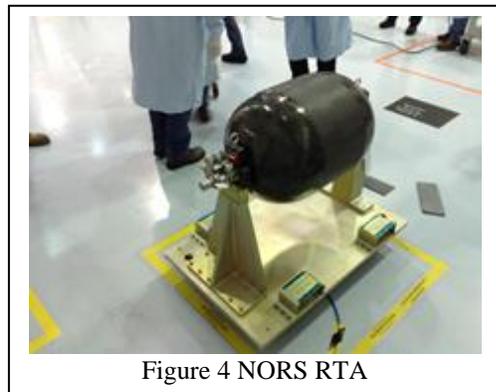
Figure 4 NORS RTA

To deal with the retirement of the Shuttle Orbiter fleet and the loss of gaseous oxygen and nitrogen resupply to the ISS HPGTs, the Nitrogen/Oxygen Recharge System (NORS) was developed. Figure 4 shows a NORS Resupply Tank Assembly (RTA) without its flight soft cover. The development of high pressure (41,369 kPa (6,000 PSI)) composite tanks, regulators and a modification kit for installation into the U.S. *Quest* Airlock to facilitate gas transfer to the HPGTs from inside the ISS has been challenging. NORS design and progress has been discussed in detail in several ICES papers at the 40<sup>th</sup>, 41<sup>st</sup>, 42<sup>nd</sup> & 43<sup>rd</sup> ICES conferences. Delivery of the Airlock Installation Kit

(AIK) to ISS occurred on Orb-2 in July 2014, and is waiting to be installed in the *Quest* Airlock Equipment Lock. The flight RTAs deliveries to KSC have begun and first flight of a full NORS oxygen tank is imminent. The first attempted flight of a Nitrogen NORS tank was on the Cygnus CRS Orb-3 flight on October 28, 2014 but did not reach ISS due to loss of the vehicle following launch. One each O<sub>2</sub> & N<sub>2</sub> NORS tanks were planned for SpX-6, but due to the loss of Orb-3 vehicle and necessary manifest replanning they have been delayed to one O<sub>2</sub> tank on SpX-7 and one N<sub>2</sub> tank on SpX-8.

After delivery of RTAs commenced, an issue with a lockout pin between the isolation valve and the vent valve designed to prevent both valves from a being opened at the same time was discovered.

Due to a tolerance stack-up issue when opening the vent valve the isolation valve was found to slightly open. As this was the complete opposite of the pins function, something had to be done. Subsequent study showed that the RTA design evolution enhanced safety in several areas after the pin was introduced, thus overcoming the need for the pin.

It was decided the pin could be removed completely to eliminate the vent valve opening risk. Since the only unit launched to date was lost on Orb-3, all other units were accessible on the ground. The pin removal modification has been completed for the next two RTAs scheduled to fly and subsequent flight units will be modified until the entire fleet of RTAs represent the latest configuration.

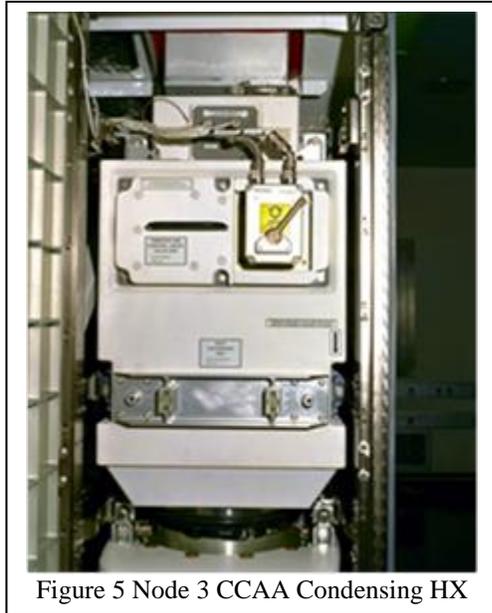
Figure 5 Node 3 CCAA Condensing HX

CCAA CHXs have been reported to have issues with the hydrophillic coatings getting contaminated and becoming hydrophobic in flight. The source of the contamination has been determined to be Polydimethylsiloxanes (PDMS),

phthalate esters and fatty acids in the atmosphere given off by crew members and a myriad of products and materials on board ISS. Reporting on the PDMS problem has occurred in several ICES papers over the last few years from several aspects, including the periodic increase in WPA product water TOC.

Since the CHX ORUs are difficult, expensive and time-consuming to build, a dedicated effort to find a method to recover contaminated heat exchangers was initiated and successfully achieved. By “ashing” the CHX coating in an oven at high temperature, the coatings are rejuvenated allowing the CHX to successfully pass Acceptance Testing. Five contaminated CHXs have been through the rejuvenation process and the first rejuvenated CHX ORU has been flown and installed in the Node 3 CCAA, as shown in Figure 5, and is performing nominally.

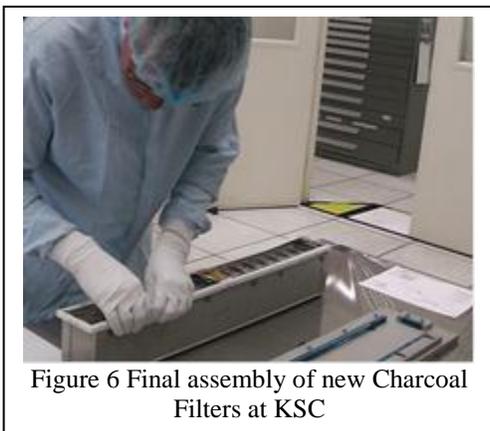
Figure 6 Final assembly of new Charcoal Filters at KSC

Cabin Air Catalyst Element Assemblies used for launch-to activation of Node 1 and the U.S Laboratory modules to scrub trace contaminants out of the cabin that build up between hatch closure on the ground and crew ingress in space were replaced with HEPA filters and returned to earth and have been stored at KSC for years. The ECLS team proposed re-purposing them by taking 4 units and filling them with the most promising (and accessible) scrubbing media in test at KSC. See Figure 6. This idea was approved by NASA and the four modified “charcoal filters” were installed in

Node 1 on May 12, 2015 in place of the currently installed HEPA filters. They expect to be installed and working for about a year. This should reduce the background PDMS level in the atmosphere, extend the WPA MF-bed life and delay the next high TOC event.

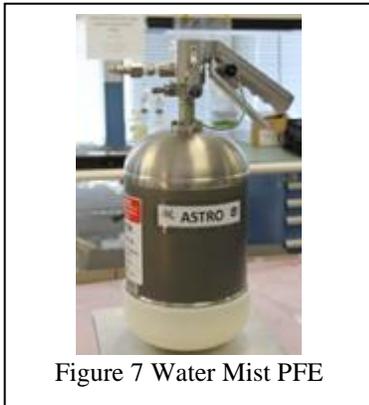
Figure 7 Water Mist PFE

Additionally NASA has developed the Water Mist (WM) PFEs (see Figure 7) for exploration use and intend to fly some to ISS for in-flight experience. This should begin in late 2015.

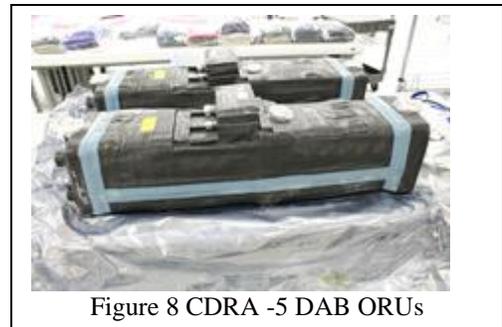
Figure 8 CDRA -5 DAB ORUs

carryover damaging the RK-38 and creating breakdown and subsequent rapid dusting of the material. With the priority of crew time on science, not maintenance, a “-5” version has been designed. It is essentially the “-4” mechanical design but with the original ASRT zeolite, which after more thorough testing proved to be more robust than the new zeolite under wetter than expected conditions, which appear to be more the norm in flight.

As of this writing two “-3” DAB ORUs are in the Lab CDRA and two “-4” Bed ORUs that were in Node 3 CDRA have just been replaced with two “-5” DAB ORUs on May 12, 2015 that flew up to ISS on SpX-6. The poorly performing “-4s” will be returned for conversion to “-5s” which will then launch and be installed in the Lab CDRA bringing the fleet of CDRA beds all up to the “-5” configuration. See Figure 8 for CDRA Dash 5 DAB ORUs delivered on SpX-6.

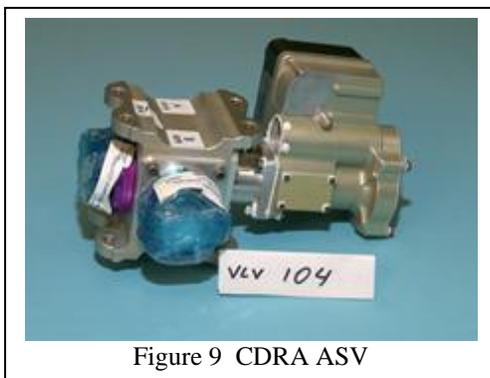
Figure 9 CDRA ASV

Along with CDRA DAB issues, the Air Selector Valves (ASVs) (See Figure 9) have shown a marked increase in failure rates at lower cycle counts. Four offending valves were returned in late 2013 and a failure investigation was conducted in 2014. The conclusion was discovery of several factors including a mis-match between the actuator torque output design point and the valve body allowable torque at assembly, causing the valve to be underpowered. Add to that a tolerance stack up condition that allowed excessive force to be applied to the ball seals resulting in buildup of contamination at the ball-to-seal interface that quickly exceeded the actuator torque capability required to rotate the ball valves.

A re-design of the valve body to a “-2” configuration should eliminate all the problems except contamination and the new valves should begin to be fielded in 2017.

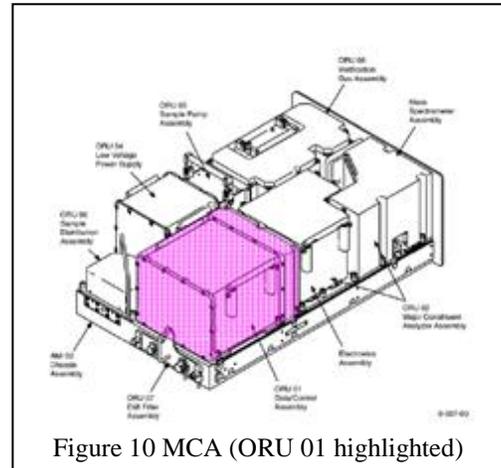
Figure 10 MCA (ORU 01 highlighted)

The original Lab and Node 3 MCAs flew with firmware (FW) version 4.18 installed in the MCA Controller ORU (See Figure 10). This FW provided the basic functionality for the MCA, however over time many “tweaks” to the

Since the MCA was not designed to have firmware uploaded through telemetry or on-orbit through a laptop connection, the Data & Control Assembly ORU (ORU 01) had to be returned, re-loaded and re-launched. This has happened for the Lab MCA with the new FW ORU being installed in December, 2014. Unfortunately a connection issue with a new mass spectrometer ORU (ORU 02) has delayed the initial on-orbit use and checkout of the new firmware. Hopefully crew time will be found to fix the problem and return the Lab MCA operation. Once that occurs the Node 3 MCA will will also receive a FW upgrade.

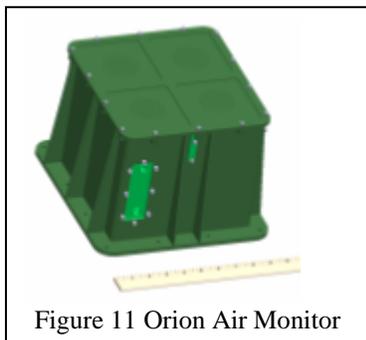
Figure 11 Orion Air Monitor

Not unlike the carbon dioxide removal system development with respect to exploration, the MCA, while currently comprised of 7 ORUs and takes up a full drawer in the AR rack, is not suitable for the challenge of supporting exploration vehicles going beyond low earth orbit. Case in point – Orion. Orion needs a similar capability to the MCA but in a much smaller package with lower power and weight. The Orion Program came to the ISS program and collaboration on a next-generation Multi-Platform Air Monitor (MPAM) concept was initiated. (See Figure 11.)

ISS, driven by obsolescence issues with MCA electronics making sparring for 2028 a challenge, and Orion, looking for ways to cost-share component development, are working together to develop the MPAM for use on both programs. The idea is that ISS will develop the MPAM and retro-fit an MPAM in one of two MCA on-orbit locations adapted to work with the existing Sample Distribution System (SDS) and AR rack structural, power and C&DH interfaces, while Orion will be able to buy a flight MPAM directly and install it in an Orion capsule for atmospheric monitoring.

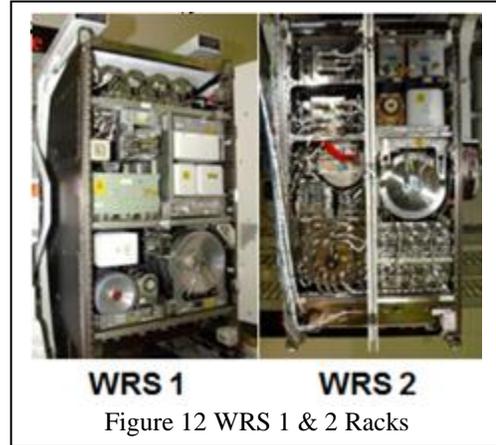
Considering the combined launch weight of the WRS 1 & 2 racks (See Figure 12) and all needed spares come to approximately 3,000 kg (6,600 lbs.) that proves the investment in regenerative water processing systems.

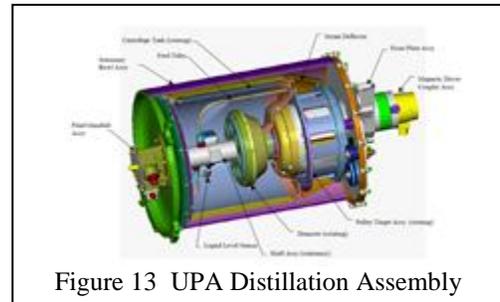
The Distillation Assembly (DA) ORU had early problems with its DA bearings that needed to be re-designed. The redesigned bearings resolved the DA rotation issue. This was followed by encountering a higher calcium concentration residing in the on-orbit pretreated urine supply relative to ground test assumptions. The higher calcium level resulted in precipitation of calcium in the UPA DA causing its fluid passages to get blocked. Investigation revealed that a new pretreat formulation had to be developed that could more effectively handle the calcium load without precipitating solids. Prior to this problem, UPA recovery of water from the pretreated urine was approximately 85%, but due to the precipitation risk recovery had to be reduced to 75%. It is expected that the new pre-treat formulation, targeted for implementation in late 2015, will allow for recovery rates to return to ~ 85%. See Figure 13 for image of the UPA DA.

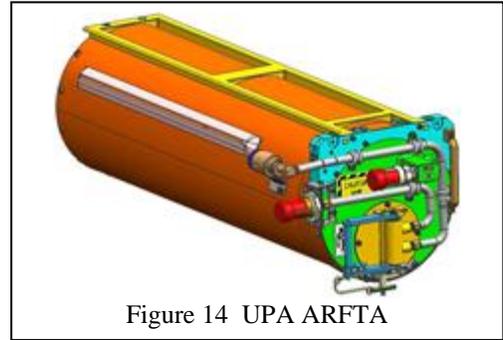
Figure 14 UPA ARFTA

As originally designed, the UPA Recycle Filter Tank Assembly (RFTA) was a one-time use on-board design. It was a non-bellows tank that had a vacuum applied pre-launch. When on-board ISS it would be filled with pretreated urine and used in the UPA until it had concentrated brine. Once processing was complete the RFTA would be brought back to the ground for brine disposal and re-application of a vacuum for re-flight. Since the UPA was designed during the Shuttle era and the U.S. had no means of brine disposal (short of venting overboard from Shuttle) the design made sense. However, once the Shuttle retired it became a challenge to continue operating this way, so the *Advanced* RFTA (or ARFTA) was built. (See Figure 14.) It is a bellows tank design that can be filled with pretreated urine on board, just like the RFTA, but then when processing is complete it can be removed from the UPA and by applying a back pressure to the bellows the brine can be dumped to a Progress Rodnik tank (with Russian permission), EDV (Russian fluid container) or into a Temporary Urine Brine Storage System (TUBSS) bag for disposal on an unmanned logistics vehicle. Six ARFTAs have been built with 3 units (2 in regular use, 1 spare) sent to the ISS with good operational success to-date.

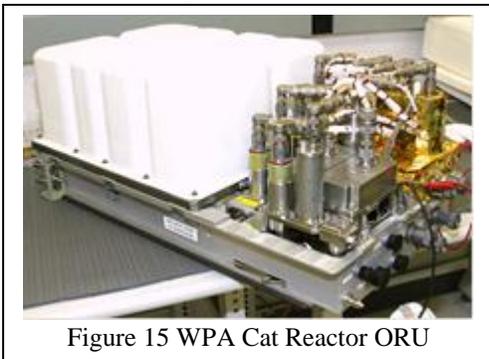
Figure 15 WPA Cat Reactor ORU

The WPA Cat Reactor ORU S/N 0001 first suffered a water leak on-orbit on March 10, 2010. It appeared a seal in the ORU “hot section” was at fault. While the ORU life is expected to be 5 years and seal life is the limiting factor driving the ORU life, it might not be surprising that a seal leak occurred, except the ORU had only been installed for 16 months prior to the failure. The ORU was replaced with on-board spare Cat Reactor S/N 0002 and returned to ground for investigation.

The investigation determined that many of the seals in the reactor hot section were, in fact, severely heat strained and no longer compliant enough to perform their sealing function. Cat Reactor ORU S/N 0003 was flown with “improved” soft seals and installed in March 2012, after Cat Reactor S/N 0002 failed in a similar fashion to S/N 0001 after 23 months of installed life. Unfortunately Cat Reactor S/N 0003 also suffered early seal failure, and now the ISS Program wants a solution that is more dependable. The WPA engineering team investigated ways to eliminate soft seals from the cat reactor hot section and has developed a method to reduce the reactor temperature when the WPA is in standby in the hopes of extending the Cat Reactor installed life. A re-design eliminating soft seals in the hot section of the ORU was proposed but not implemented due to cost. See Figure 15 WPA Cat Reactor.
