NASA/TM—2015—218940

# Flight Tests of a Supersonic Natural Laminar Flow Airfoil

*Michael A. Frederick and Daniel W. Banks  
Armstrong Flight Research Center, Edwards, California*

*G. A. Garzon and J. R. Matisheck  
Aerion Corporation, Reno, Nevada*

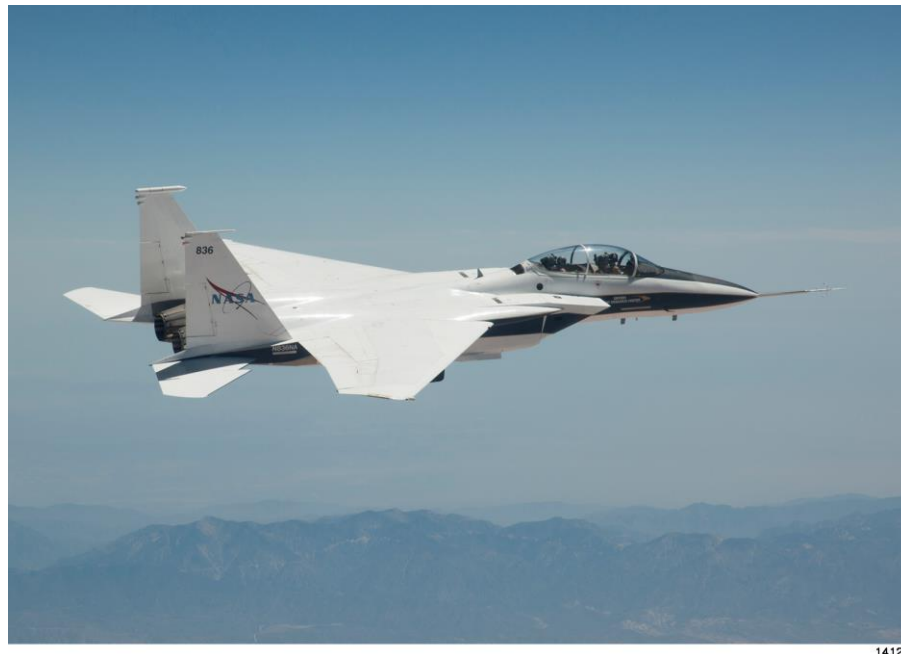
Figure 1. The NASA F-15B research test bed airplane.

The F-15B airplane is a two-seat fighter and trainer version of the F-15A high-performance, supersonic air-superiority fighter (both built by McDonnell Douglas Corporation, now The Boeing Company, Chicago, Illinois) and is powered by twin F100-PW-100 afterburning turbofan engines (Pratt & Whitney, West Palm Beach, Florida). The NASA F-15B airplane has been converted from a United States Air Force air-superiority fighter to a research test bed airplane. Research instrumentation, recording, telemetry, and video systems have been installed on the airplane. A calibrated National Advisory Committee for Aeronautics (NACA) -style flight-test nose boom was installed on the airplane and used for measurements of free-stream Mach number, angle of attack, and angle of sideslip. A research total temperature probe, installed on the bottom side of the forward fuselage of the airplane, was used for measurement of the free-stream total temperature. The total temperature and free-stream Mach number measurements were used to derive the static temperature, density, and unit Reynolds number of the free-stream flow.

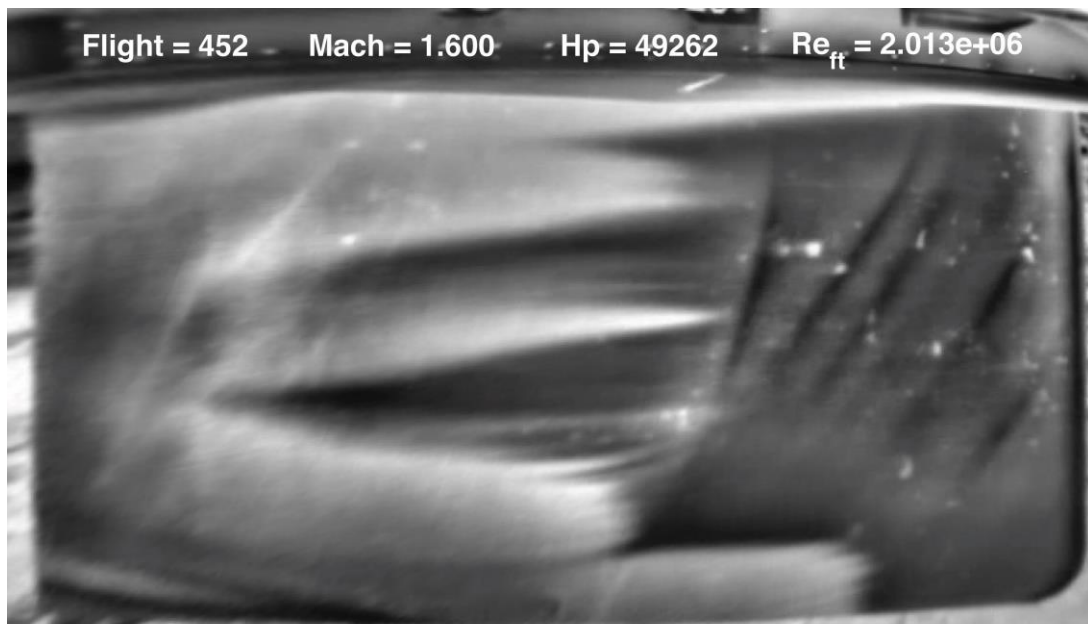
Figure 21. Mach = 1.6 during acceleration at 49,500 ft.

At Mach 1.6, shown in figure 21, a significant portion of the transition line is located beyond the camera-pod shock. Between one-quarter and three-quarters span, a large portion of laminar flow persists out to approximately 75 percent chord. A turbulent wedge, originating just aft of the camera-pod shock, is located just inboard of the mid-span location. The transition line outboard of the large run of laminar flow has a wispy, sawtooth appearance indicative of crossflow and is located just aft of the camera-pod shock. The transition line in this region is located at roughly 44 percent chord, whereas the transition line near the tip is located at roughly 25 percent chord. The difference in transition line chord locations between these two regions suggests that the crossflow due to the tip radius is significantly stronger than the crossflow generated by the shock impingement.
