Forward Skirt Structural Testing on the Space Launch System (SLS) Program

J.D. Lohrer¹ and R.D. Wright²
Orbital ATK Flight Systems Group, Promontory, Utah

Structural testing was performed to evaluate heritage forward skirts from the Space Shuttle program for use on the NASA Space Launch System (SLS) program. Testing was needed because SLS ascent loads are 35% higher than Space Shuttle loads. Objectives of testing were to determine margins of safety, demonstrate reliability, and validate analytical models. Testing combined with analysis was able to show heritage forward skirts were acceptable to use on the SLS program.

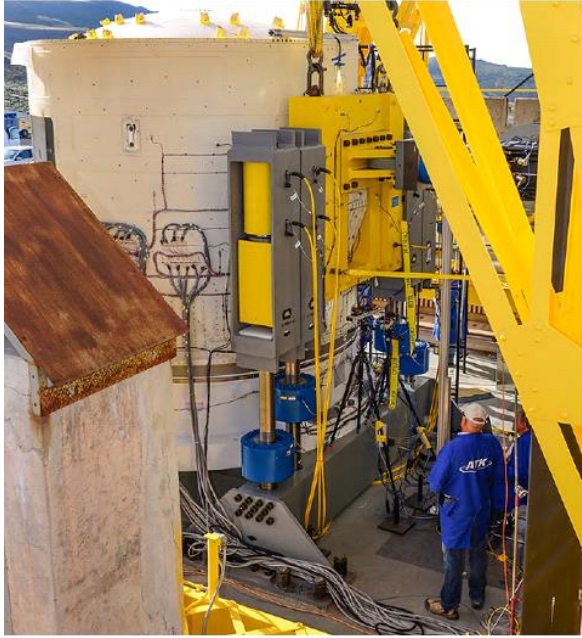
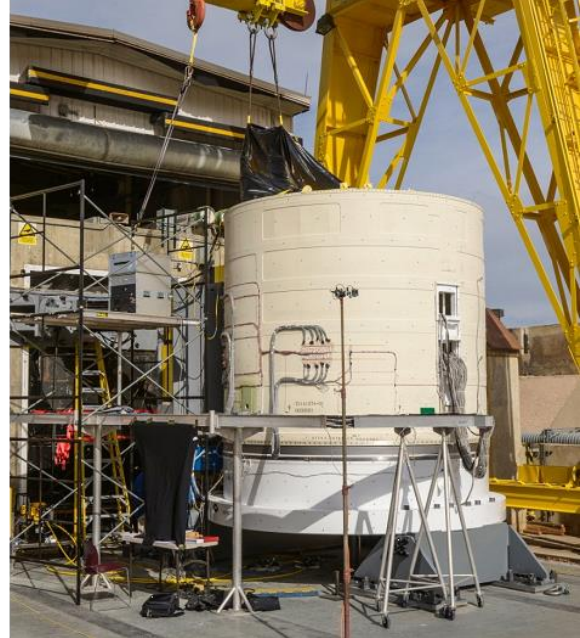
Figure 6. Test Setup.

Testing was performed at Orbital ATK facilities in Promontory, Utah. The test setup is shown in Fig. 6. The test stand applied loads to the forward skirt are shown in Fig. 7. Four hydraulic actuators were used to apply axial load and two hydraulic actuators were used to apply radial and tangential loads. Four load cells measured axial loads while load cells were built into the hydraulic actuators that applied lateral loads.

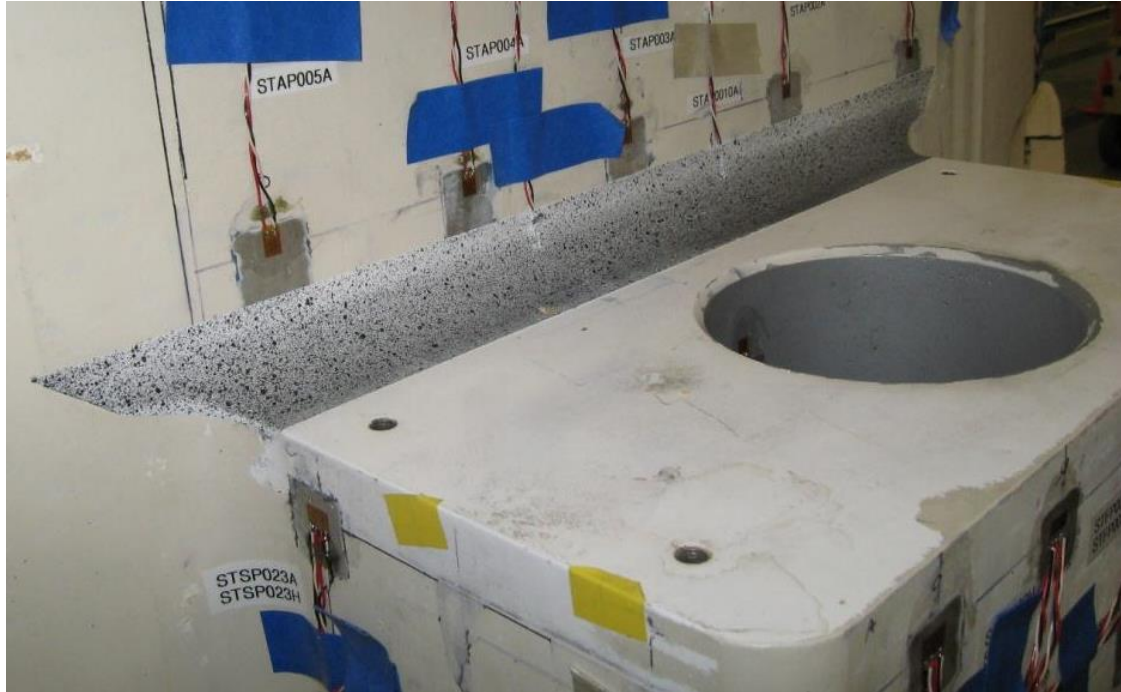
Figure 17. Post Radius Speckle Pattern.

Strain at the post radius was determined by processing digital images with the ARAMIS system. A speckled paint pattern was required on the post radius as shown in Fig. 17. Digital cameras were mounted at the top of the forward skirt as shown in Fig. 18. This was not the most desirable setup but was required to avoid tooling used to apply loads. Even with this limitation, ARAMIS was able to accurately capture the thrust post strain. ARAMIS strain results are shown in Fig. 19 for FSTA-2 just prior to failure. A high strain develops near the left side. This high strain compares well to analysis prediction for both FSTA-1 and FSTA-2 as shown in Fig. 20. The strain at this location was also plotted versus load in Fig. 21 and 22. Both FSTA-1 and FSTA-2 had excellent correlation between ARAMIS and analysis strains.

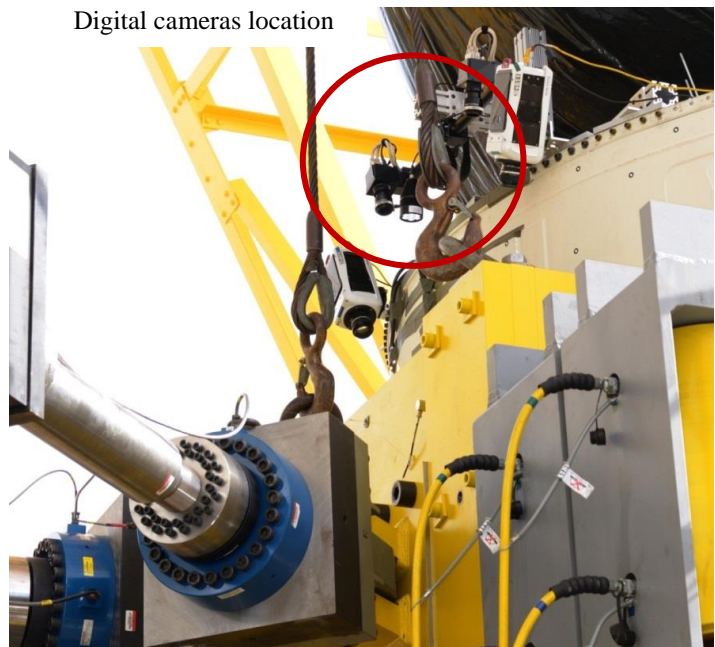
Figure 18. ARAMIS Digital Cameras.
