Johnny L. Golden, PhD, SAMPE Fellow
Consultant, Boeing-Retired
SAMPE Long Beach – 2016, May 25th

The ISS SARJ: M&P Lessons Learned

The ISS SARJ: The Anomaly

The ISS SARJ: STBD Failure Root Cause

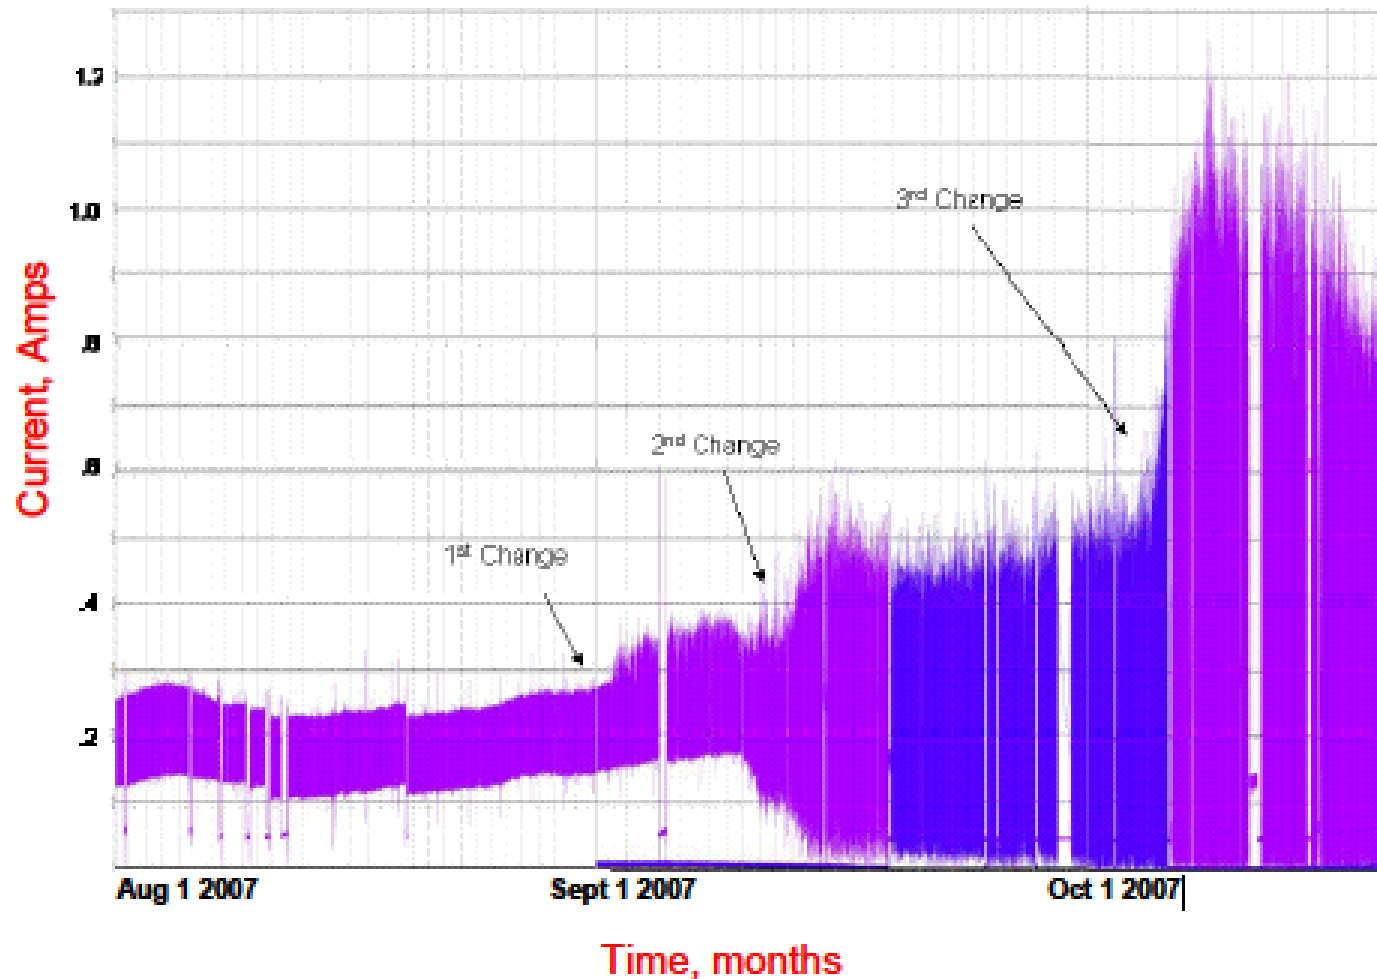
Starboard SARJ Drive Motor Current; Start-up to Failure

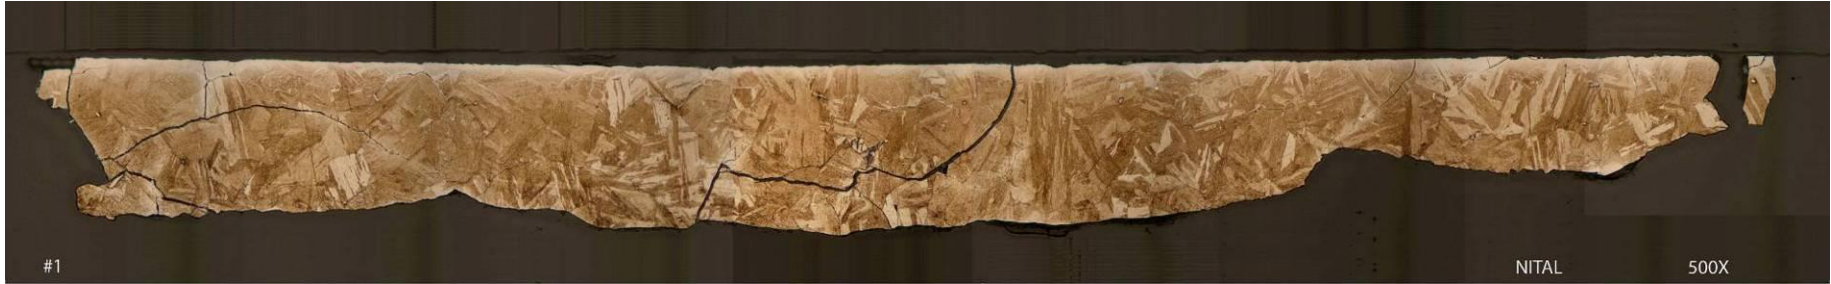
Nitrided 15-5 PH Fragment from the Starboard SARJ, imaged in cross section. Much of this particle separated at or near the case core interface, and is up to 150 μm (0.006 inch) thick.

- The Starboard SARJ function was recovered, after losing 150 μm (0.006 inch) from the outer canted race ring surface.
- The need for nitriding the race ring is not substantiated, as the mechanism can obviously tolerate a great deal of race ring wear.
- **M&P Lesson Learned**
 - Be mindful of the unintended consequences of “make it better” decisions in design.

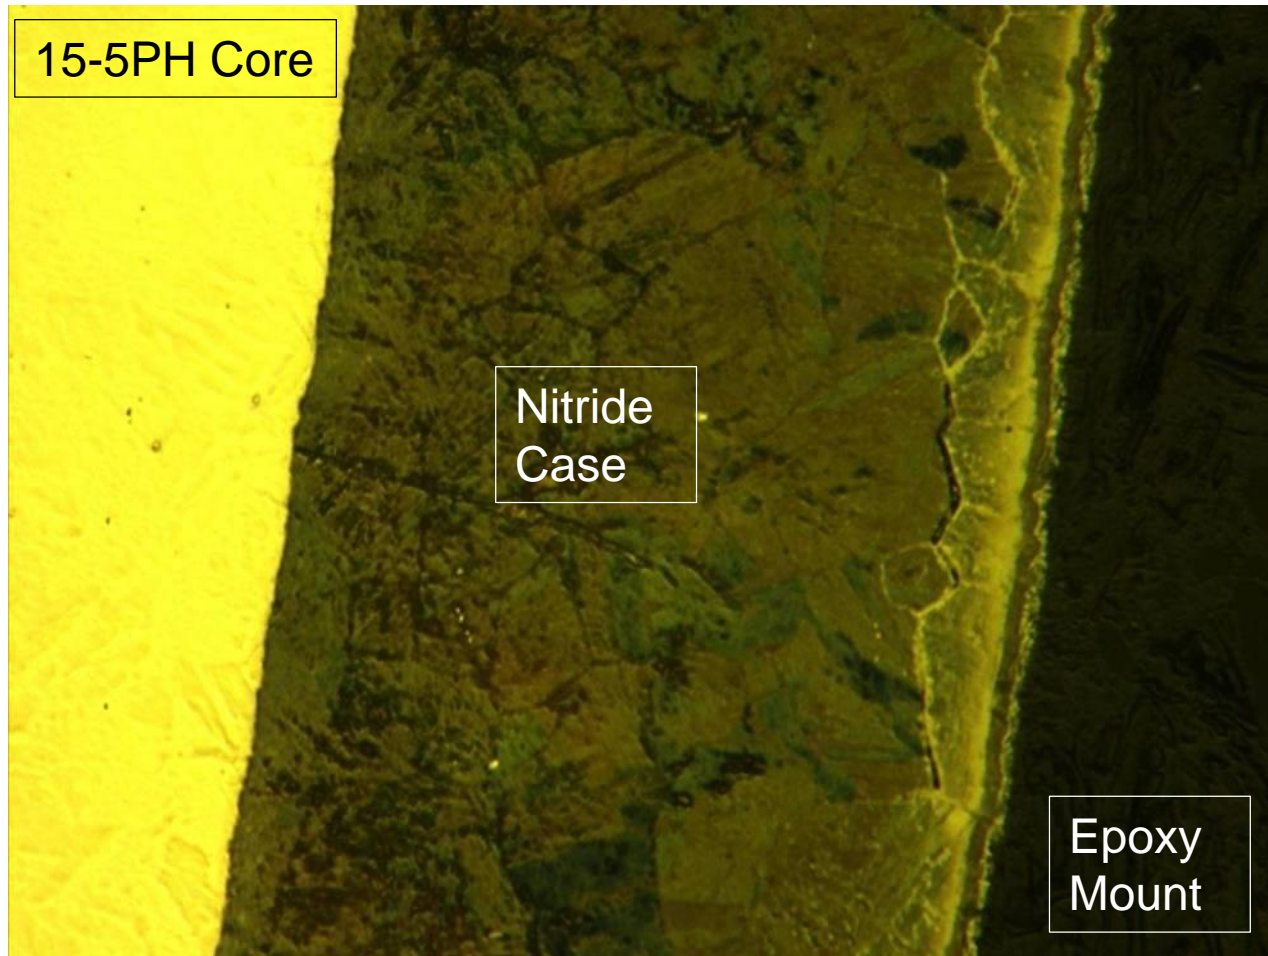
Metallographic re-examination of Nitride Control Coupons identified intergranular networking, well in excess of requirements, and the presence of separations.

- The original metallographic examination of nitride control coupons, processed with the flight hardware, did not correctly identify the extent of intergranular networking – in excess of engineering control limits.
- Additionally, the coupon examinations did not detect the presence of DIGS.
 - Even though not specifically controlled by engineering, the presence of these crack initiation sites within the nitride structure is an obvious issue.
 - It appears that the DIGS were obscured by the metallographic mounting and polishing technique.
- **M&P Lesson Learned**
 - Be critical of metallography, and assure that best practices are used to avoid distortion or obscuration of features.

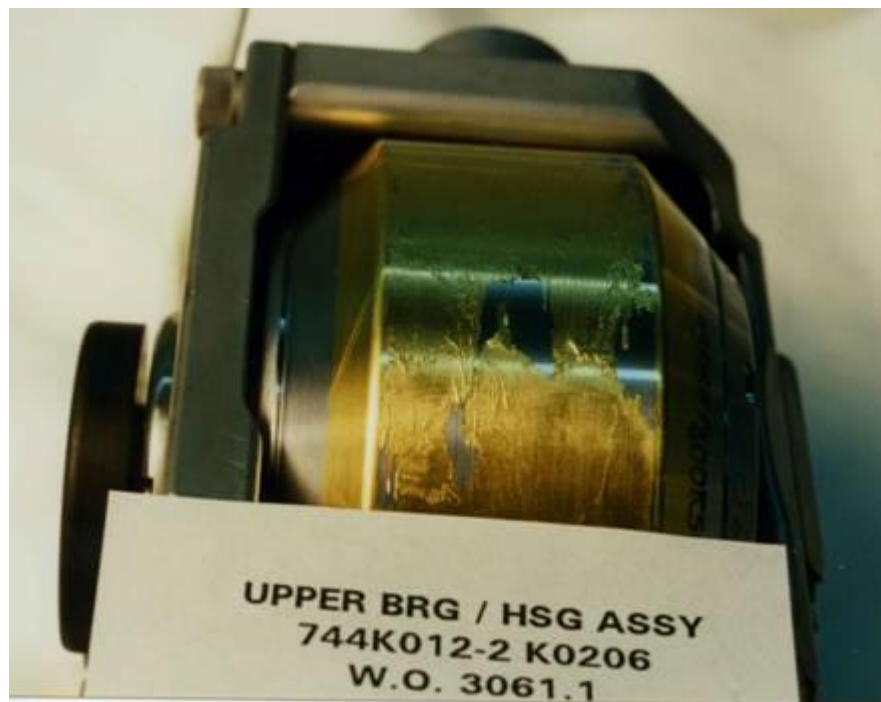
- Flight TBA roller with gold loss, accepted as-is, based on the successful PLT test.

- It was demonstrated that the 440C roller surfaces re-oxidize with time under normal terrestrial conditions, undercutting the gold coating and causing complete loss of adhesion.
- Although adhesion loss on rollers was observed on hardware preflight, the successful PLT test (where no gold remained on roller surfaces) was used to accept the condition.
- It was not recognized that gold adhesion was critical to friction control in the mechanism during flight.
- **M&P Lessons Learned**
 - Spacecraft hardware must often be designed considering the terrestrial environment, in addition to the space environment.
 - Consider a more robust approach to accommodate the ground environment or the exposure to unexpected conditions.
 - Look for finishes sensitivity, which may require environmental controls.
