Evaluation of the Second Transport Rotorcraft Airframe Crash Testbed (TRACT 2) Full Scale Crash Test

Two Transport Rotorcraft Airframe Crash Testbed (TRACT) full-scale tests were performed at NASA Langley Research Center's Landing and Impact Research Facility in 2013 and 2014. Two CH-46E airframes were impacted at 33-ft/s forward and 25-ft/s vertical combined velocities onto soft soil, which represents a severe, but potentially survivable impact scenario. TRACT 1 provided a baseline set of responses, while TRACT 2 included retrofits with composite subfloors and other crash system improvements based on TRACT 1. For TRACT 2, a total of 18 unique experiments were conducted to evaluate ATD responses, seat and restraint performance, cargo restraint effectiveness, patient litter behavior, and activation of emergency locator transmitters and crash sensors. Combinations of Hybrid II, Hybrid III, and ES-2 Anthropomorphic Test Devices (ATDs) were placed in forward and side facing seats and occupant results were compared against injury criteria. The structural response of the airframe was assessed based on accelerometers located throughout the airframe and using three-dimensional photogramme

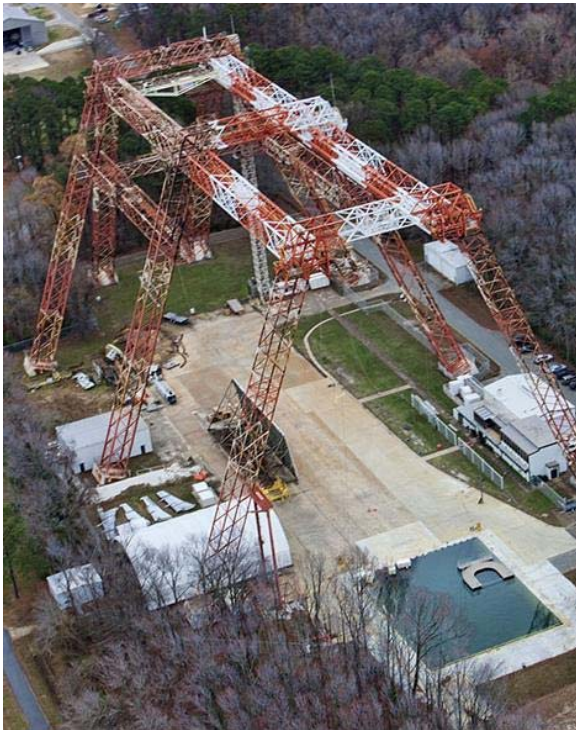
Figure 1. Landing and Impact Research Facility

vehicles into terrain, prepared surface, or water. The test article is lifted with steel cables as high as 200-ft and the lift cable is pyrotechnically released to swing like a pendulum onto an impact surface of water, concrete, or soil. Swing cables are configured to form a parallelogram to minimize pitch angular velocity during the pendulum swing. In order to simulate free flight conditions, just prior to ground contact, the swing cables are pyrotechnically severed from the test article. Critical interactions between the airframe, seat, and occupant can be evaluated based on synthesis of high speed and high definition video and sensors. A photo of the LandIR facility, otherwise known as the “Gantry,” is shown in Figure 1.

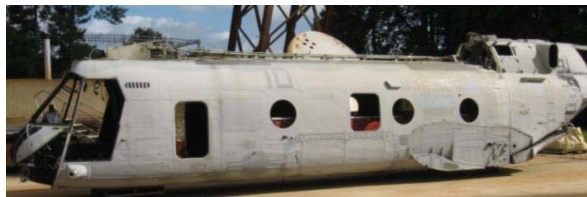
Figure 2. CH-46E Airframe

Two CH-46E airframes were obtained from the Navy CH-46E Program Office (PMA-226) at the Navy Flight Readiness Center in Cherry Point, North Carolina. The CH-46E airframe was chosen as a candidate testbed because of its common applicability as a medium-lift rotorcraft with airframe dimensions comparable to a regional jet or business jet. The CH-46E airframe design is semi-monocoque with skin stiffeners and frame sections. The cabin airframe cross section is nearly uniform from fuselage stations (FS) 190 to 320, and is composed primarily of Aluminum 2024 and 7075 alloys. A photograph of one of the CH-46E airframes is shown in Figure 2.

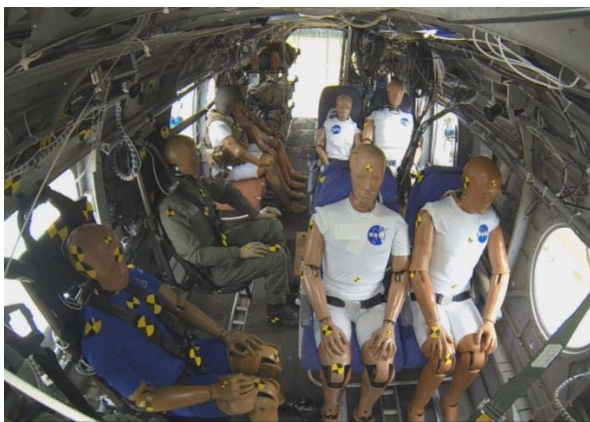
Figure 3. TRACT 1 Cabin ATDs

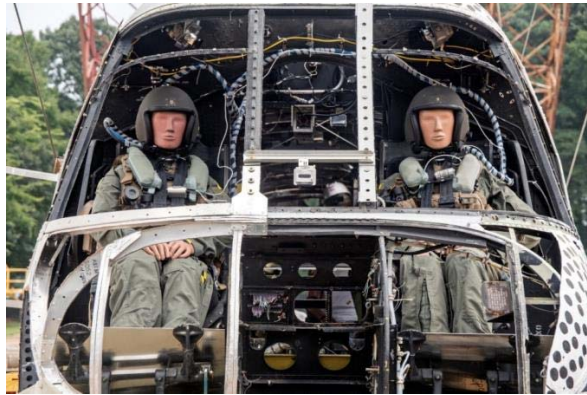
Figure 4. TRACT 1 Pilot and Co-pilot ATDs

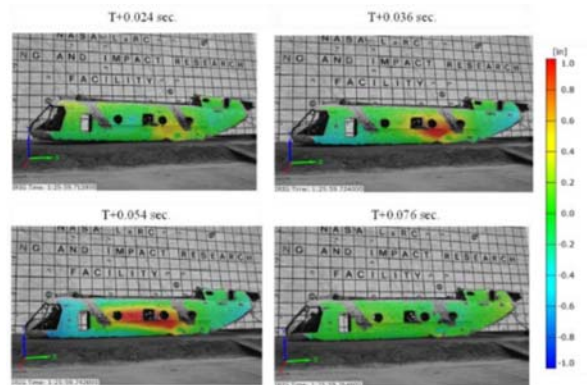
Figure 5. TRACT 1 Impact Sequence and Lateral Displacement from Photogrammetry

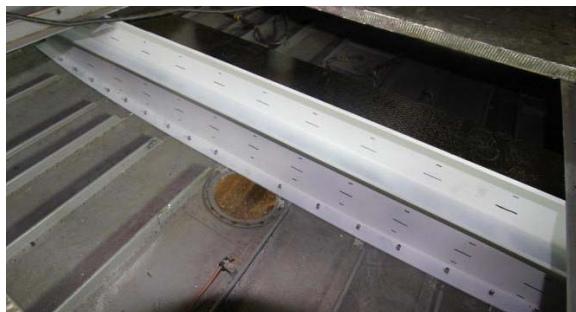
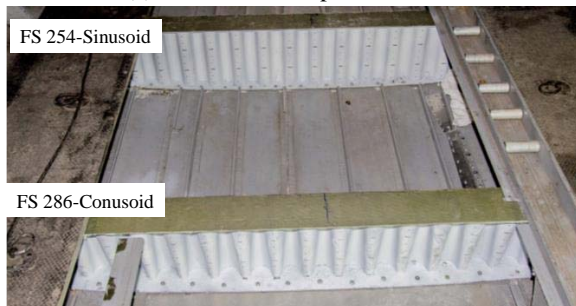
(a) ACS-DLR Composite Subfloor

(b) NASA Composite Subfloors

Figure 6. Composite Subfloor Retrofit for TRACT 2

The three composite subfloor designs are shown installed within the subfloor the TRACT 2 test article in Figure 6. The honeycomb sandwich floor sections that cover the composite shear panels were modified to include three polycarbonate windows. High speed cameras were installed just above the three windows to capture video of the impact behavior. The window and floor configuration is shown in Figure 7.

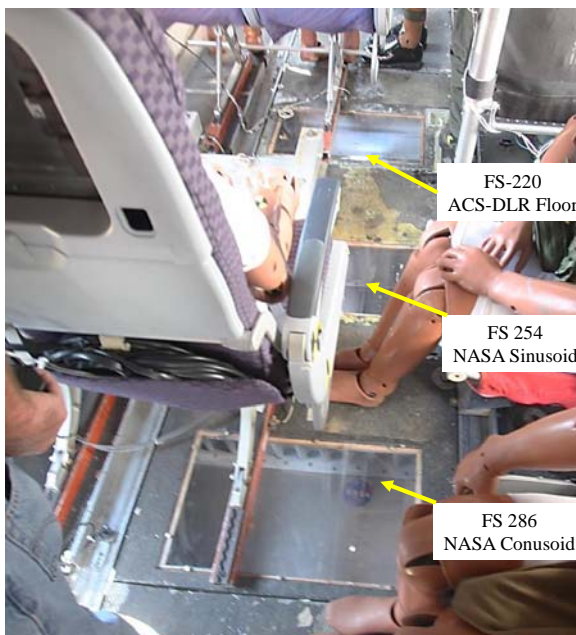
Figure 7. Cabin Installation over Subfloors

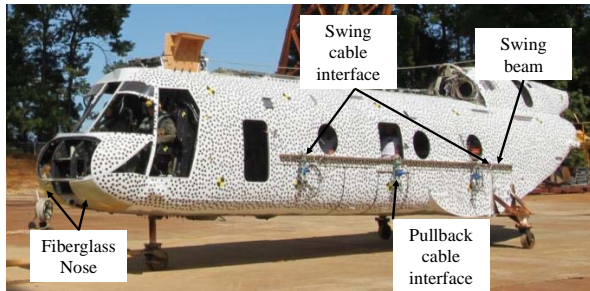
Figure 8. TRACT 2-Swing Beams and Photogrammetric Dot Pattern

There were several key modifications to the airframe prior to conducting the test. Fiberglass panels, fabricated for TRACT 1, were attached to the underside of the cockpit enclosure to reduce plowing of the exposed cockpit. Two angle channel beams used for TRACT 1 were bolted along the outer sidewalls three inches above the waterline (WL) to

provide hard points for the swing and pullback cables. The location of the swing beams was chosen to keep the windows accessible and visible. The hard points on the beam were selected to ensure proper spacing for a parallelogram swing, and align the cables near the center of gravity (CG). A random pattern of over 8,000 one-inch diameter dots were applied to the airframe skin on the left side. The motion of the dots could be tracked, and the airframe full-field deformation and kinematics could be computed. These modifications are shown in Figure 8.

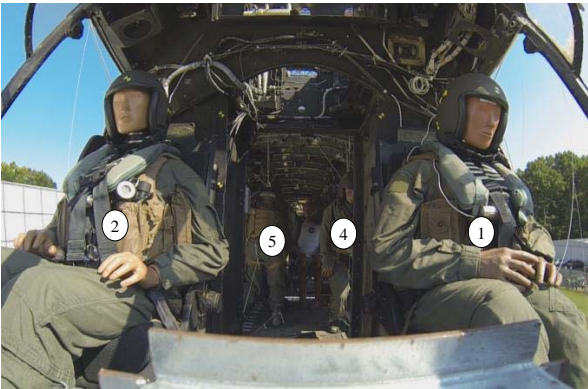
Figure 10. TRACT 2 Experiments- Cockpit and Front Cabin

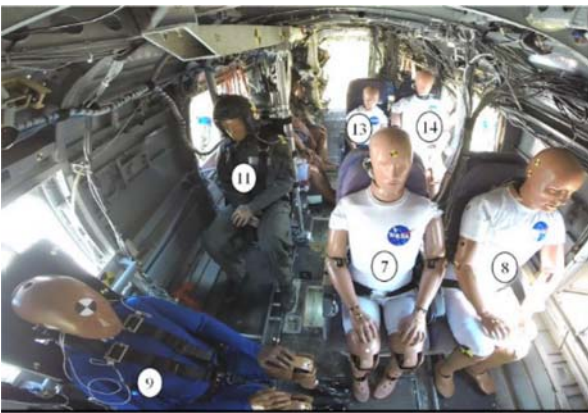
Figure 11. TRACT 2 Experiments- Mid Cabin

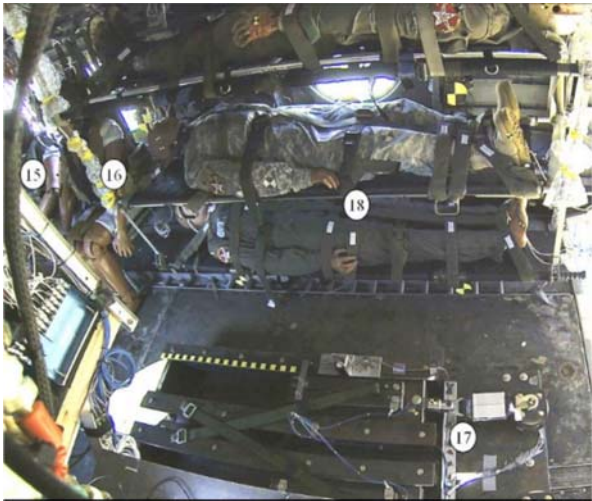
Figure 12. TRACT 2 Experiments- Aft Cabin

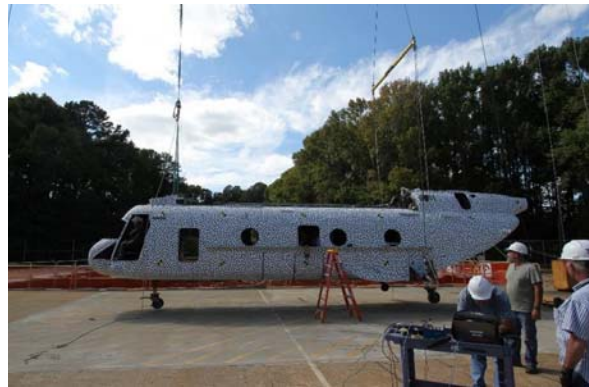
Figure 13. TRACT 2 Weight and Balance Test

A weight and balance was conducted on the TRACT 2 test article. The test article was suspended by three cables over the west side of LandIR. Load cells on all three cables measured the loads at zero pitch and 20 degree pitch. Figure 13 shows the weight and balance test. The weight of the test article (minus the nose and main wheel assemblies) was 10,534-lb. The longitudinal CG was at FS 262.8. The lateral CG was less than ½-inch off the centerline, and the vertical CG was 10 inches below the WL. The weight and CG location were similar to TRACT 1, and confirmed that the placement of swing and pullback cable interfaces on the test article was acceptable.

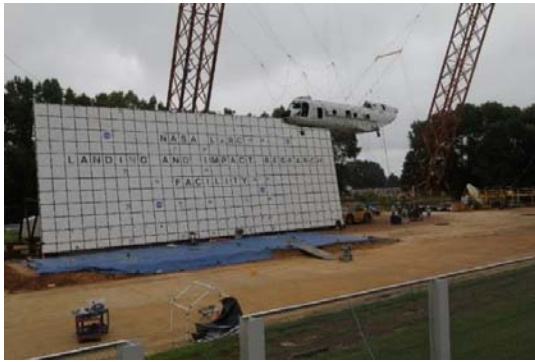
Figure 14. TRACT 2 Dry Run

One week prior to the test, a dry run was conducted. The fully instrumented test article was moved to the impact area underneath the gantry. All checklist procedures to align swing cables, switch from external to onboard power, hoist the test article to drop height, and trigger and download data and video were performed. The dry run was conducted without any complications in execution and performance verification. The dry run is shown in Figure 14.

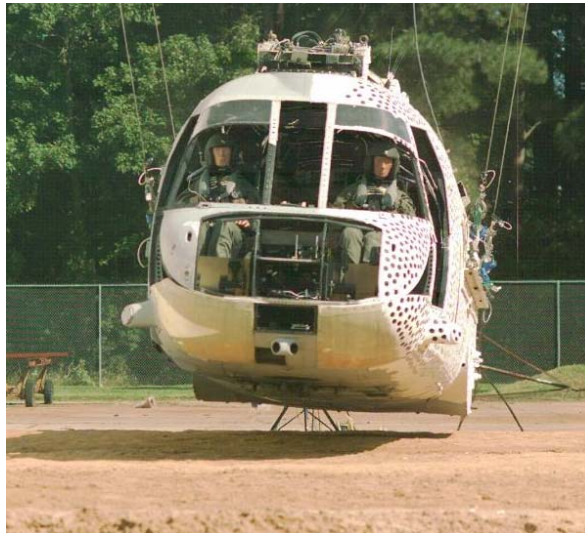
Figure 15. TRACT 2, Front View, Prior to Impact

Figure 15 shows the TRACT 2 orientation just prior to impact. The nominal and actual impact conditions are listed in Table 2. The airframe impacted the soft soil with a 2.5-degree nose-up pitch attitude, and a 3.6 degree roll to the left, and a 2.5-degree yaw to the right. The aft left side impacted initially. The roll and yaw angles were significantly higher than TRACT 1. A photo time lapse from an external high-speed camera is shown in Figure 16. The region forward of the stub wing box begins to crush 0.016-sec after impact. Cockpit touchdown occurs at 0.045-seconds. At 0.055-sec, the subfloor skin between FS 190 and FS 220 begins to dimple inwards. The aft cabin and tail rebounded starting at 0.090--sec, and reached maximum rebound height at 0.280-seconds. This rebound height was about 30% lower than the rebound height seen in TRACT 1. Following the second contact of the cabin belly on the soil, the test article came to rest abruptly at 0.53-seconds.

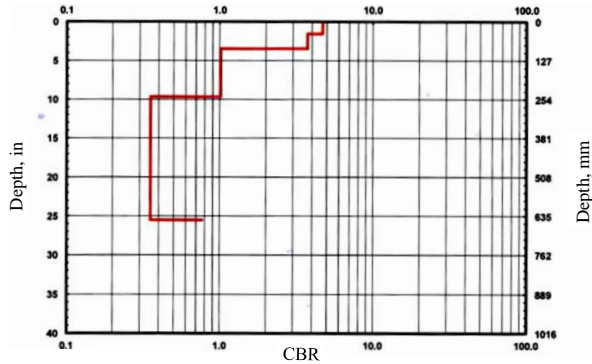
Figure 17. TRACT 2 Soil Strength

However, the soil properties were further studied with a dynamic cone penetrometer (DCP), which samples the bearing strength of the soil at various depths. At around 10 inches of depth, the soil softens considerably due to high moisture content, ranging from 9.7% to 16%. A representative plot of the California Bearing Ratio (CBR) versus depth is shown in Figure 17. The layered soil with a softer base yielded a large crater depth, as deep as 9-inches.

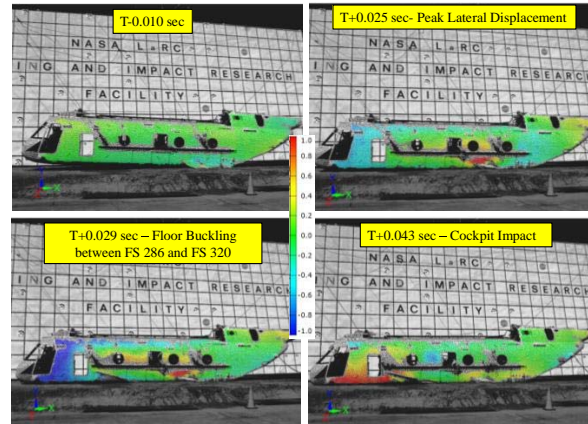
Figure 19. TRACT 2 Lateral Displacement from Photogrammetry

Full-field lateral displacements of the outer surface of the sidewall skin are fringe plotted in Figure 19. The peak displacements in and out of the page are represented by dark blue and red colors, respectively. The baseline reference state is shown at 0.010-seconds before impact. At 0.025-seconds after impact, the skin aft of FS 286 begins to bow out. Meanwhile, the cockpit skin displaces inwards, because the cockpit is rolling from left to right. At 0.043-seconds, the cockpit belly impacts, and the skin above the cockpit belly deforms outward.

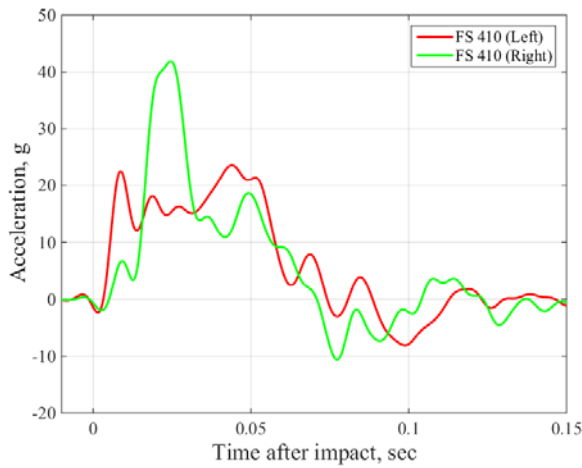
Figure 20. TRACT 2 Aft Cabin Frame Vertical Accelerations- Adjacent to Floor

The region in the aft section of the cabin was expected to sustain high vertical accelerations with the initial impact occurring on the aft left side. Figure 20 shows the vertical accelerations at FS 410 near the floor. The left side of FS 410 was the location of the NAVAIR/Penn State cargo restraint experiment and the right side of FS 410 was where the USAARL patient litter experiment was located. The vertical acceleration at FS 410 (L) is a sustained 20-g load over 0.050-seconds, while FS 410 (R) shows a peak of 41-g occurring at 0.025-seconds after impact as the airframe rolled right. The crushing behavior of the left side of the aft cabin was comparable to an energy absorber.

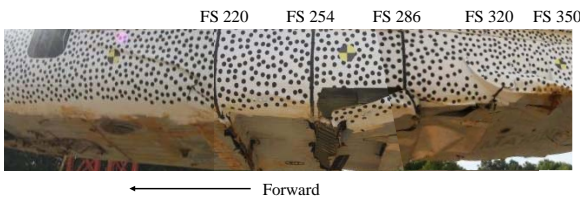
Figure 21. TRACT 2, Post-test Photo, Airframe Deformation

A photo of the understructure after impact is shown in Figure 21. Significant deformation is seen in the tail, and the belly skin is torn at FS 220, 254, and 286. The progression of failure is evident when viewing an onboard time lapse of the three critical frame sections, shown in Figure 22. At 0.010-seconds, the 5th and 95th percentile NASA ATDs press into the seat cushions. At 0.046-seconds, the belly skin begins to dimple up aft of the flange of the conusoid. All three subfloors begin to fold as the floor moves forward relative to the belly. The belly and subfloor sections then can no longer support any of the longitudinal loading. At 0.1-seconds, the ATDs flail forward, and the induced loads and moments from the ATDs cause the floor above the conusoid and ACS-DLR to detach. This response differed from TRACT 1, where only minor longitudinal shearing was evident in the cabin subfloors.

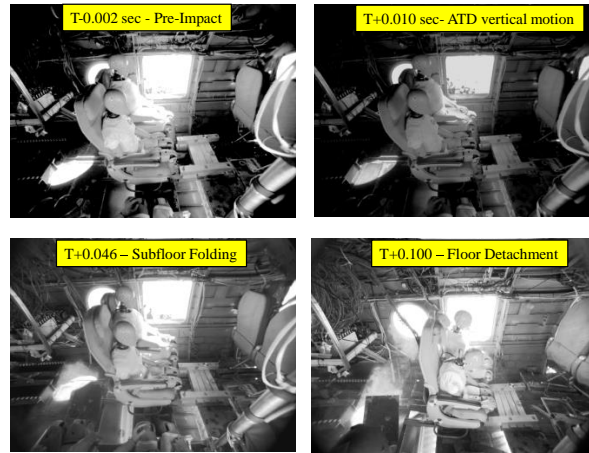
Figure 22. TRACT 2 Cabin, Impact Sequence

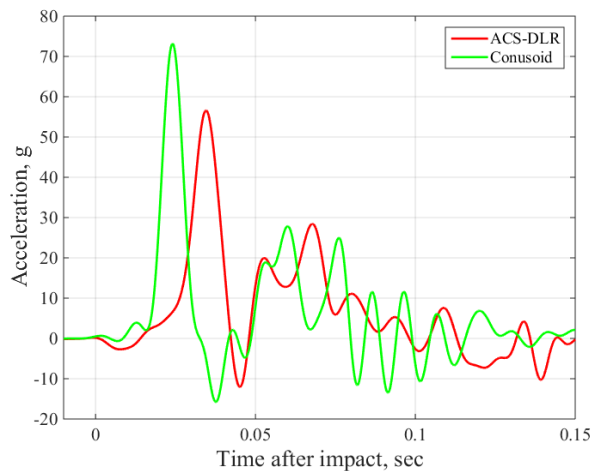
Figure 23. TRACT 2 Mid-Cabin Floor Vertical Accelerations

All accelerations are low-pass filtered to the SAE J211 standard, using a Channel Frequency Class (CFC) 60 (Ref. 13) for vehicle accelerations. Vertical acceleration plots near the cabin floor centerline reveal the lack of subfloor energy absorption and load path distribution seen in TRACT 1. Figure 23 shows the vertical accelerations above the ACS-DLR subfloor and the conusoid. Peak accelerations are 70-g at the conusoid and 55-g at the ACS-DLR subfloor and the durations are approximately 0.015-seconds. By contrast, the TRACT 1 accelerations were less than 40-g.

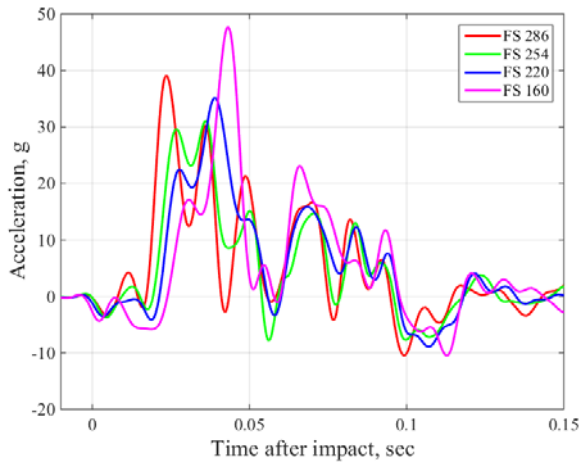
Figure 24. TRACT 2 Mid Cabin Frame Vertical Accelerations- Adjacent to Floor

The vertical responses from accelerometers mounted on cabin frames are plotted in Figure 24 and 25. Figure 24 shows the vertical accelerations on the frames at floor-height. Figure 25 shows the vertical accelerations on the frames at window height. The acceleration profiles are similar to TRACT 1, ranging from 20-g to 40-g and a duration of 0.080-seconds. As the airframe pitches over from initial contact, there is a negative component of acceleration which increases going forward in the cabin. This negative component is evident in

the acceleration response of FS 160 at plot around 0.020-seconds, as shown in Figure 24.

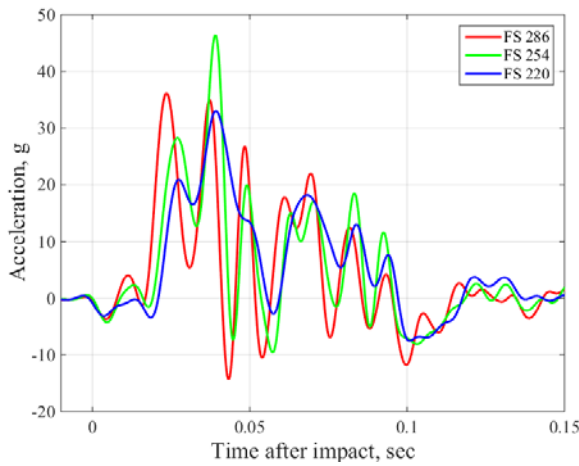
Figure 25. TRACT 2 Vertical Accelerations- Sidewall

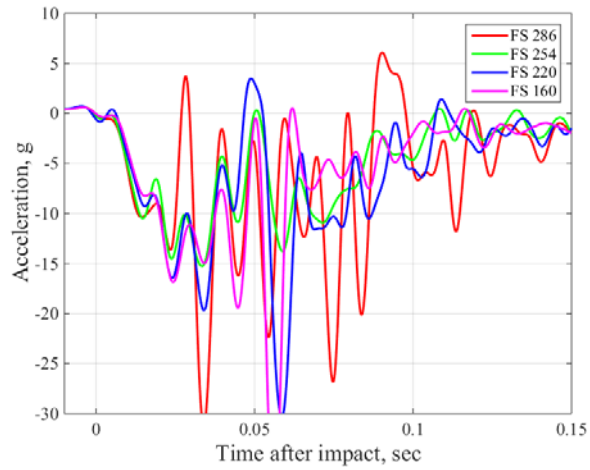
Figure 26. TRACT 2 Cabin Frame Longitudinal Accelerations- Adjacent to Floor

The longitudinal accelerations as recorded by accelerometers mounted on cabin frames are plotted in Figure 26. The acceleration traces are similar to TRACT 1 in duration, but the magnitudes range from 15-g to 30-g for TRACT 2 which is higher than the 10-g average peak for TRACT 1.

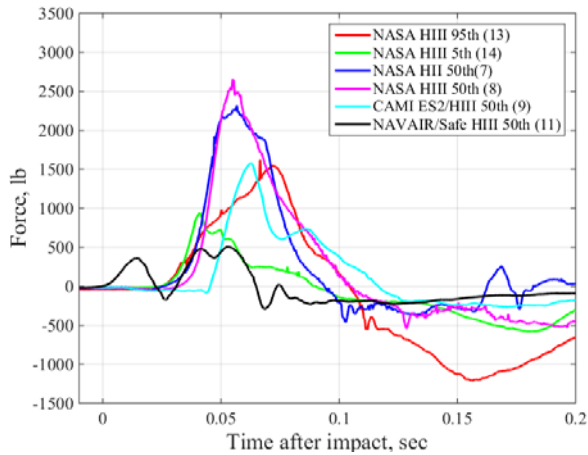
Figure 27. TRACT 2 Cabin ATDs, Lumbar Load

The resulting occupant responses are best explained with a plot of lumbar load versus time. Figure 27 shows lumbar load which has been low-pass filtered using CFC 1000. A compression force is defined to be positive. The NASA ATDs are on lap-belted passenger seats. The CAMI and NAVAIR/Safe ATDs are on energy absorbing troop seats with five-point harnesses. The lumbar loads for the two NASA 50th ATDs exceed 2,300-lb, well above the 1,500-lb lumbar load limit for seat certification. The lumbar loads for the 5th female and 95th male are 936-lb, and 1,544-lb, respectively. There is not a specific FAA lumbar load requirement defined for 5th and 95th ATDs. However, the DOD has recommended injury limits of 1,281 lb. for the 5th female and 2,534 lb. for the 95th male (ref. 14). The DOD recommendations for the 50th ATD are scaled up relative to the FAA requirement. Therefore, equivalent civilian requirements for the 5th and 95th would likely be lower. It is apparent that lumbar loads for the 5th female and 95th male are near or below injury tolerance levels. Of note, the 5th and 95th ATD lumbar loads transition from compression to tension because of the forward torso flail. The lumbar loads for the CAMI and NAVAIR/Safe ATDs are 1,581-lb and 509-lb, respectively. The CAMI ATD is at the tolerance level, while the NAVAIR/Safe ATD is well below.

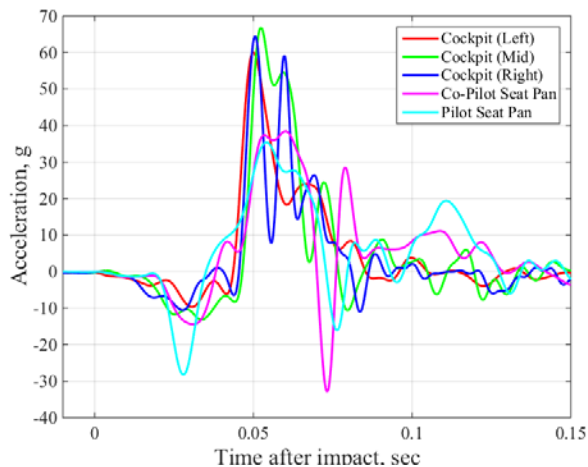
Figure 28. TRACT 2 Vertical Accelerations- Cockpit

The vertical accelerations on the cockpit floor under the pilot and co-pilot seats, within the center console, and on the seat pans are shown in Figure 28. The negative accelerations due to the airframe pitching over are greater than 10-g. The peak loads on the floor are 60-g to 70-g with a duration of 0.050-seconds. The energy absorbing seats attenuate the loads, with seat pan loads peaking around 35-g.

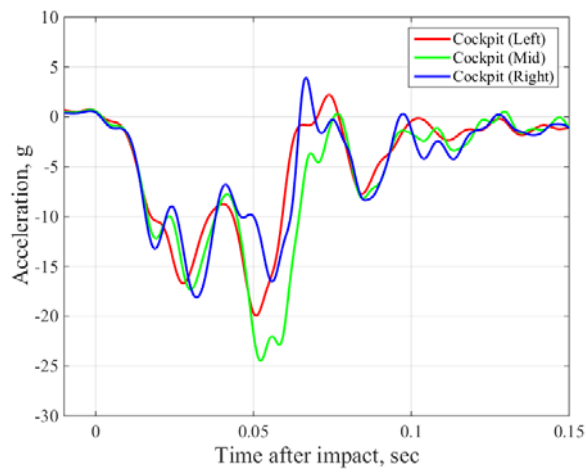
Figure 29. TRACT 2 Longitudinal Accelerations- Cockpit

The longitudinal cockpit accelerations on the cockpit floor under the pilot and co-pilot seats and within the center console are plotted in Figure 29. The accelerations are consistent with the rest of the airframe with peaks of 15-g to 20-g and durations of 0.100-seconds

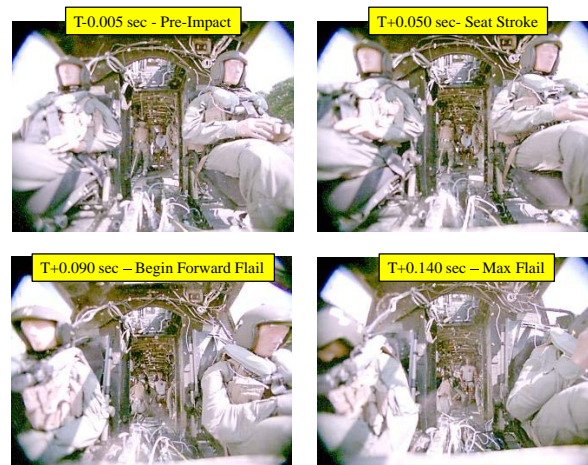
Figure 30. TRACT 2 Cockpit- Impact Sequence

The response of the pilot and co-pilot ATDs is shown with time lapse photos in Figure 30. Just after tail impact, the ATDs elevate out of their seat due to the negative acceleration, then re-contact the seat at 0.050-seconds. The torsos begin to pitch forward at 0.090-seconds. Maximum flail occurs at 0.140-seconds.

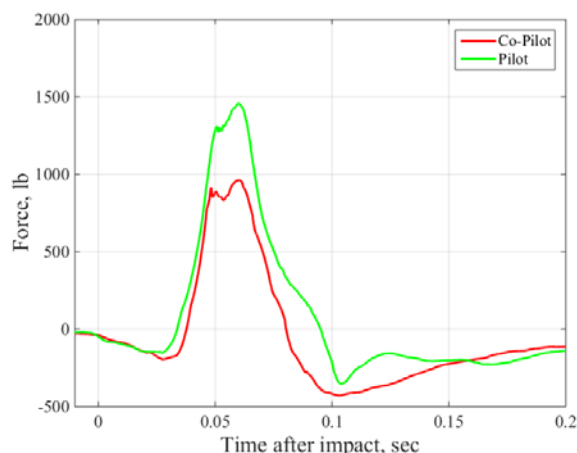
Figure 31. TRACT 2 Co-Pilot and Pilot Lumbar Loads

The lumbar loads for the pilot and co-pilot are filtered to CFC 1000 and plotted in Figure 31. Both lumbar loads are within the DOD limit of 2,096-lb, indicating good performance by the crew seat energy absorbers. The peak co-pilot load was 900-lb, and the peak pilot load was 1,450-lb. The lumbar loads are lower than those seen by the co-pilot and pilot in TRACT 1, where lumbar loads were 2,200-lb and 1,500-lb, respectively. In both TRACT 1 and TRACT 2, there were significant differences between the pilot and co-pilot lumbar loads. This may be attributed to the changing positions of the ATDs as the seat strokes, and also the distribution of loads

between their pelvis and feet. The lumbar loads are in tension as the ATDs flail forward.
