NASA/TM-2016-218974

Compressive Testing of Stitched Frame and Stringer Alternate Configurations

A series of single-frame and single-stringer compression tests were conducted at NASA Langley Research Center on specimens harvested from a large panel built using the Pultruded Rod Stitched Efficient Unitized Structure (PRSEUS) concept. Different frame and stringer designs were used in fabrication of the PRSEUS panel. In this report, the details of the experimental testing of single-frame and single-stringer compression specimens are presented, as well as discussions on the performance of the various structural configurations included in the panel.

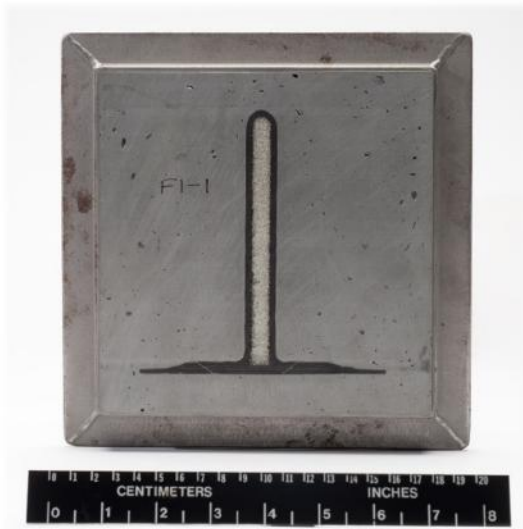
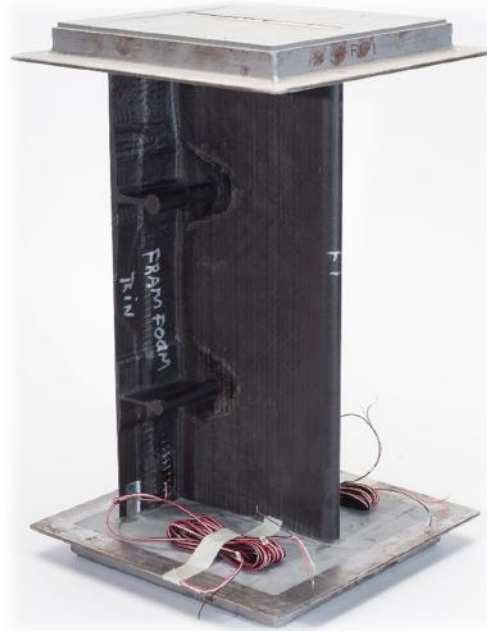
Figure 7: Foam-filled frame specimen F1-1.

Twelve single-frame compression specimens were harvested from the alternate center keel panel. For each of the three frame configurations, two specimens were cut to a width of 5.7 inches and two specimens were cut to a width of 10.0 inches. The frame specimens are each 16.0 inches in length, and contain two stringers. Examples of the F1, F2, and F3 single-frame compression specimens are shown in figures 7, 8, and 9, respectively.

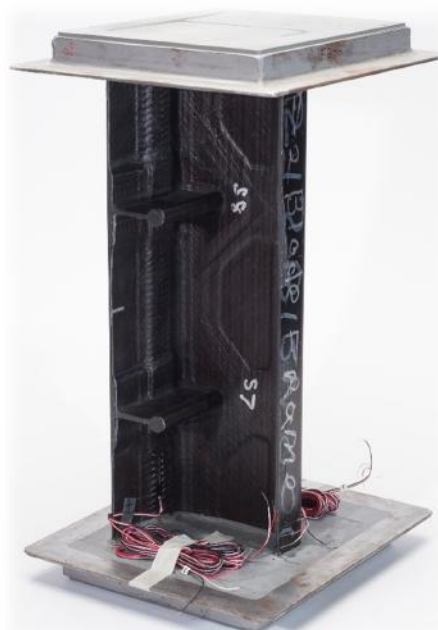
Figure 8: Tapered-blade frame specimen F2-2.

For the F2 specimens, a combination of the built-up thickness around the stringer keyhole (visible in figure 8) and the through-the-thickness stitching prevented the failure path from passing through the keyhole. Instead, the observed failure paths connected the minimum gauge sections of the frame web and the stringer flange edges. The final F2 stiffener damage passed either between the two stringers (e.g., figure 19c) or between the potting and a stringer (e.g., figure 19d). The

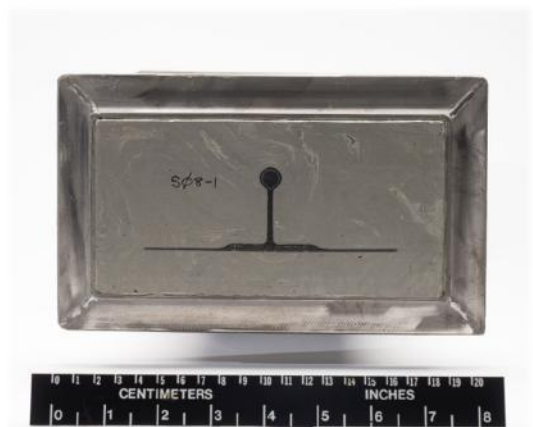
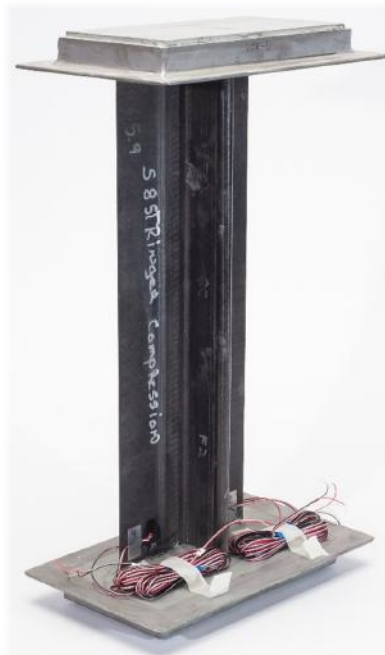
Figure 10: Stringer specimen S08-1.

Ten single-stringer compression specimens were harvested from the alternate center keel panel. The stringer specimens are each 5.90 inches in width and 17.5 inches in length. An example of a single-stringer compression specimen is shown in figure 10. The numbering of the single-frame compression and single-stringer compression specimens and the locations from which they were taken in the alternate center keel panel are shown in figure 4.

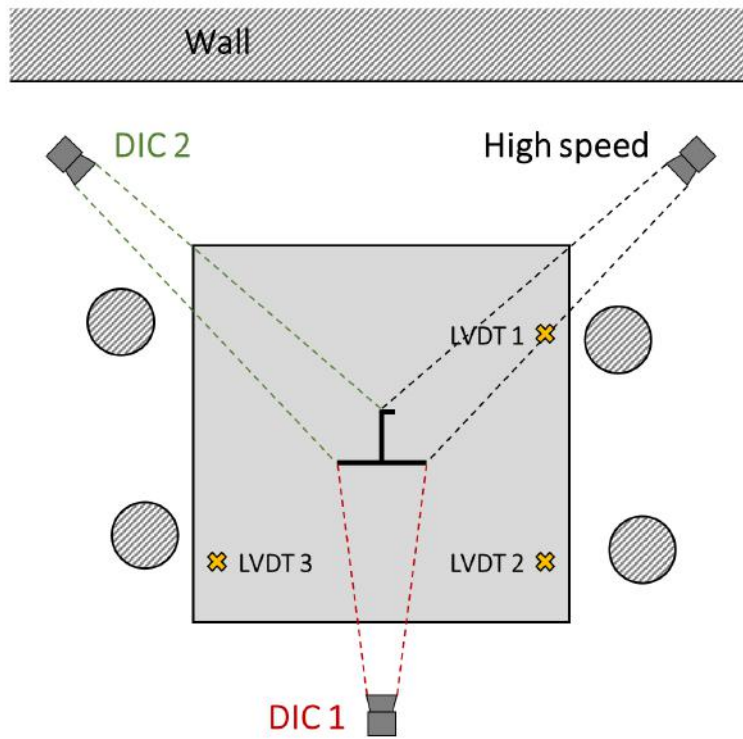
Figure 13: Measurement systems setup from the top-down view of the load frame.

Two three-dimensional digital image correlation (DIC) systems were used to monitor the full-field deformation of the specimens during testing. The first DIC system (DIC 1 in figure 13) was equipped with Point Grey Grasshopper 5.0MP monochrome cameras, and was used to monitor the OML surface. Twenty-three-millimeter (mm) lenses were used during the frame compression tests and 17-mm lenses were used during the stringer compression tests. The second DIC system (DIC 2 in figure 13) was equipped with Point Grey Flea 2G 5.0MP monochrome cameras with 35-mm lenses, and was used to monitor one side of the stiffener. For the F2 and F3 single-frame compression specimens, the second DIC system monitored the flat side of the stiffener. During the tests, the out-of-plane displacement and loading direction strain were monitored to check for buckling and local material failure, respectively. Images were captured at a rate of one frame per two seconds. Prior to testing, the regions to be monitored by the DIC systems were spray painted with a flat, black-on-white speckle pattern, typical of DIC setups. The regions monitored by the two DIC systems were illuminated with white light-emitting diode (LED) lights during the tests.

A Vision Research Phantom v311 digital high-speed camera was used to monitor one side of the stiffener, positioned opposite the second DIC system. A 28-mm Schneider lens was used. Because the exact location of failure was a priori unknown, the full lengths of the frame and stringer specimens were monitored during loading. The image capture rates varied from 60,000 to 100,000 frames per second, depending on the field of view required for each specimen type. Prior to testing, the region to be monitored by the high-speed camera was spray painted with a flat white paint to allow for easier detection of surface cracks. The region monitored by the high-speed camera was illuminated with red LED lights. In order to avoid light leakage between the high-speed camera setup and the second DIC setup, a cardboard partition was placed between them and attached to the top of the stiffeners.

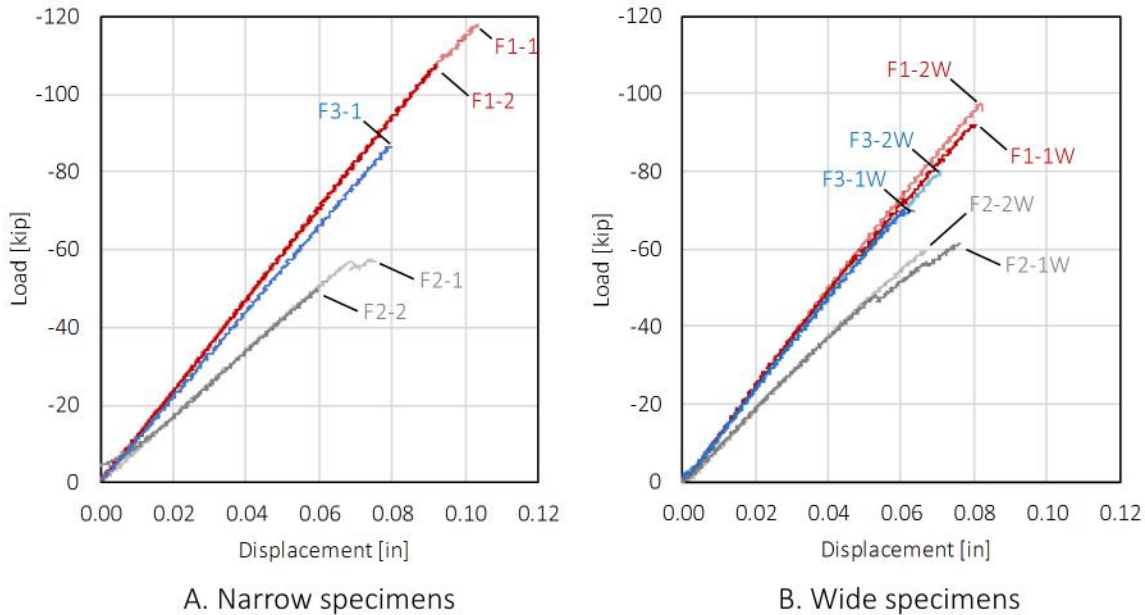
Figure 14: Frame compression specimen load-displacement responses.

The load-displacement histories for each of the tested single-frame compression specimens are shown in figure 14. The displacement in figure 14 is the displacement at the center of the top load platen, calculated using the positions and measured displacements of the three LVDTs. None of the specimens exhibited any major load drops prior to failing, with the exceptions of specimens F2-1 and F2-1W. All of the narrow frame specimens exhibited linear load-displacement behavior up to initial failure. Some load-displacement nonlinearity occurred in the wide F1 and F3 specimens beyond -60 kips, and beyond -30 kips in the wide F2 specimens.

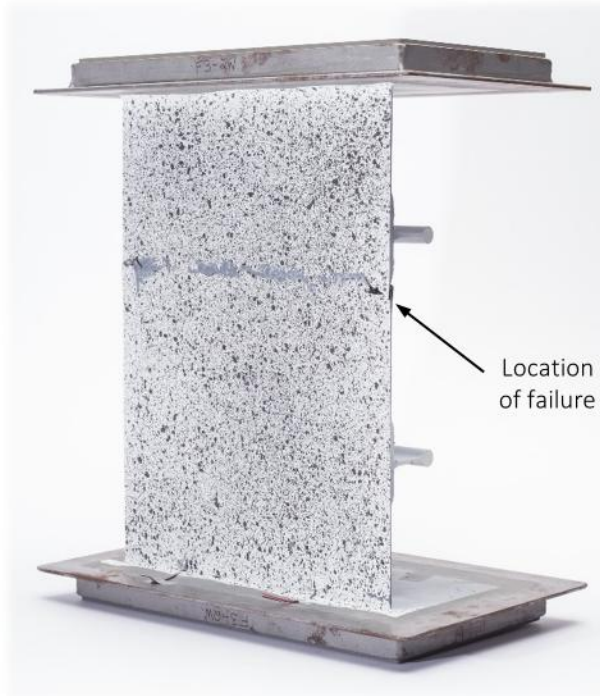
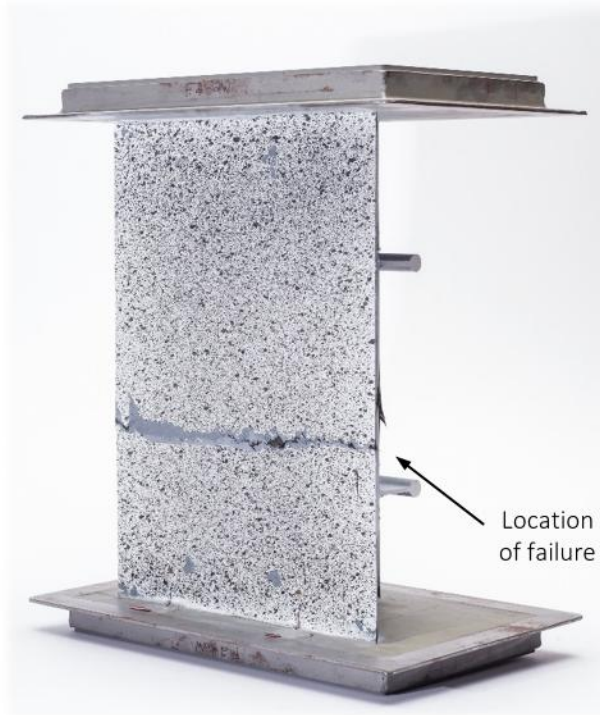
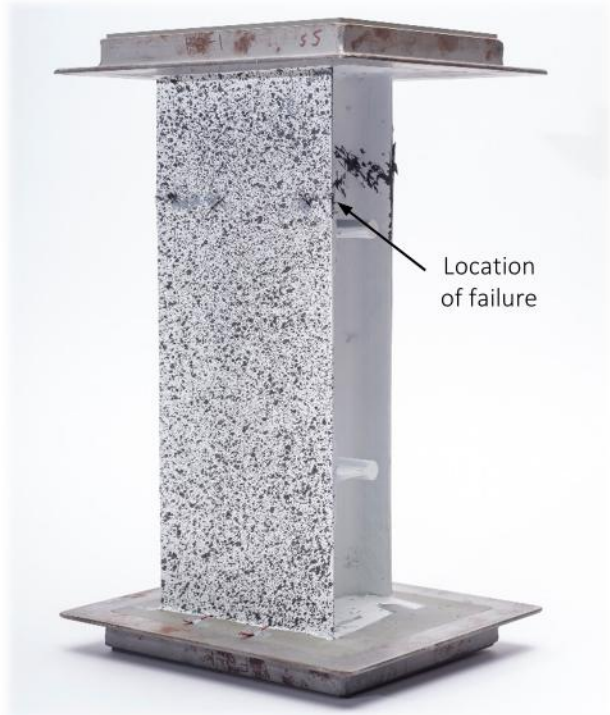
Figure 18: Locations of failure in the skins of a representative set of frame compression specimens, OML view.

The exact location and path of the final specimen failures varied across specimen configurations and across replicates. However, in all cases, the final damage state within the skin extended the full width of the specimen along either the edge of a stringer flange or beneath one-half of a stringer flange (e.g., figure 18); no dominant failures occurred in the skin between the stringers.

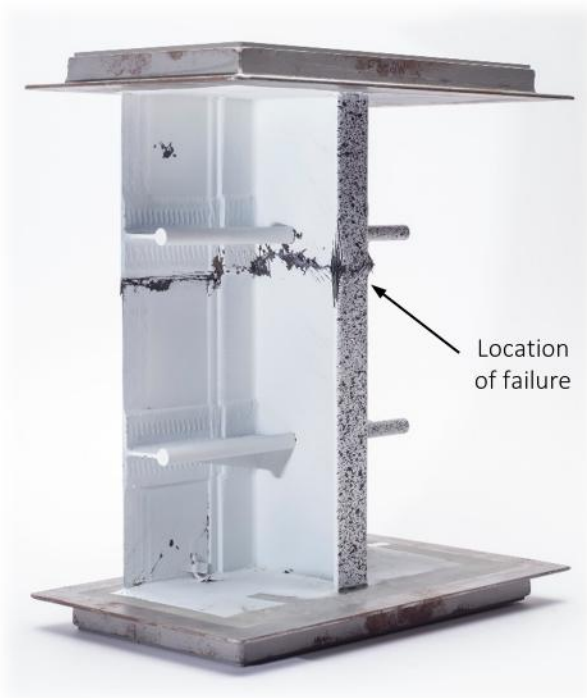
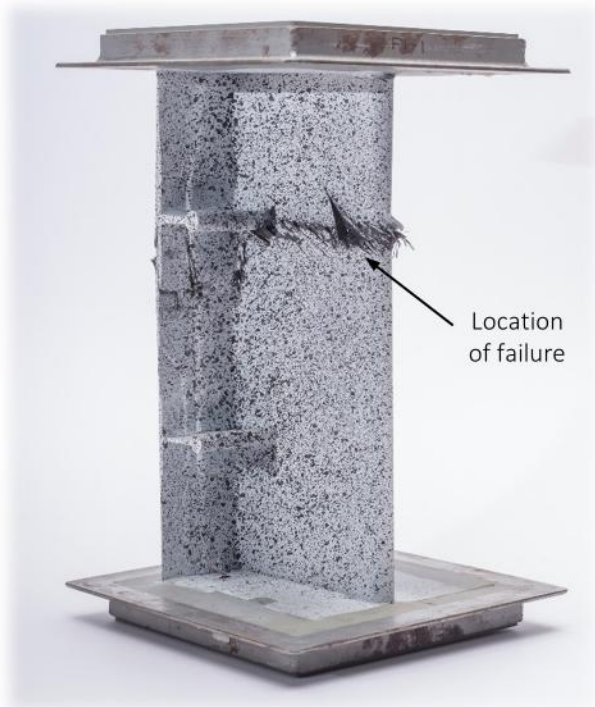
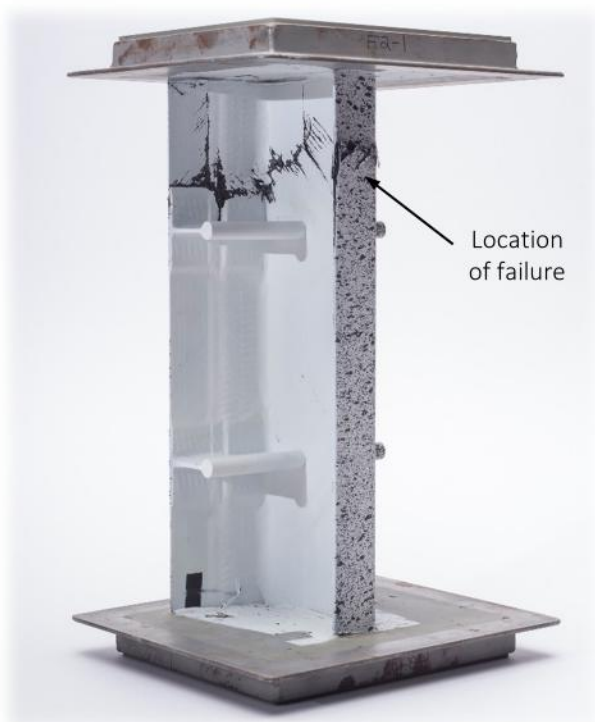
Figure 19: Locations of failure in the stiffeners of a representative set of frame compression specimens, IML view.

For the F1 and F3 specimens, the failure path in the stiffener tended either to be coplanar with the skin failure (e.g., figure 19a), or to pass through the stringer keyhole (e.g., figure 19b). For all of the F1 and F3 failures which were captured via the high-speed camera system, the failures originated at the root of the frame near the frame/stringer intersections, and propagated up the frame web. The failure process of specimen F3-2W is representative of the F1 and F3 specimens,

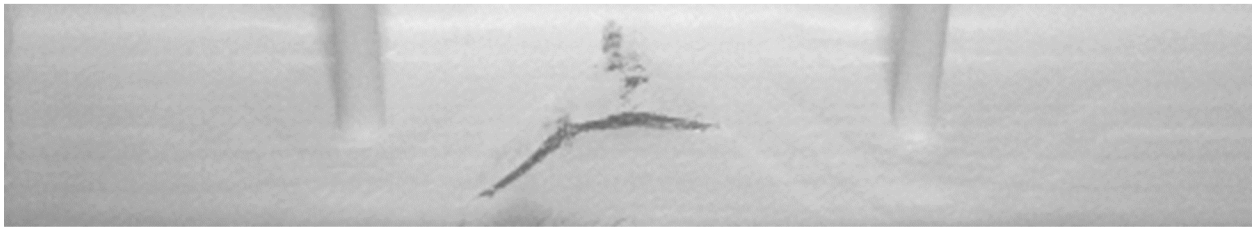
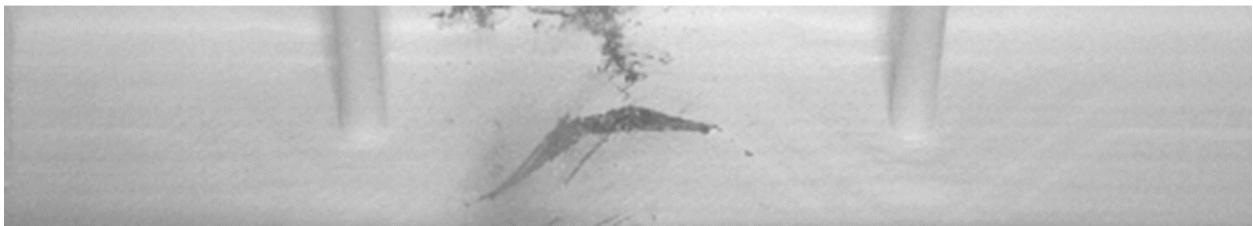
Figure 21: High-speed photography images of the failure of specimen F2-2W. Stitch lines are located along the stack terminations in the web.

failure process of specimen F2-2W is representative of the F2 specimens, and is shown in figure 21. Damage was observed to initiate along the edge of the minimum-gauge region of the F2 frame web (figure 21b) and propagate along the stitch line along the stack termination in the frame web (figure 21c). The stitch line temporarily arrested the damage propagation (figure 21d) before ultimate failure (figure 21e).

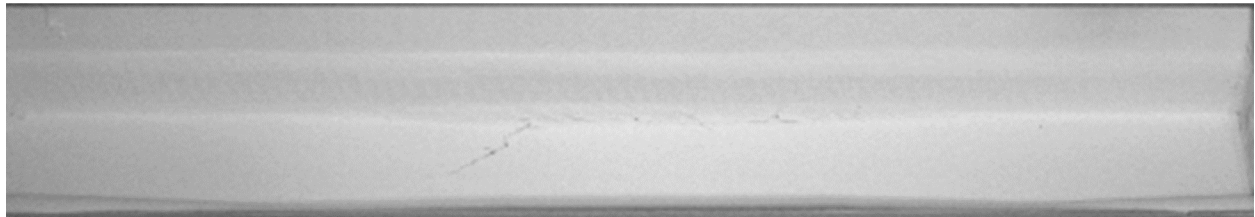
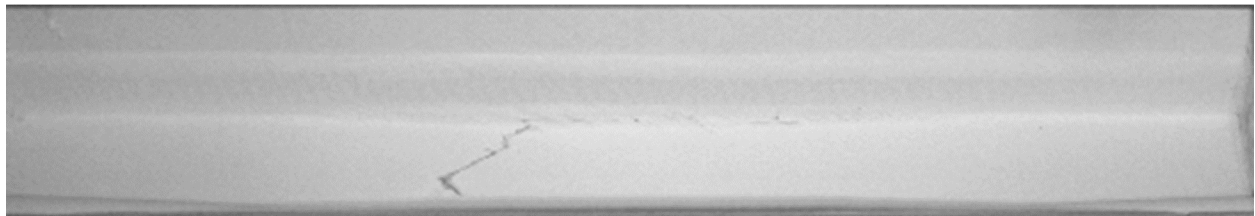
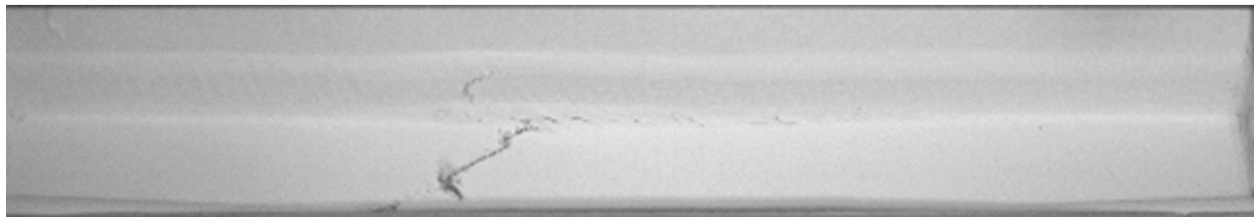
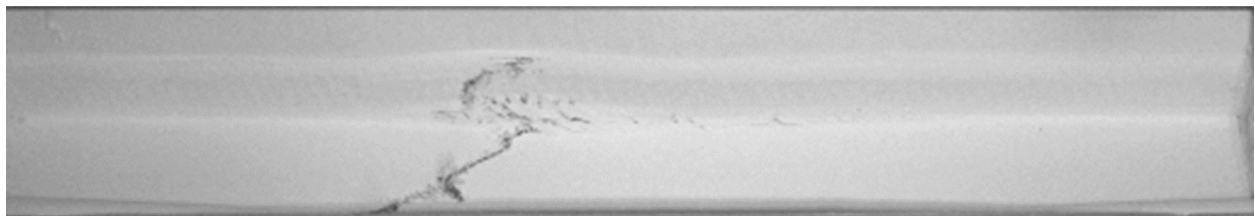
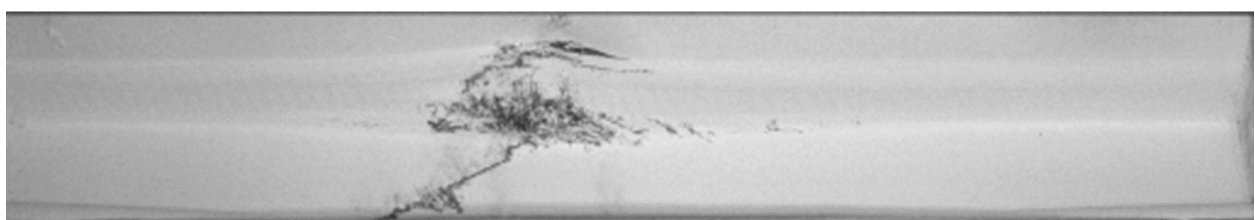
Figure 25: High-speed photography images of the failure of specimen S04-1.

The high-speed digital camera results revealed that the failures in the stringer specimens originated either at the fillets at the base of the stringer web or along the edges of the stringer flange. An example of failure propagation originating at the base of the stringer web is shown in figure 25 for specimen S04-1. The stiffener in specimen S04-1 buckled toward the second DIC system, causing the stringer rod to be out of frame at the bottom of the images in figure 25. Damage propagated from the base of the stringer web up toward the rod before also propagating through the skin. The damage in the stringer web propagated up and around the rod in most cases, though the rod itself was not observed to break.
