Overview of the Transport Rotorcraft Airframe Crash Testbed (TRACT) Full Scale Crash Tests

Martin Annett

NASA Langley Research Center

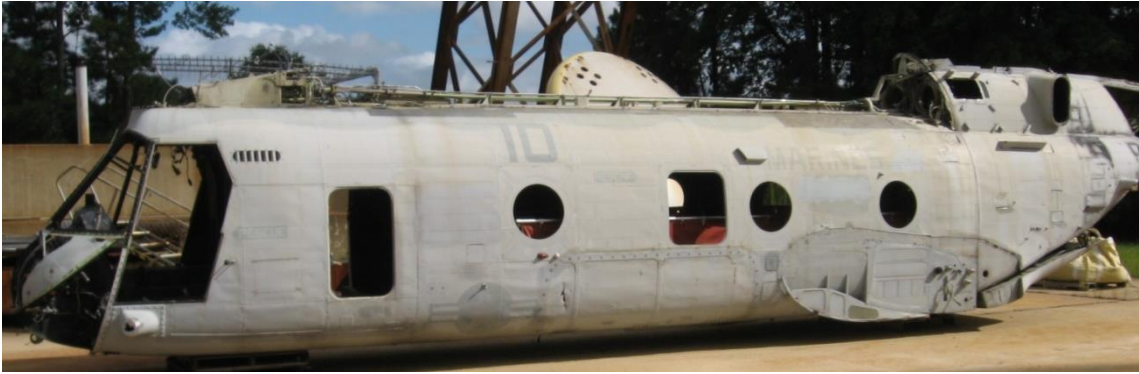
Figure 2. CH-46E Airframe

Two CH-46E airframes were obtained from the Navy CH-46E Program Office (PMA-226) at the Navy Flight Readiness Center in Cherry Point, North Carolina. The CH-46E airframe was chosen as a candidate testbed because of its common applicability as a medium-lift rotorcraft with airframe dimensions comparable to a regional jet or business jet. The CH-46E airframe design is semi-monocoque with skin stiffeners and frame sections. The cabin airframe cross section is nearly uniform from fuselage stations (FS) 190 to 320, and is composed primarily of aluminum 2024 and 7075 alloys. The CH-46 has no keel beam and its longitudinal stiffness comes from the floor and cargo rails. A photograph of one of the CH-46E airframes is shown in Figure 2.

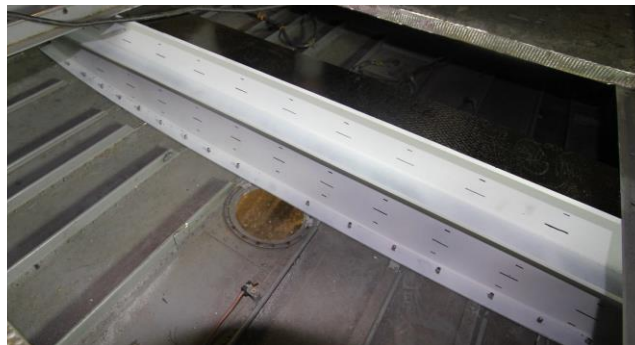
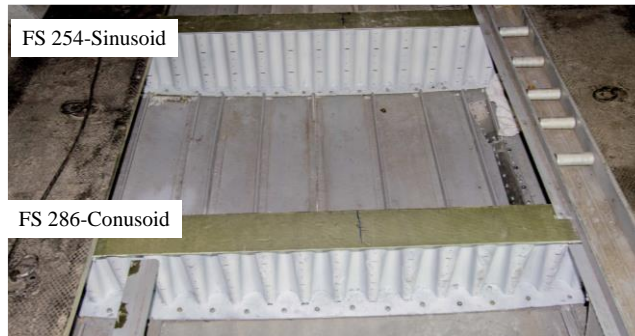
Figure 9. Composite Subfloor Retrofit for TRACT 2

The three composite subfloor designs are shown installed within the subfloors of the TRACT 2 test article in Figure 9. The honeycomb sandwich floor sections that cover the composite shear panels were modified to include three polycarbonate windows. High speed cameras were installed just above the three windows to capture video of the impact behavior. The window and floor configuration is shown in Figure 10.

(a) ACS-DLR Composite Subfloor

(b) NASA Composite Subfloors

ACS and DLR developed a third composite subfloor made of carbon fiber and containing a stiff upper shear web and a crushable lower web. The ACS-DLR subfloor was installed at FS 220. The two NASA subfloors were installed at FS 254 and 286.

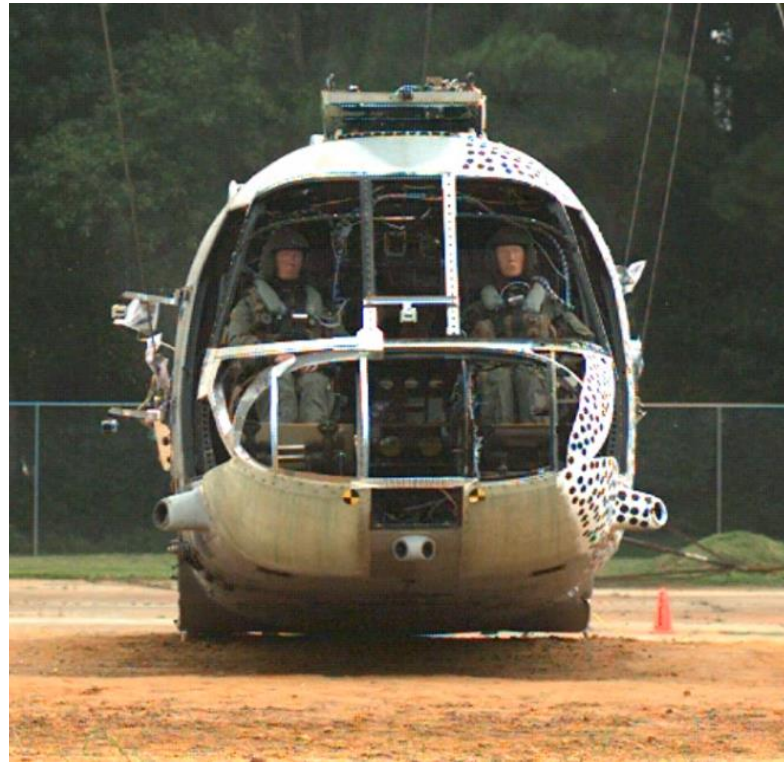
Figure 11. TRACT 1 Front View, Prior to Impact

The TRACT 1 test was conducted on 28 August 2013. The vertical and horizontal impact velocities were 25.0- and 33.0-ft/sec, respectively. Figure 11 shows

the front view of TRACT 1 prior to impact. The airframe impacted the soft soil with a 2.5-degree nose-up pitch attitude, and less than 1.0-degree yaw to the right. Only airframe accelerations/loads will be reported. Information on particular experimental results can be found in [8] and [10].

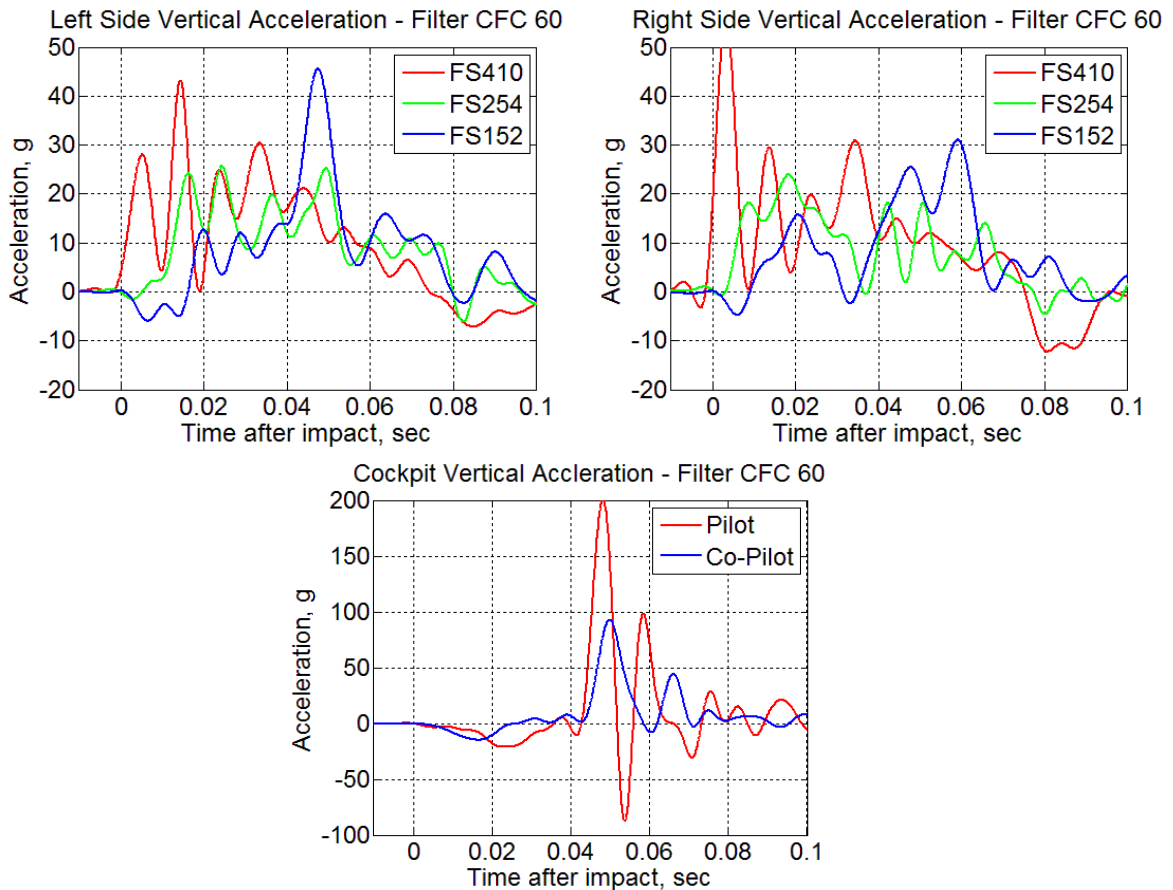
Figure 14. Vertical Floor-Level Acceleration Results for the Left and Right Sides of the Cabin and the Cockpit

Given the nose-up pitch attitude at impact, it is expected that the onset of acceleration would occur first for FS 410, next for FS 254, and last from FS 152. The data shown in Figure 14 confirm this. The left side acceleration responses range in peak magnitude between 25- and 45-g with durations of approximately 0.08 seconds. The right side responses range in peak magnitude between 22- and 55-g with a duration of approximately 0.08 seconds. At FS 152, there is a noticeable negative component of acceleration before 0.03 seconds as the test article pitches down. The behavior is more pronounced in the pilot and co-pilot responses. The co-pilot and pilot responses have very high magnitude oscillations after slam down at 0.04 seconds. There is a large difference between the co-pilot and the pilot responses because of the locations of the accelerometer blocks on the thin-walled floor.

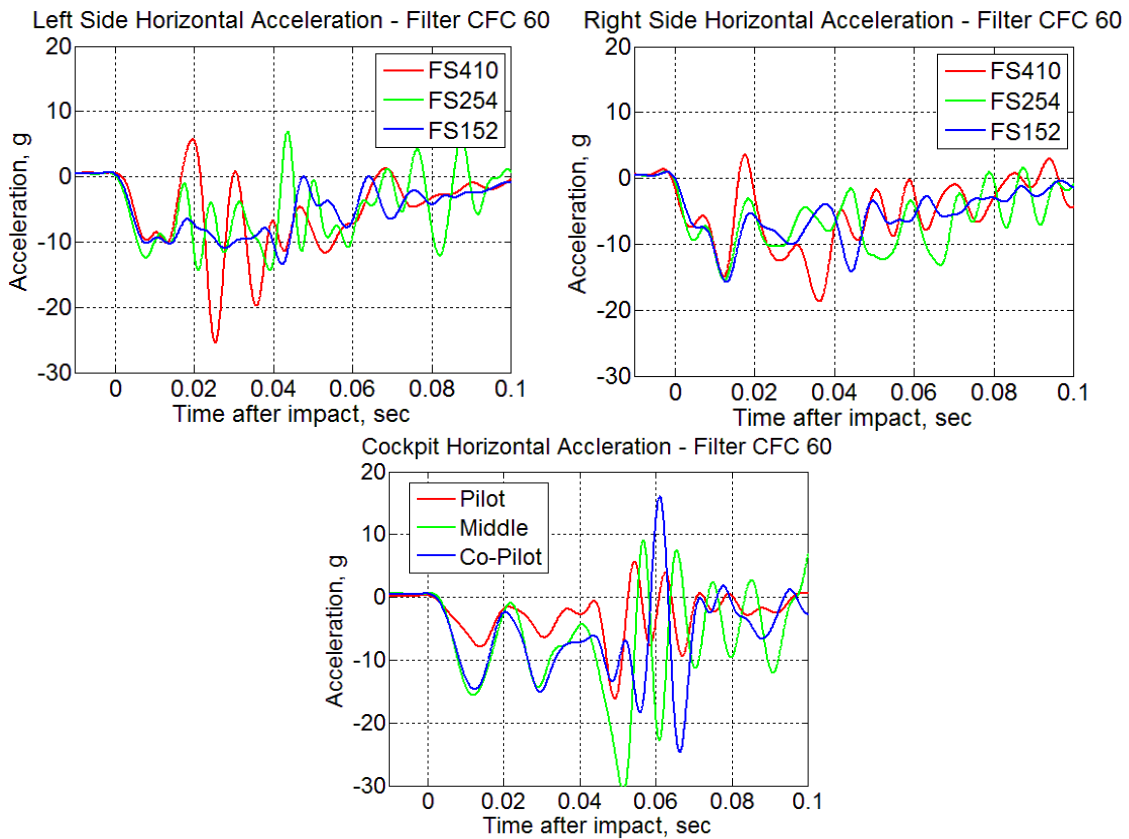
Figure 15. Horizontal floor-level acceleration responses

Horizontal acceleration time history responses are shown in Figure 15, along with a fuselage schematic showing instrumentation locations. Three plots are shown for the left and right sides of the airframe, and for the cockpit. Each of the curves shows a similar response, with average magnitudes of approximately 10-g. The entire aircraft begins to horizontally decelerate within the first 0.005 seconds. The magnitude of the peak horizontal acceleration is approximately 30-g; however, most traces are lower.

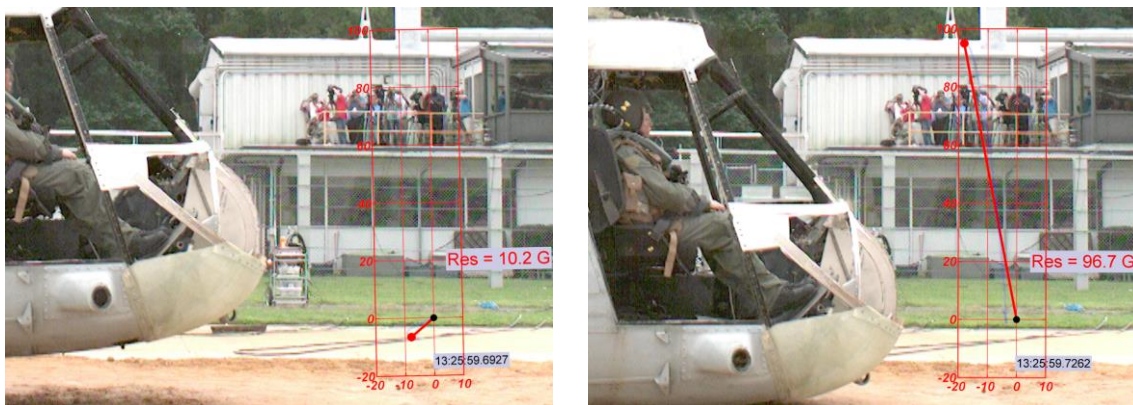
Figure 16. Cockpit resultant acceleration

The orientations and magnitudes of the resultant accelerations just before and after cockpit belly impact are illustrated in Figure 16. In Figure 16a, the orientation of the airframe deceleration is pointed to the aft and down. The pilot and co-pilot excursions are in the opposite direction, upward and forward. The magnitude of the negative component is approximately 10-g during nose over. In Figure 16b, after

cockpit belly impact, the acceleration is directed up and slightly aft with a magnitude greater than 95-g.

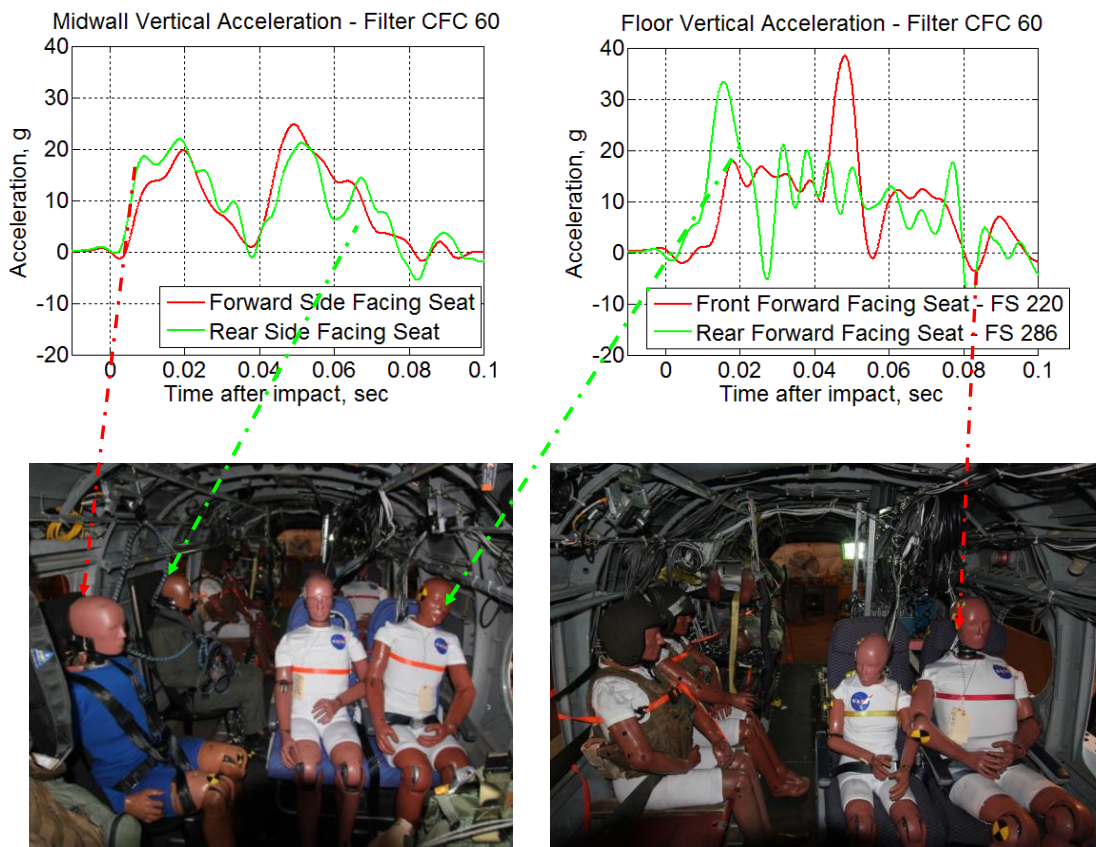
Figure 17. Cabin vertical acceleration responses at seat attachment locations

Cabin mid-wall and floor vertical acceleration responses are shown in Figure 17, along with photographs indicating the locations of instrumentation. The mid-wall traces

indicate two peaks, the first having a magnitude of approximately 20-g and the second having a magnitude of 25-g. The floor traces are from the two pair of forward facing seats. Whereas the mid-wall traces were very similar, the floor traces are opposite to one another. The forward seat exhibits a 15-g uniform acceleration response, which suddenly increases near the end of the pulse to a peak of 38-g. Conversely, the rear seat exhibits an initial peak of 34-g, which is reduced to a relatively uniform 15-g response that decays near the end of the pulse. Both responses have durations of approximately 0.08 seconds.

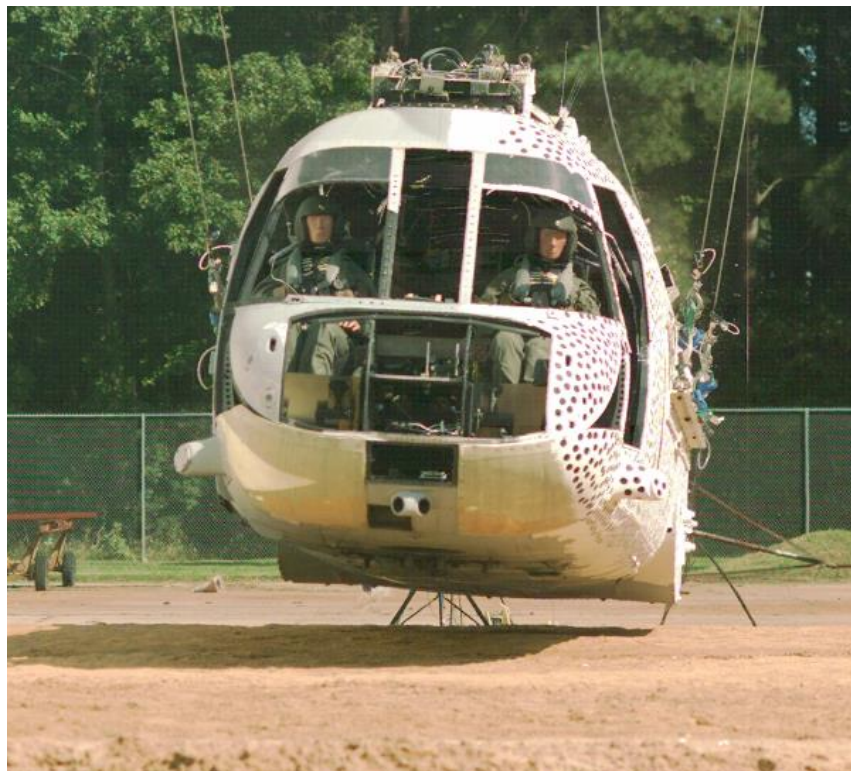
Figure 18. TRACT 2, Front View, Prior to Impact

The TRACT 2 test was conducted on 1 October 2014. Figure 18 shows the TRACT 2 orientation just prior to impact. The vertical and horizontal impact velocities

were 25.4- and 33.7-ft/sec, respectively. The airframe impacted the soft soil with a 2.5-degree nose-up pitch attitude, and a 3.6 degree roll to the left, and a 2.5-degree yaw to the right. The aft left side impacted initially. The roll and yaw angles were significantly higher than TRACT 1. A time lapse photo sequence from an external high-speed camera is shown in Figure 19. The region forward of the stub wing box begins to crush 0.016-seconds after impact. Cockpit touchdown occurs at 0.045-seconds. At 0.055-seconds, the subfloor skin between FS 190 and FS 220 begins to dimple inwards. The aft cabin and tail rebounded starting at 0.090-seconds, and reached maximum rebound height at 0.280-seconds. This rebound height was about 30% lower than the rebound height seen in TRACT 1. Following the second contact of the cabin belly on the soil, the test article came to rest abruptly at 0.53-seconds.

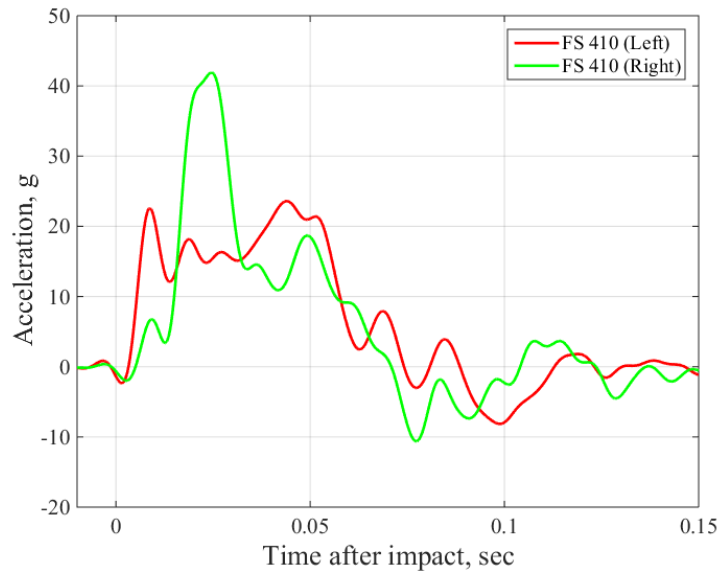
Figure 23. TRACT 2 Aft Cabin Frame Vertical Accelerations- Adjacent to Floor

The region in the aft section of the cabin was expected to sustain high vertical accelerations with the initial impact occurring on the aft left side. Figure 23 shows the vertical accelerations at FS 410 near the floor. The left side of FS 410 was the location of the NAVAIR/Penn State cargo restraint experiment and the right side of FS 410 was where the USAARL patient litter experiment was located. The vertical acceleration at FS 410 (L) is a sustained 20-g load over 0.050-seconds, while FS 410 (R) shows a peak of 41-g occurring at 0.025-seconds after impact as the airframe rolled right. The crushing behavior of the left side of the aft cabin was comparable to an energy absorber.

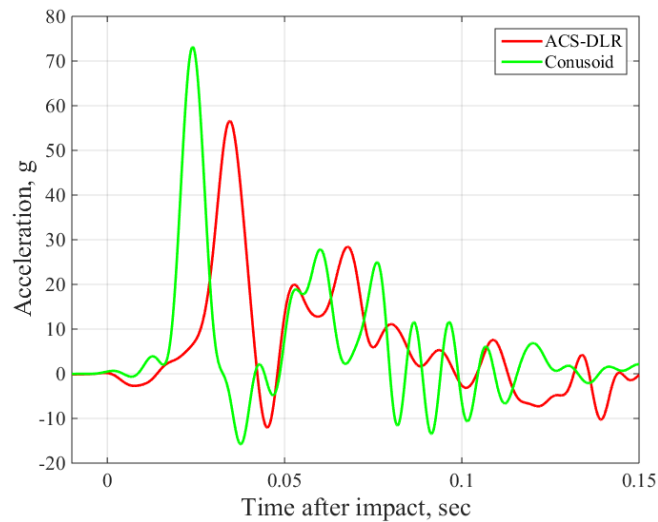
Figure 26. TRACT 2 Mid-Cabin Floor Vertical Accelerations

All accelerations are low-pass filtered to the SAE J211 standard, using a Channel Frequency Class (CFC) 60 [19] for vehicle accelerations. Vertical acceleration plots near the cabin floor centerline reveal the lack of subfloor energy absorption and load transfer seen in TRACT 1. Figure 26 shows the vertical accelerations above the ACS-DLR subfloor and the conusoid. Peak accelerations are 70-g at the conusoid and 55-g at the ACS-DLR subfloor and the durations are approximately 0.015-seconds. By contrast, the TRACT 1 accelerations were less than 40-g.

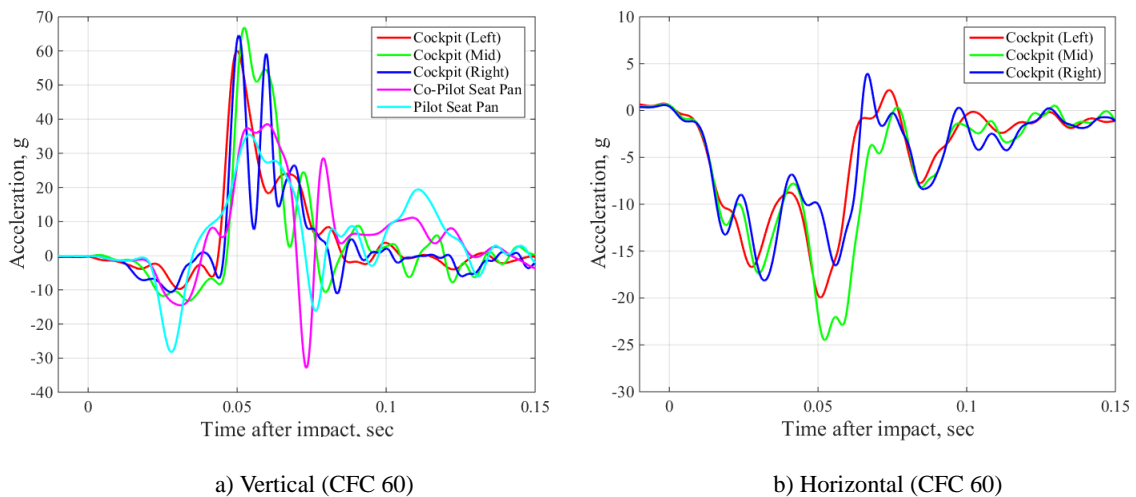
Figure 29. TRACT 2 Cockpit Accelerations- Cockpit

The vertical accelerations on the cockpit floor under the pilot and co-pilot seats, within the center console, and on the seat pans are shown in Figure 29(a). The negative accelerations due to the airframe pitching over are greater than 10-g. The peak loads on the floor are 60-g to 70-g with a duration of 0.050-seconds. The energy absorbing seats attenuate the loads, with seat pan loads peaking around 35-g.

The horizontal cockpit accelerations on the cockpit floor under the pilot and co-pilot seats and within the center console are plotted in Figure 29(b). The accelerations are consistent with the rest of the airframe with peaks of 15-g to 20-g and durations of 0.100-seconds

The vertical decelerations within the cabin were similar to TRACT 1 and varied from 20- to 50-g. The 2.5-degree pitch up attitude caused the cockpit to accelerate downward just prior to belly contact. Vertical seat pan accelerations exceeded 60-g due to the weaker cockpit structure.
