Summary of Full-Scale Blade Displacement Measurements of the UH-60A Airloads Rotor

Anita I. Abrego
Aerospace Engineer

NASA Ames Research Center
Moffett Field, California

Presented at the 2016 AHS Technical Meeting on Aeromechanics Design for Vertical Lift, Fisherman's Wharf, San Francisco, CA, January 20–22, 2016. This is a work of the U.S. Government and is not subject to copyright protection in the U.S. All rights reserved.

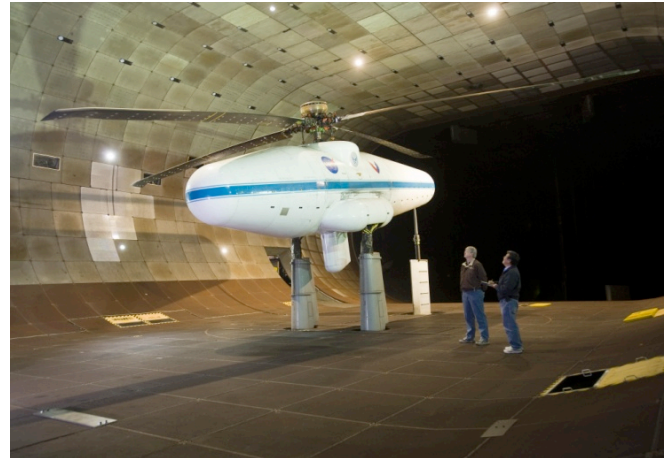
Figure 1. UH-60A Airloads rotor installed on the Large Rotor Test Apparatus (LRTA) in the NFAC 40- by 80-Foot Wind Tunnel.

The 2010 Airloads test conducted in the NFAC 40- by 80-Foot Wind Tunnel used a Sikorsky Aircraft UH-60A rotor system mounted on the NASA Large Rotor Test Apparatus (LRTA) as seen in Fig. 1. The closed test section consists of semicircular sides and closed-circuit air return

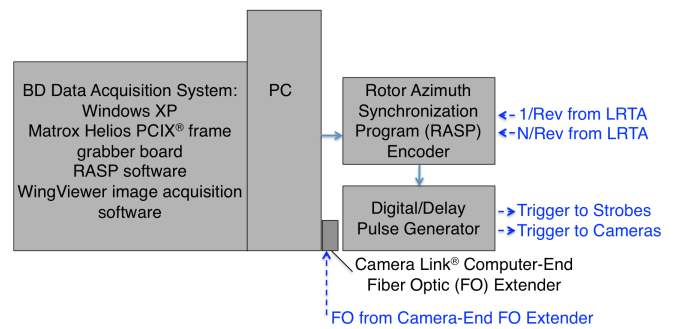
Figure 13. Master BD data acquisition system computer room components.

The BD image acquisition hardware consisted of components in both the wind tunnel computer room and in the test section viewports. The data acquisition system consisted of four PC's running Windows XP Professional®, each with a Matrox Helios PCIX® frame grabber board that was interfaced via Camera Link® through fiber optic cables. Due to the extreme distances (> 250 ft) between the cameras and the BD data acquisition system, Camera Link fiber optic extender units, shown in Figure 12, were required to connect data via fiber from the cameras to the PC frame grabber boards. Acquisition software included NASA developed Rotor Azimuth Synchronization Program (RASP) rotor encoder (Ref. 16) and WingViewer image acquisition software (Ref. 17). A digital/delay pulse generator provided the synchronized trigger to the strobes and cameras based on the image acquisition software and RASP selection of azimuth. The master BD data acquisition system configuration, which enabled RASP to control the synchronized strobe, camera, and acquisition triggers to the other three systems, is illustrated in Fig. 13.

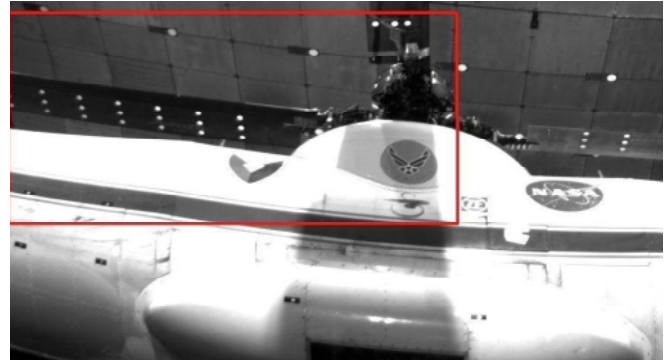
a. Close-up of LRTA with region of interest for Figs. 16b and 16c.

b. Trailing edge targets of Blade 1 are visible.

c. Trailing edge targets of Blade 1 become blocked by the LRTA fuselage.

Figure 16. Example of blade targets blocked by the LRTA fuselage for images from the same data sequence.

become partially blocked, causing the identified centroid locations to be offset. This holds true even near the inboard portion of the rotor blades. Figure 16 is an example where targets may appear in several images of a data set, but then disappear (either fully or partially) in later images of the same sequence. Figure 16a is a long-exposure close-up of the LRTA and inboard portion of the rotor blades with the blade area of interest indicated within the red box. Figures 16b and 16c are two data images from the same image sequence where the trailing edge targets of blade 1 can be seen in Fig. 16b, but are no longer visible in the next image, Fig. 16c. As the blade flaps, the LRTA fuselage

intermittently blocks the trailing edge targets. This is common for the inboard targets and caused difficulty in fully automating the image processing.

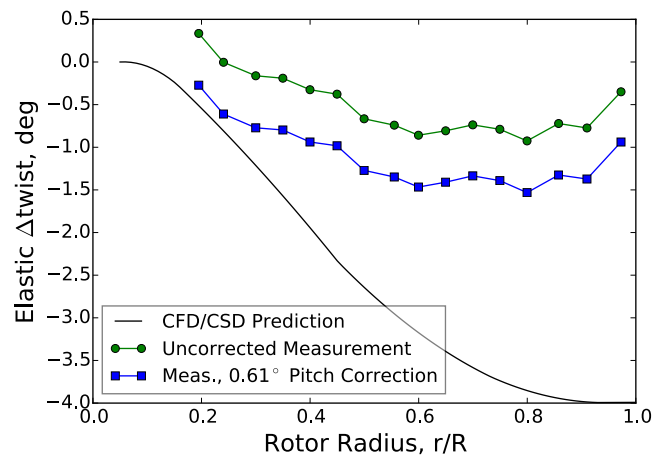
Figure 20. Estimated elastic Δ twist deformations from CFD/CSD and from corrected and uncorrected photogrammetry measurements at three blade-azimuth, ψ , locations for $\mu = 0.30$ and $CT/\sigma = 0.10$.

Figure 20 shows estimated elastic Δtwist deformations from CFD/CSD predictions and from photogrammetry measurements for the same test conditions and blade azimuths as provided in figure 19. For elastic Δtwist deformations, the correction for the registration error due to blade deformation is a correction in the blade pitch angle, which simply shifts the elastic Δtwist values by an offset that is constant over the span of the rotor. Since it is easy to visualize how such offsets would affect the data, percentage variations in the value of the correction, as provided for in figure 19, are not provided. Elastic Δtwist estimates from the photogrammetric measurements have more uncertainty and show more scatter. This is primarily due to the angle measurements being essentially the derivative of measured target positions, whereas the ΔZ values are determined directly from measured target positions after blade orientation transformations are made. In Fig. 20a, the corrected Δtwist measurements for the first three radial stations fall right on top of the CFD/CSD prediction. However, the CFD/CSD prediction shows the Δtwist values becoming increasingly more negative as the radius increases, whereas the measured Δtwist values tend to level out. Changing the value of the correction used would not improve the comparison of the measured values to the CFD/CSD prediction. In Figs. 20b and 20c, a small change in the value of the pitch correction would make the measured Δtwist values better match the CFD/CSD predictions at the inboard stations. However, the CFD/CSD

predictions still show a strong trend of increasingly negative Δ twist values with radial station that is not shown by the measured values.
