Compressive Loading and Modeling of Stitched Composite Stiffeners

Frank A. Leone, Jr.¹, Dawn C. Jegley²
NASA Langley Research Center, Hampton, VA, 23601, USA

A series of single-frame and single-stringer compression tests were conducted at NASA Langley Research Center on specimens harvested from a large panel built using the Pultruded Rod Stitched Efficient Unitized Structure (PRSEUS) concept. Different frame and stringer designs were used in fabrication of the PRSEUS panel. In this paper, the details of the experimental testing of single-frame and single-stringer compression specimens are presented, as well as discussions on the performance of the various structural configurations included in the panel. Nonlinear finite element models were developed to further understand the failure processes observed during the experimental campaign.

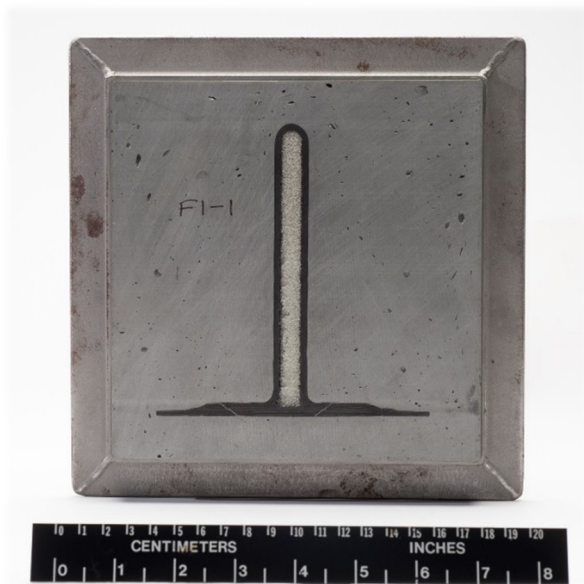
Figure 7. Foam-filled frame specimen (F1-1 is shown).

and F3 single-frame compression specimens are shown in Figs. 7, 8, and 9, respectively.

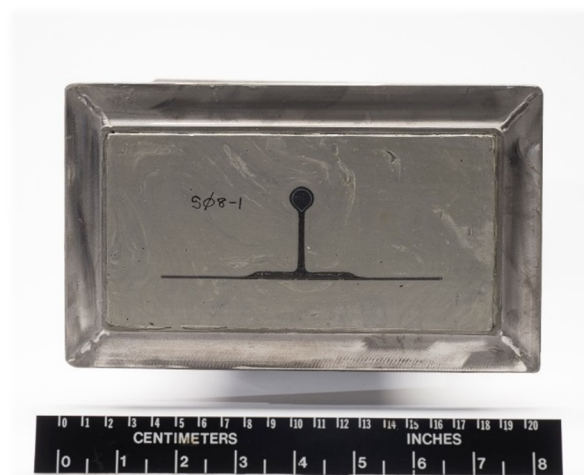
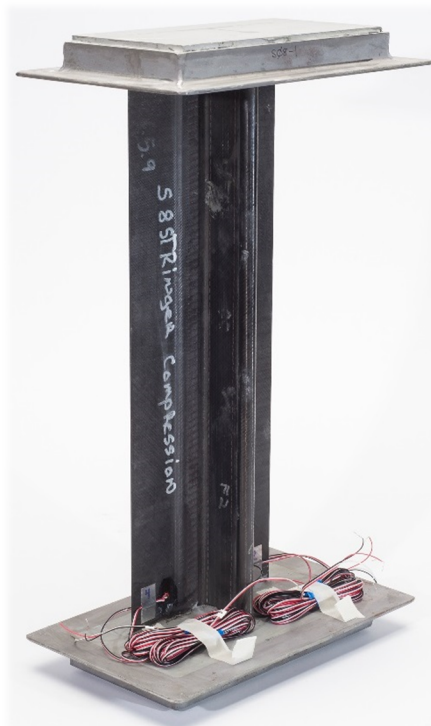
Figure 10. Stringer specimen (S08-1 is shown).

Ten single-stringer compression specimens were harvested from the alternate center keel panel. The stringer specimens are each 5.90 inches in width and 17.5 inches in length. An example of a single-stringer compression specimen is shown in Fig. 10. The numbering of the single-frame compression and single-stringer compression specimens and the locations from which they were taken in the alternate center keel panel are shown in Fig. 4.

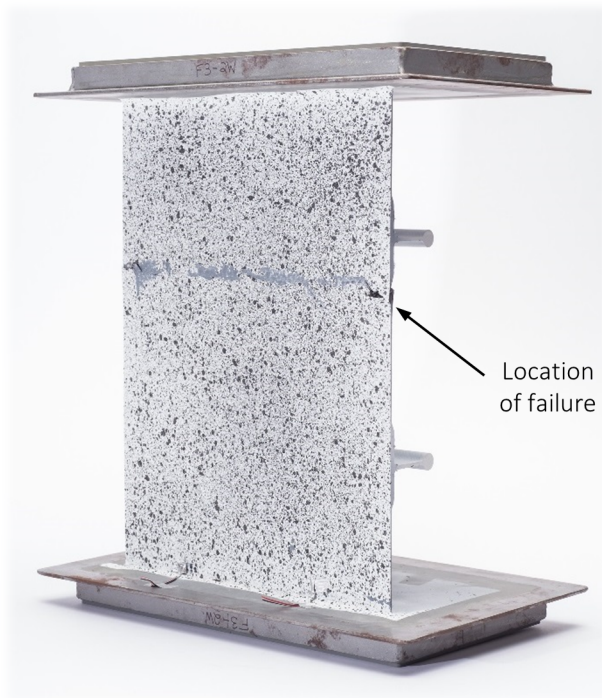
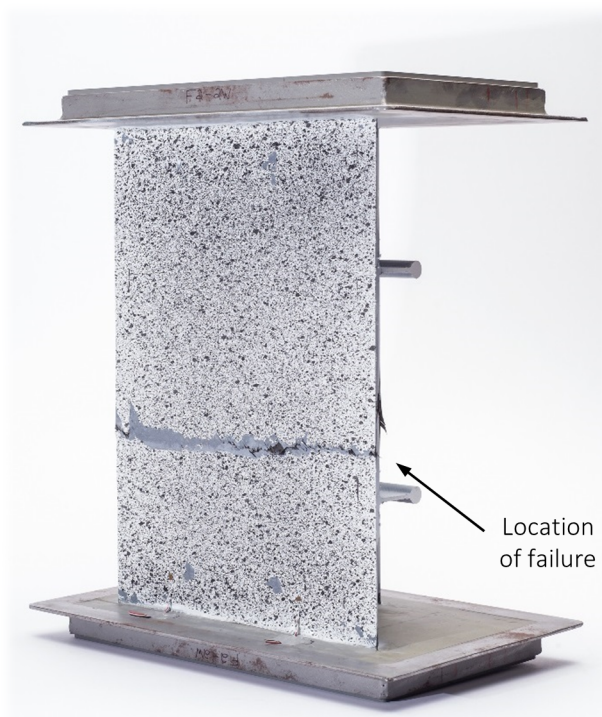
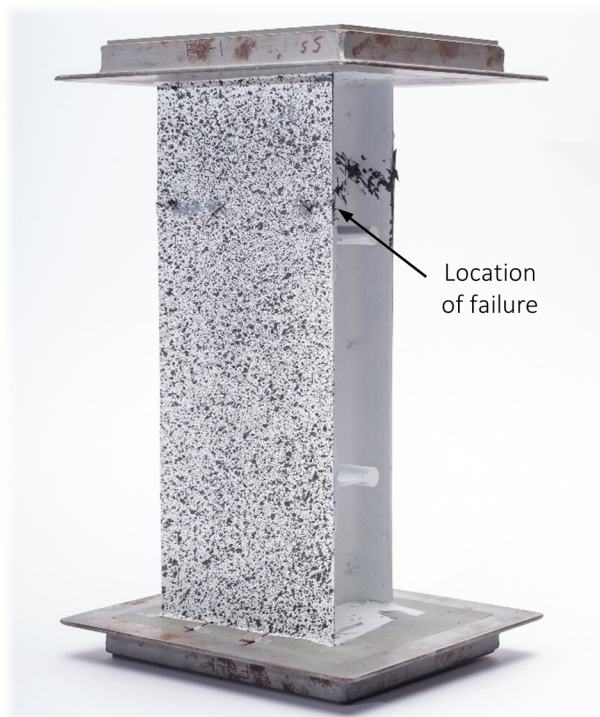
Figure 18. Locations of failure in the skins of a representative set of single-frame specimens, OML view.

The exact location and path of the final specimen failures varied across specimen configurations and across replicates. However, in all cases, the final damage state within the skin extended the full width of the specimen along either the edge of a stringer flange or beneath one-half of a stringer flange (e.g., Fig. 18); no dominant failures occurred in the skin between the stringers.

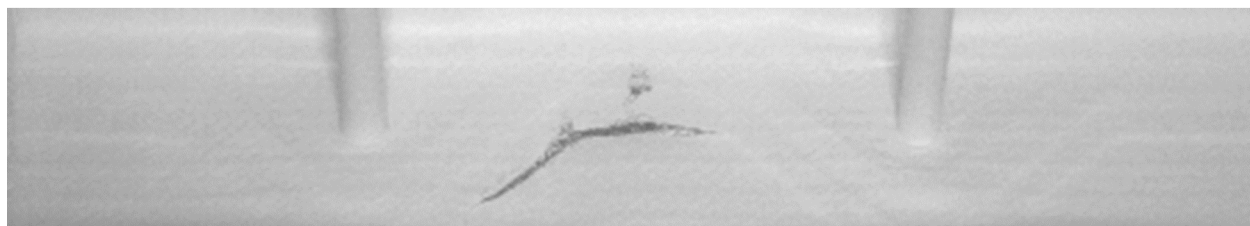
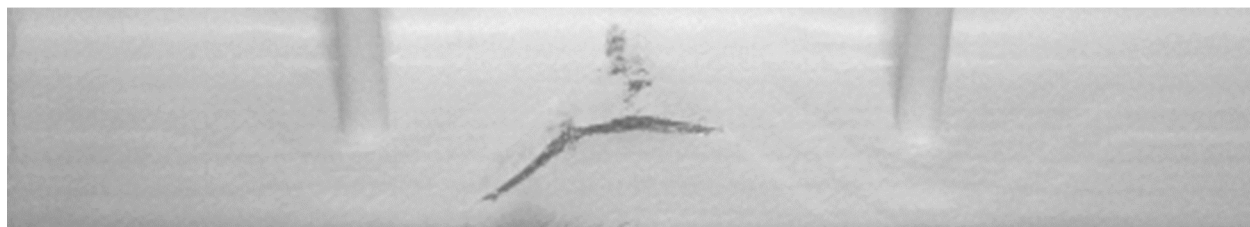
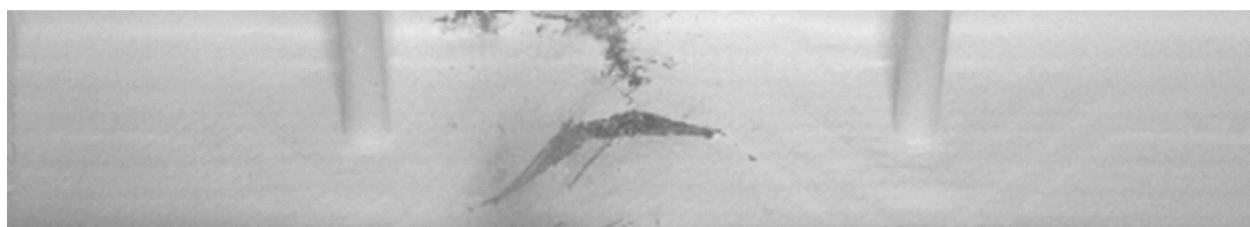
Figure 21. High-speed photography images of the failure of specimen F2-2W.

For the F2 specimens, a combination of the built-up thickness around the stringer keyhole (visible in Fig. 8) and the through-the-thickness stitching prevented the failure path from passing through the keyhole. Instead, the observed failure paths connected the minimum gauge sections of the frame web and the stringer flange edges. The final F2 stiffener damage passed either between the two stringers (e.g., Fig. 19c) or between the potting and a stringer (e.g., Fig. 19d). The failure process of specimen F2-2W is representative of the F2 specimens, and is shown in Fig. 21. Damage was observed to initiate along the edge of the minimum-gauge region of the F2 frame web (Fig. 21b) and propagate along the stitch line along the stack termination in the frame web (Fig. 21c). The stitch line temporarily arrested the damage propagation (Fig. 21d) before ultimate failure (Fig. 21e).

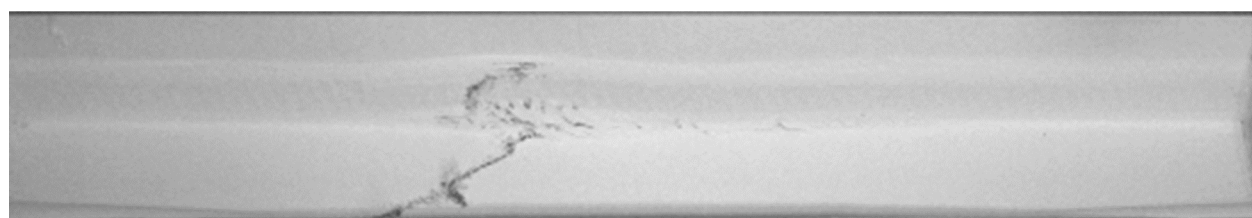
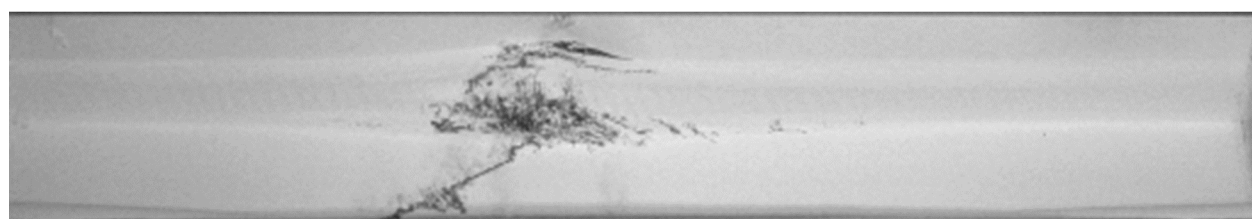
Figure 27. High-speed photography images of the failure of specimen S04-1.

The high-speed digital camera results revealed that the failures in the stringer specimens originated either at the fillets at the base of the stringer web or along the edges of the stringer flange. An example of failure propagation originating at the base of the stringer web is shown in Fig. 27 for specimen S04-1. The stiffener in specimen S04-1 buckled toward the second DIC system, causing the stringer rod to be out of the camera frame at the bottom of the images in Fig. 27. Damage propagated from the base of the stringer web up toward the rod before also propagating through the skin. The damage in the stringer web propagated up and around the rod in most cases, though the rod itself was not observed to break.

The predicted load-displacement response of the S07 stringer configuration model is shown in Fig. 28. Like the frame analyses, the stiffness of the single-stringer compression analysis overpredicted the experimental stiffness, likely due to overly stiff boundary conditions. Buckling was predicted to occur at approximately -37 kips applied load. This prediction is in good agreement with the average buckling load of -33.4 kips from the S07 and S08 stringer specimen tests reported in Table 2. After buckling, the model predicted the lateral displacement of the rod and overwrap to be approximately 0.12 inch at the center of the specimen, as shown in Fig. 29. The buckling of the stringer caused significant bending rotations at the two fillets located at the base of the stringer web. The bending at the base of the stringer web caused the 90° -direction stresses to exceed the compressive allowable shortly after buckling, as shown in Fig. 30. At the next solution increment, the 90° -direction stresses on the other side of the stringer web were predicted to exceed the tensile allowable. This prediction of damage initiating at the base of the stringer web agrees with the failure processes observed experimentally via high-speed video, e.g., Fig. 27.
