Overview of Fatigue and Damage Tolerance Performance of SLM Alloy 718

Kristin Morgan
MSFC Science and Technology Office
kristin.l.morgan@nasa.gov
256-544-1025

Douglas Wells
MSFC Damage Tolerance Branch
douglas.n.wells@nasa.gov
256-544-3300

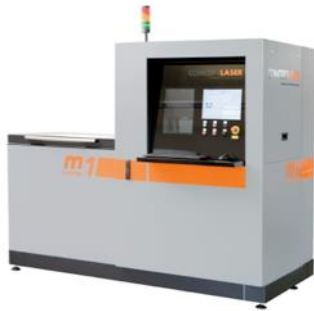
M1

Procured 2015

Build envelope
250 x 250 x 250 mm

Laser system
Fiber laser 400 W

No glovebox

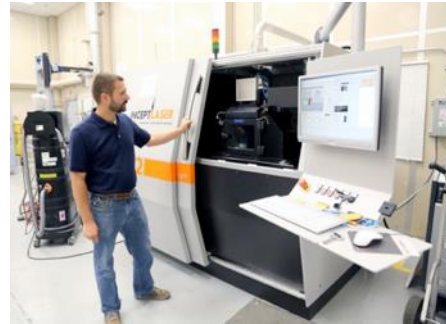
M2

Procured 2012

Build envelope
250 x 250 x 280 mm

Laser system
Fiber laser 400 W

Inert atmosphere
glovebox

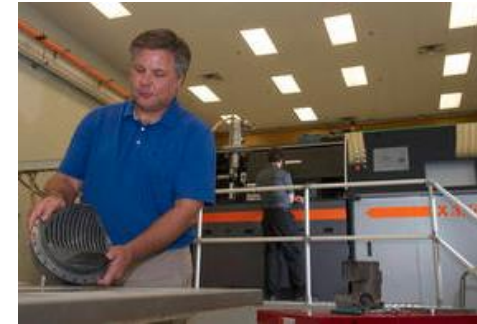
XLine 1000R

Procured 2015

Build envelope:
630 x 400 x 500 mm

Laser system:
Fiber laser 1 kW

Inert atmosphere
glovebox

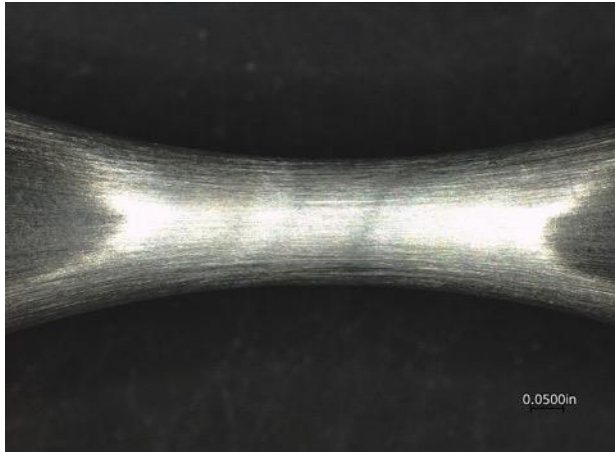
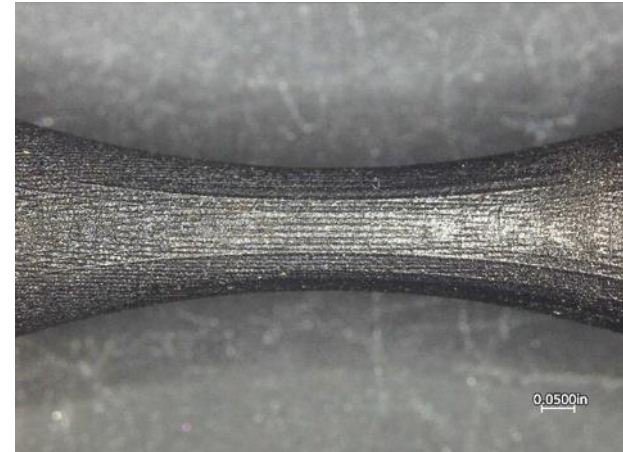
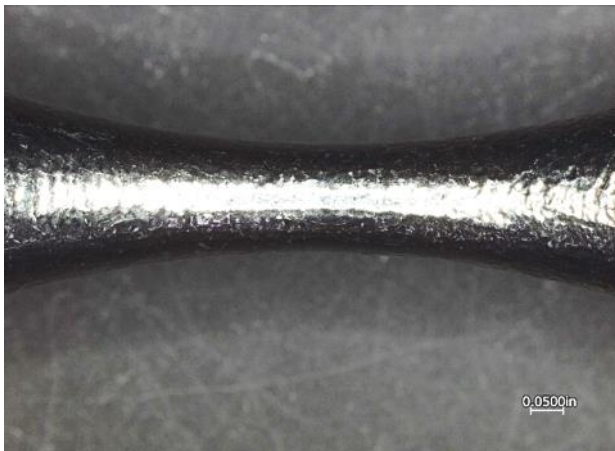
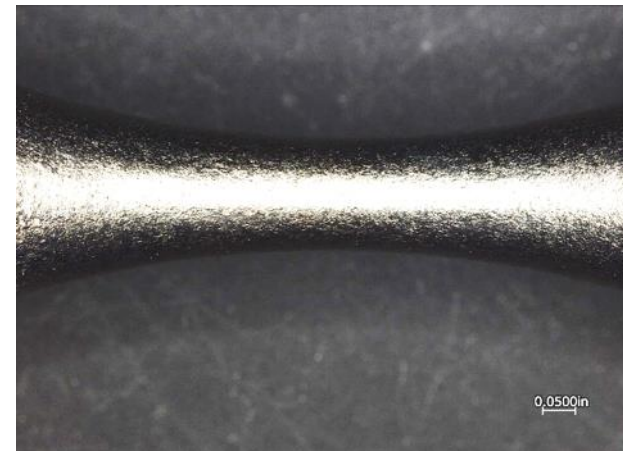
Fatigue life decreases with increasing surface roughness.

Low stress ground

As-built

Tumbled & Electropolished

Tumbled & Chem Milled

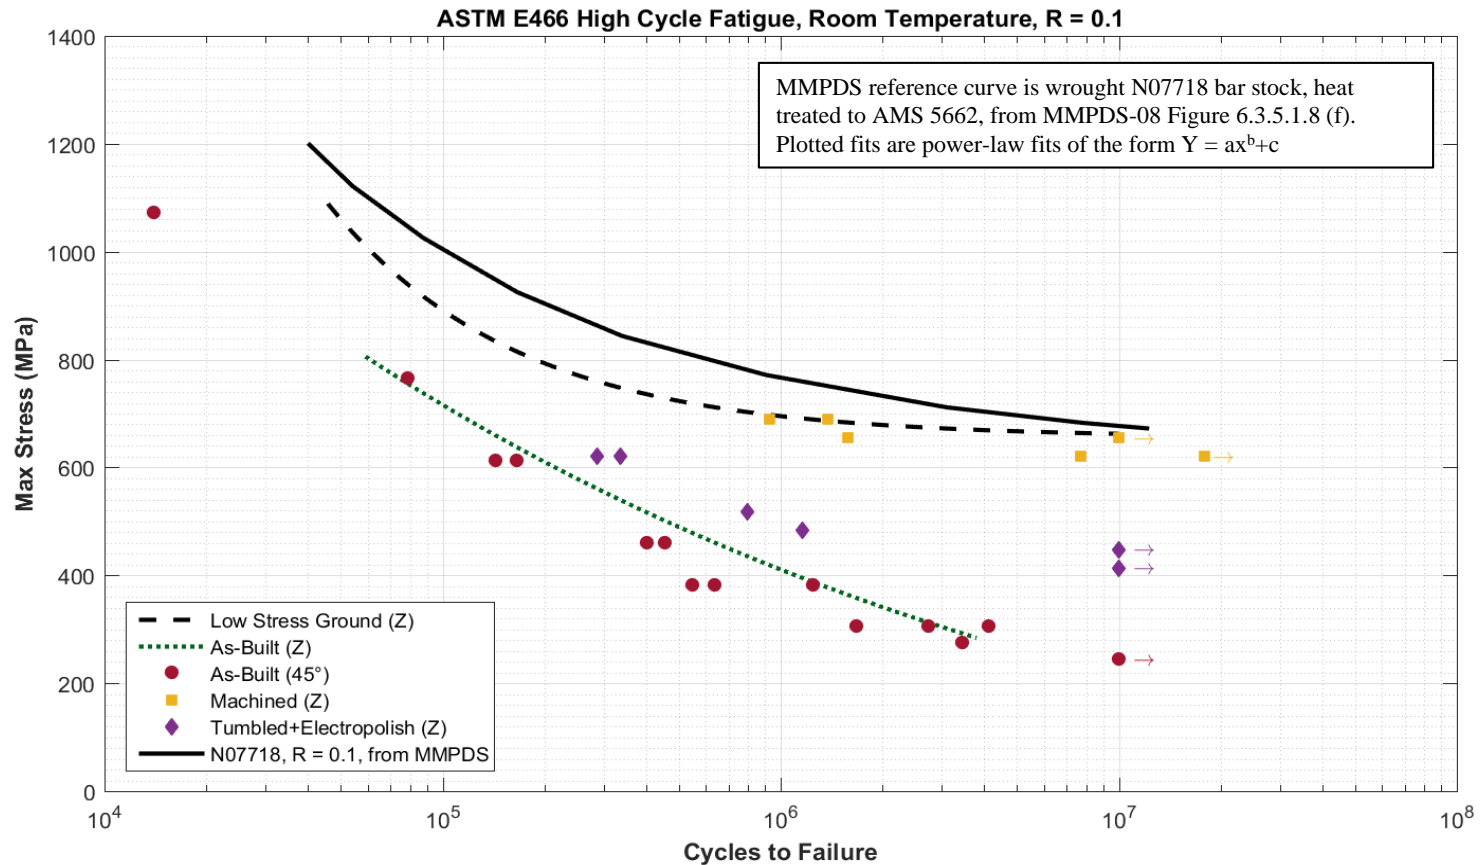
Z-oriented, tumbled then electropolished.
