Practical Applications of Cables and Ropes in the ISS Countermeasures System

Cherice Moore¹

Johnson Space Center, National Aeronautics and Space Administration, Houston, TX 77058

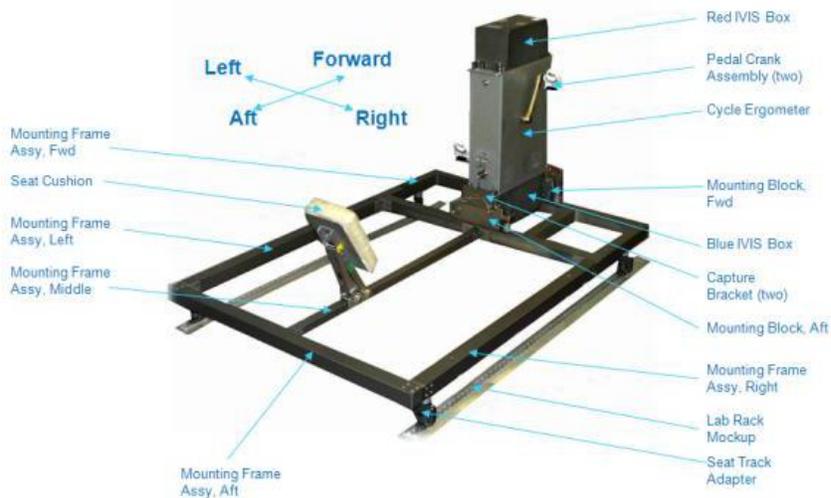
While the TVIS provides the ability to run or walk in microgravity, the CEVIS system provides cycling aerobic exercise, in either a recumbent or upright posture. CEVIS is also used for pre-breathe operations prior to an Extravehicular Activity (EVA), periodic fitness evaluations, and pre-landing fitness evaluations. The CEVIS Ergometer can be controlled electronically via protocols in a control panel, or it can be manually controlled by the subject. The Control Panel displays real-time subject data, including heart rate, speed, and workload. Two Inertial Vibration Isolation and Stabilization Boxes are attached at either end of the Ergometer and provide passive mechanical counter-inertia to the forces imparted by the riding subject. These minimize forces imparted into the CEVIS frame and hence into the ISS structure via wire rope isolators located in each of the four corners. CEVIS was deployed on ISS in March 2001 and continues to be in service. Figures 3 and 4 shows the CEVIS schematic and the CEVIS in use in an upright posture, respectively [3].

Figure 3. CEVIS System.

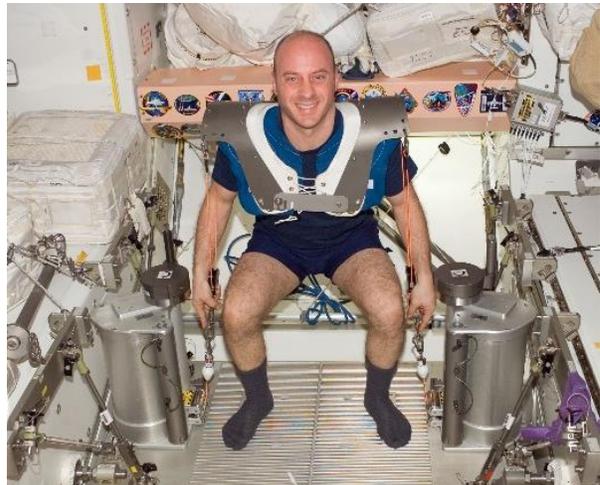
Figure 5. IRED Figures

Aerobic exercise is one powerful countermeasure to microgravity effects, but additionally, resistive exercises are needed to prevent both muscle and skeletal atrophy. To provide ISS astronauts an interim resistive exercise capability, the IRED was developed and was in service from May 2000 until ARED was installed in January 2009. It had a capability of 320 pounds of resistive load using two canisters. The canisters contained rubber spring flexpacks, which when rotated about a center shaft, provided resistive load to the user via a rope and pulley system. The load adjustment was created by turning a hand crank and preloading the flexpack stack to the desired load. IRED did not contain vibration isolation features or a capability to record data to verify device performance. Figure 5 shows the elements in the canister used to provide resistance as well as the IRED in use [4].

IREDD Canister Exploded View

IREDD in use on ISS

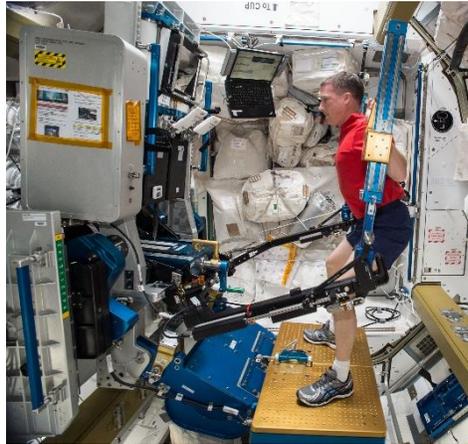
Figure 6. ARED in use on ISS.

IRED provided an interim capability until the ARED was ready for use. Today, the ARED is the primary resistive exercise device on ISS, utilizing two vacuum cylinders to provide workload. The ARED system incorporated multiple improvements to the IRED hardware, including increased load to 600 pounds, a more desirable load characterization, vibration isolation, lower maintenance requirements, and greater ease of use and reliability. It provides bar and cable (rope) exercises, much like ground gym equipment, and it contains an inertial flywheel system to simulate the feel of 1-g free-weights. ARED was deployed in January 2009 and continues in service. Figure 6 shows the ARED as it is used on ISS [5].

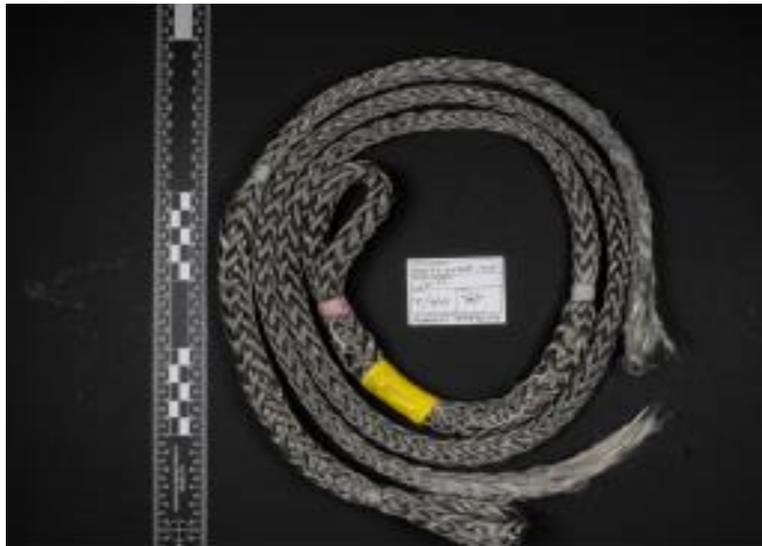
The life-cycle testing was conducted on 3/8 inch diameter cable arm ropes and yielded a failure of 138,612 cycles. The 80-inch ropes had breakage about 24 inches from the end near the cam pulley. A broken Vectran rope was submitted to JSC Materials and Process Branch for failure analysis, and the analysis concluded that the failure was caused by flex fatigue and abrasion from the pulleys during the life-cycle testing. Based on the test results and lower stretch characteristics, the Vectran cable arm ropes were certified using a scatter factor of 2 for 69,306 cycles, which was initially projected to last greater than 6 months for 3 crewmembers. Subsequently, the actual consumption rate was higher, so they currently last approximately 3-4 months for 6 crewmembers. Figure 9 provides a photograph of a failed Vectran ARED Cable Arm Rope after initial life cycle testing.

Figure 9. Failed ARED Cable Arm Rope

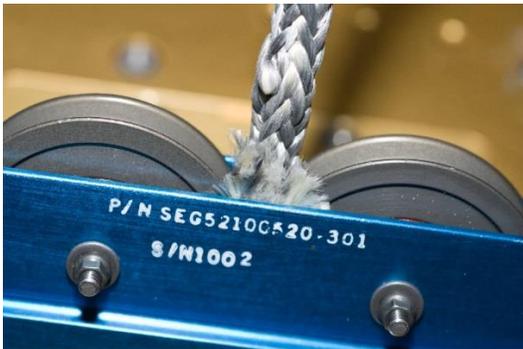
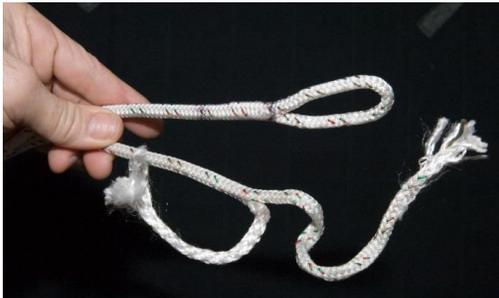
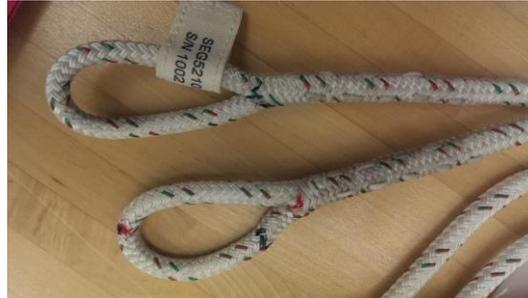
Figure 10. ARED Exercise Rope Designs and Related Failures

Failures of the ARED workload rope led to two improvements in the design. The first failure occurred in the Vectran exercise rope design on ISS. As the rope was cycled over time through the outlet pulleys, the splice grew in diameter due to end (tail) of the rope working its way back through the braid. This caused the splice to wedge in the pulleys and added tension to the system, which caused the cable arms to pop out of the detents during bar exercise. This was corrected by loosening the tension on the cable arm ropes and allowing the exercise rope splice to no longer retract into the pulleys. This issue, along with the short life of the Vectran exercise rope, helped justify the new polyester exercise rope redesign. The second failure of an exercise rope occurred on ISS with the polyester

rope. In January 2012 the crew was exercising and noticed that the splice had come apart, rendering the rope unusable. This condition was never observed on the ground during testing, but the possibility of manual manipulation during zero-load conditions of the splice could have caused the splice to come apart, as without load on the rope, the fibers tend to loosen slightly. Based on this failure, the ISS Program and the CMS team decided to stand down on use of the polyester rope on orbit and install the Vectran rope as an interim workaround. After a redesign effort, including consulting with the rope supplier, the team decided to add a lock stitch to the rope splice in order to prevent the splice from coming apart during zero-load conditions. After the design was fabricated, the life cycle test was reinitiated with the new rope design and certified to the same cycle count as the previous polyester rope design (242,717 cycles). The updated polyester rope design was installed on orbit in September 2014 and continues in use currently. The life cycle test continues currently, and as of August 2015, the rope was certified for 481,958 cycles, which equates to approximately 2 years of operational life. Figure 10 provides several images of ARED exercise rope designs and related failures. [12,13]

Vectran Rope Wedged in Pulley

Polyester Rope Installed

Polyester Rope Splice Pull-Out

Polyester Rope With Lock Stitch

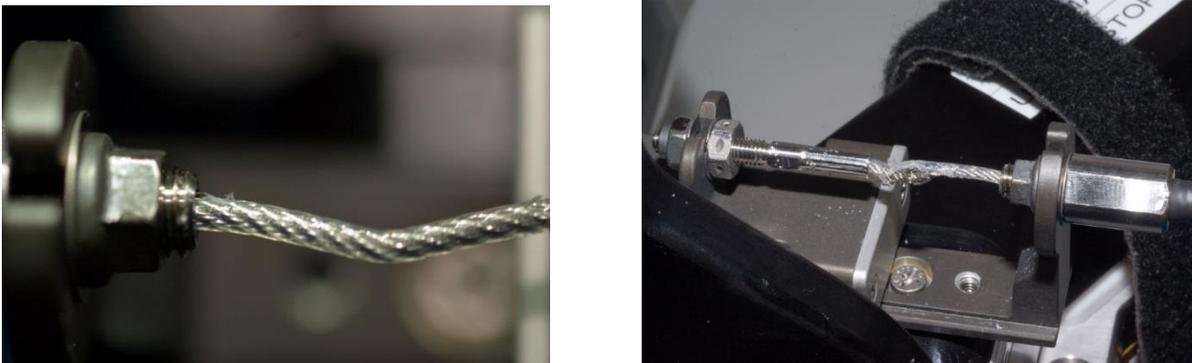
The upper stop cable has been an area of multiple failures since ARED was put into service in 2009. The failure typically begins as a bent or kinked cable and progresses to a broken or frayed cable, halting all exercises performed from the upper stops. This problem had a history of occurring approximately every 2 years, requiring the cables be replaced with new units, but in late 2014 into early 2015, a series of rapid-succession failures occurred on the upper stop cables on both the left and right sides. This initiated a root-cause investigation, and it was concluded that the mechanics of the mechanism applies a push force on every repetition of bar exercise as the pawl follows the bottom edge of the upper stop plate. However, the forces applied to the upper stop cables were never intended to be push forces. They were only intended to operate in tension. The fatigue resulting from the cycling of this push force eventually causes a kink in the cable, which erodes the Teflon sheath on the cable housing, and eventually causes it to fray or break, halting upper stop exercises until it can be replaced. As a result of the findings, the crew was requested to increase their frequency of inspections, and the engineering team launched additional spares to ISS. A redesign of the upper stop mechanism to eliminate the push forces is currently in work, and life-cycle testing will be used to compare the life of the old and new designs. (Note: There was no life cycle testing performed on the upper stop hardware) ARED Upper Stop Cable Failures on ISS are depicted in Figure 12 [14,15].

Figure 12. ISS ARED Upper Stop Cable Failures

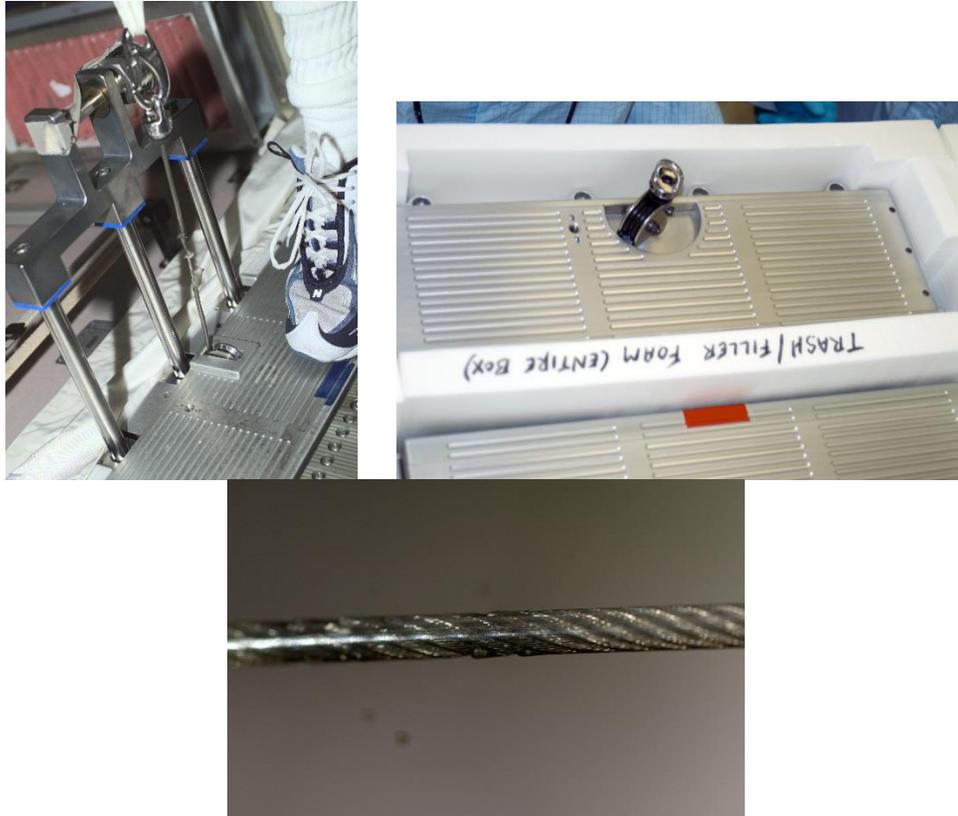
The first set of SLDs went into service with the rest of the system in November 2000. On July 30, 2001, the crew reported that the SLD cable nylon sheath had worn away from the wire rope portion of the cable, causing the cable to jam. The root cause was determined to be off-axis cable loading and cable sheath abrasion due to TVIS exercise without the crew using SPDs. Passive exercise caused the subject to lean forward to manually drive the treadmill belt. As an interim workaround, the crew installed the SLD eyebolts and used SBSs for loading as a contingency. New SLDs were flown and installed in December 2001. In March 2002 the crew reported scraping noises coming from the second set of SLDs and noted asymmetric loading between the SLDs. These were removed from service, and again, the SBSs became the backup loading mechanism. A post-flight inspection revealed that exit pulley bearings and load cell pulley bearings had failed. This damage was caused when the SLD cable jumped off of the exit pulley during passive exercise on the TVIS System, again without the crew using SPDs. The bearings were not able to handle the off-axis loads and failed prematurely. In September 2006 the left SLD of the third set of SLDs installed on ISS experienced a failure where the cable end stop detached from the SLD cable during exercise. The cable end stop remained attached to the crewmember’s harness, and the free end of the cable retracted into the SLD housing. Visual inspection determined that the wire rope had separated from the ball shank termination that was swaged to it. Suspected causes were failure due to an improper crimp or a material defect, but the failed components were lost in transit from ISS to JSC, so no ground analysis was performed. Additionally, the post-fabrication verification pull test records could not be found by the external vendor. As a result the SLD drawing was updated to include a mandatory inspection point for the post-swage pull test, and all subsequent SLD cable swages were inspected using X-rays to verify proper crimping. A series of redesign efforts and life cycles tests were performed between 2003 and 2009, and changes were made to the SLD design to increase the pulley size, update the bearings, and add a rotating and fleeting exit pulley to prevent off-axis loading of the bearings. A final redesigned SLD was installed on orbit April 23, 2009, and the failures did not reoccur. Figure 14 shows a damaged TVIS SLD cable and the new fleeting pulley design [16,17,18].

Figure 14. Damaged TVIS SLD Cable and Fleeting Pulley Design

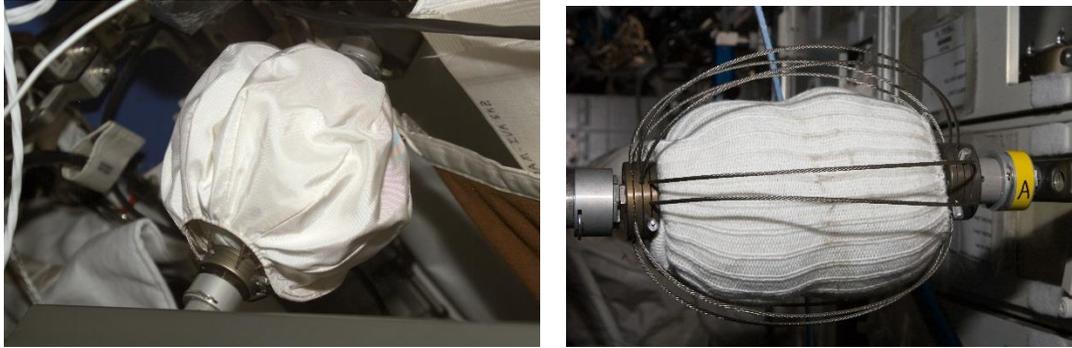
The CEVIS isolators are wire rope egg-beater type devices that provide the only structural attachment between the CEVIS frame assembly and the ISS US Lab rack using seat track adapters. They contain 12 strands of 1/16 inch wire rope without sheathing, and an isolator assembly is attached at each of the four corners of the CEVIS frame to minimize the vibrations transmitted from the CEVIS system to the ISS structure during operation. The isolators were not initially assigned a limited life, and they are changed out on an as-needed basis when more than 8 out of 12 wire ropes are severed in a single isolator. The isolators are inspected every 3 months and have had a service life varying from 1 to 3 years. CEVIS isolators used on ISS are shown in Figure 15 [3].

Figure 15. CEVIS Isolators on ISS

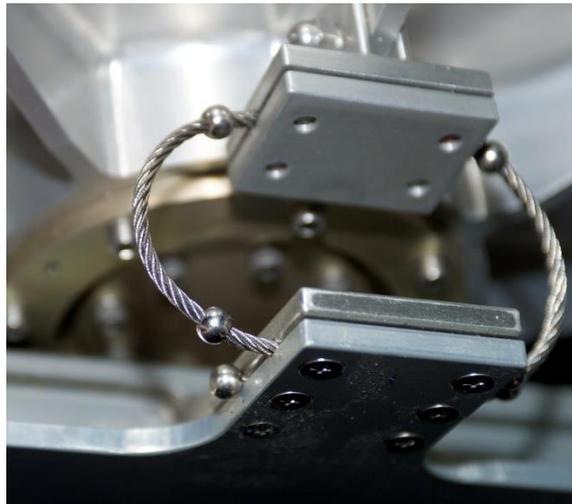
The TVIS Gyroscope Assembly is used to stabilize the TVIS System from excessive roll motion during operation and provides current peak smoothing of the TVIS System power sources. The Gyroscope has a vertical spin axis and pivot bearings positioned in the pitch direction to allow for the required precession during operation. The TVIS gyroscope incorporated two (one per side) 1/8 inch swaged wire rope assemblies that aided in restoring the gyroscope back to its neutral position and prevented excessive movement. The thought was that the wire ropes would act as a spring and dampen out extreme motion before the gyroscope pivots hit the hard stops. The gyroscope wire rope originally was not assigned a limited life, and no spares were launched, but after failures on orbit, a certified operational life of at least 250 hours was derived based on historical data and maintenance inspections. This equated to approximately 9 months with three crewmember use. The gyroscope wire ropes could continue in service past the 250-hour limit if monthly inspections were performed. The wire ropes were required to be changed out, at a minimum, every year. In the event that the gyroscope wire ropes were severed, gyroscope motion increased, resulting in contact with the gyroscope blue rubber bumpers, which acted as the secondary damping system. Once wire rope damage was identified, both wire ropes were replaced prior to resuming TVIS System operations. Figure 18 shows the TVIS gyroscope wire ropes as configured for ISS use [2].

Figure 18. TVIS Gyroscope Wire Ropes

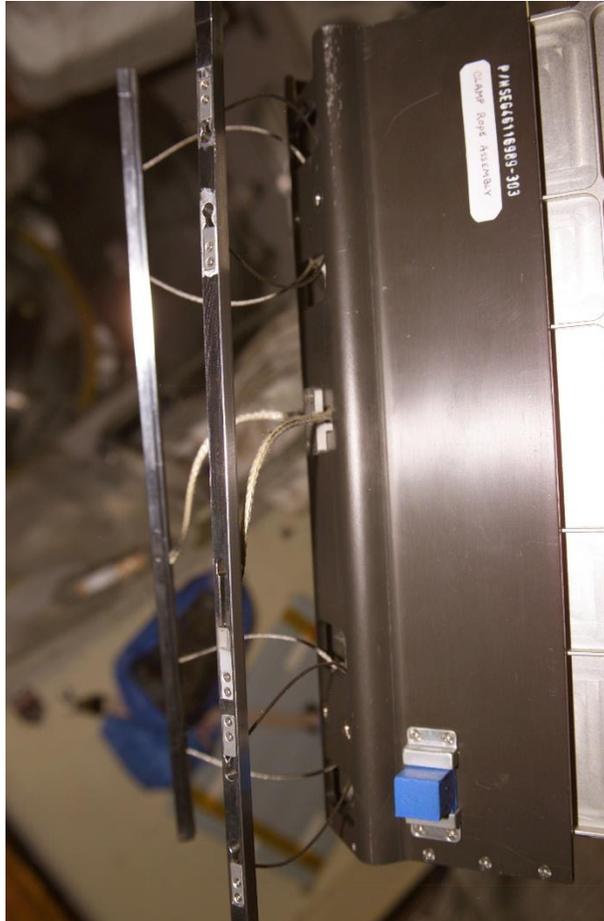
The TVIS Stabilizer wire ropes centered the TVIS System in the SM pit, provided an attachment point to the SM structure, and isolated forces from being transmitted to the ISS. Each corner assembly contained one textile Kevlar® (later Vectran) stabilizer protection tether and four 1/16 inch steel wire ropes to limit the travel of the movement within the pit. The wire ropes were attached to the TVIS stabilizers via a terminal ball-swage inserted into a slot with a fastened cover plate to retain them. They were mounted on the opposite end in a similar fashion to rails that mounted to the corners of the SM pit. Figure 20 provides a photograph of the TVIS Stabilizer Corner Bracket Assembly including the Wire Ropes.

Figure 20. TVIS Stabilizer Corner Bracket Assembly Including Wire Ropes

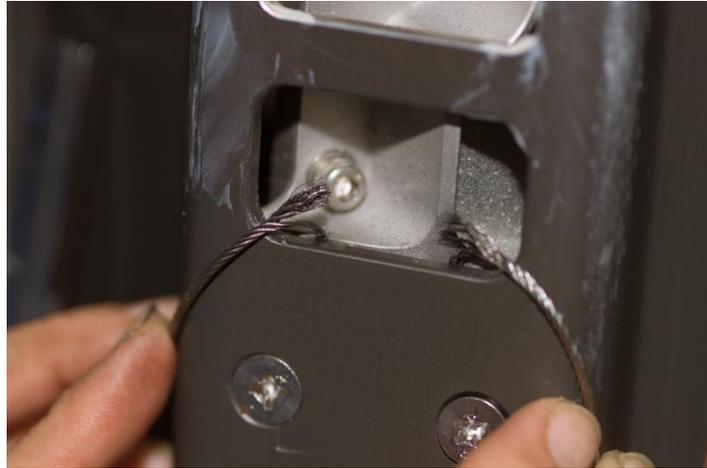
The steel wire ropes and Kevlar over-travel protection ropes did not originally have a limited life assigned to them and no spares were stored on-orbit. Damage observed by the crew on Expedition 1 in February 2001 due to the Kevlar stabilizer protection tether severing highlighted the need for maintenance on the ropes. The protection ropes were originally made of Kevlar, but their load rating was below the applied forces on orbit. After a short ground evaluation, the Kevlar design was replaced with Vectran, which had five to six times the break strength of the Kevlar rope, replacements were launched to ISS, and the failure was never observed again. During the same call-down as the Kevlar rope severing, the crew reported that multiple stabilizer wire ropes were damaged or severed. The subsequent investigation concluded that the failure could be contributed to three causes. First, the failure of the Kevlar over-travel protection rope allowed the wire ropes to become taut and experience the full load of the treadmill chassis pulling on them. Second, it was determined that excessive clamp force between the rope clamp assembly and the stabilizer interface deformed the wire rope, causing premature fatigue. Third, the sharp bend radius imposed on the wire rope also caused the failure at the point of greatest cycling fatigue. As a result, spares were launched to ISS, the damaged wires were replaced, and spares were maintained onboard for the duration of the remaining TVIS service. The TVIS Stabilizer Corner Bracket Assemblies were inspected monthly and the wire ropes were replaced when at least half were severed. A redesign was a possibility, but the ISS Program chose to resupply the ropes and change them out periodically when damage was observed. After the Vectran over-travel protection rope was installed, stabilizer wire ropes typically lasted ~3 years between change-outs. A failed TVIS Stabilizer Corner Wire Rope is shown in Figure 21 [21,22].

Figure 21. Failed TVIS Stabilizer Corner Wire Rope

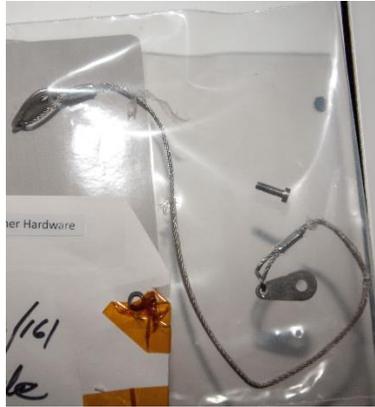
Crew reports in 2012 indicated that the VIS PIP pin tethers had frayed Teflon sheaths, but the crew did not think the damage required tape to protect them from sharp frayed wire strands. The root cause could not be determined, but the most likely cause was the tethers being pinched between the pin and the VIS outer plate due to the pins not being temporarily stowed in the provided stowage slots when not inserted into the VIS. This would allow the pin to float and become pinched during ARED exercise. The crew was trained to temporarily stow the pins when not inserted, and spare tethers are on-board the ISS in case replacement is required. Figure 22 shows a damaged ARED VIS PIP Pin Tether [24].

Figure 22. Damaged ARED VIS PIP Pin Tether

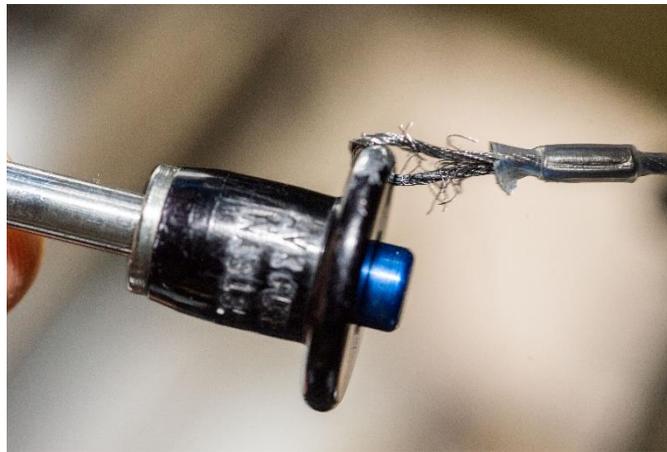
Crew reports in 2013 indicated that the ARED hard stop PIP pin tethers had frayed Teflon sheaths and wire. The crew was instructed to wrap the tethers with tape to protect them from contacting sharp, frayed wire strands with their hands. The root cause could not be determined, but the most likely cause was the tethers being pinched between the hard stop mechanism and upper stop plate. This can occur when the pins are not temporarily stowed in the provided stowage holes when removed from the upper stop mechanism. This allows the pin to float and become pinched during ARED exercise. The crew was trained to temporarily stow the pins when not inserted, and spare tethers are on board the ISS in case replacement is required [25]. Figure 23 shows a damaged ARED Hard Stop Pin Tether.

Figure 23. Damaged ARED Hard Stop Pin Tether
