NASA Electronic Parts and Packaging (NEPP) Program

NEPP Task: Reliability of Advanced Wet and Solid Tantalum Capacitors

Deformation of Cases in High Capacitance Value Wet Tantalum Capacitors under Environmental Stresses

Alexander Teverovsky

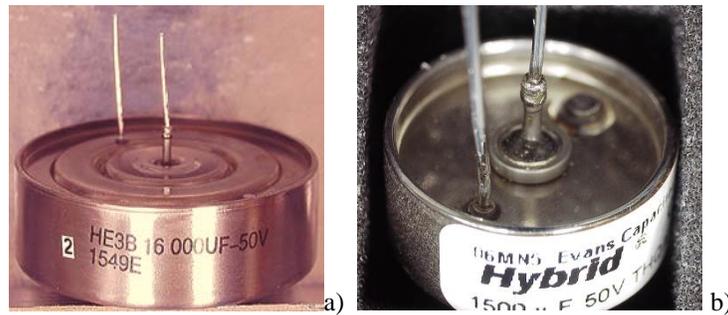
Figure 1. Examples of button-case designs of wet tantalum capacitors: THQ series (DWG#04005) from Evans (a) and HE series (DWG#10011) from Vishay.

High capacitance value wet tantalum capacitors are used in space applications as energy storage devices that allow a fast charge delivery in a variety of power supply systems. These parts are manufactured to DLA LAM drawings #04003, #04004, #04005, and #10011 (commercial equivalents are THQ series from Evans and HE series from Vishay). To increase volumetric efficiency compared to traditional, cylinder case wet tantalum capacitors that are manufactured per MIL-PRF-39006, these parts employ a button-case design as shown in Fig.1. Contrary to the military grade capacitors that are manufactured with internal sealing provided by Teflon bushing and crimping of the case, first THQ designs of capacitors did not have protection of the glass seal area, and their hermeticity was provided only by welding of the lid and tubing.

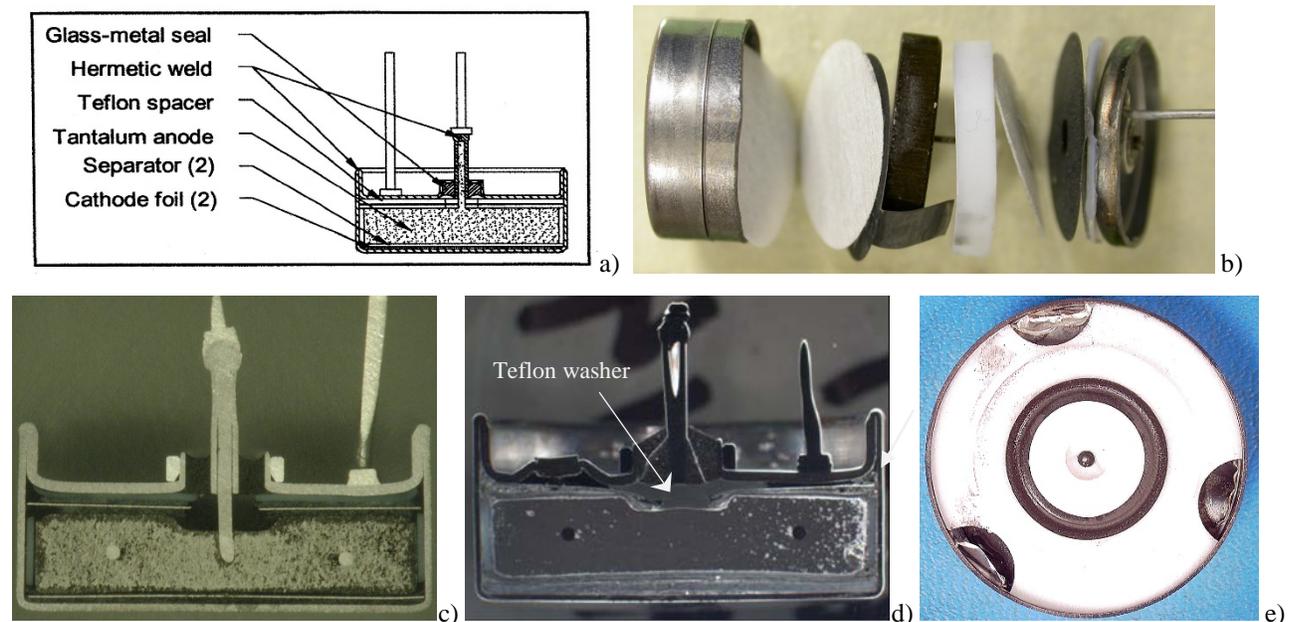
Figure 2. A schematic (a) and internal elements (b – d) of THQA and HE3 (e) capacitors. (b) Internal components of the disassembled THQA capacitor. Cross-sectioning of THQA capacitors manufactured in 2004 (c) and in 2008 (d). Contrary to 2004 design (c), capacitors manufactured in 2008 (d) had a Teflon washer protecting the glass seal area. Note that capacitors manufactured in 2013 had rubber instead of Teflon washers. Fig.(e) shows a top view of HE3 capacitor after lid removal. Note a rubber seal in the groove of the Teflon separator.

First THQ-style capacitors were manufactured before 1996. The parts were assembled dry, with electrolyte added through a small hole in the cover that was closed by a welded tantalum plug [5]. A schematic and internal features of THQA capacitors manufactured in 2004 and 2013 are shown in Fig.2. Testing of THQA capacitors manufactured in 2004 showed that these parts often fail hermeticity during various environmental tests. For this reason, in later versions of this design, Teflon or rubber washers were installed to protect the glass seal area. Note that all HE3 capacitors have internal rubber seals.

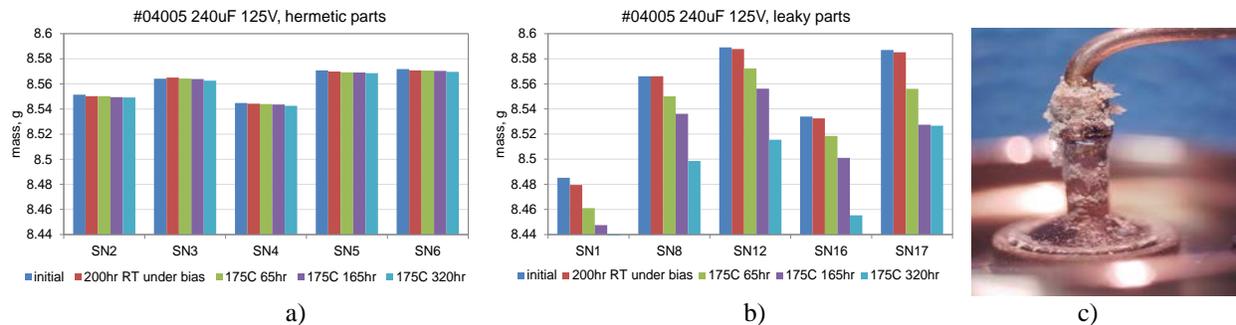
Figure 3. Variation of mass of DWG#04005 capacitors manufactured in 2004 during environmental testing. (a) hermetic parts; (b) leaky parts; (c) remnants of electrolyte on a tubing in a leaky part after the testing.

Fig.3 shows variations in the mass of 240 μF 125 V DWG#04005 capacitors manufactured in 2004, weighed after 200 hours of room temperature testing at rated voltage and then during high temperature storage at 175 $^{\circ}\text{C}$ after 65 hr, 165 hr, and 320 hr. Approximately half of the parts (17 samples total were tested) had noticeable (up to 80 mg) decreases in the mass caused by the electrolyte leak. However, no catastrophic failures during these tests was observed. In all cases the leak was in the tubing weld area (see Fig 3c).

Analysis shows that temperature increase from room to 175 $^{\circ}\text{C}$ increases electrolyte leak more than two orders of magnitude [3], so a part having the measured leak rate 10^{-8} atm*cc/s should have lost less than 10 mg of electrolyte during two weeks of storage at 175 $^{\circ}\text{C}$. Considering that initially, based on the fine leak testing, the parts were hermetic, it is possible that the leak was caused by corrosion of tantalum in the weld area. It is known that pure tantalum is immune to attack by sulfuric acid at temperatures below ~ 200 $^{\circ}\text{C}$. However, in the presence of contaminations, and specifically, carbon, the weld area can be attacked by acids. It is also possible that the seal was compromised by excessive internal pressure and deformation of the case.

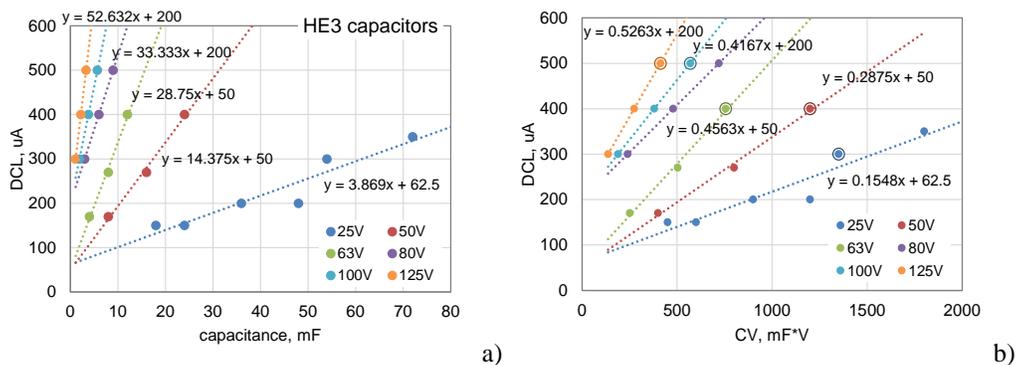
Figure 4. Variations of the maximum specified leakage currents with capacitance (a) and CV values (b). Solid marks correspond to HE3 and circles to THQ3 capacitors. Not that circles coincide with the marks in all cases.

Leakage currents specified for HE3 capacitors are increasing linearly with the value of capacitance as it is shown in Fig.4a. Some deviation from the linearity exists for capacitors rated to 25 V. The linearity remains valid when maximum leakage currents are plotted against CV values as shown in Fig. 4b. Note, that contrary to a simple rule that determines DCL values for chip tantalum capacitors ($DCL = 0.01 \times CV$ for MnO₂ and $DCL = 0.1 \times CV$ for polymer capacitors), no simple relationship exists for wet tantalum capacitors. For these parts, the limit is most likely set by a combination of statistical analysis, internal manufacturers' rules, and marketing. Comparison of DCL requirements for HE3 and THQ3 capacitors (see Fig. 4b) shows that similar parts from different manufacturers have same requirements. This confirms an important role of marketing in setting DCL limits for commercial and DLA drawing products.

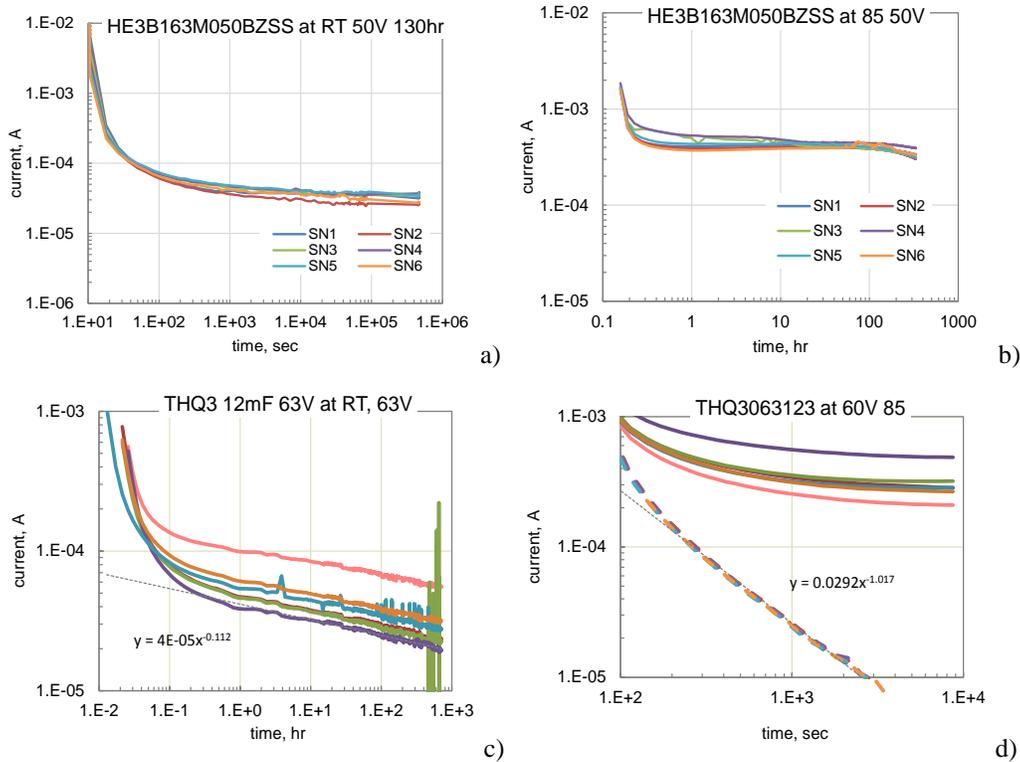
Figure 5. Variations of currents with time at room temperature (a, c) and 85 °C (b, d) for HE3 (a, b) and THQ3 (c, d) capacitors. Dashed lines in Fig. (d) indicate depolarization (absorption) currents.

Variations of leakage currents with time at room temperature and 85 °C are shown in Fig. 5. Results at room temperature show reproducible and stable leakage currents for HE3 and a relatively large spread for THQ3 capacitors. Two out of six THQ samples had unstable leakage currents after 100 hours of testing. For high-value capacitors intrinsic currents prevail over absorption currents after ~ 1000 sec.

Leakage currents in HE3 capacitors measured after 5 min of electrification were within the range from 40 μA to 60 μA , which is several times below the specified value of 270 μA . Measurements at 85 °C during 340 hours showed that currents are decreasing with time, and although some instability was observed, the currents remain close for different parts in the group. Currents measured at 85 °C were approximately an order of magnitude greater than at room temperature, from 400 μA to 500 μA . However, for these parts currents at 85 °C are not specified, which limits the capabilities of the quality assurance system.

For THQ3 capacitors, leakage currents at room temperature were in the range from 60 μA to 150 μA , which is below the limit of 400 μA . At 85 °C the currents increased up to 800 μA . For both part types currents decreased gradually with time under bias during hundreds of hours of testing at room temperature and 85 °C.

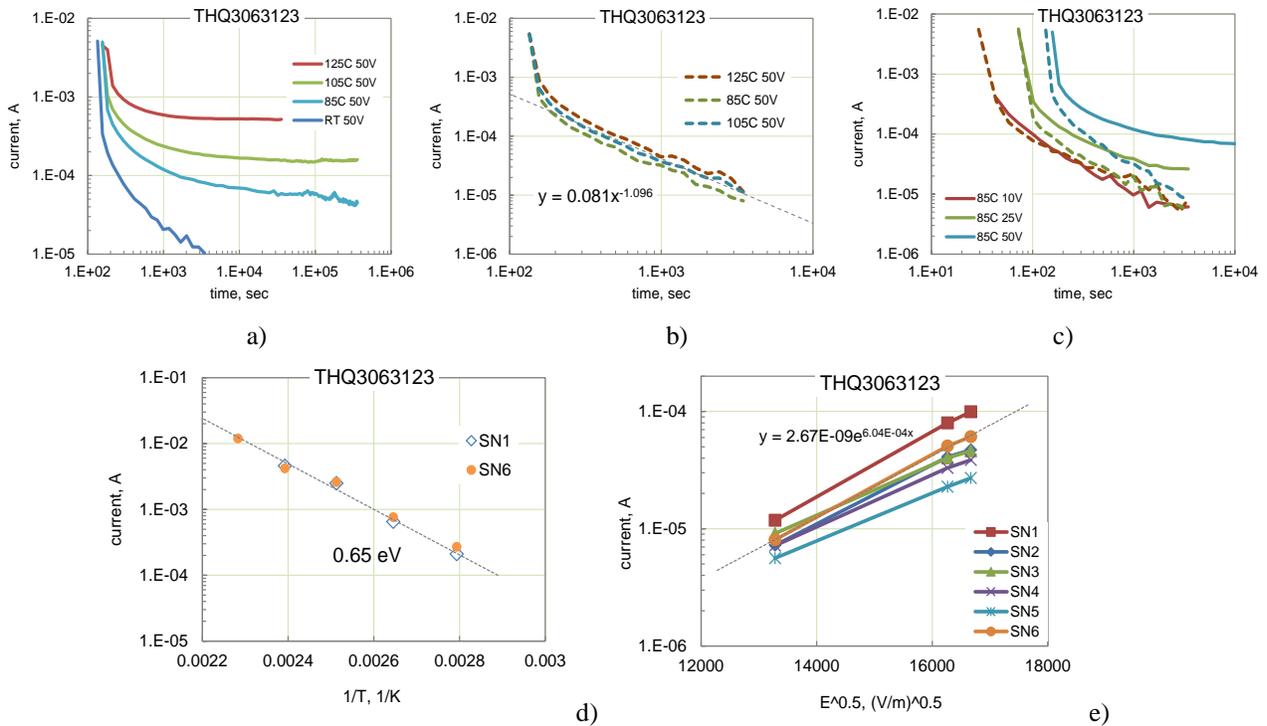
Figure 6. Leakage currents in THQ capacitors. (a – c) Relaxation of leakage currents at different temperatures and voltages; (d) temperature dependence of leakage currents in Arrhenius coordinates; (e) current-electric field characteristics in Schottky coordinates.

Relaxation of currents at different temperatures and voltages for THQ3 capacitors are shown in Fig. 6. At 50 V absorption currents prevail at room temperature (RT) for at least one hour of electrofication (see Fig. 6a). Increasing temperature to 85 °C makes intrinsic currents evident after ~ 0.5 hour and after a few minutes at 125 °C. Contrary to intrinsic currents that increase from RT to 125 °C by more than 2 orders of magnitude, absorption or depolarization currents are increasing less than 2 times (see Fig. 6b). At 85 °C and 10 V, polarization and depolarization currents are similar (see Fig. 6c), but the prevalence of intrinsic currents became obvious as the voltage increases to 25 V and 50 V. Based on measurements of leakage currents at 50 V the activation energy of intrinsic leakage currents is ~0.65 eV (Fig. 6d).

To present I - V characteristics of the part in Schottky coordinates, $\ln(I)$ vs. $E^{0.5}$, the thickness of the dielectric was calculated as $d = 1.8 \cdot VR \cdot \alpha_F$, where d is in nm, $VR=63$ V is the rated voltage, and α_F , which is the voltage formation coefficient, was assumed to be 2. Calculations yielded $d = 227$ nm. Results in Fig. 6e show that the slope of $\ln(I)$ vs. $E^{0.5}$ characteristics is $\sim 6E-4$ (m/V) $^{0.5}$, which is close to the theoretical value for the Schottky model, $6.5E-4$ (m/V) $^{0.5}$ [3], and indicate that the currents are limited by a barrier at the electrolyte/Ta2O5 interface.

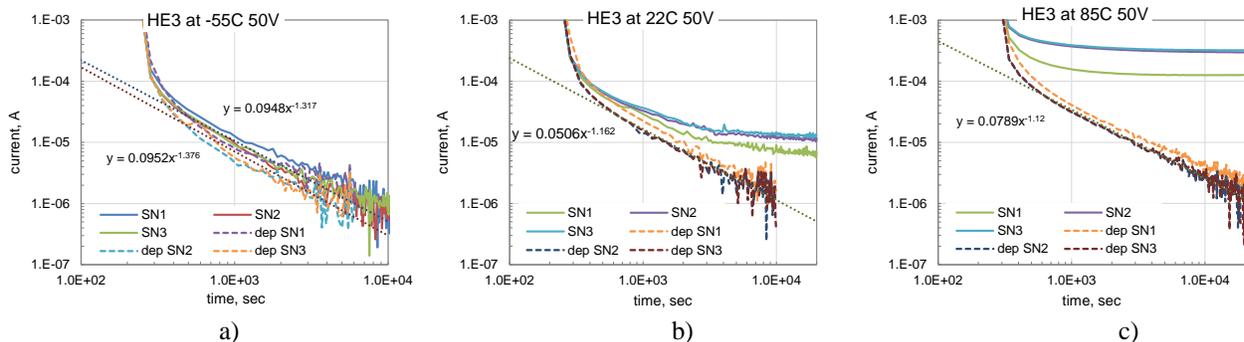
Figure 7. Polarization and depolarization currents in HE3 capacitors at $-55\text{ }^{\circ}\text{C}$ (a), room temperature (b), and $85\text{ }^{\circ}\text{C}$ (c). Dashed lines correspond to depolarization currents.

Variations of polarization and depolarization currents with time at temperatures from $-55\text{ }^{\circ}\text{C}$ to $+85\text{ }^{\circ}\text{C}$ for SNs 1 to 3 of HE3 capacitors are shown in Fig.7. At low temperatures, $-55\text{ }^{\circ}\text{C}$, polarization and depolarization currents are similar. At room temperature (RT) and rated voltage, intrinsic currents are several times greater than absorption currents after 1000 sec, and at $85\text{ }^{\circ}\text{C}$ this difference is almost an order of magnitude. Calculation of the absorption charge, Q_t , and absorption capacitance, C_t , showed that at $-55\text{ }^{\circ}\text{C}$ and RT, Q_t is in the range from 0.24 C to 0.25 C, and, respectively, C_t is 27% to 28% of the nominal value, C_0 . At $85\text{ }^{\circ}\text{C}$ Q_t increases to 0.44 C and C_t rises to 49% of C_0 . These values of C_t are substantially greater than the values observed for capacitors with lower values (12% to 19 %) [3].

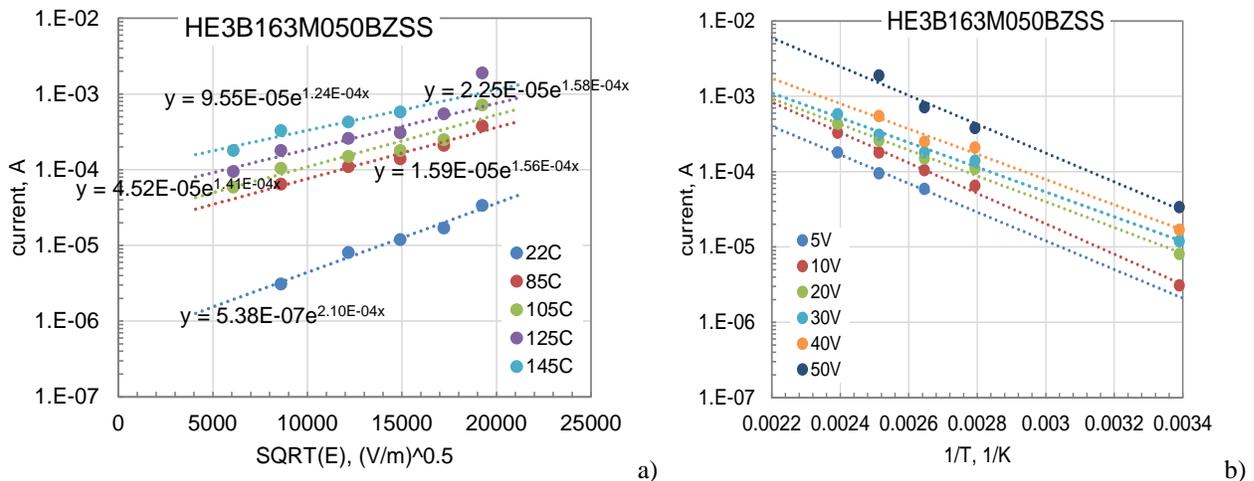
Figure 8. Variations of leakage currents with electric field (a) and temperature (b) for HE3 capacitors.

Temperature dependencies of leakage currents at different voltages are shown in Fig.8b and indicate activation energies ~ 0.4 eV. This value is lower than what is typically observed for wet tantalum capacitors, 0.75 ± 0.1 eV [3] and might be due to specifics of electrolyte used in these parts or to a relatively thin dielectric. The latter factor increases electric field in the oxide and reduces the Schottky barrier.

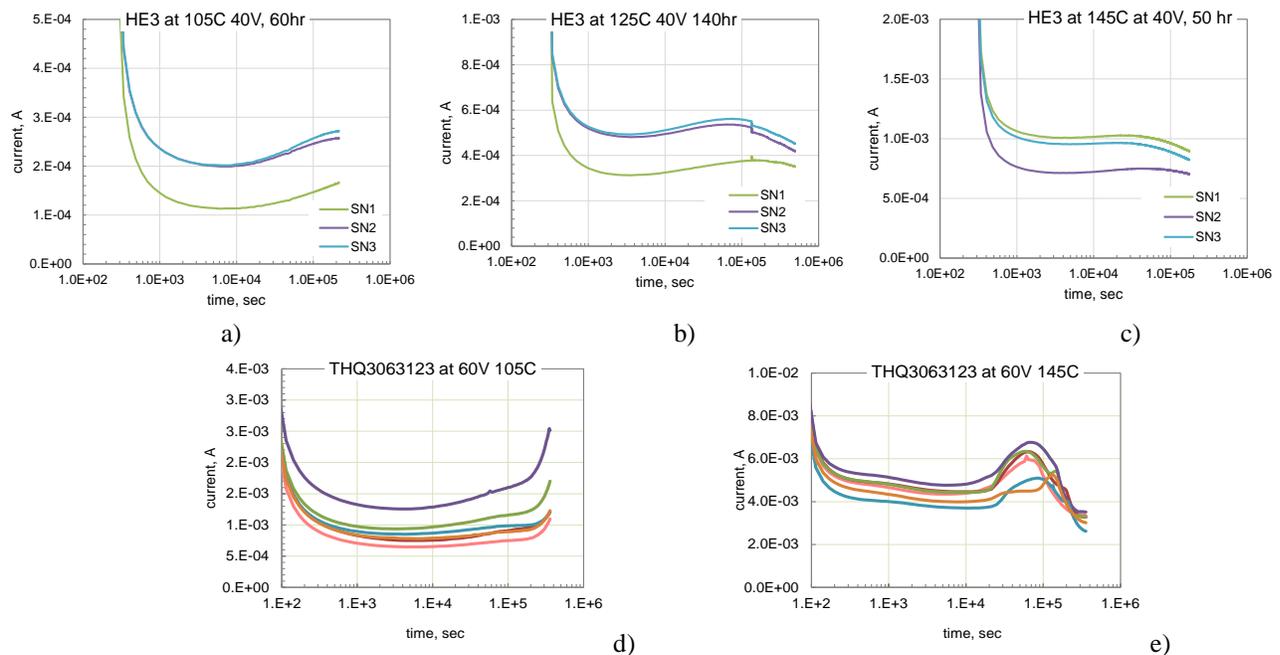
Figure 9. Variations of currents with time during 100-hour testing at different temperatures for HE3 (a – c) and THQ3 (d, e) capacitors.

Results of testing at 105 °C, 125 °C, and 145 °C are shown in Fig.9. In all cases, after initial relaxation due to absorption processes, currents are increasing with time, reaching maximum, and then decreasing again. For HE3 capacitors, the time to maximum is decreasing from more than 100 hours at 105 °C to ~ 35 hours at 125 °C and to ~ 20 hours at 145 °C. Interestingly enough, similar times to maximum were observed for THQ3 capacitors.

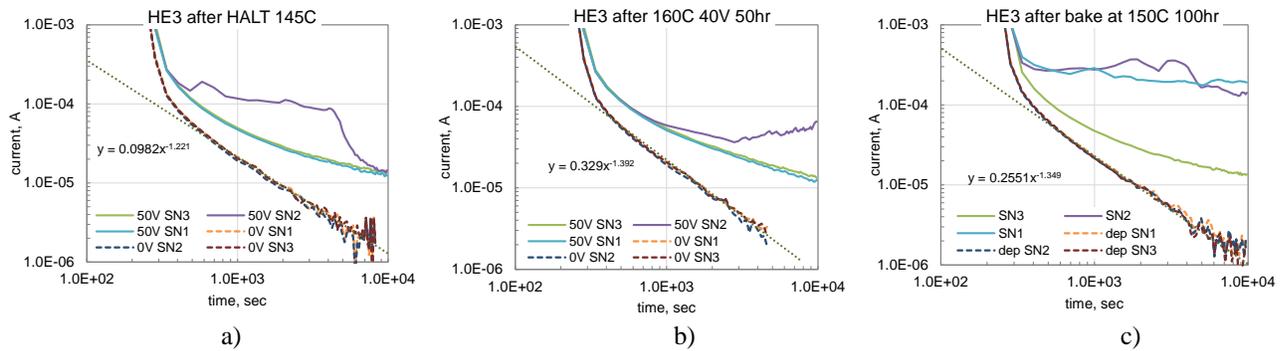
Figure 10. Relaxation of leakage currents at room temperature in HE3 capacitors after HALT at 145 °C (a) and 160 °C (b) and after bake at 150 °C (c). Dashed lines show depolarization currents.

Post-HALT measurements at room temperature showed anomalies in current relaxation in two out of three tested HE3 capacitors (see Fig. 10) and in 2 out of 6 THQ3 capacitors (see Fig. 11). One of HE3 capacitors, SN2, had increased currents after HALT at 145 °C and the same sample showed anomalous relaxation after HALT at 160 °C. After bake at 150 °C one more sample, SN1, had currents substantially, approximately an order of magnitude, greater than normal. Note that after HALT the currents remained within the specified requirements, and failed marginally only after the bake. Depolarization currents in all three capacitors were identical, and no significant variations in leakage currents after HALT was detected for capacitors with normal relaxation (SNs 1 before bake and SN3 after all stresses).

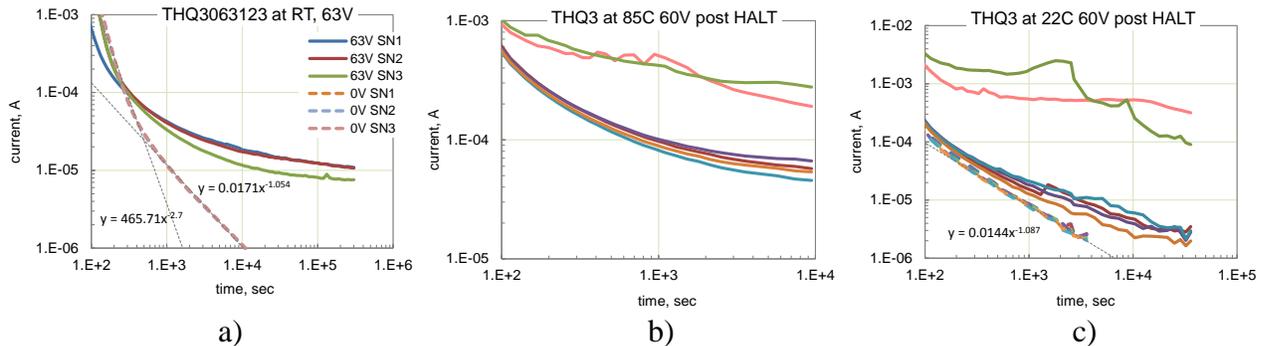
Figure 11. Relaxation of leakage currents in THQ3 capacitors at room temperature initially (a) and after HALT at 165 °C 60 V 100 hr (b, c).

Anomalies in current relaxation were observed also after HALT at 160 °C in two THQ3 capacitors (see Fig.11). Leakage currents increased almost two orders of magnitude resulting in parametric failures. Similar anomalies in HE3 and THQ3 capacitors might be attributed to the presence of electrolyte at the glass seal area [3].

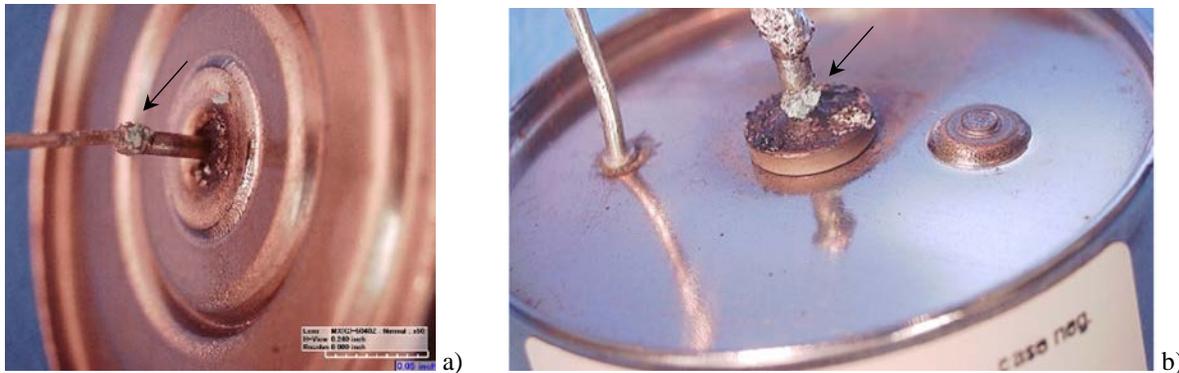
Figure 12. External views of the leaky HE3 (a) and THQ3 (b) capacitors. 2/6 HE3 after HALT and 100 hr at 150 °C

External examination of the capacitors after testing showed evidences of electrolyte leak in HE3 samples SN1 and SN2 and in two THQ3 samples with anomalous current relaxation. Images of the leaky parts are shown in Fig. 12. Note that capacitance and dissipation factors remained the same, and no changes between the initial and post_HALT $C-f$ characteristics were observed.

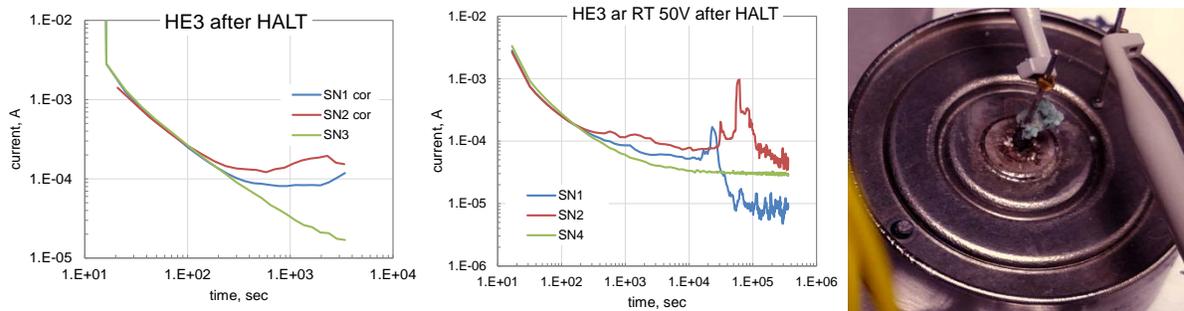
Figure 13. Relaxation of leakage currents in HE3 capacitors after HALT and 1.5 month of storage at room conditions (a) and during 100 hour testing at RT and 50V (b). Fig. (c) shows a view of SN2 after 70 hours of testing.

After 1.5 months of storage at room conditions, relaxation of leakage currents in HE3 capacitors that had been stressed by HALT was measured again (see Fig. 13a). All parts had leakage currents within the specification limits. Currents in sample SN3 decreased to below 20 μA after 1 hour of polarization, whereas two other capacitors with evidences of leak at the weld had increased leakage currents after 5 min of electrification. Sample SN3 was used for displacement testing described in the next section, and monitoring of leakage currents continued for samples SN1, SN2 and SN4 that appeared normal after 100 monitored temperature cycles between room temperature and 125 $^{\circ}\text{C}$ (see Fig 13b). Anomalies in behavior of leakage currents in SN1 and SN2 became more obvious with time of testing. Both samples had unstable currents that reached maximum after a few dozens of hours of testing. Visual examination of the parts during the testing revealed a substantial increase of the volume of the dried electrolyte at the weld area in SN1 and SN2. Figure 13c shows a large amount of blue material (dried electrolyte) at the tube weld in SN2 (compare this picture with Fig.12a where only a small amount of the material at the weld was detected after HALT). Apparently, gas generation increased pressure in the case and forced electrolyte leakage through the compromised weld.

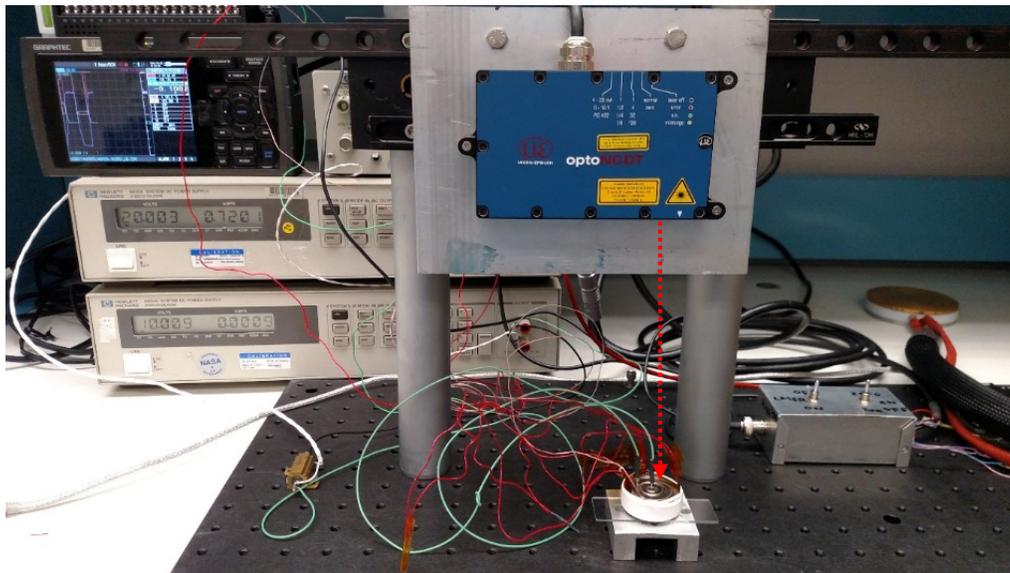
Figure 14. Overall view of the set-up for displacement measurements. Dashed red line indicate location of the beam.

Displacements of the lid in the button case capacitors was carried out using a laser-optical displacement measuring system, ILD1700-40, manufactured by Micro – Epsilon. The laser beam was focused on the central area of the lid close to the glass seal (see Fig. 14). Flexible Minco heaters and a thermocouple were attached to the cylindrical surface of the part and isolated with Teflon tape. Leakage currents were monitored by measuring voltages across a 100 ohm resistor connected in series with the part. A set-up consisted of two power supplies, one to bias the capacitor and another for the heaters, and a data logger. Power supplies were controlled by a PC and the data logger measured temperature, displacement, power supply voltages, and leakage currents. Calibration showed that the sensitivity of displacement measurements was 0.244 $\text{mV}/\mu\text{m}$.

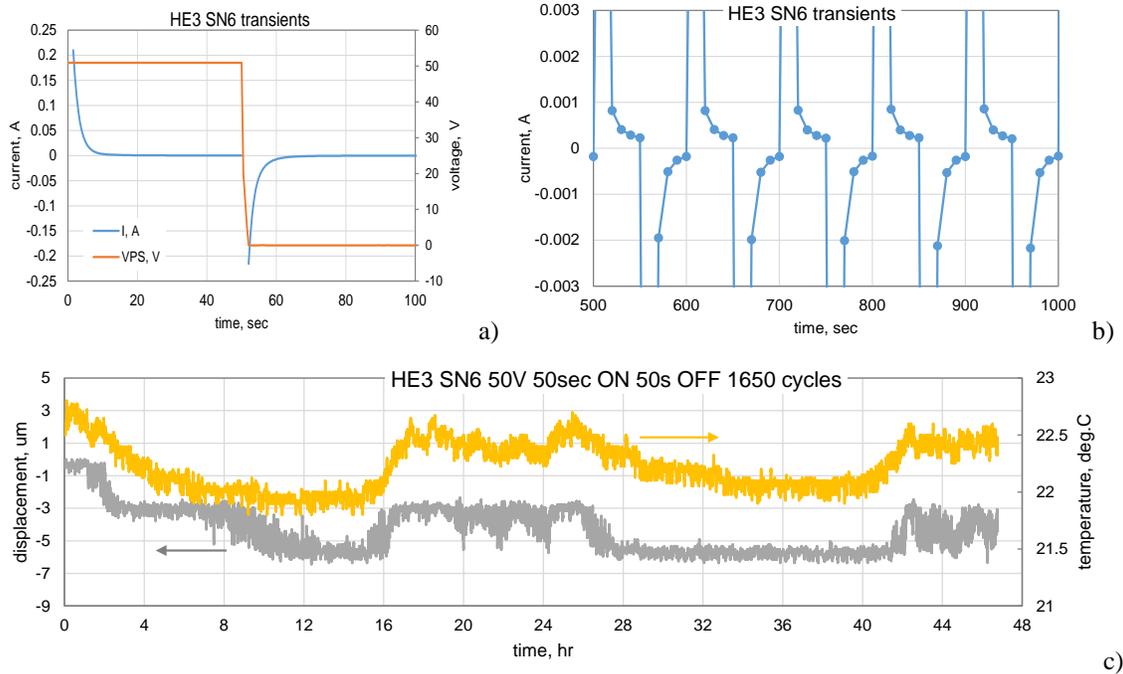
Figure 15. Current transients during 50 sec ON/50 sec OFF cycling in HE3 capacitors during one cycle (a), during several cycles (b), and variations of the displacement and temperature during 1650 cycles (c).

No systematic increase in the displacement that would be expected in case of gas generation as a result of transients was observed (see Fig. 15c). However, there was a clear correlation between the displacement and temperature variations in the room. Variations of temperature ~ 0.5 $^{\circ}$ C resulted in the lid displacement of ~ 2 μ m.

After that the part was stressed at room temperature by 1000 voltage cycles with each cycle having 60 sec at 50 V and 100 sec at 0 V. Similar to HE3 SN6 (Fig. 15) multiple high current transients did not cause substantial variations of the displacement.

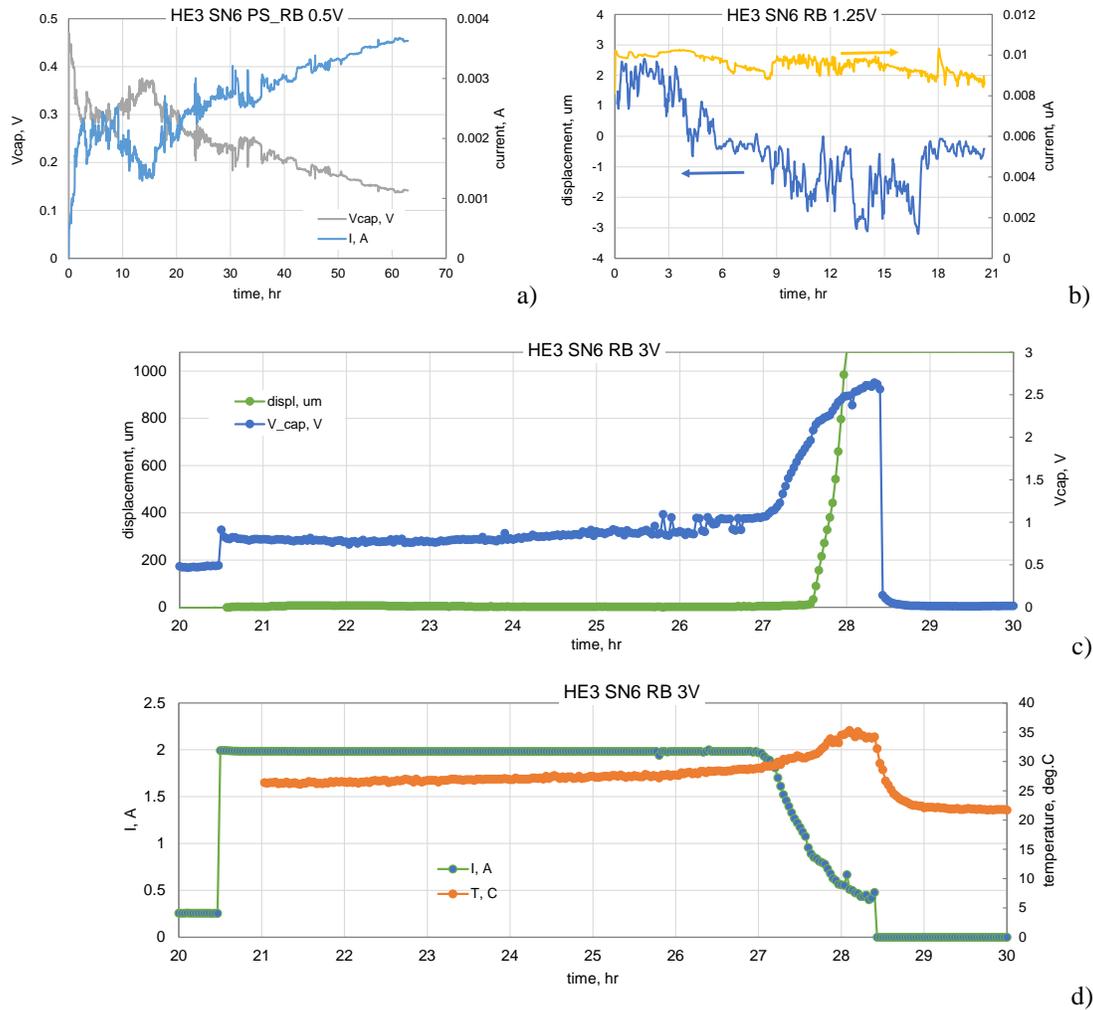
Figure 16. Reverse bias testing of HE3 capacitor SN6 under PS = 0.5 V and $R_{sens}= 100$ ohm (a), PS = 1.25 V and $R_{sens}= 100$ ohm (b), and PS = 3 V and $R_{sens}= 10$ ohm up to 20.5 hours and 1 ohm after 20.5 hr (c, d). The power supply was turned off after 28.4 hours.

After that, the current sense resistor was reduced to 1 ohm. Results of this testing are shown in Fig. 16 c, d. The reverse voltage across the capacitor increased instantly to ~ 0.75 V and the current to ~ 2 A (maximum PS current). Case temperature raised above the environmental temperature of 22°C by $\sim 3^\circ\text{C}$ in approximately one hour, and then increased gradually up to $\sim 30^\circ\text{C}$ after 7 hours of testing. After 27 hours, the current started decreasing and voltage across the capacitor increasing. The process lasted approximately 1.5 hour, during which deformation increased substantially at a rate ~ 50 $\mu\text{m}/\text{min}$. Eventually, deformation exceeded 1 mm and reached the limit of the test set-up, 1.05 mm. Temperature during this period increased to 35°C . After 28.4 hours the power supply voltage was switched to 0 V and testing continued for several hours more. The temperature returned to 22°C in ~ 30 min, but the displacement remained above 1.05 mm.

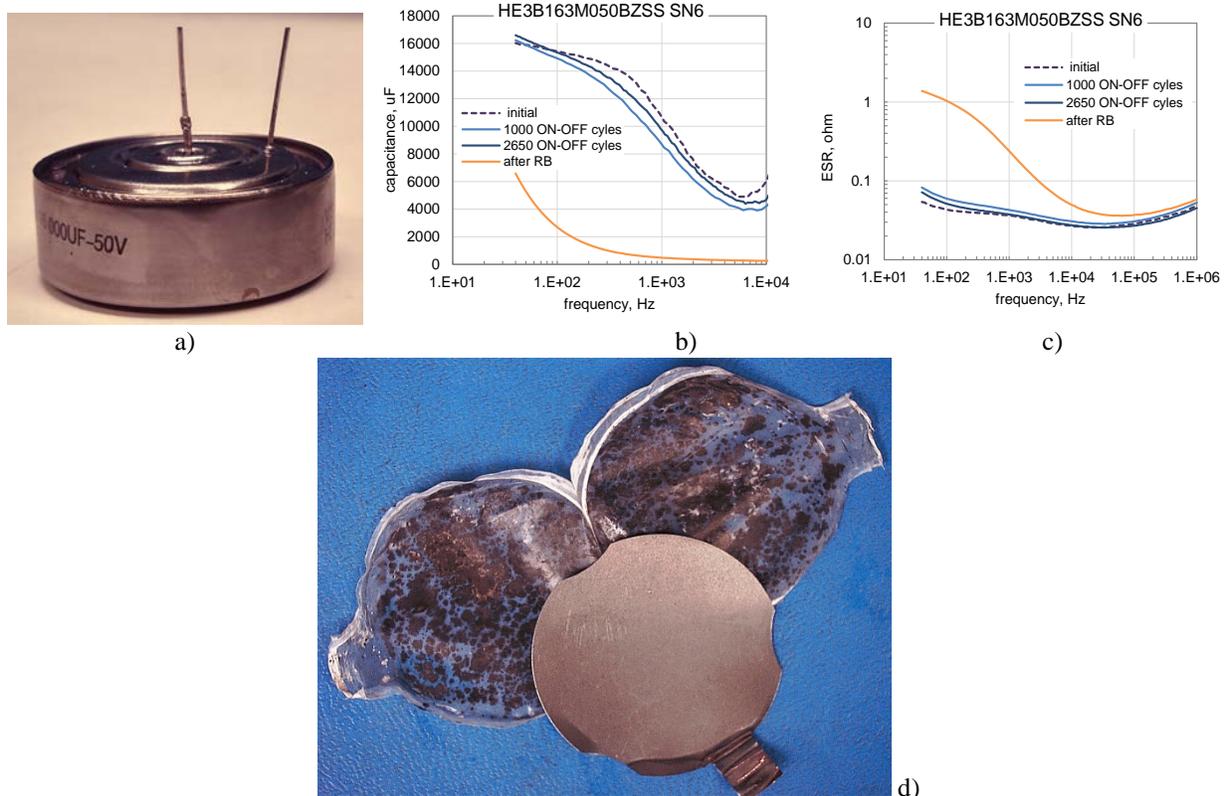
Figure 17. An overall view of SN6 after reverse bias testing showing bulging of the case (a) and frequency dependencies of capacitance (b) and ESR (c). Tantalum cathode plate and polymer separators with remnant of the cathode layer (d).

A substantial bulging of the case after testing could be observed visually, see Fig. 17a. However, the case was not compromised and no electrolyte leak or hermeticity loss was detected. The part was shorted and had a current of > 10 mA at 50 V. Frequency dependencies of the part showed a substantial reduction of capacitance and increase in ESR (see Fig. 17 b, c). Internal examinations (Fig.17.d) revealed delamination of the cathode coating from the tantalum plate that explains a substantial decrease in capacitance.

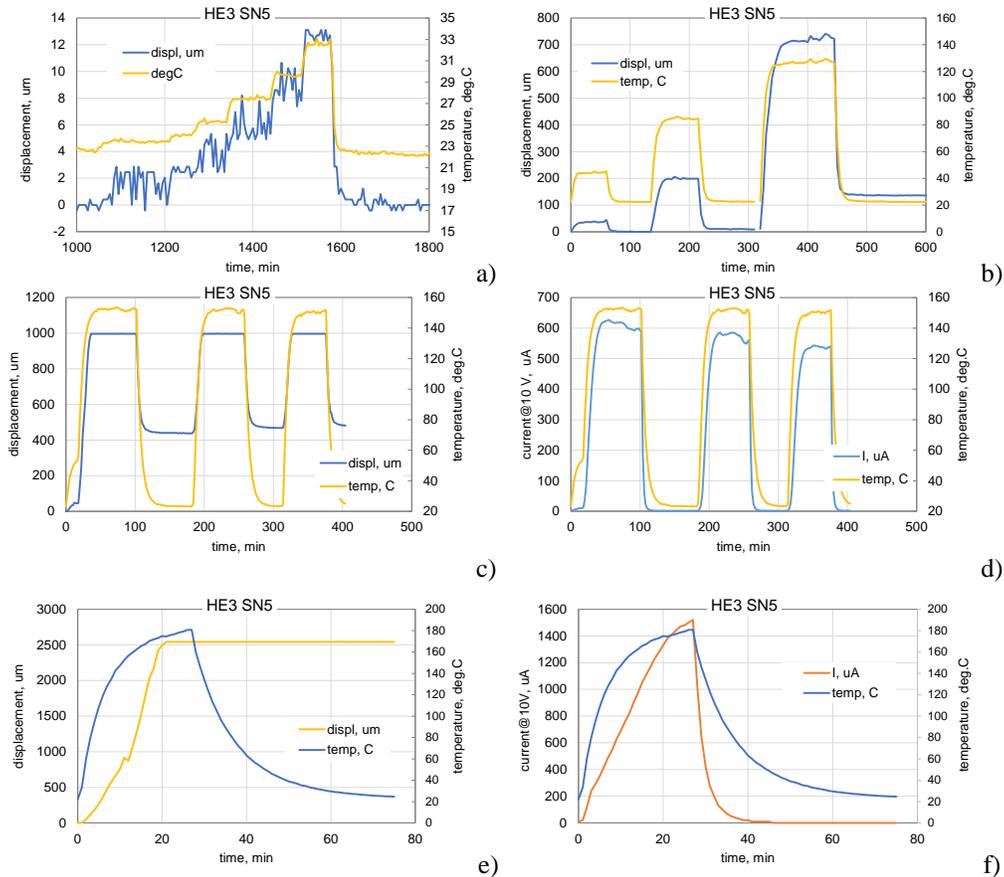
Figure 18. Displacements in HE3 SN5 during temperature cycling.

Displacements in another sample of HE3 capacitors, SN5, were measured during temperature cycling caused by power cycling of the heaters. The amplitude of voltage pulses applied to the heaters increased incrementally to allow temperature stabilization at different levels. Typically, temperature stabilized approximately in 20 min after voltage application. Results of this testing are shown in Fig. 18. Temperature excursions up to 100 $^{\circ}\text{C}$ resulted in reversible deformation of the case. After exposure to 125 $^{\circ}\text{C}$, the displacement reached 700 μm and irreversible deformation of 25 μm was recorded (see Fig. 18b). When temperature exceeded 140 $^{\circ}\text{C}$, the displacement exceeded 1 mm and irreversible deformation increased to 450 μm . To assure measurements at high temperatures, the set-up was changed to the maximum value of 2500 μm . This maximum was reached at 180 $^{\circ}\text{C}$ (see Fig. 18d) and remained stable after the heating power was turned off. Currents through the capacitor during the testing that were measured at 10 V increased up to 0.6 mA. This resulted in 6 mW dissipated power that should not have caused any substantial additional increase in the temperature.

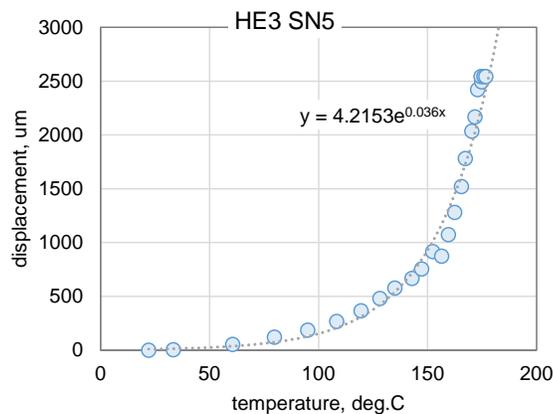
Figure 19. Variation of displacement with temperature for SN5.

Based on test results, variations of the displacement with temperature are plotted on Fig. 19. Temperature rise increased displacement exponentially up to 2.5 mm at ~175 °C.

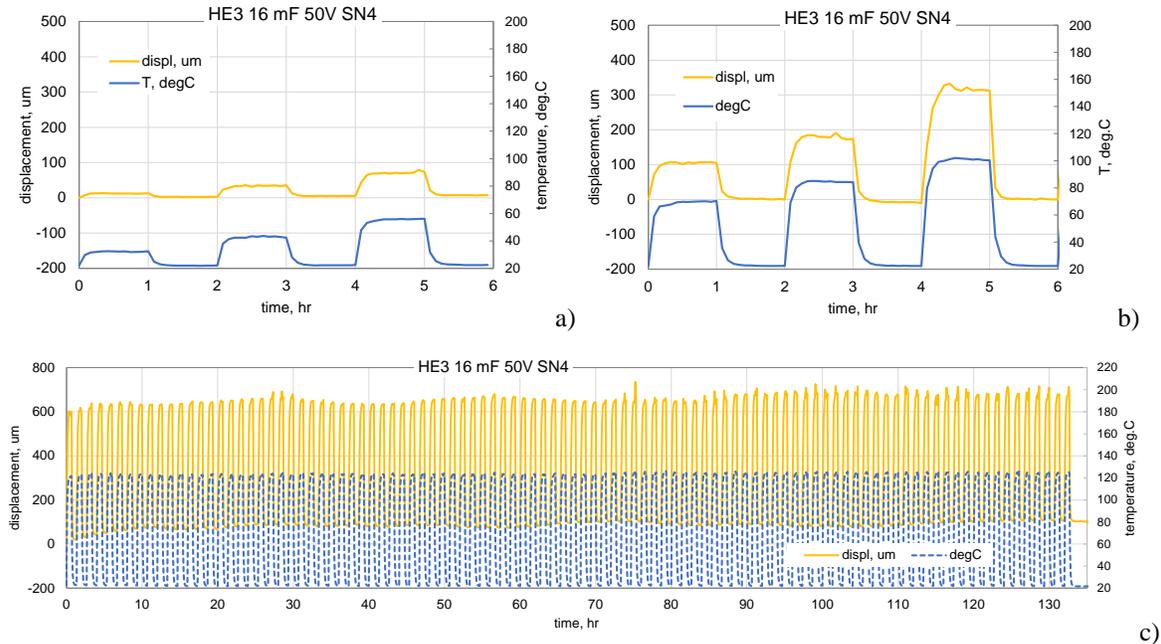
Figure 20. Displacement during power cycling in sample SN4 of HE3 capacitors.

After that, the part was stressed by 100 cycles (40 min ON and 40 min OFF) that resulted in temperature increase to 125 °C and displacement to ~ 650 μm (see Fig. 20c). No substantial changes in the amplitude of displacement during this testing was observed. Deformation was reversible during first tests and by the end of testing irreversible deformation reached ~100 μm.

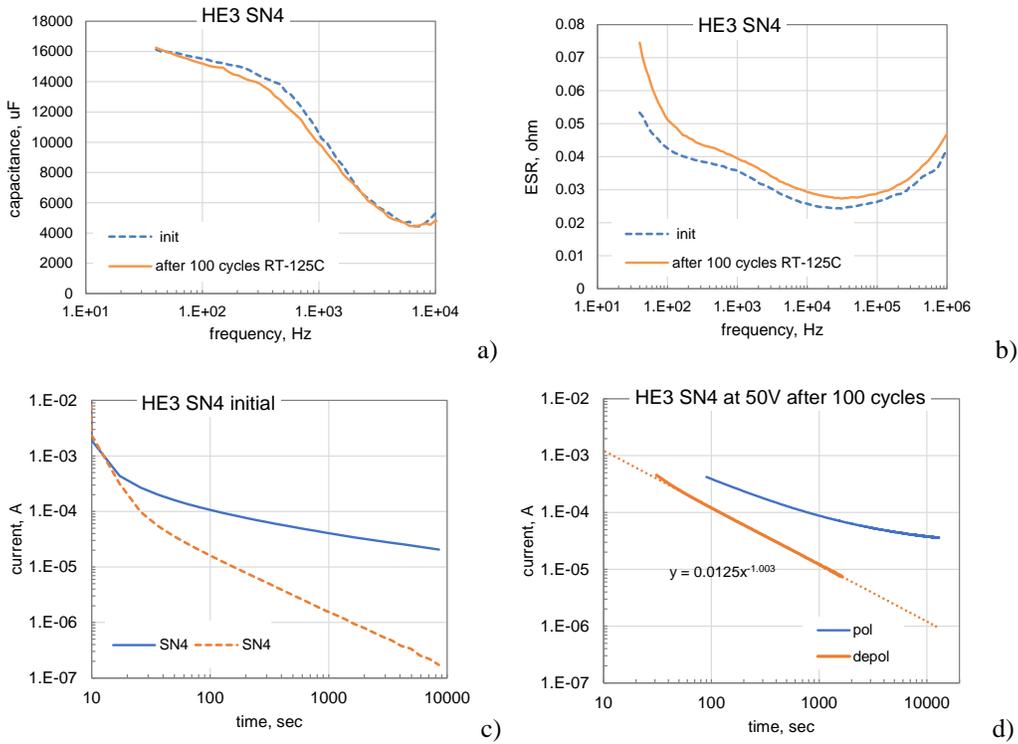
Figure 21. Frequency dependencies of capacitance (a) and ESR (b) and initial (c) and post-cycling relaxations of polarization (50 V) and depolarization (0 V) currents in SN4 HE3 capacitor.

Temperature cycling did not cause any substantial changes in frequency dependencies of capacitance and ESR (see Fig. 21 a, b). However, measurements of leakage currents showed that both polarization and depolarization currents increased (see Fig. 21 c, d). Current readings taken after 1000 sec increased more than two times. Note, that relaxation currents were measured initially using 100 ohm and after cycling using 10 ohm sense resistors. This resulted in different charging/discharging timing and a slower relaxation initially.

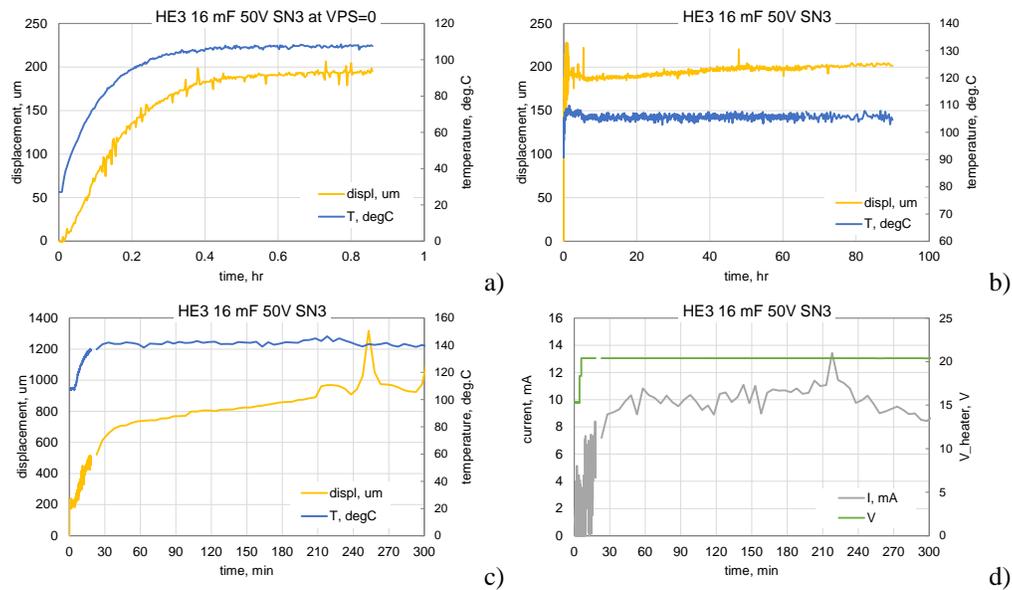
Figure 22. Displacement testing of sample HE3 SN3 at temperatures stabilizing at 105 °C (a, b) and 140 °C (c, d).

An HE3 sample SN3 that had no case defects and showed normal electrical characteristics after HALT was tested for displacement first with no bias applied and temperature increasing from room to 105 °C. This resulted in ~90 μm of the case deformation (see Fig.21). After temperature stabilized, a forward bias of 50 V was applied. Currents increased during the first 30 min up to 2.7 mA, and then gradually decreased to ~ 1 mA after 90 hours. Displacement slightly increased during this testing from 185 μm to 203 μm (Fig. 22b).

After testing at 105 °C, voltage on the heater was increased so the temperature rose to 140 °C while the part remained at 50 V bias. At 140 °C the current increased to ~ 8 mA and displacement rose to ~650 μm. After temperature stabilization the displacement continued increasing from ~650 μm to ~900 μm after 4 hours of testing. Continued testing resulted in a displacement spike up to 1300 μm, and electrolyte vapor leaking from the glass seal area was observed. For this reason, testing at 140 °C was terminated after 5 hours.

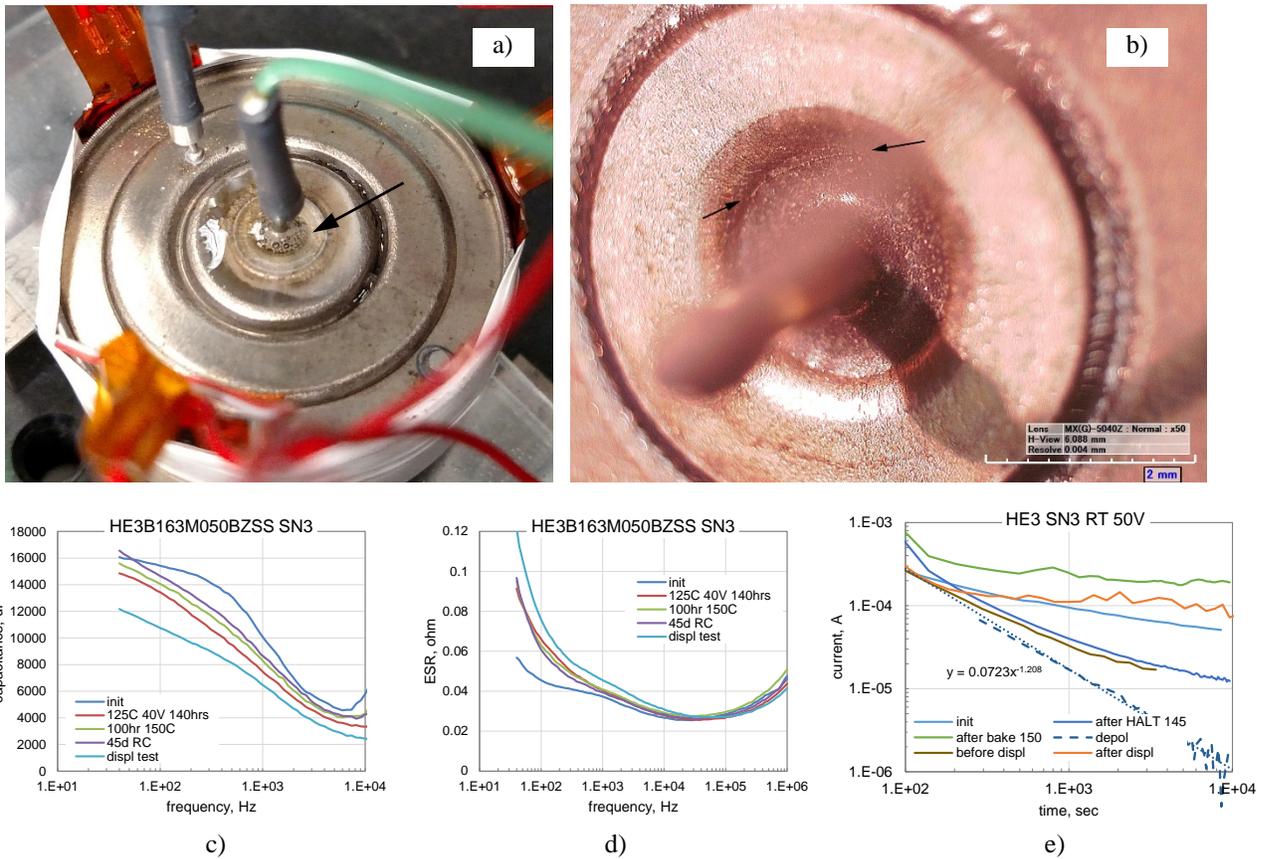
Figure 23. External views (a, b) and electrical characteristics (c, d, e) of capacitor HE3 SN3 after displacement testing. Arrows in Fig. (b) show location of a crack in the glass that resulted in electrolyte leak. Dashed line in Fig (e) corresponds to absorption (depolarization) currents.

Visual examinations of sample SN3 showed a large amount of electrolyte and bubbles in the central area of the lid (see Fig. 23a). Optical examinations revealed a crack in the glass (Fig. 23b) that most likely was due to the high internal pressure developed by the generated gas during testing at high temperatures.

Electrolyte leak resulted in a substantial decrease of capacitance, from 15.2 mF initially (at 120 Hz) to 10.4 mF after the testing, and increasing ESR, from 0.0371 ohm to 0.0452 ohm at 1 kHz, (see Fig. 23 c, d). Note that ESR only marginally exceeded the specified limit of 0.045 ohm. Leakage currents measured after 1000 sec of electrification (~ 110 μ A) increased compared to the post-HALT results, but still remained below the specified limit.

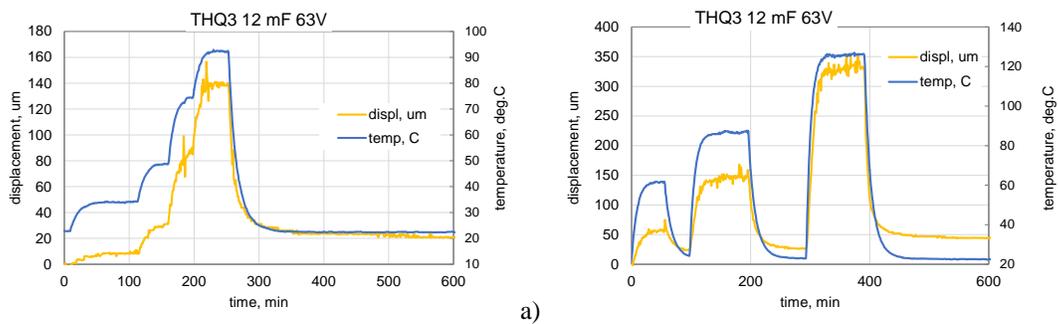
Figure 24. Variation of displacement with time at different levels of the heaters' power for a THQ3 capacitor.

Displacements for a sample of THQ3063123 capacitors was first measured at different levels of the power on heaters. Temperature was stabilized at different levels in the range from 33 °C to 125 °C and the relevant displacements varied from 7 μm to 330 μm (see Fig. 24).

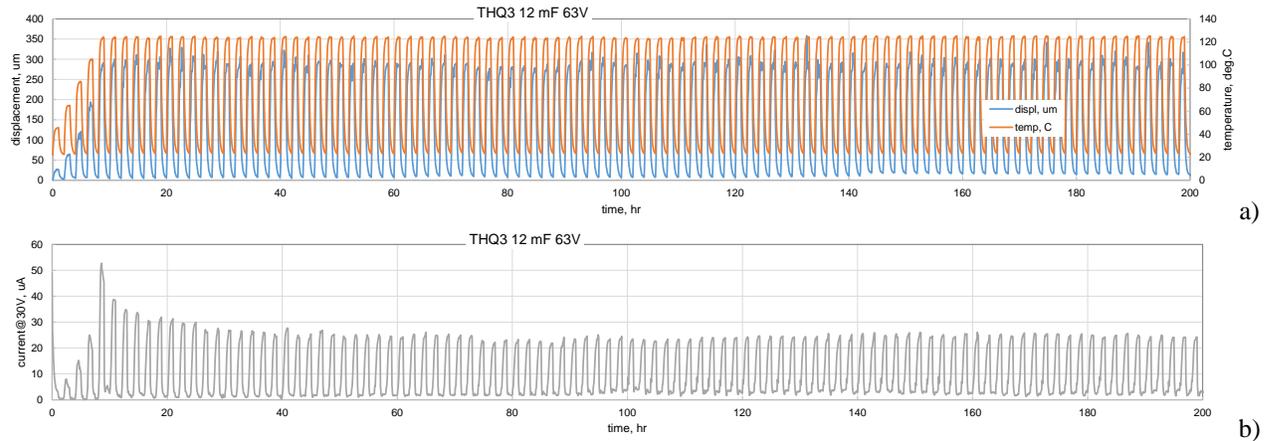
Figure 25. Variations of displacement and temperature (a) and current at 30V (b) during temperature cycling testing of a THQ3063123 capacitor.

The next testing with THQ3 capacitor was carried out during 100 temperature cycles when the heaters were ON for one hour and OFF also for one hour while the voltage across the capacitor was maintained at 30 V. Results of this testing are shown in Fig. 25. Note that the first five cycles were carried out with increasing power of the heater, and the 100 cycle test started after maximum temperature reached 125 °C. Displacement during this testing changed periodically from 0 to ~ 300 μm and current increased up to 30 μA during the first 125 °C cycle, but then stabilized at ~ 25 μA.
