NASA Electronic Parts and Packaging (NEPP) Program

NEPP Task: Reliability of Advanced Wet and Solid Tantalum Capacitors

Deformation of Cases in High Capacitance Value Wet Tantalum Capacitors under Environmental Stresses

Alexander Teverovsky

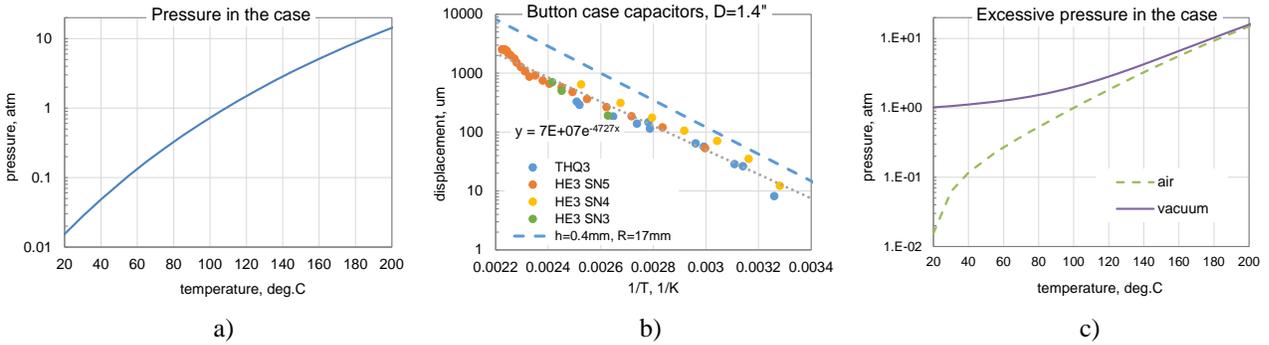
Figure 26. Variations of the internal case pressure (a), case displacement (b) and excessive pressure (c) with temperature. Dashed line in (b) indicates calculations based on Eq.(4).

Variations of the pressure in atm with temperature calculated per Eq.(1) are shown in Fig. 26a. Note that the chart shows an excessive pressure caused by the electrolyte vapor. The total pressure is a sum of the air pressure in the can and the vapor pressure. The air pressure in the can at room temperature is 1 atm and increases linearly with the absolute temperature according to the gas law. In vacuum, the excessive pressure will be 1 atm already at room temperature. According to chart Fig. 26a, the excessive pressure and deformation of the case in space would be equivalent to terrestrial conditions at ~ 105 °C.

Excessive pressure in air is $\Delta P_{air} = \Delta P_{vac} - P_0$. Temperature variations of ΔP_{air} and ΔP_{vac} are shown in Fig.26c. According to this chart, the excessive pressure in vacuum at 85 °C would be equivalent to excessive pressure in air at 117 °C. In this regard, storing or operating in vacuum at 125 °C would be equivalent to storing or operating in air at 140 °C. Assuming a 10 °C margin, to assure that the part can operate in vacuum at 125 °C, high temperature storage (HTS) testing at 150 °C for 1000 hours is recommended. If maximum operating temperature can be reduced to 85 °C, the HTS testing can be carried out at 125 °C.

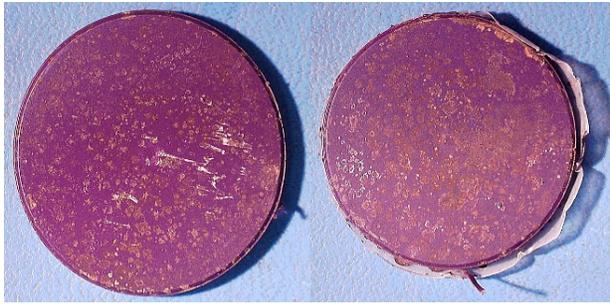
a) Spots on the surfaces of tantalum slugs.

Large transfer charges during reverse bias testing that did not result in any substantial gas generation indicate a non-Faradaic charge transfer. This is possible if shorts between the anode slug and cathode plates are formed. Internal examinations and XRF analysis revealed spots of Cu/Pd compositions on the surface of polymer separators (see Fig 17.d). Similar spots were also observed on the surface of the tantalum slugs (see Fig. 26). Most likely, ions of copper and palladium under reverse bias conditions are migrating to the slug and depositing on its surface. Some deposits are also formed on the porous separators thus creating a short and allowing electron transport across the formed metal bridges. Note that at the specific resistivity of palladium of ~1E-7 ohm*m, a tiny wire with a length of 0.1 mm and diameter of 3 μm would result in a 1 ohm short.

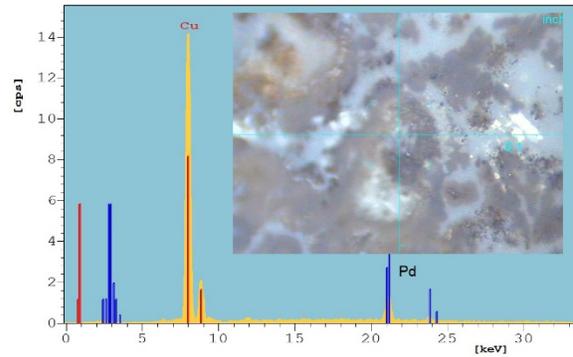
b) XRF spectrum of the dark area on the separator indicating Cu and Pd.

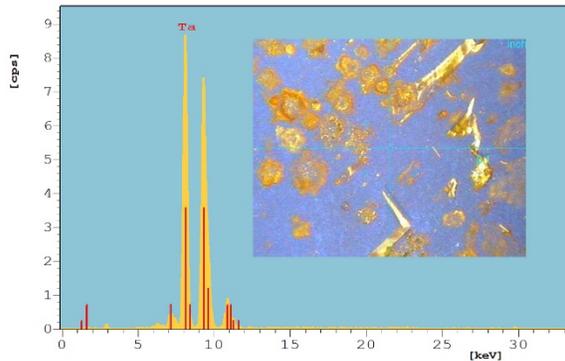
c) XRF of clean area on the slug showing Ta

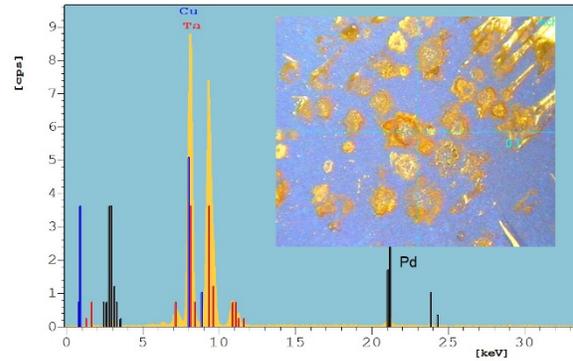
d) XRF of spot area on the slug showing Ta, Cu and Pd.
