Experimental Durability Testing of 4H SiC JFET Integrated Circuit Technology at 727 °C

David J. Spry¹, Philip G. Neudeck¹, Liangyu Chen²,
Carl W. Chang³, Dorothy Lukco³, Glenn M. Beheim¹

¹NASA Glenn Research Center

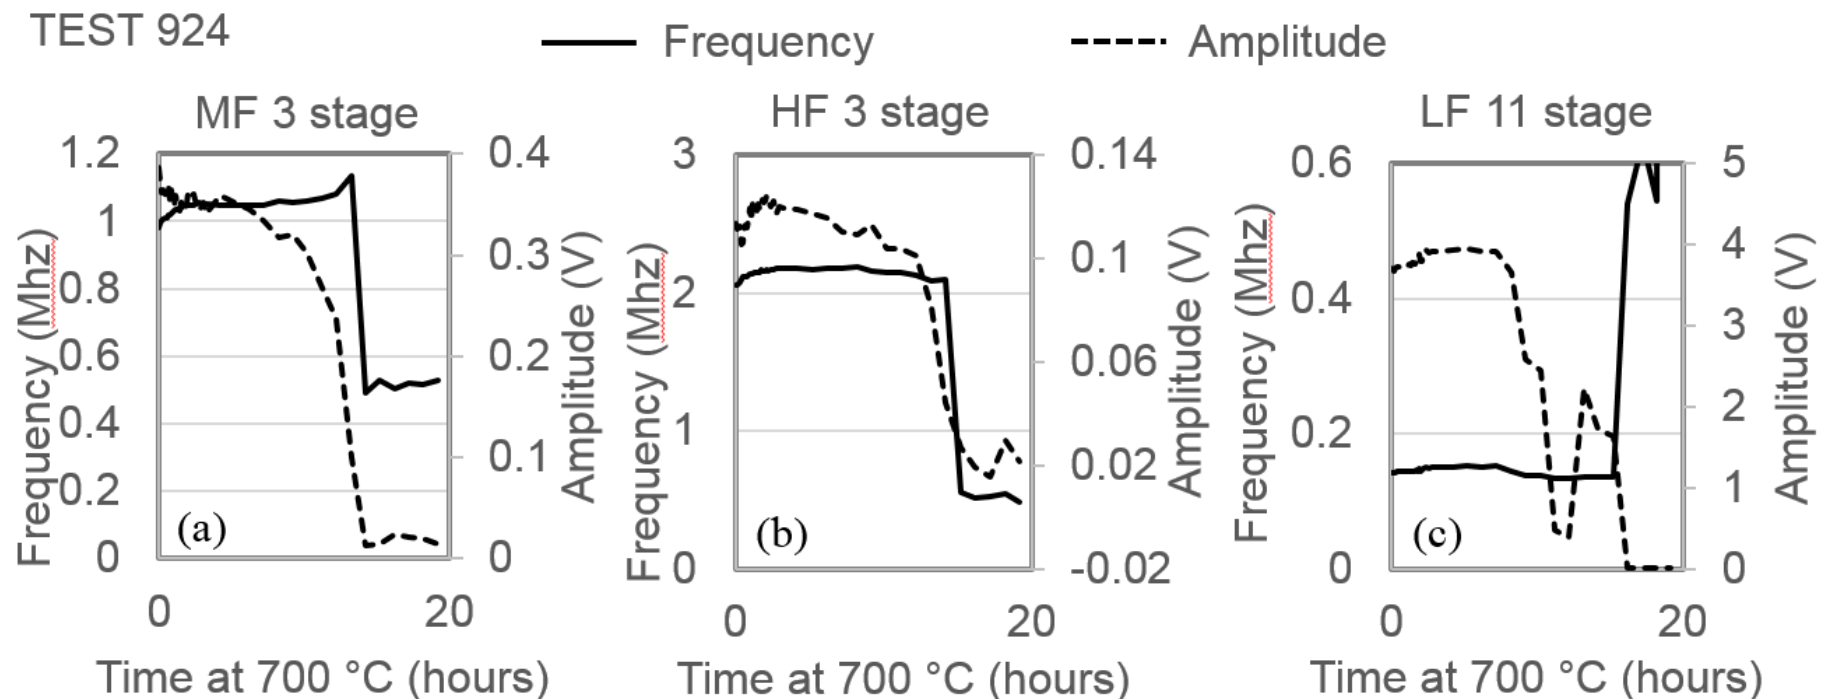
- Plot of frequency and amplitude output of 3 different ring oscillators
- HF lasted the longest possibly since it had the least lead oxide on it.
- LF had an intermittent failure at 10 hours.
- All three the output amplitude first started to drop at 8 hours.

VSS=-20V and VDD=25V

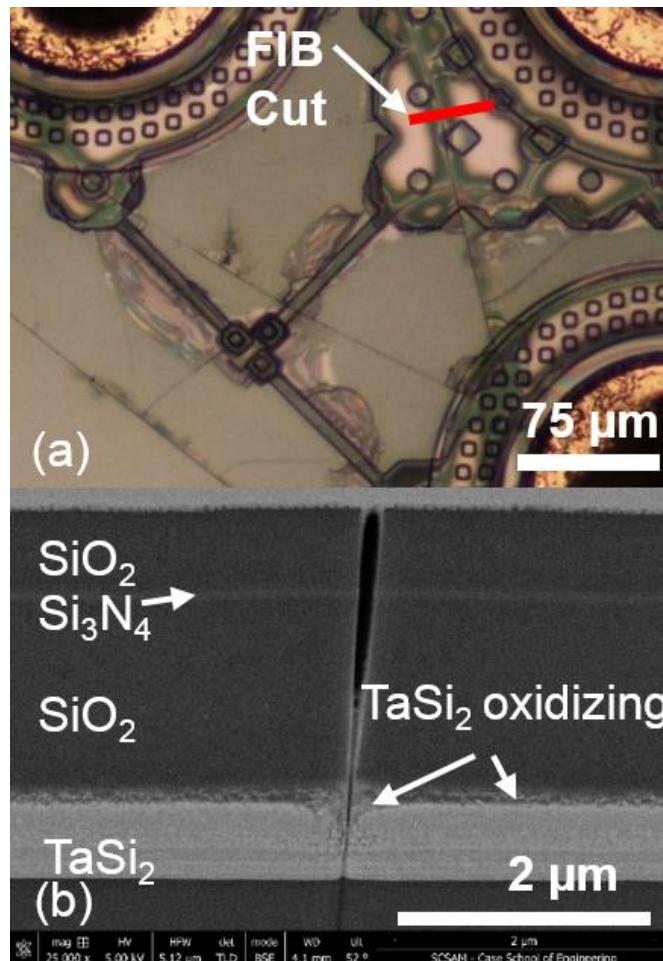
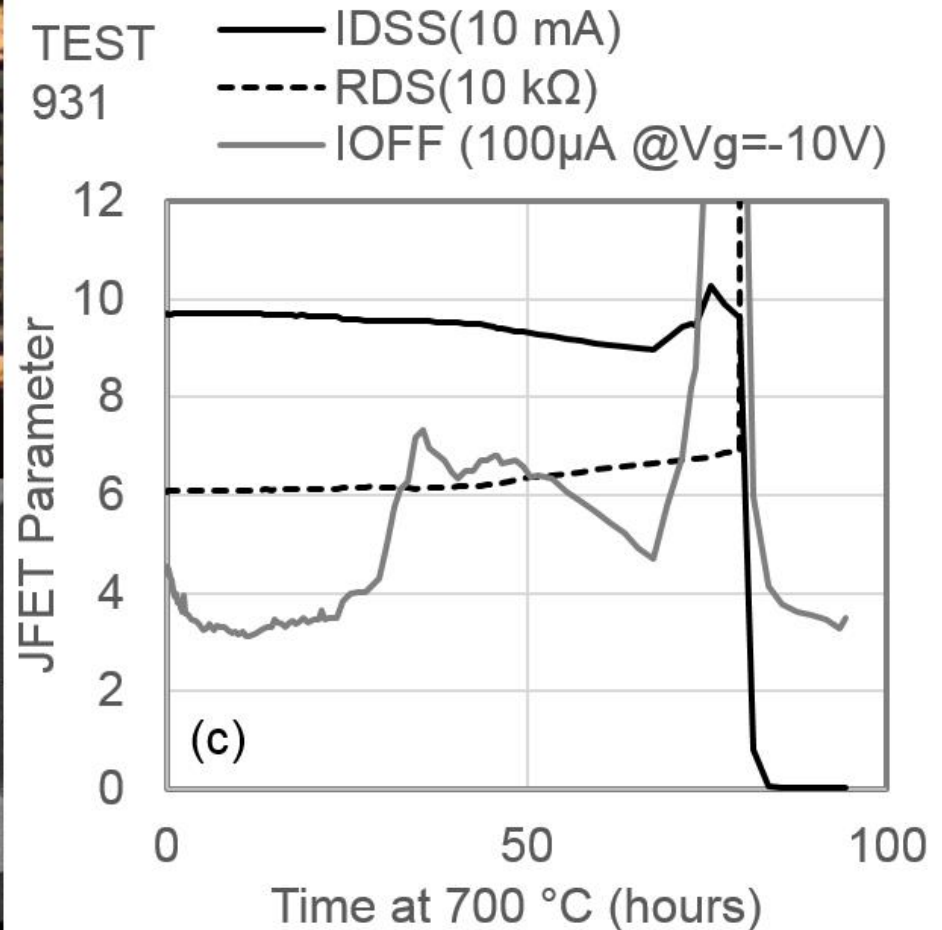
- (b) FESEM image of a FIB prepared cross-section of a crack. The crack allowed the TaSi₂ to oxidize.
- (c) JFET IOFF started shifting at 25 hour but with did not fail like 6A2.

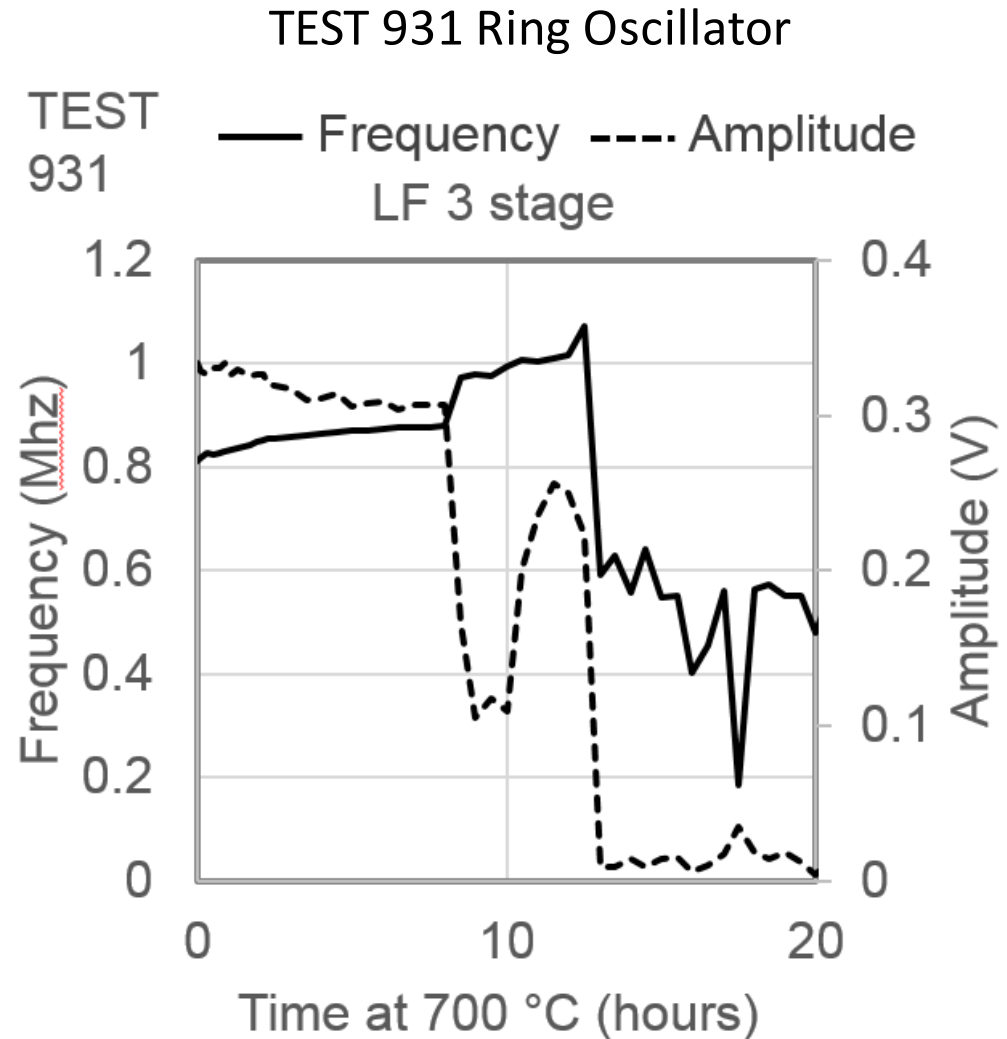
- The LF 3-stage ring oscillator of test 931 started to fail intermittently at 8 hours, similar to the LF 11 stage from 924.
- The three ring oscillators of test 924 and the ring oscillator of test 931 (shown right) all exhibited a shift in amplitude 8 hours into 700 °C testing suggests a possibly common mode/location of failure for these integrated circuits.

VSS=-25V and VDD=25V

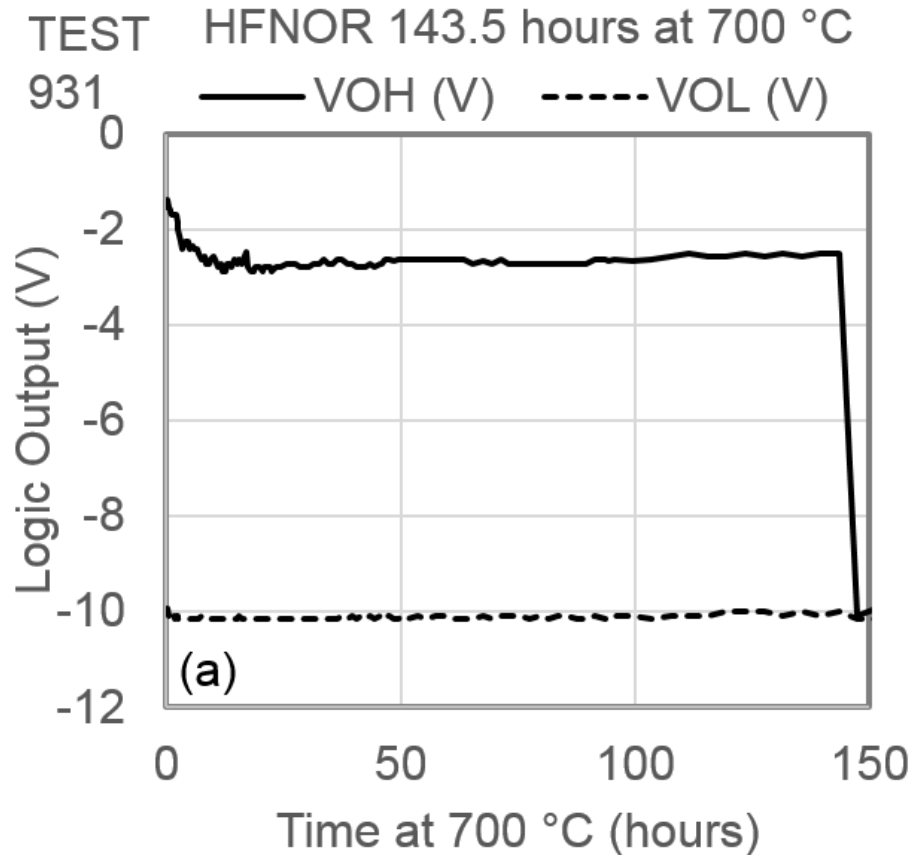
Output high and output low values as functions of time at 700 °C

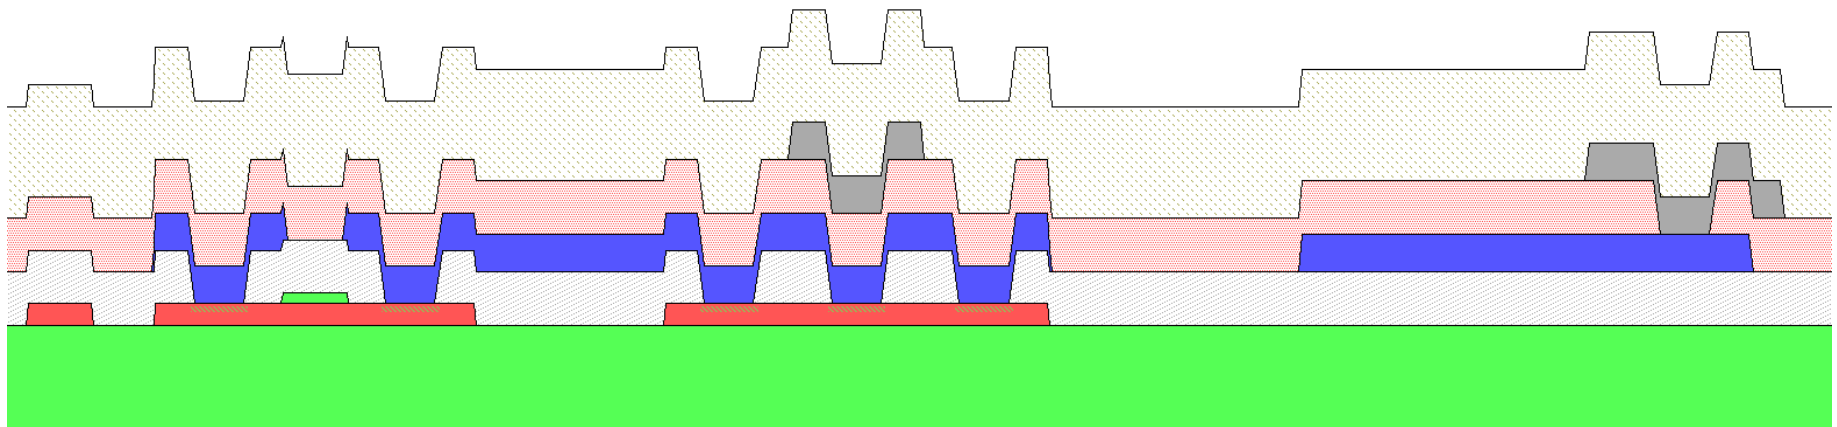
- Dry etch of metal 3.
