Acoustic Detection of Faults and Degradation in a High-Bypass Turbofan Engine During Vehicle Integrated Propulsion Research (VIPR) Phase III Testing

Devin K. Boyle

NASA Armstrong Flight Research Center

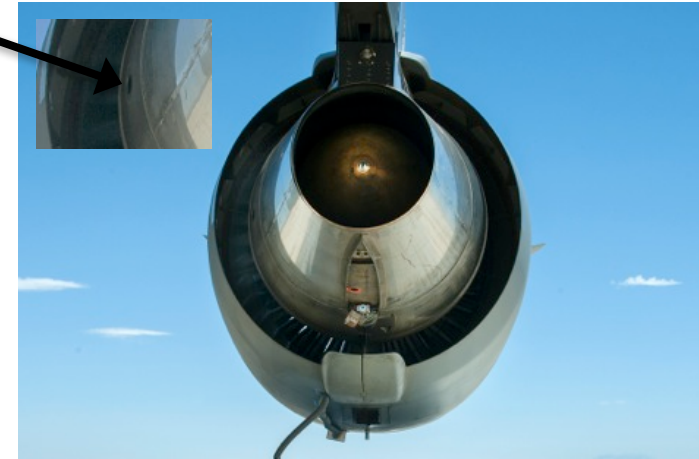
14th Stage (HPC)

- $F_n \sim 40,000 \text{ lbf}$
- $BPR = 6$
