Post-test Inspection of NASA's Evolutionary Xenon Thruster Long Duration Test Hardware: Ion Optics

George C. Soulas¹ and Rohit Shastry²
NASA Glenn Research Center, Cleveland, OH, 44135

A Long Duration Test (LDT) was initiated in June 2005 as a part of NASA's Evolutionary Xenon Thruster (NEXT) service life validation approach. Testing was voluntarily terminated in February 2014, with the thruster accumulating 51,184 hours of operation, processing 918 kg of xenon propellant, and delivering 35.5 MN-s of total impulse. The post-test inspection objectives for the ion optics were derived from the original NEXT LDT test objectives, such as service life model validation, and expanded to encompass other goals that included verification of in situ measurements, test issue root causes, and past design changes. The ion optics cold grid gap had decreased only by an average of 7% of pretest center grid gap, so efforts to stabilize NEXT grid gap were largely successful. The upstream screen grid surface exhibited a chamfered erosion pattern. Screen grid thicknesses were $\geq 86\%$ of the estimated pretest thickness, indicating that the screen grid has substantial service life remaining. Deposit

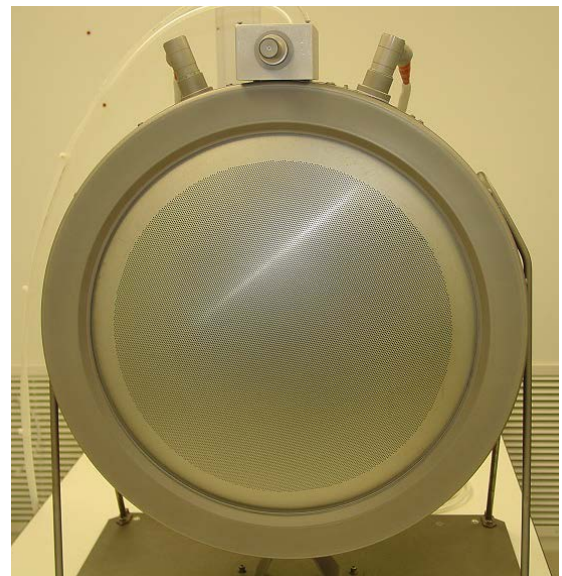
Figure 1. Pretest image of the NEXT LDT thruster.

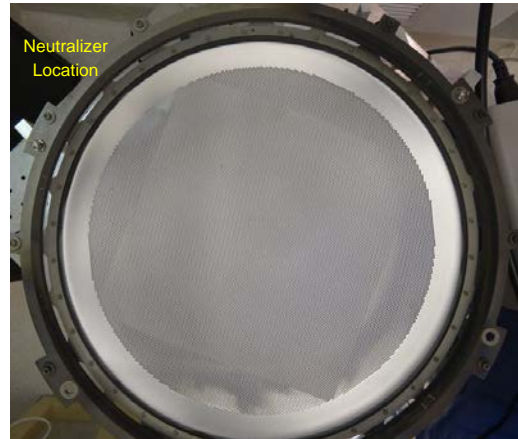
Figure 3. Post-test upstream screen grid mounted to the ion optics assembly. The orientation of the neutralizer is shown.

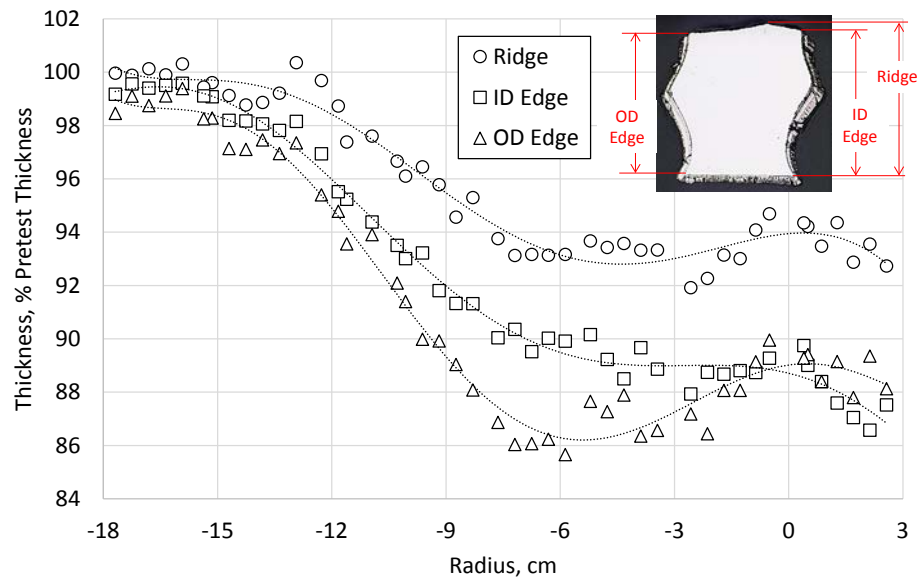
Screen grid thicknesses were measured from the webbing photomicrographs. Figure 8 shows the thicknesses as a function of radial location at the three locations indicated on the webbing in the plot. Results are shown as a percentage of the estimated pretest thickness, which includes grid thinning as a result of the grid forming process. The smallest screen ridge thickness was 92% of the estimated pretest thickness. The smallest overall thickness was 86% of the estimated pretest thickness. Figure 8 further shows that the worst case erosion was off-center by about 6 cm. The off-center, worst case erosion may be an artifact of the annular-shaped, doubly-charged ion current density radial profile from the NEXT discharge chamber.²² At 25 V, which is an approximate LDT discharge voltage, doubly-charged ions eroded the screen grid with a sputter yield that is 350 times that of singly charged ions.²³ As a result, doubly-charged ions can dominate screen grid erosion near the grid center where plasma densities are large. Regardless, because so little of the screen grid thickness was ultimately eroded during the 51.2 kh LDT, test results show that the NEXT screen grid has substantial service life remaining.

Figure 8. Screen grid webbing thicknesses at three webbing locations as a function of radial location along radius B (see Fig. 2). Thicknesses are shown as a percentage of the estimated pretest thickness. Thicknesses > 100% are due to measurement and pretest thickness estimate uncertainties.

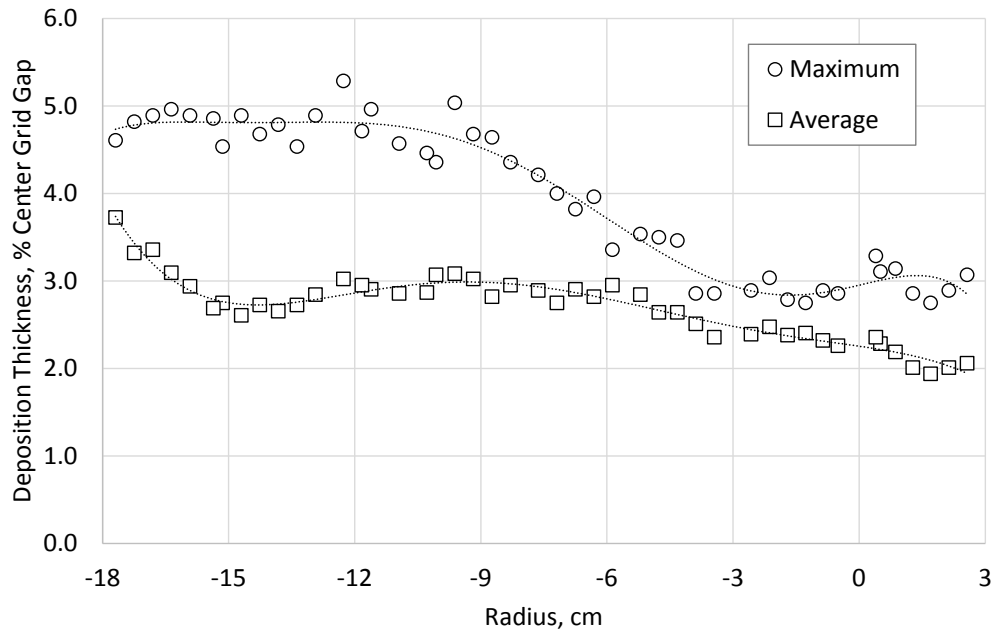
Downstream surface deposition thicknesses are shown in Fig. 13 as a function of radial location. The figure shows that deposition thicknesses were ultimately a small percentage of the cold grid gap. Deposition thicknesses generally increased with increasing radius and the maximum thickness was on the ID side at larger radii. As with aperture wall deposition, this uneven

deposition is most likely the result of the non-uniform accelerator aperture wall erosion discussed earlier. As a result, the downstream webbing ID surface collected more deposition because of its proximity to the erosion site of the accelerator grid. The maximum deposition thicknesses of Fig. 13 were used to correct the measured cold grid gap data to create Fig. 4.

Figure 13. Downstream webbing deposition thicknesses as a function of radial locations along radius B (see Fig. 2). Thicknesses are shown as a percentage of the cold grid gap at the ion optics center. Three measurements at OD, middle, and ID locations were averaged and plotted in the graph.

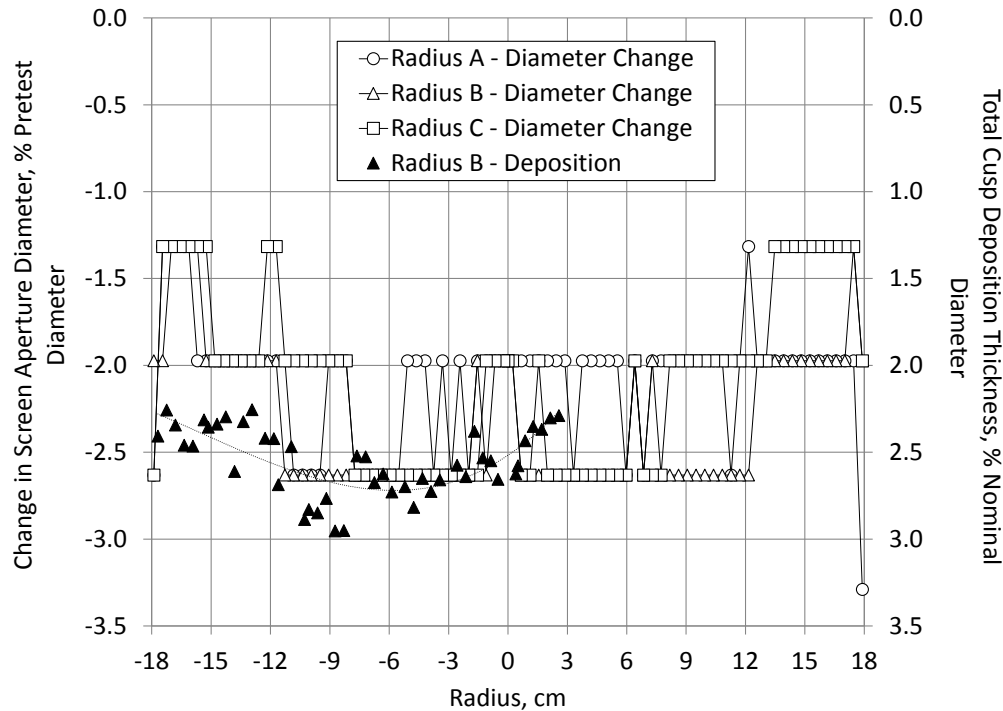
The change in screen grid aperture diameters from pre- to post-test as a function of radius is shown in Fig. 14. As the figure shows, aperture diameters decreased by 1.3-2.6% of the pretest values, with a 2.2% average decrease. Also shown in the figure is the total deposition on both cusps of an aperture measured along radius B. As the figure shows, the deposition on the cusps was responsible for the decrease in screen grid aperture diameters.

Figure 14. Change in screen grid aperture diameter from pre- to post-test as a function of radial location along three optics radii. Also included is the screen aperture wall deposition measured along radius B (see Fig. 2) at both cusps of an aperture. Aperture diameters were measured with pin gages in increments of 0.67% of the nominal screen aperture diameter. Changes in aperture diameter are expressed as a percentage of the pretest measurement and deposition thickness as a percentage of the nominal screen aperture diameter.

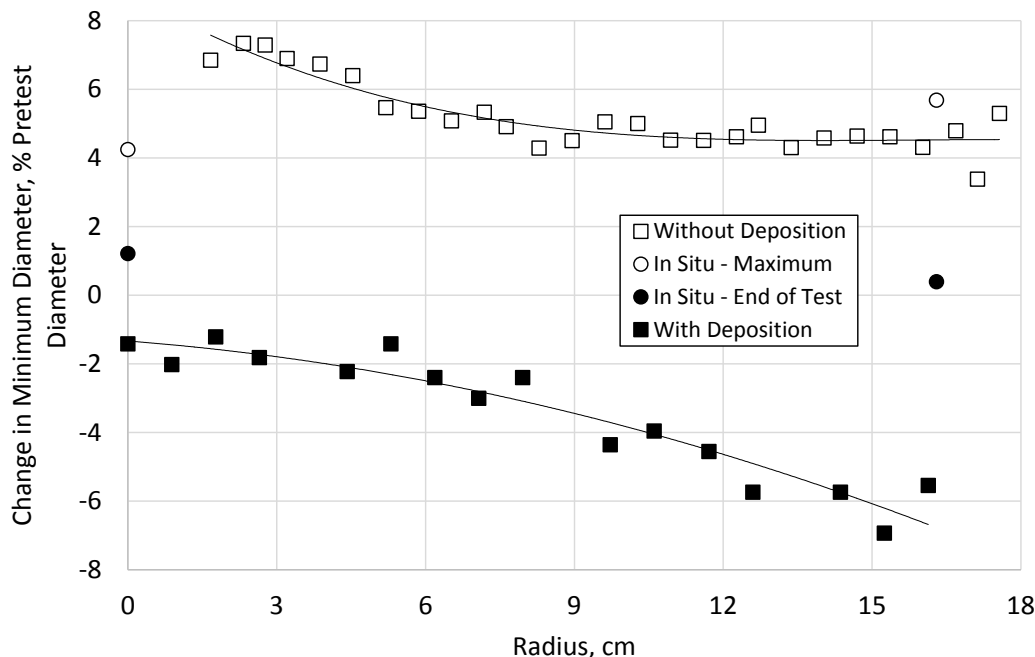
Post-test aperture diameters as a function of radial location are shown in Fig. 20 for the minimum diameters and in Fig. 21 for the downstream and upstream surface diameters. For both figures, non-contact methods were used to make these measurements. Also included in both figures are in situ measurements for the ion optics center aperture and an aperture at a radius of 16.3 cm. All results are shown as changes relative to the measured pretest diameters, which were within $\pm 2\%$ of the average diameter. The tighter manufactured tolerances of the pretest PM accelerator aperture diameters represented a significant improvement over prior NEXT accelerator grids.⁶

Figure 20. Change in accelerator grid aperture minimum diameter from pre- to post-test as a function of radial location along radius A (see Fig. 2). Also included are the maximum and end of test in situ measurements. Changes in aperture diameter are expressed as a percentage of pretest measurements.
