# Microstructural and Material Quality Effects on Rolling Contact Fatigue of Highly Elastic Intermetallic NiTi Ball Bearings

*Christopher DellaCorte, S. Adam Howard, Fransua Thomas, and Malcolm K. Stanford  
Glenn Research Center, Cleveland, Ohio*

## Abstract

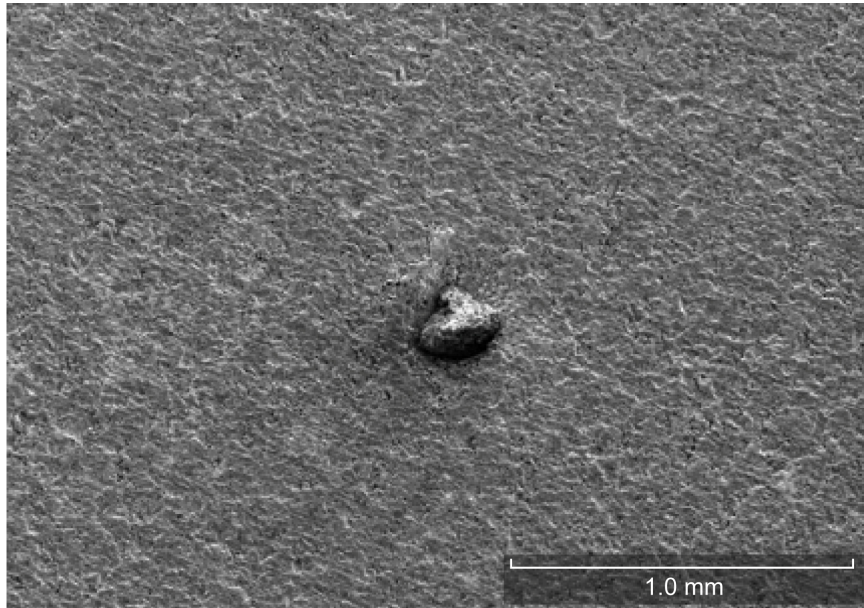
Figure 1.—Ceramic particle inclusions in 60NiTi made by powder metallurgy.

The second RCF test program evaluated the 3 ball-on-rod performance of 60NiTi rods made via powder metallurgy processing (Ref. 5). In that study, the same test protocol used for the cast and hot rolled 60NiTi RCF measurements was applied to RCF rods made via emerging powder metallurgy (PM) processes. The results were bifurcated. PM 60NiTi rods that were of high quality exhibited no failures at the lowest stress levels (1.7 GPa) and only very occasional failures at modest stress level (2.5 GPa). At the highest stresses (3.6 GPa) failure was rapid often occurring in less than 20 hr of run time. Lower quality PM 60NiTi rods made from contaminated batches of powder material showed sporadic failures even at the lowest stress level. Typical material flaws observed included the presence of ceramic particle inclusions and the persistence of prior particle boundaries despite hot isostatic pressing that normally promotes good particle-to-particle diffusion bonding (Refs. 6 and 7). Figures 1 and 2 show such flaws.

The lower quality 60NiTi powder was atomized in a system that introduced ceramic particle contaminants as shown previously in Figure 1. In this process, nickel and titanium metals are melted in a ceramic crucible and injected through a ceramic nozzle into a chamber filled with argon. Contact of the molten 60NiTi with the crucible and nozzle appears to introduce a small quantity of small ceramic particles into the powder. During later consolidation into ingots, the ceramic particles become hard inclusions in the bulk 60NiTi ingot. These small, faceted inclusions are believed to lead to stress risers and fatigue initiation. The nature of the contaminants is well documented in an earlier paper (Ref. 8). It is to be understood by the reader that at the time of production, it was not known that such contamination had occurred. It was only during RCF and full-scale bearing testing that performance issues arose. The general thermophysical and mechanical properties of the lower quality 60NiTi do not appear to be affected by the small-scale inclusions.

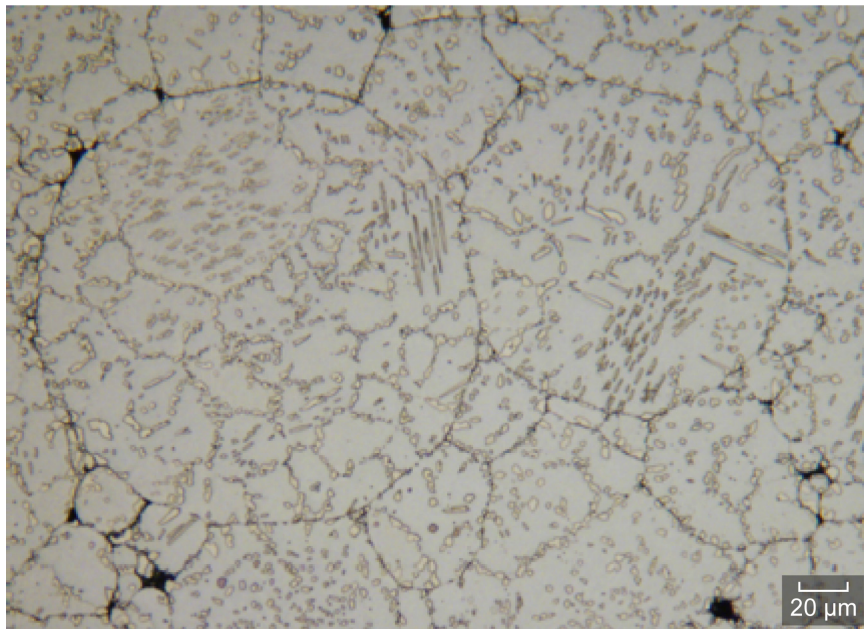
Figure 2.—Unconsolidated particle flaws in powder metallurgy processed 60NiTi resulting from particle surface oxidation.

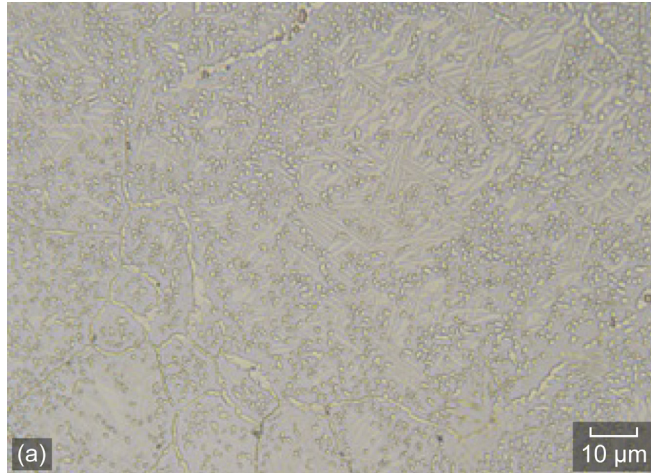
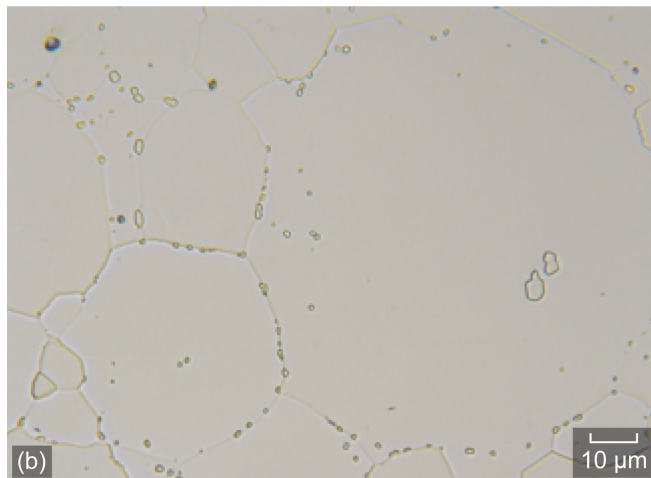
Figure 3.—Metallurgical cross-sections of PM processed 60NiTi: (a) as received, annealed condition, and (b) heat treated, hardened condition. Optical micrographs, acid etched to reveal microstructure.

stream. The argon stream breaks up the drops into smaller droplets that fall into an argon-filled chamber where they solidify into rounded particles. The interior of the tank and associated piping is made from titanium further reducing downstream contamination. Images of the powder have been previously reported (Ref. 9) and cross-section micrographs of the high quality 60NiTi in the as-received (annealed) and heat-treated (hardened) conditions are shown in Figures 3(a) and (b), respectively.

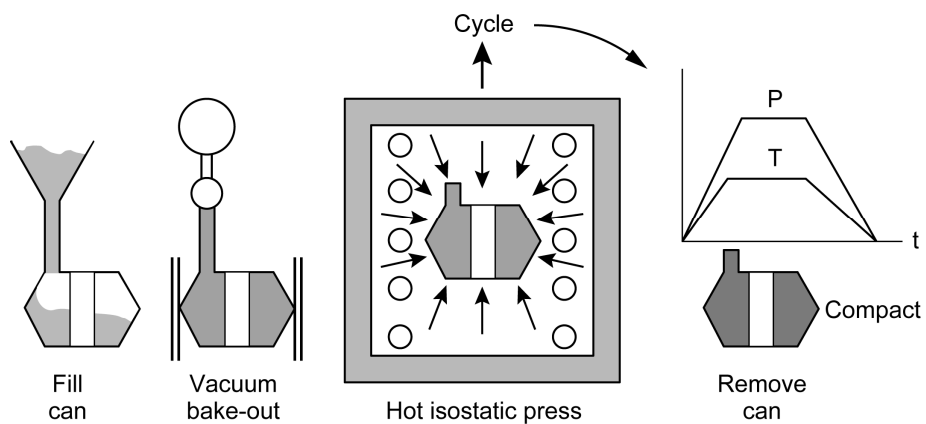
Figure 4.—Powder metallurgy processing route for 60NiTi.

The 60NiTi (60 Ni and 40 Ti by weight%) is processed by powder metallurgy methods into ingots from which 50 mm bore ball bearings and RCF rods are then fabricated. For the present work, starting powder manufactured by both of the aforementioned atomization processes was obtained and made into ingots using the hot-isostatic pressing method as shown in Figure 4 and generally described by Reference 9. Briefly, the pre-alloyed powder is poured into a well-cleaned, mild steel container that is welded shut and evacuated to remove air and moisture from between the NiTi particles. The can is placed into a high-pressure furnace for consolidation. After consolidation, the ingots are slowly furnace cooled in order to avoid hardening that accompanies rapid cooling.

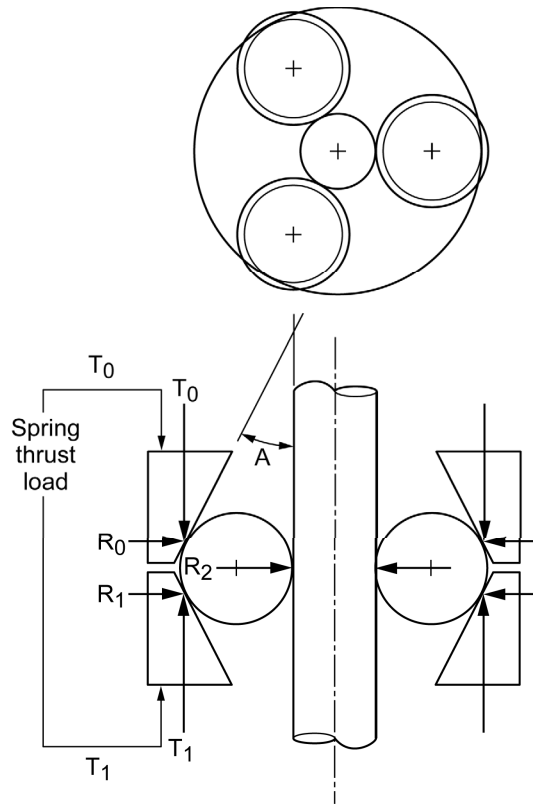
Figure 5.—Sketch of the specimen configuration for the 3 ball-on-rod RCF test.

In the 3 ball-on-rod test, depicted in Figure 5, polished Grade 10 steel bearing balls are loaded against a polished, NiTi rod that rotates at 3600 rpm (Refs. 10 and 11). An oil drip system provides lubrication and an accelerometer is used to monitor vibration. Surface damage, such as the formation of a pit, gives rise to increased vibration that is detected by the accelerometer triggering a halt to the test. If no increase in vibration is detected after 800 hr, indicating no surface damage, the tests are ended and reported as a suspension. Each hour of test time results in the accumulation of approximately one-half million-stress cycles on the test rod.

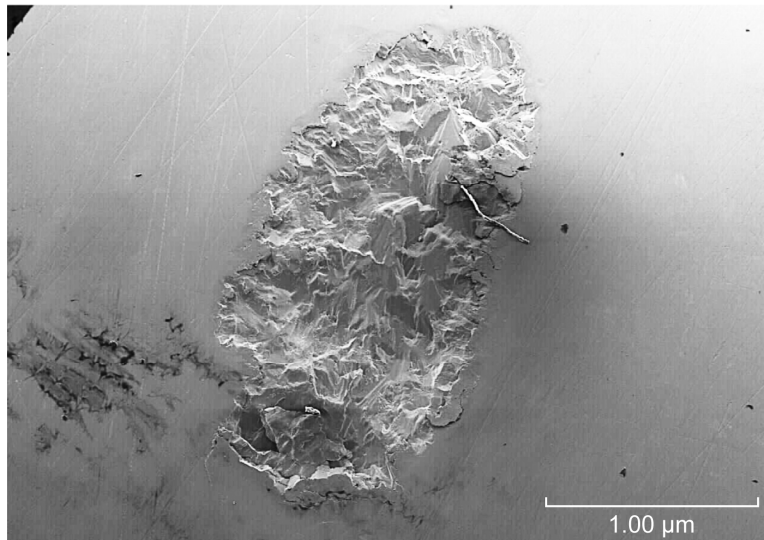
Figure 6.—Scanning electron microscopic (SEM) view of the surface of fatigue spall on PM-60NiTi RCF rod.

Figures 6 to 8 depict typical surface damage in 60NiTi. The failure surface is faceted and reveals the grain structure of the underlying material. It is this type of brittle fracture damage that is expected from full-scale bearings that fail through surface fatigue. Earlier detailed studies showed that the damage mechanism for both high quality and low quality 60NiTi rods is similarly brittle fracture in nature. The main difference is the stress level at which surface fatigue begins.

Examination of the fatigue failure sites also suggests a commonality of damage mechanisms between the full-scale bearing tests and the 3-ball tests. The fatigue pits on the RCF rod surface (Fig. 6) and the bearing inner race (Fig. 12(a)) have similar, faceted features indicative of similar damage mechanisms. This is not surprising since the drip fed oil-lubricated rolling contact of the 3-ball test is intended to mimic ball bearings under normal operation (Ref. 11). In practice, to reduce test times, bearing steels are often run in the 3-ball test against roughened steel balls and at extremely high stress levels that can exceed the test material's yield strength. For steel, such an acceleration test protocol is possible because of the ductility of the steel. Similar acceleration (through increased stress and surface roughness) for 60NiTi was discounted early in the current test program as it led to immediate fatigue failures. Most likely, the inability to accelerate the fatigue tests of NiTi bearing materials is due to its intrinsic brittleness. For brittle materials, if the stress exceeds the fracture strength failure is rapid.

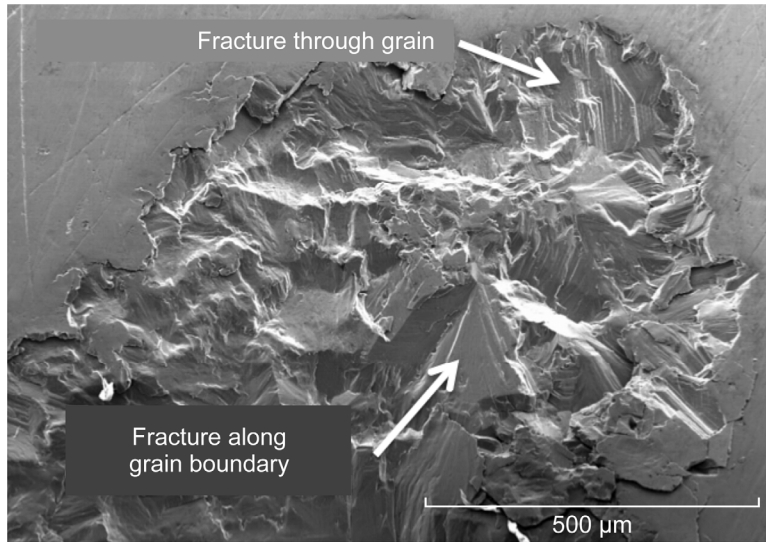
Figure 7.—Close-up surface view (SEM) of initiation damage area of fatigue spall on PM-60NiTi RCF rod.

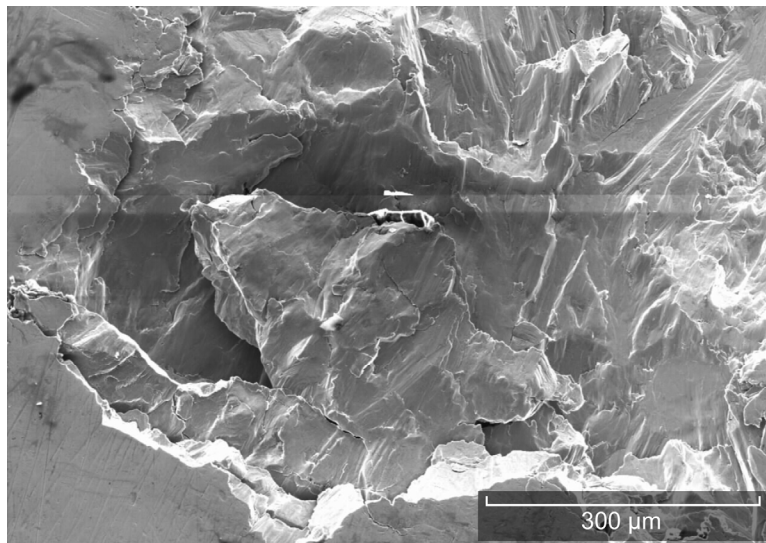
Figure 8.—Close-up (SEM) view of propagating edge of fatigue spall on PM-60NiTi RCF rod.

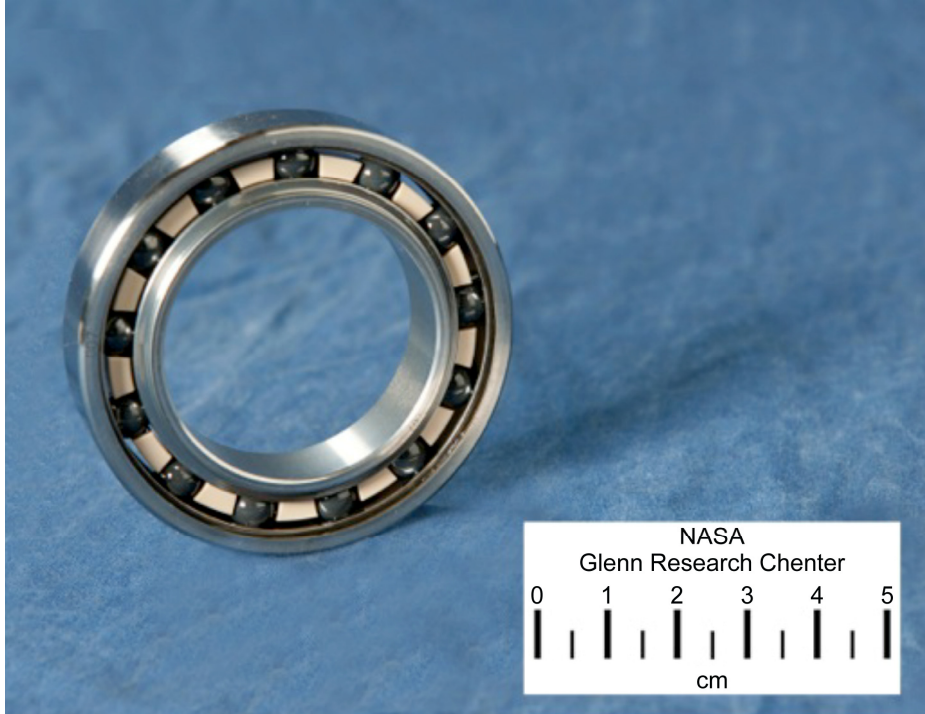
Figure 9.—The 50 mm test bearing with grease shields removed. Hybrid design made with 60NiTi races and Si<sub>3</sub>N<sub>4</sub> balls.

The 50 mm bore hybrid 60NiTi ball bearings (Fig. 9) are tested to ascertain their fatigue life performance. Since the technology is yet immature, the availability of test bearings is extremely limited. The data presented in this work is preliminary and offers qualitative insight into the fatigue response of 60NiTi. These hybrid bearings are designed for use in a low speed (200 rpm), centrifugal distillation assembly used on the International Space Station as part of the wastewater treatment system (Ref. 8).

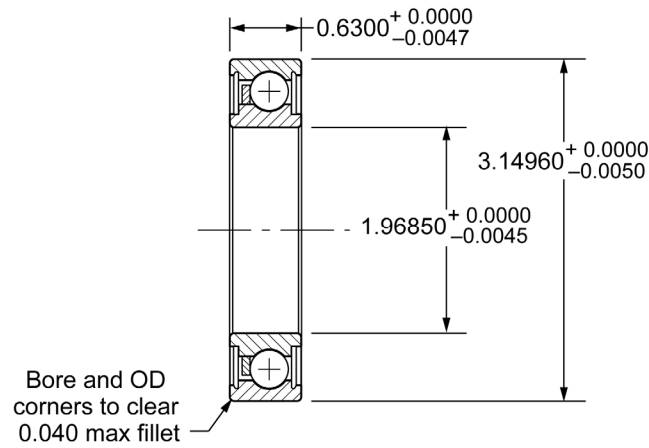
Figure 10.—Test bearing assembly drawing.

The bearings are a deep groove design with a contact angle of approximately 10° to 15°. The bearings operate in a zero-gravity environment and the primary bearing load comes from the axial preload wave spring set at 90 lb (~400 N). Under this load, the peak stress level between the balls and races is approximately 2 GPa. This stress level is comparable to that generated in the 3-ball tests. Based upon the 3-ball test results, it is anticipated that the bearings made from high quality material will run without suffering from fatigue while the lower quality material may show signs of surface fatigue after test. Figure 10 presents the general bearing geometry.

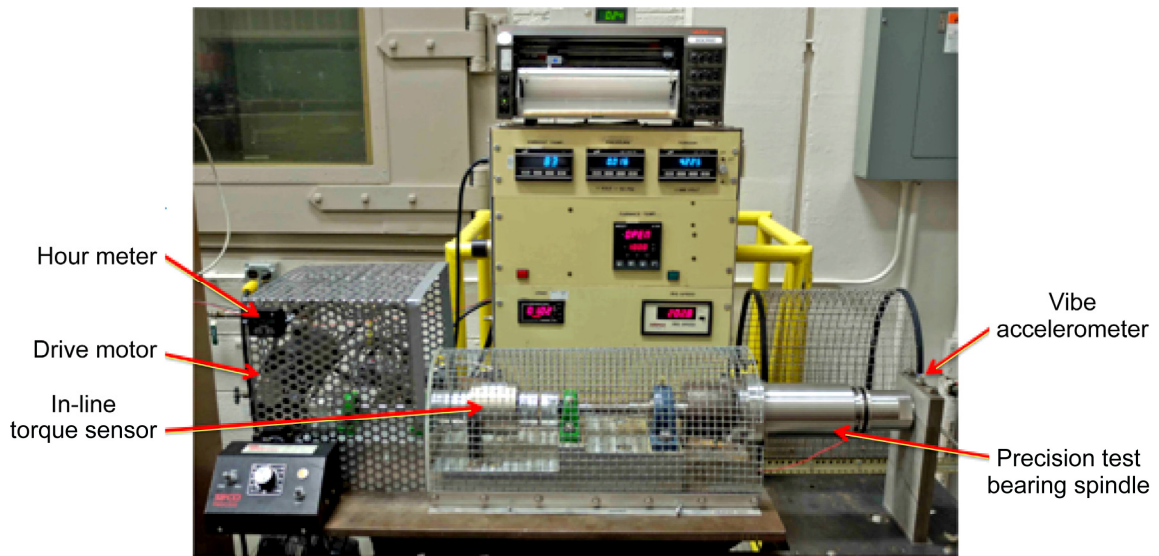
Figure 11.—Bearing test rig.

The bearings are evaluated in the test rig shown in Figure 11. Two identical bearings are greased (~30% fill level) and installed into the spindle. The preload is set and rotation is begun. The test rig measures speed and drive torque continuously during the test. The rig rotates the bearing outer races and the inner races rest on a stationary shaft. An accelerometer is mounted on the stationary test rig shaft and is used to monitor any changes in the smooth operation of the bearing during the test. Accelerometer data is collected and stored each hour. Plotting the data over time enables real-time health monitoring. Surface damage arising from a fatigue pit will result in increased vibration amplitudes, particularly at key frequencies (e.g., ball pass frequency).

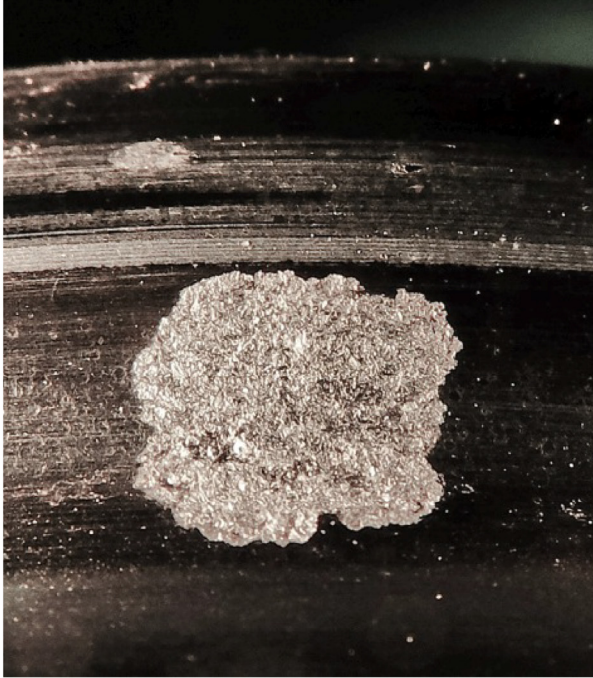
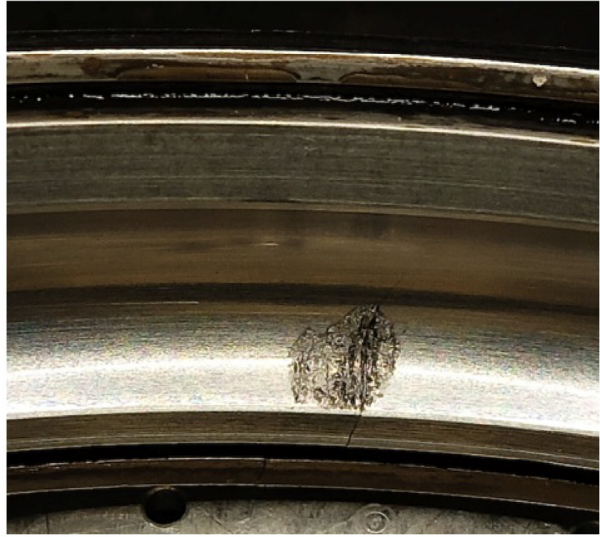
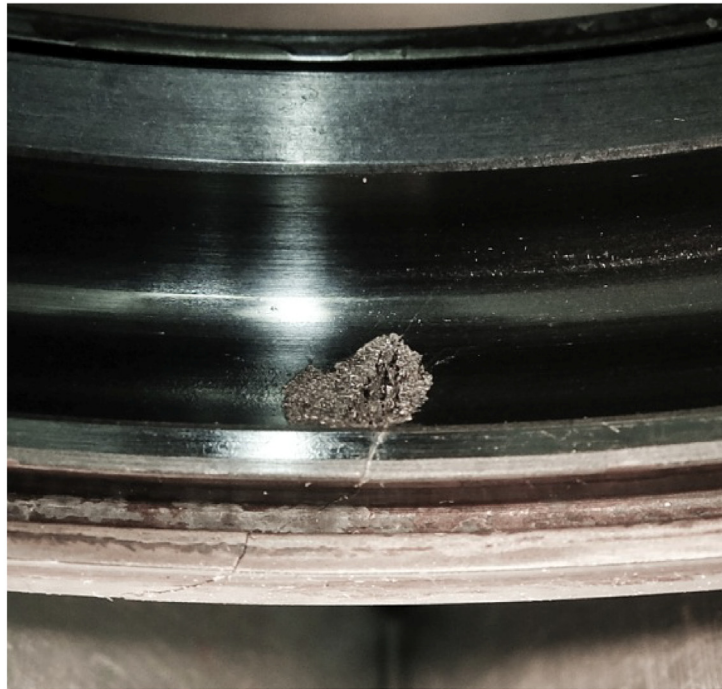
Figure 12.—Bearing fatigue damage observed in low quality 50 mm bearings after 1160 hr of run time.

In the deepest pits, cross-race cracks had begun to form and propagate through the race cross section. Figure 12 shows representative examples of the wear and damage. It is apparent that surface fatigue had occurred after less than 1160 hr, which is equivalent (in ball pass stress cycles) to approximately 200 hr of run time for the 3-ball test. This fatigue life correlates well with the number of stress cycles observed in the 3-ball test (Table II) for the rod material with inclusions.

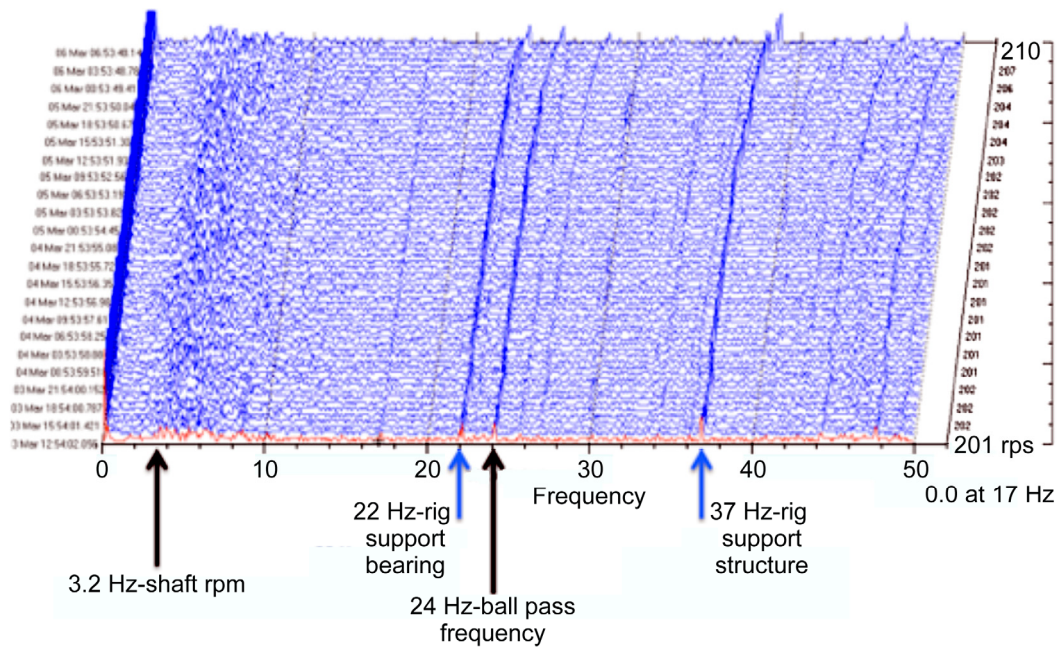
Figure 13.—Cascade plot of hourly vibration spectra (three-day test period) taken during life test of high quality 60NiTi ball bearing.

vibration signatures were essentially equivalent to the beginning of test (BOT) and no internal bearing wear or damage was anticipated. Recall, the bearings made from the low quality material exhibited significant wear and fatigue damage after a similar time period. Figure 13 shows the vibration plot leading up to the 1100-hr inspection point. Upon disassembly it was observed that the bearing wear surfaces appeared as new. No wear track, no surface pits or other damage was noted. Also the cage pockets were unworn and the grease's appearance and consistency were unchanged. The bearings were cleaned, filled with new grease and reinstalled in the test rig.

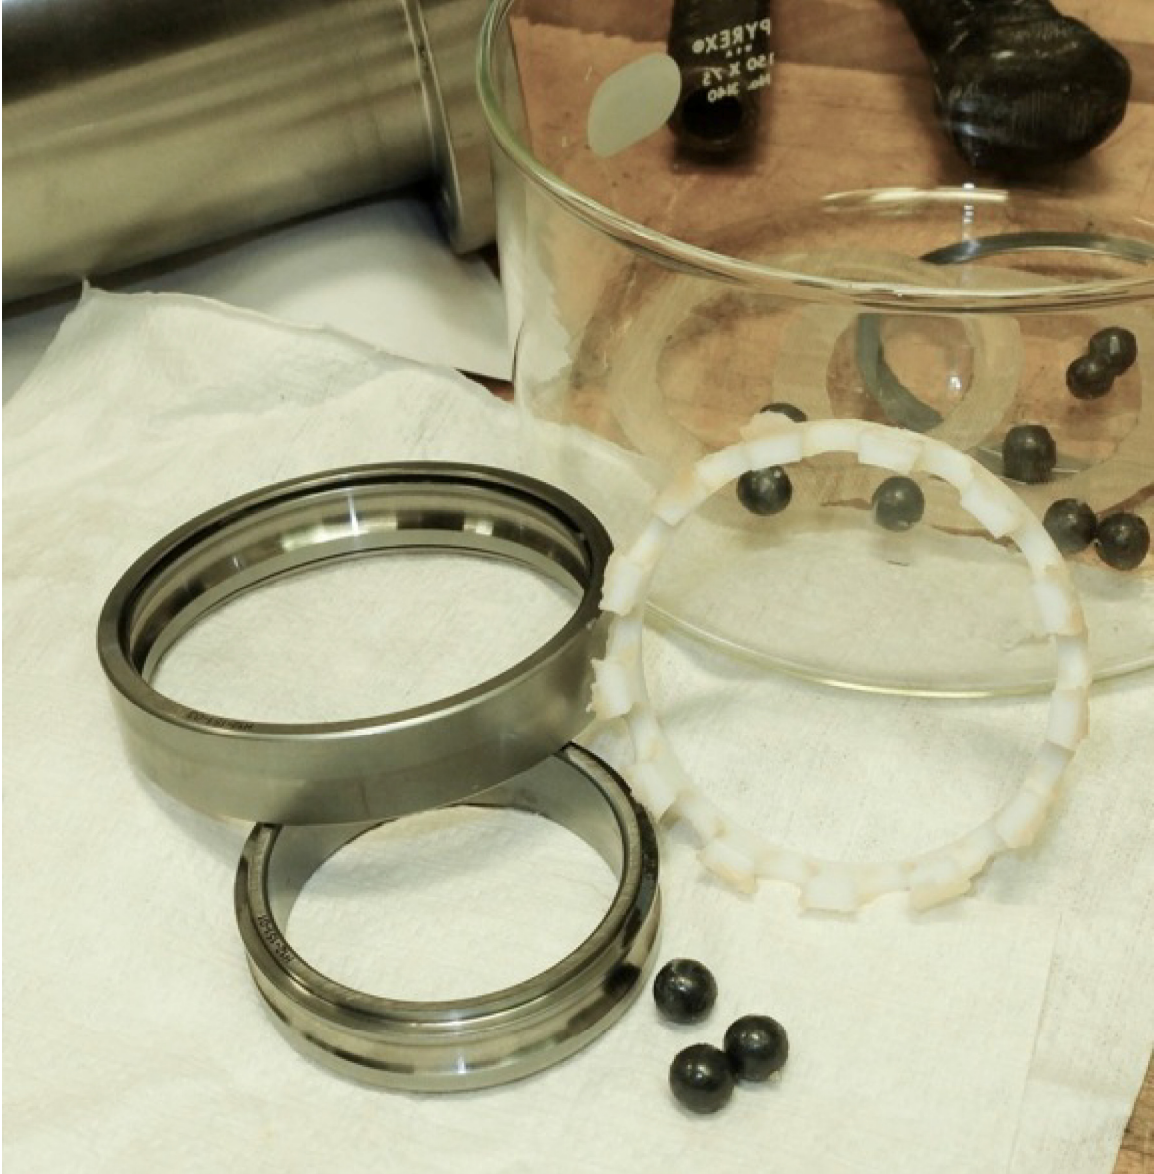
Figure 14.—Photograph of high quality 60NiTi ball bearing during post-test (5000-hr) inspection in which no grease degradation, wear or fatigue was observed.

After operating for 5000 hr, the test was halted because it had achieved the desired number of hours essentially equivalent to the 3-ball test (in terms of ball pass cycles). Again, the bearings were removed, disassembled and inspected. The bearing wear surfaces and the grease appeared as new. No damage was observed indicating that at this stress level the bearing was operating within its capability limits. Figures 14 shows images of the bearings after test.
