Status of the Redesign of the Extravehicular Mobility Unit Airlock Cooling Loop Recovery Assembly

John Steele¹, Dane Arnold², Barbara Peyton³ and Tony Rector⁴
UTC Aerospace Systems, Windsor Locks, CT 06096-1010

Mallory Jennings⁵
NASA.JSC Houston, TX

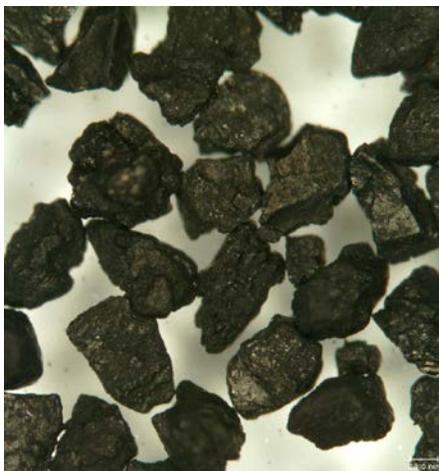
Water rinsing operations to reduce the amount of particulates generated from Ambersorb 4652 vs. Darco 20x40 indicated that Ambersorb 4652 is much easier to process and generates far fewer particulates, thought to be due to the material type and uniform, circular shape (see Figure 12)

Darco 20x40 Activated Carbon

Ambersorb 4652 Synthetic Carbon

Figure 12. Magnified View of Darco 20x40 vs. Ambersorb 4652

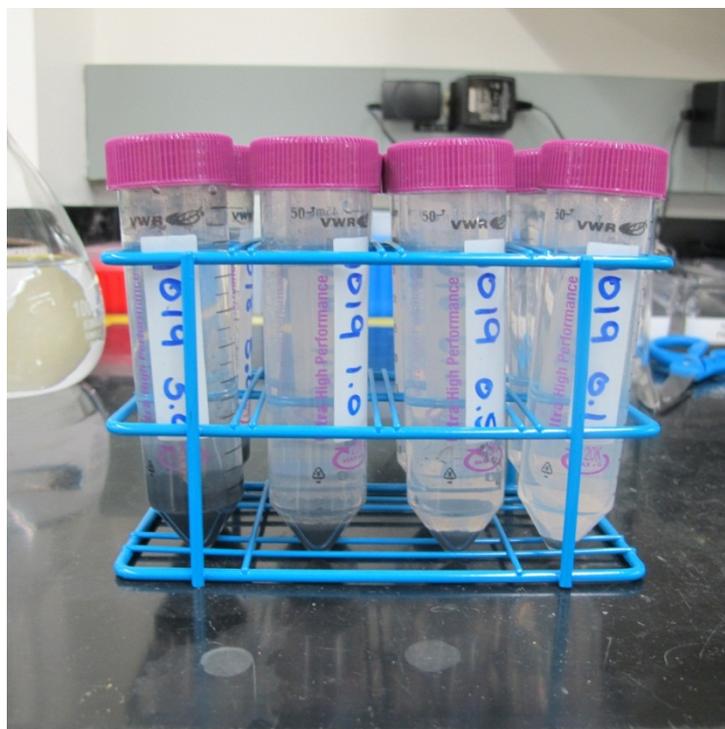
Varying amounts (0.5 – 5.0-grams) of the test organic adsorbent will be placed in plastic test tubes with the challenge glutaraldehyde solution (see Figure 16). The test tubes will then be agitated overnight in a Jar Mill (see Figure 17). At the end of the agitation period, the free water will be analyzed for glutaraldehyde content. The concentration of remaining glutaraldehyde will be directly related to the loss in capacity in the activated carbon due to the ersatz challenges.¹⁰

Figure 16. Plastic Test Tubes with Varying Amounts of Organic Adsorbent and Glutaraldehyde Test Solution

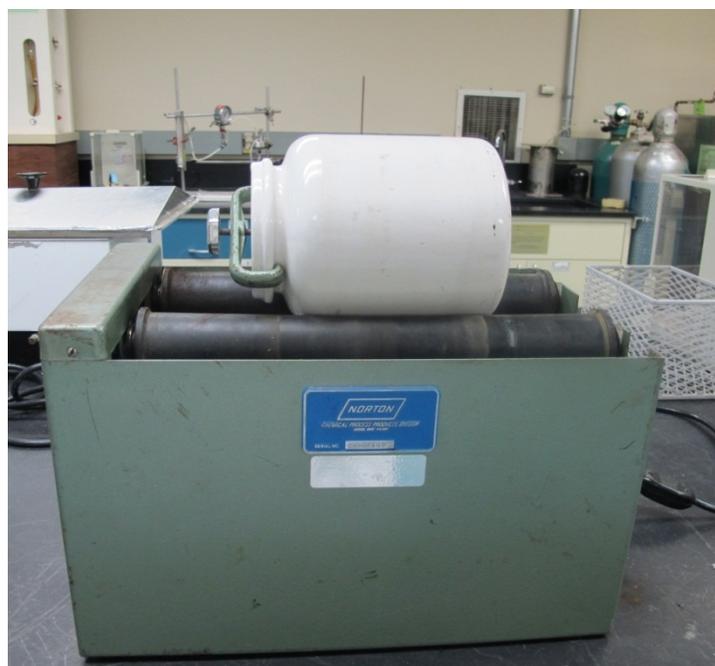
Figure 17. Jar Mill for Mixing
