NASA/TM—2017-219405

Lessons Learned: Mechanical Component and Tribology Activities in Support of Return to Flight

*Robert F. Handschuh and Erwin V. Zaretsky
Glenn Research Center, Cleveland, Ohio*

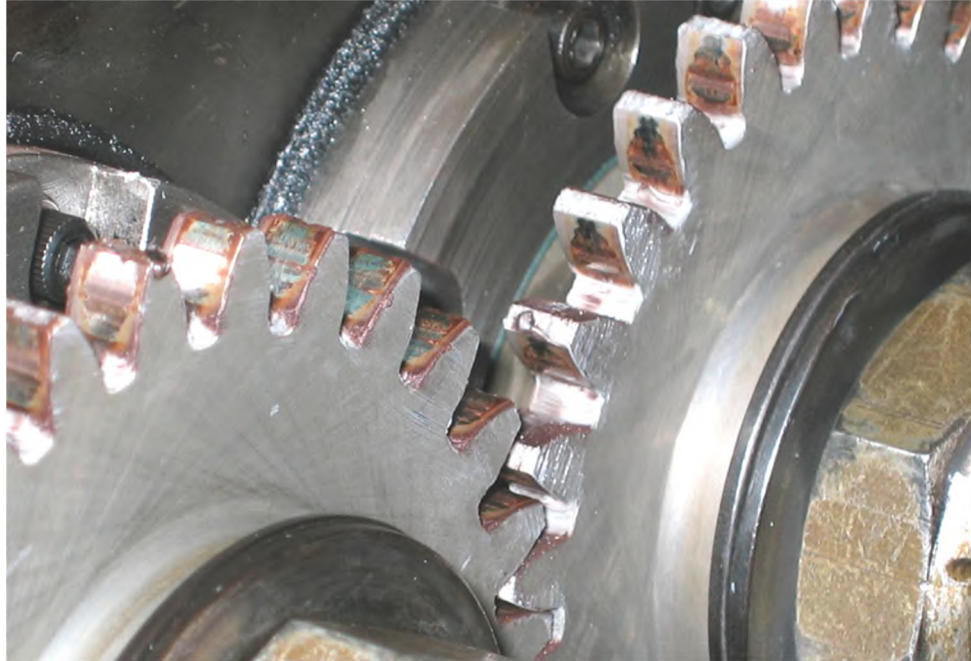
Figure 1.2.—Condition of the test gears after 3 hr of operation for test number 1 having test conditions of perfluoro type grease, 515 rpm shaft speed, 5 ft-lb torque, and ambient air atmosphere.

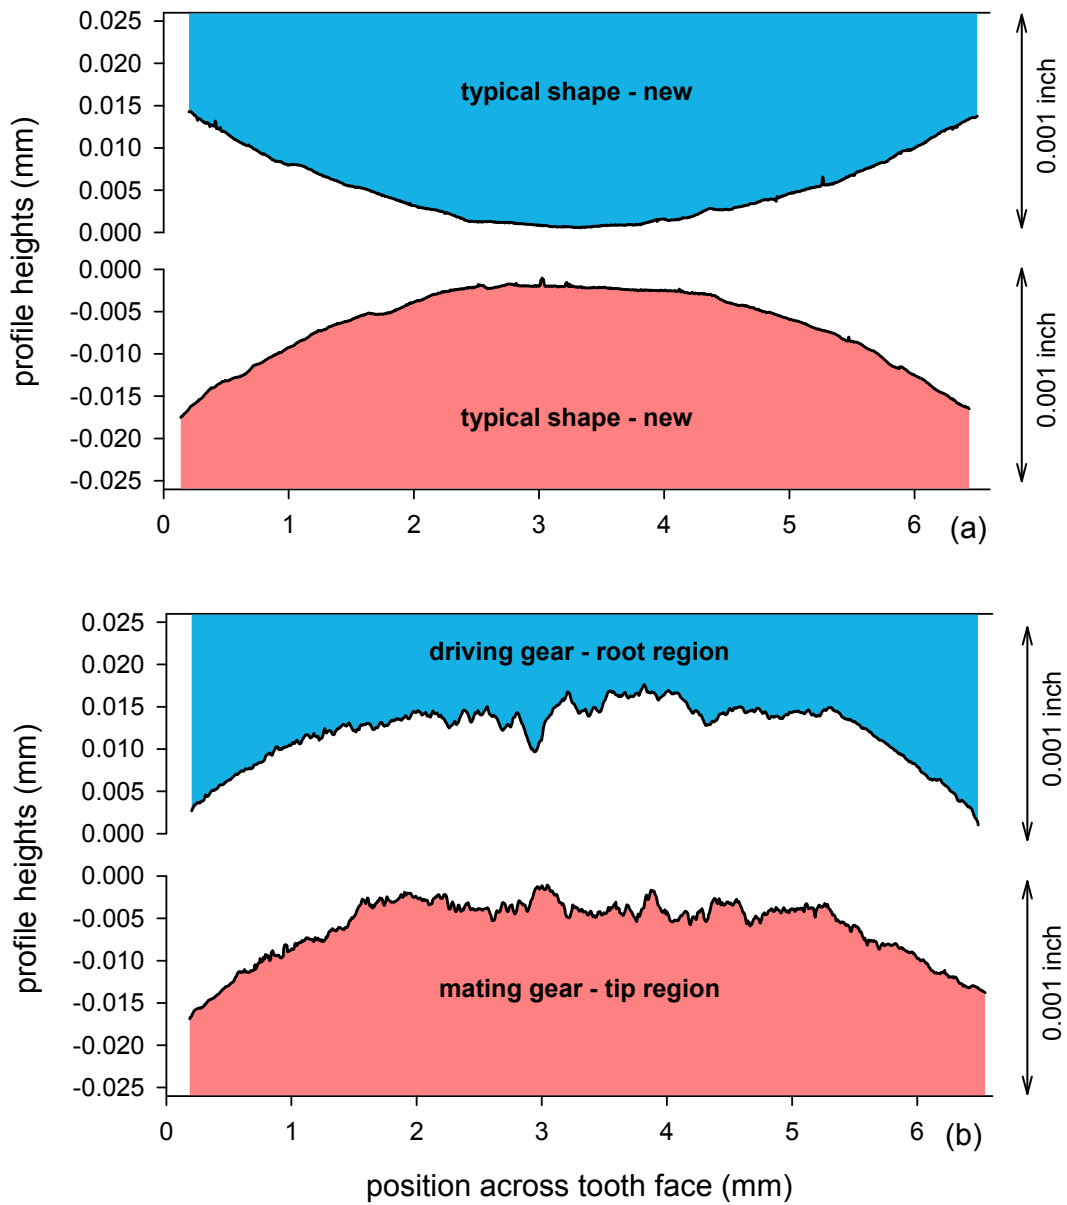
Figure 1.5.—Profilometry traces of gear teeth in the lead direction reveal that the original crowned geometry is significantly changed with increase of roughness due to wear during test number 1. (a) Typical measurements of gear teeth before running shows crowned lead geometry. (b) Measurements of mating teeth after running show that the crowned geometry of the mating gear's tip region has been worn into the driving gear's root region.

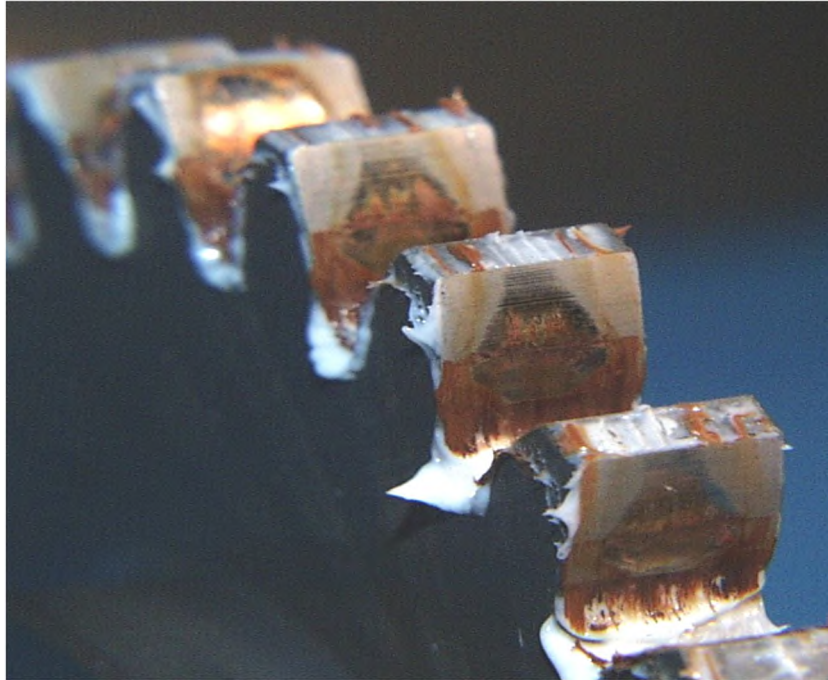
Figure 1.6.—Condition of the driven gear after 15 hr of testing for test number 2 having test conditions of perfluoro type grease, 200 rpm shaft speed, 2 ft-lb torque, and ambient air atmosphere. A mixture of original white and red colored grease is evident along with wear patterns.

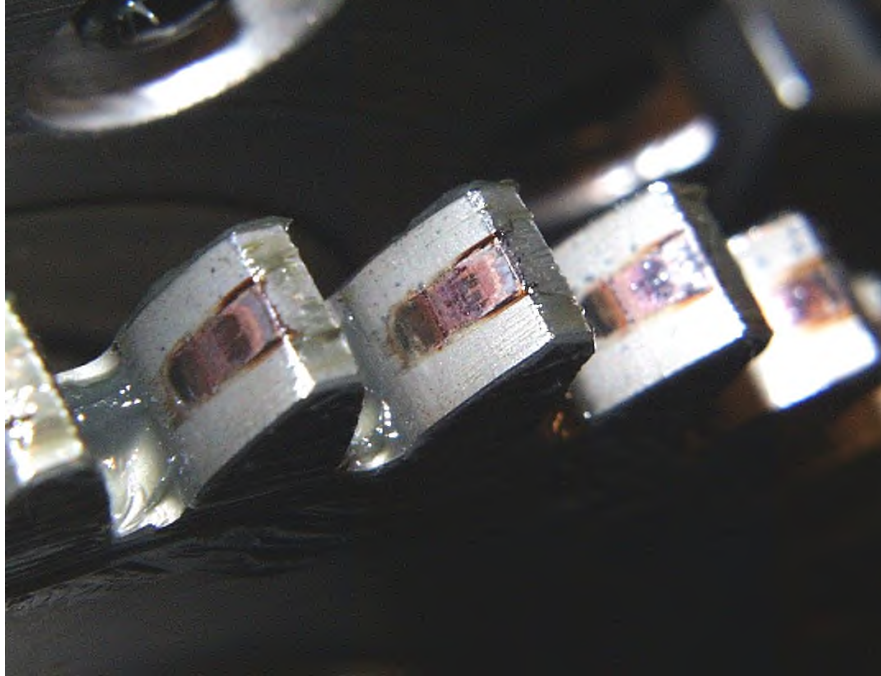
Figure 1.10.—Condition of the driven gear after 1 hr of testing for test number 6 having test conditions of hydrocarbon-based grade 2 grease, 214 rpm shaft speed, 2 ft-lb torque, and ambient air atmosphere.

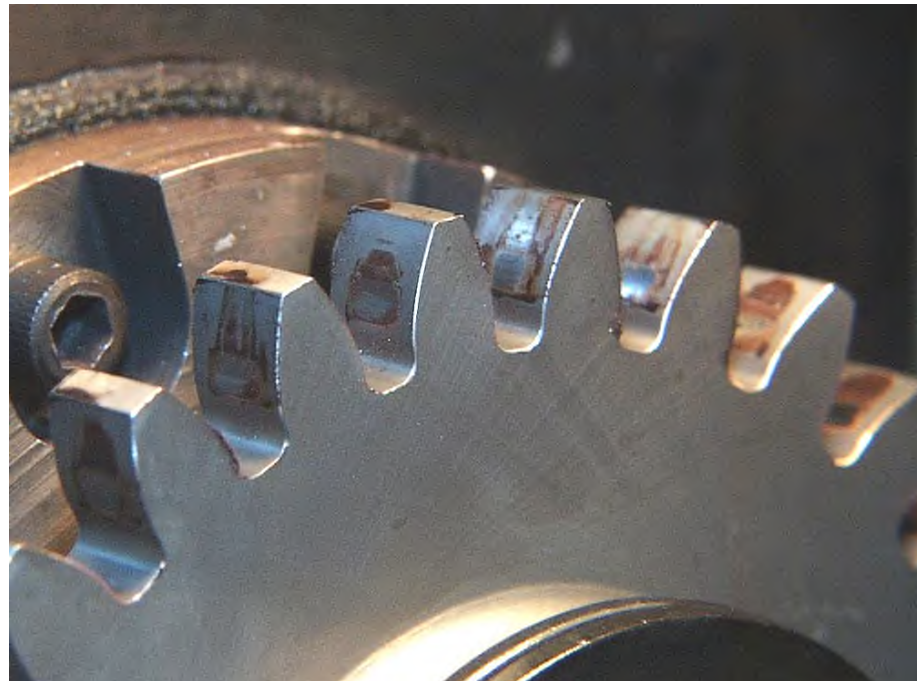
Figure 1.11.—Condition of the driven gear after 1 hr of testing for test number 7 having test conditions of no lubricant, 705 rpm shaft speed, 2 ft-lb torque, and ambient air atmosphere.

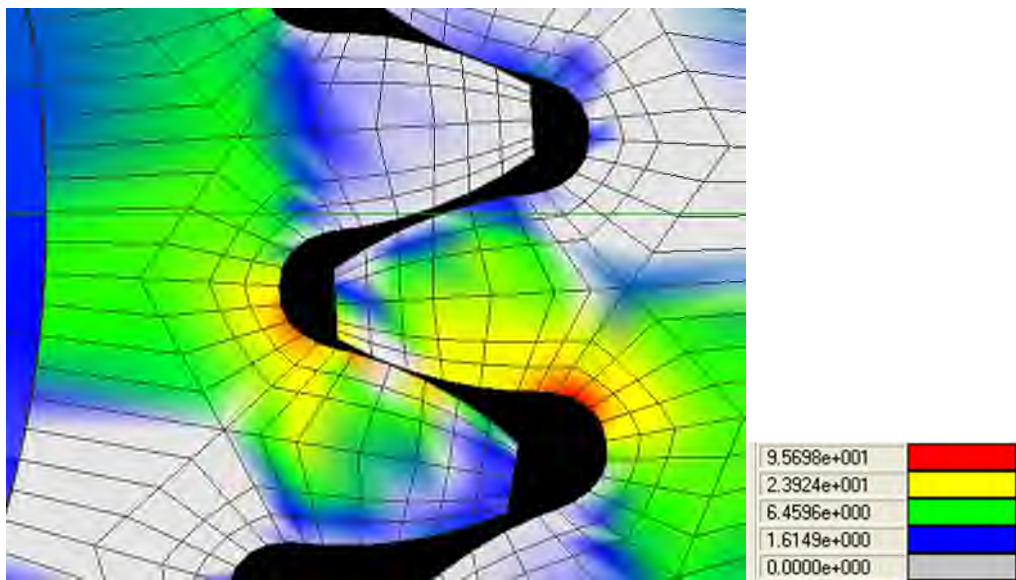
Figure 2.6.—Finite element analysis result showing distribution of maximum principal tensile stresses for a unit load at the highest point of single-tooth contact. The color key has units of psi.

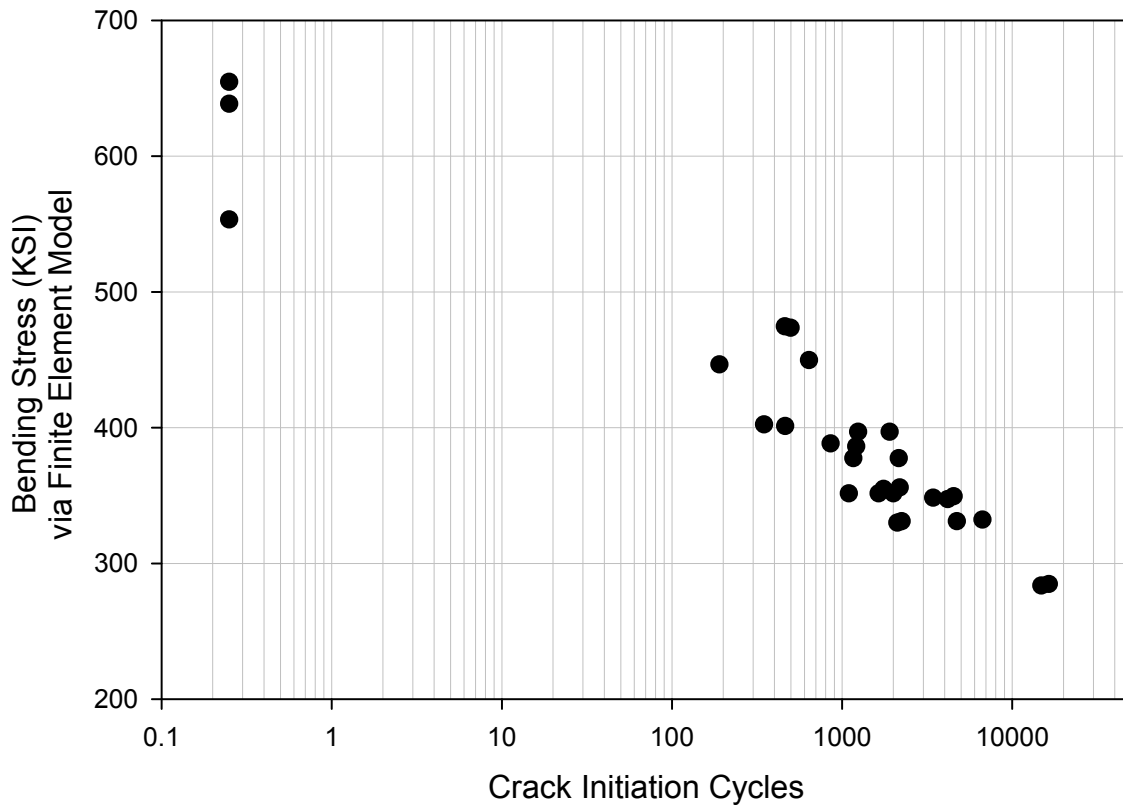
Figure 2.7.—Single-tooth bending data, crack initiation.

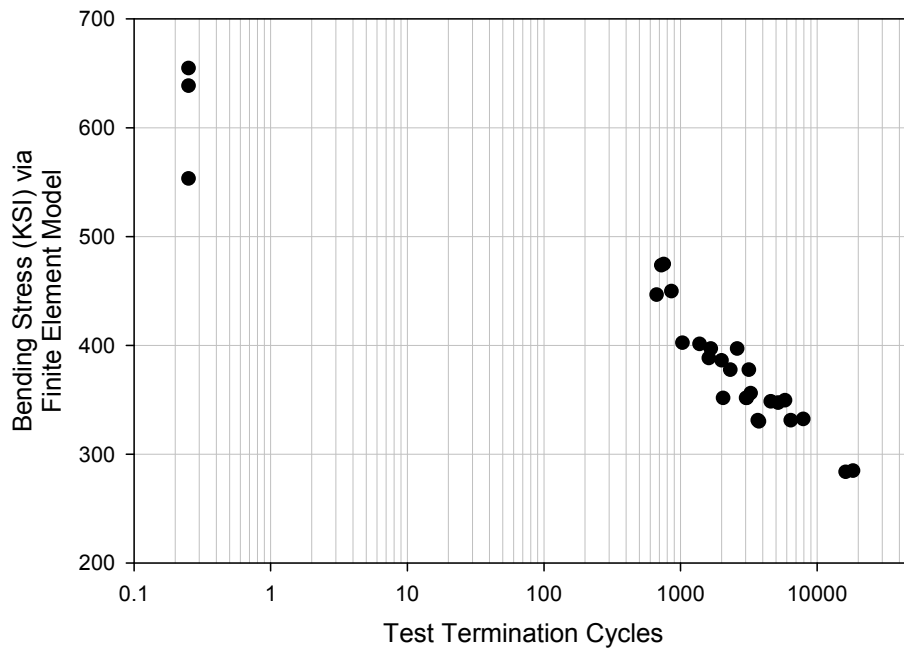
Figure 2.8.—Single-tooth bending data, test termination.

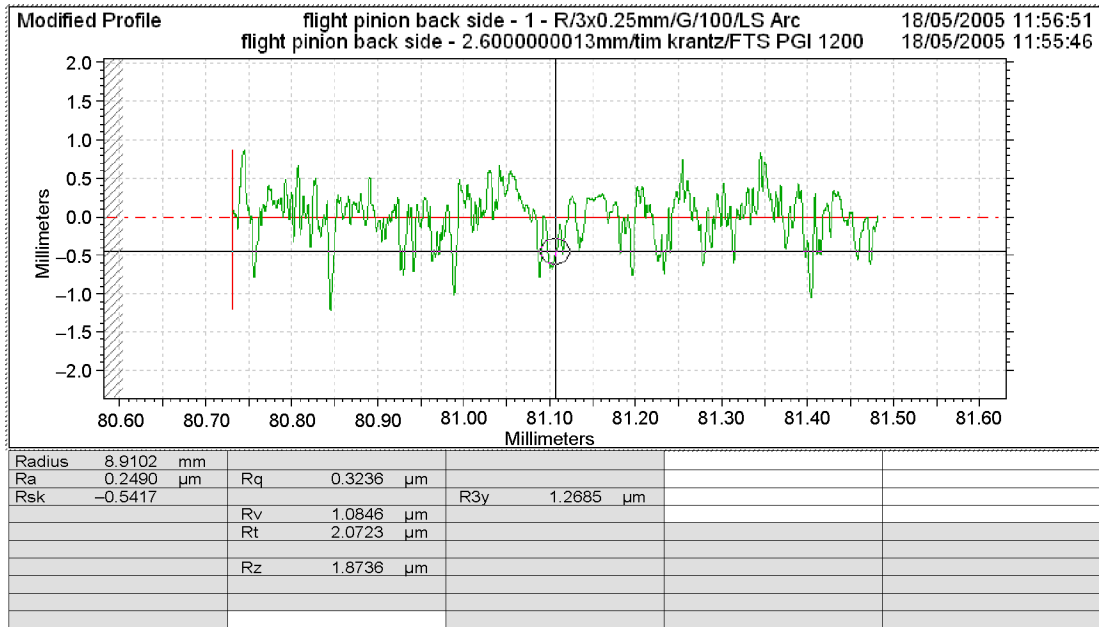
Figure 3.7.—Typical microtopography of the pinion gear teeth.

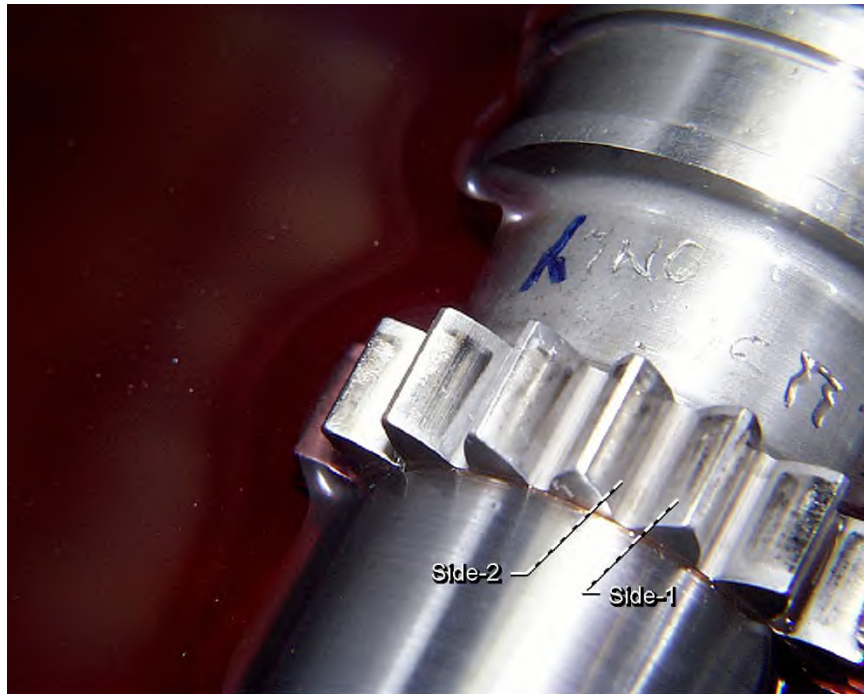
Figure 3.15.—Wear marks on driven side of pinion gear teeth after Score-1 test on side-2, build-1.

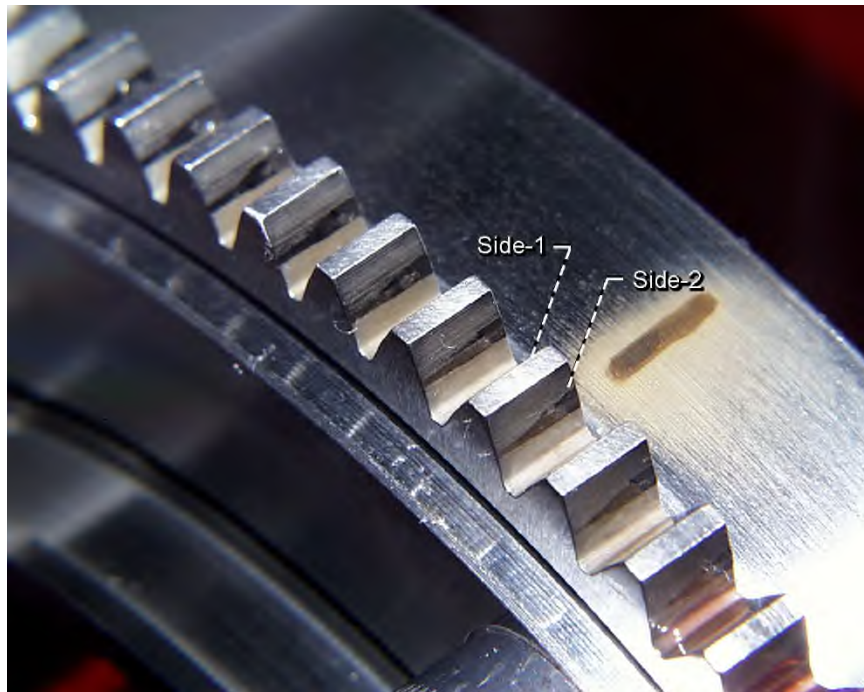
Figure 3.16.—No visible damage on driving side of ring gear teeth after Score-1 test on side-2, build-1.

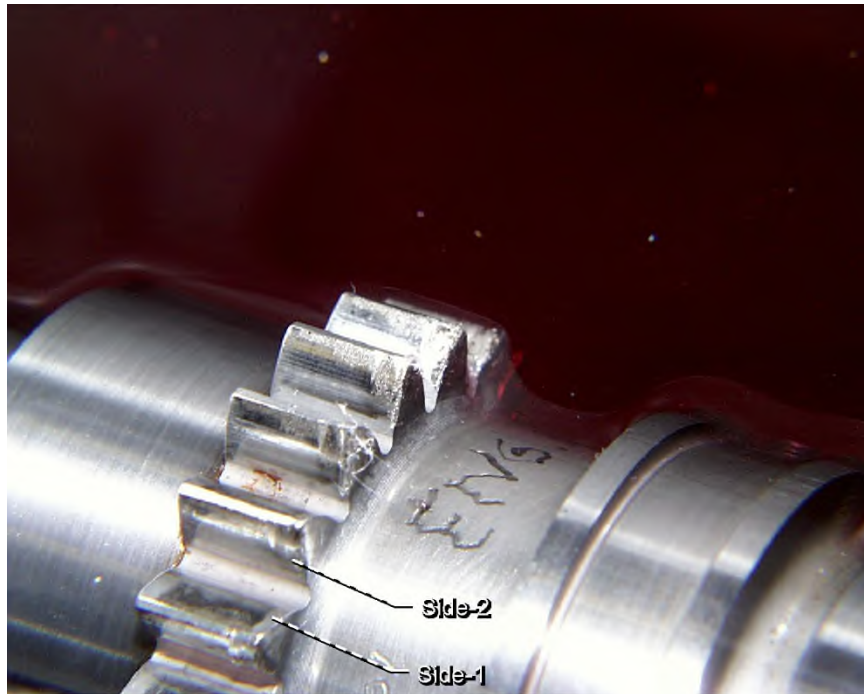
Figure 3.18.—Damaged teeth of pinion gear after disengagement at 14,000 rpm pinion speed during the Score-2 test on side-2, build-1. White cloth fibers are caught on teeth from wiping oil.

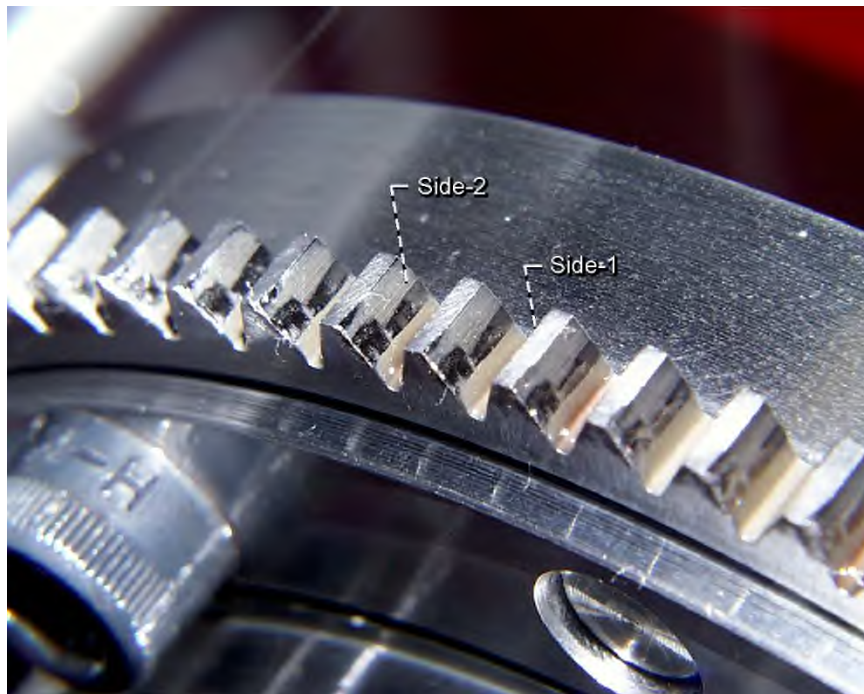
Figure 3.19.—Damaged teeth of ring gear after disengagement at 14,000 rpm pinion speed during the score-2 test on side-2, build-1. White cloth fibers are caught on teeth from wiping oil.

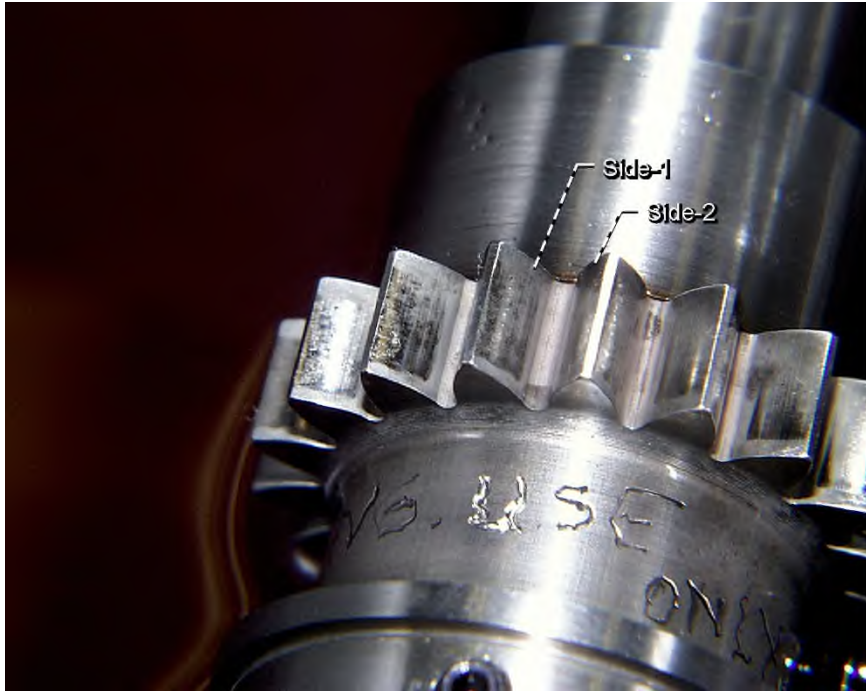
Figure 3.20.—Driven side of pinion gear teeth after the test Final-5 are still in good condition.

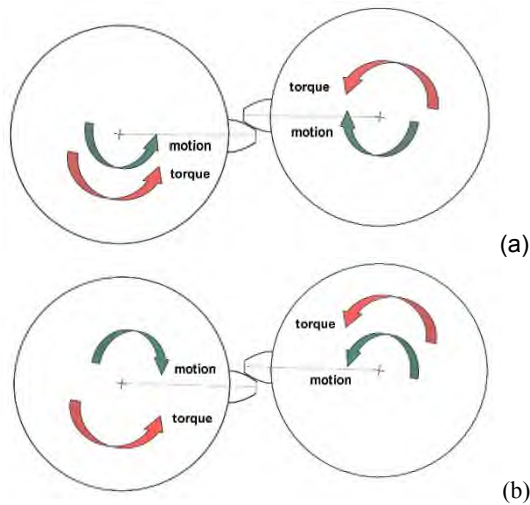
Figure 4.2.—Illustration of the reversal of motion and constant direction of torque used for wear testing. (a) Forward stroke of dithering motion. (b) Reverse stroke of dithering motion.

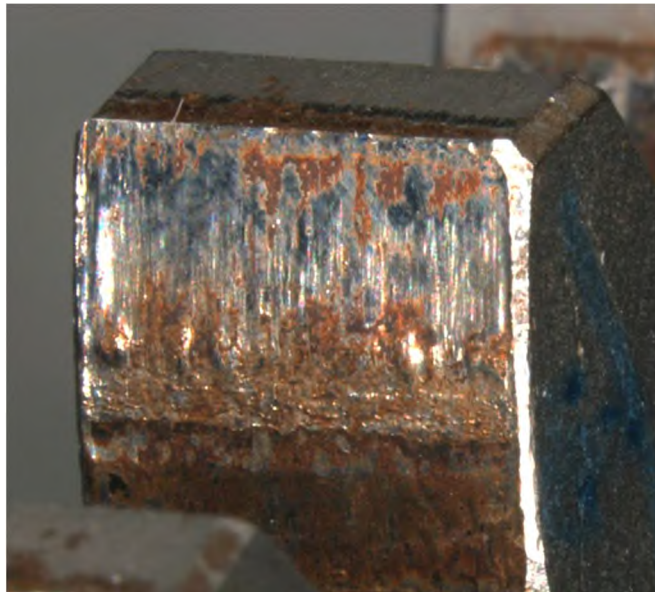
Figure 4.6.—Typical condition of the worn gear teeth.

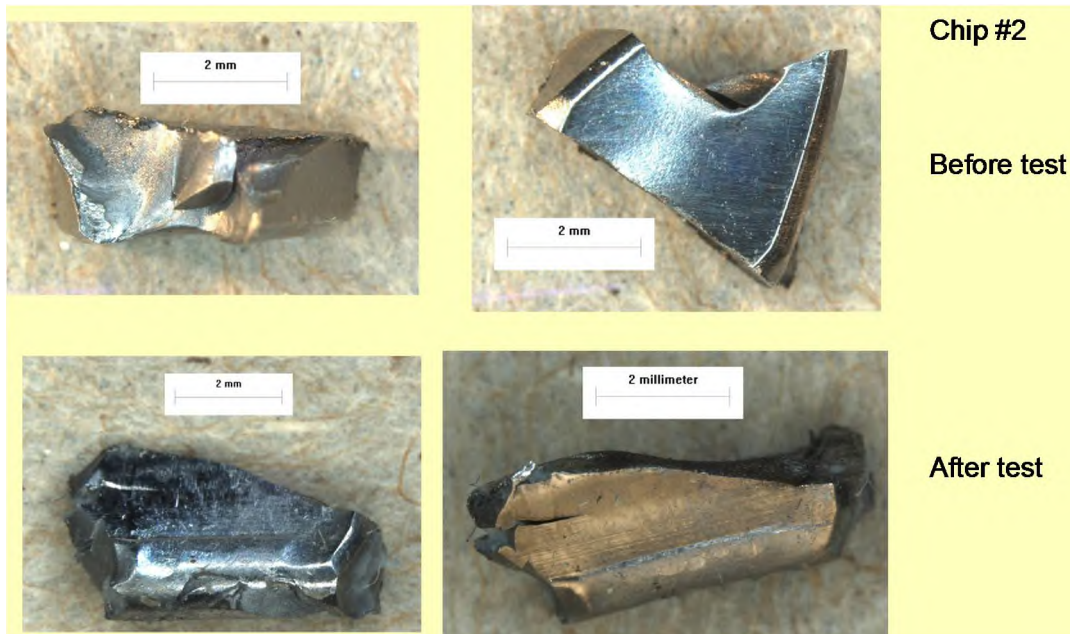
Figure 6.10.—Chip #2, mass of chip 0.100 grams.

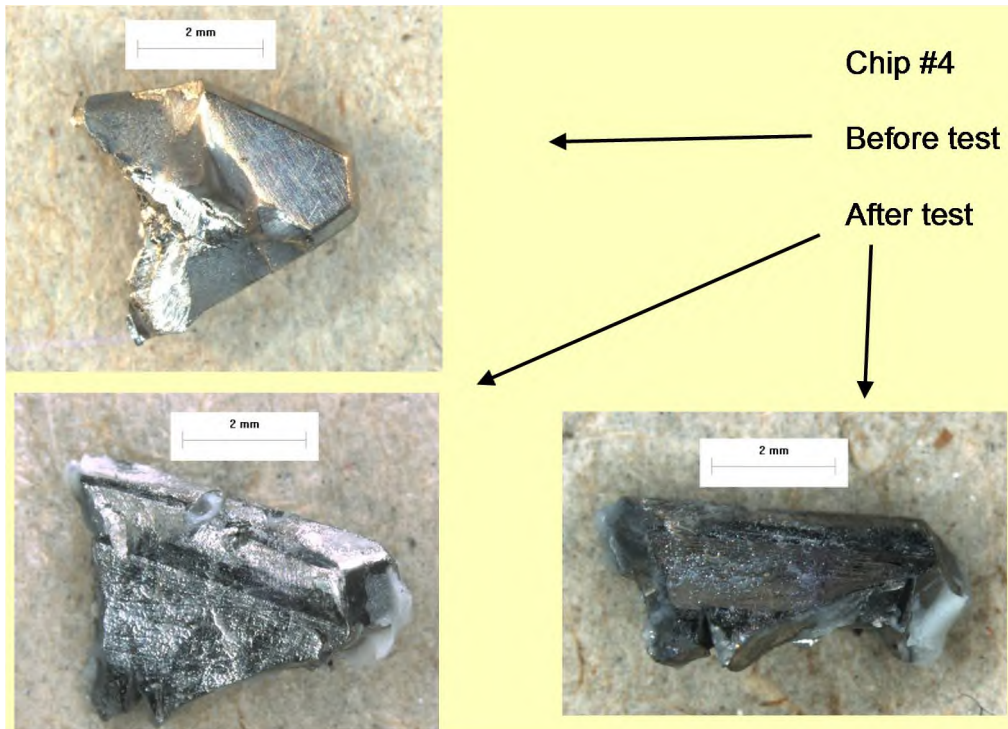
Figure 6.12.—Chip #4, mass of chip 0.116 grams.
