# Post-test Inspection of NASA's Evolutionary Xenon Thruster Long Duration Test Hardware: Ion Optics

George C. Soulas & Rohit Shastry

# Introduction

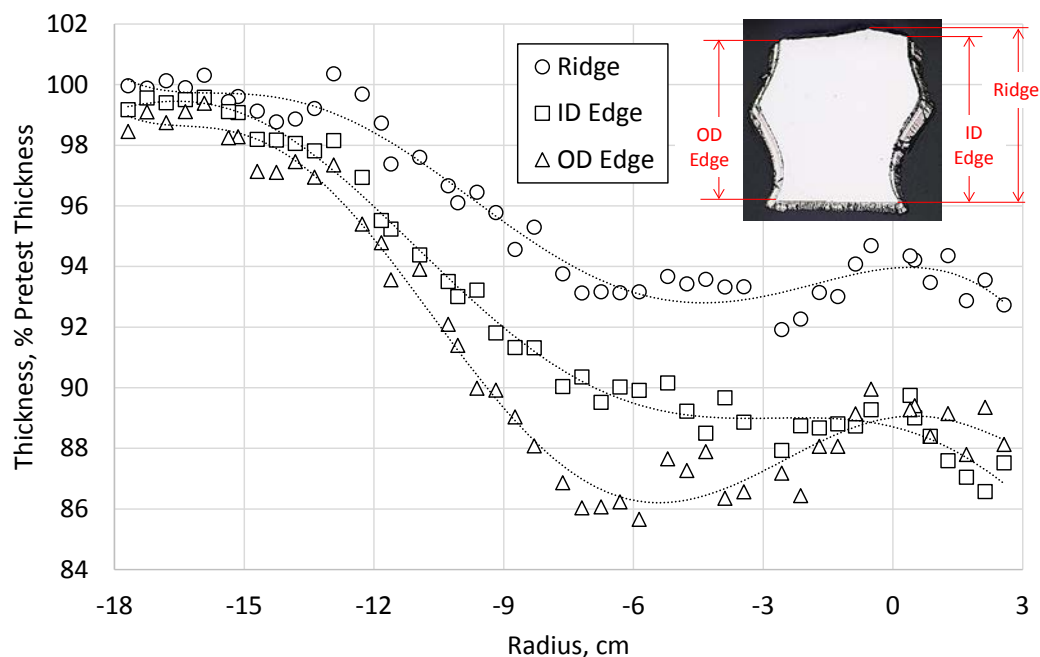
# Screen Grid Thickness

- Webbing cross-sectioned
  - Radius B selected because along probe path & highest  $j_b$
  - Photomicrographs show eroded pattern & deposition
- Minimum screen grid thickness was 86% of pretest (off-center)
- *Screen grid has substantial service life remaining*

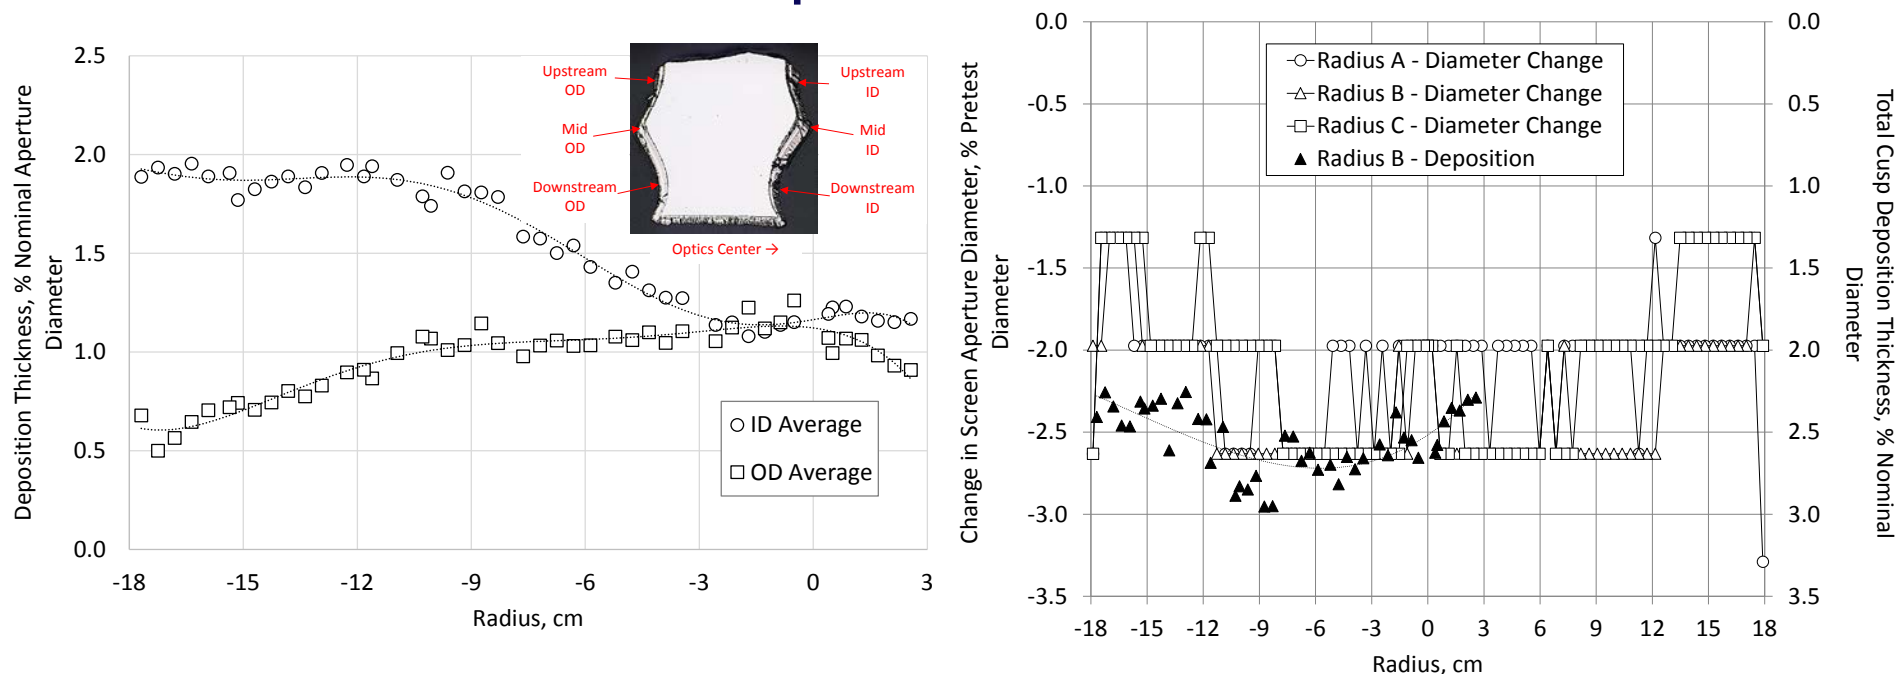
# Screen Grid Aperture Wall Deposition

- Aperture wall deposition was thicker on webbing surface closest to grid center at large radii, which increased with radius
  - Due to non-uniform accelerator wall erosion
- Deposition led to average 2.2% decrease in screen aperture diameters
  - Reduces open area by 4.4% & *likely contributed to reduced screen grid ion transparencies during test*

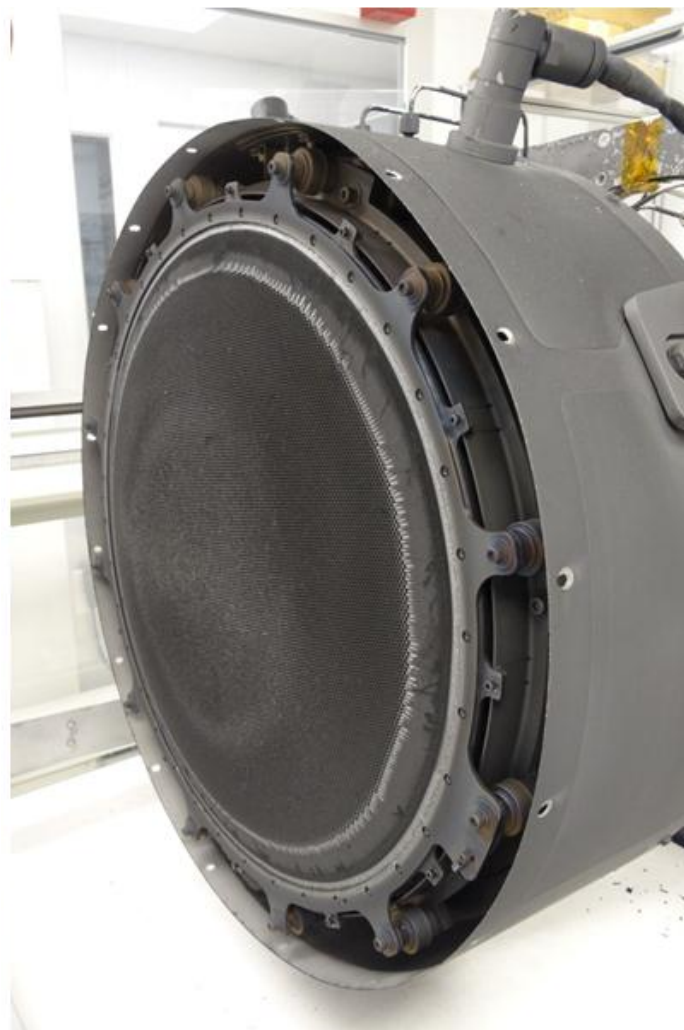
# Accelerator Grid Overall Condition

- Net carbon deposition was observed throughout most of grid perforated region
- Net carbon deposition expected within aperture walls
  - Removal rate of back-sputtered carbon decreases as aperture enlarges
- Net carbon deposition within pit & groove erosion pattern unexpected
  - Investigation revealed that erosion persisted until 36.5 kh (621 kg throughput)

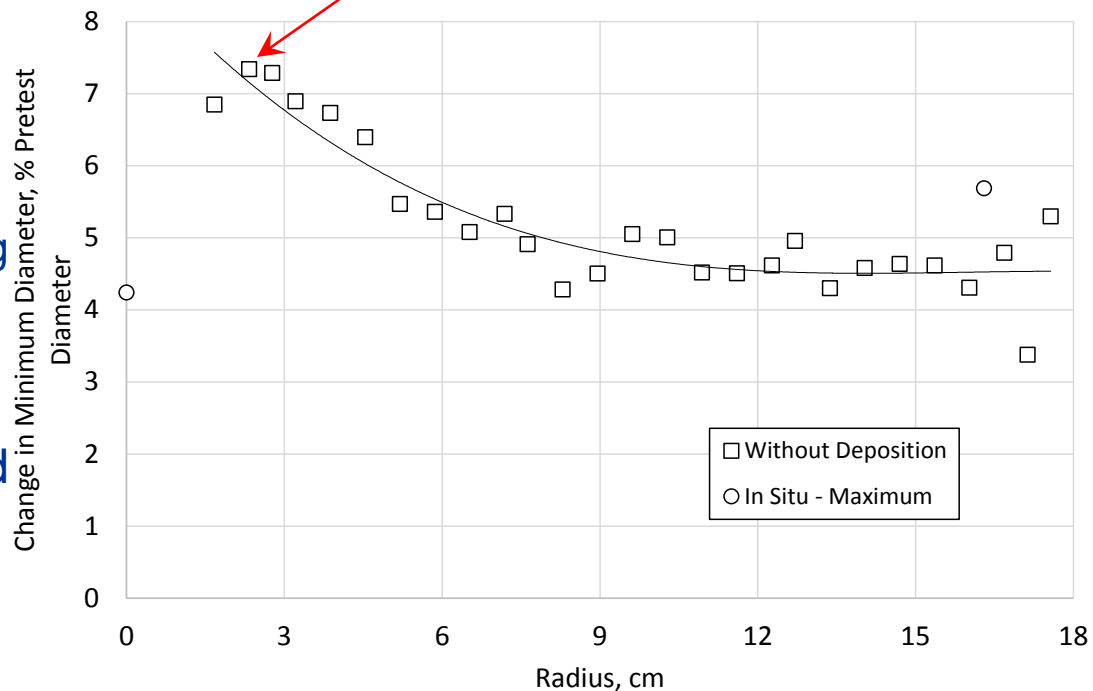
# Accelerator Grid Aperture Enlargement

- Minimum aperture diameters without deposition increased by ~5-7% of pretest measurements
  - In situ measurements indicate that minimum diameter increases occurred during throttled power operation (13.0-29.2 kh)
- Smaller than NSTAR ELT changes, which was as large as 24% of pretest
  - In addition to different operating voltages, lower peak beam current density & 11% larger BOL diameter
- In situ measurements compared favorably with post-test
  - Within measurement uncertainties

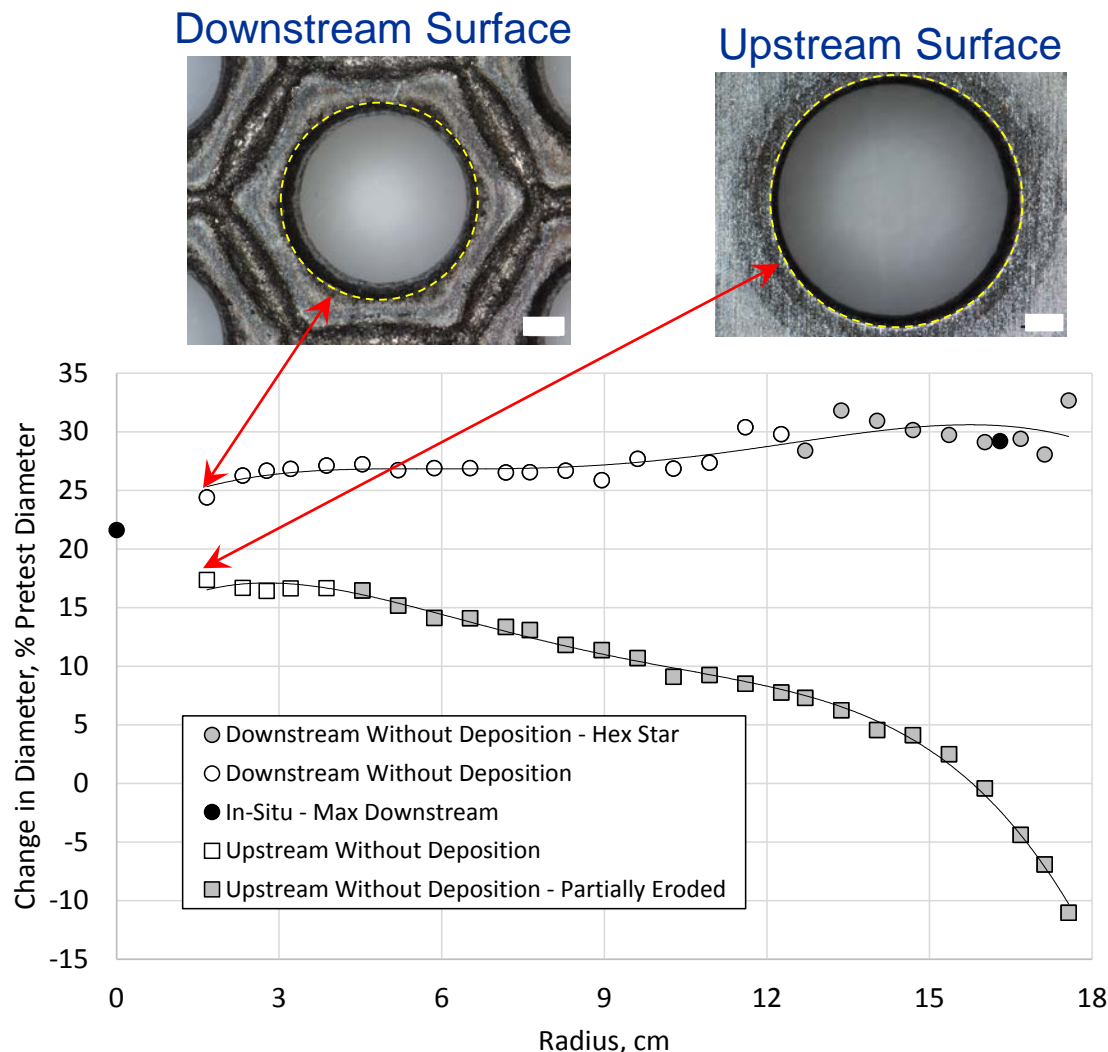
# Accelerator Grid Aperture Erosion

- Downstream aperture diameters without deposition increased by 24-33% of pretest diameter
  - In situ measurements indicate that that increase occurred predominantly during 1st full power segment (up to 13 kh)
- *Grid geometric changes (36 cm, large diameter, & better tolerance control) reduced degree of erosion at larger radii*
- Upstream diameter increased by as much as 17% of pretest diameter
- Impact on ion optics performance requires further assessment
  - Affect perveance, electron backstreaming, & accelerator current

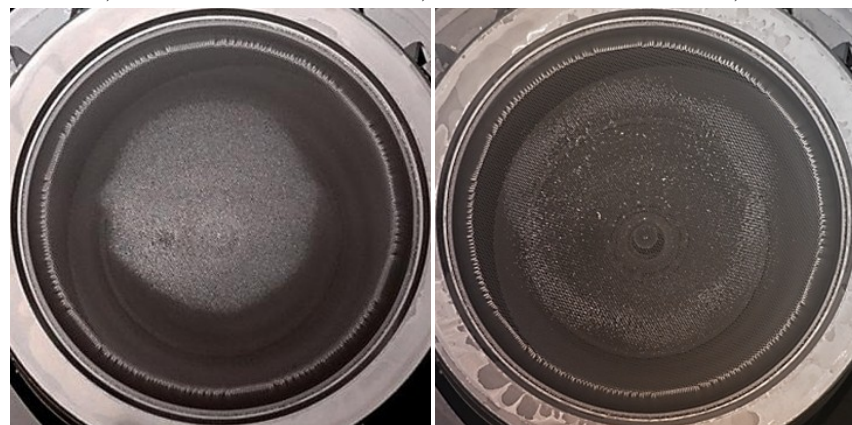
# Accelerator Grid Net Deposition

- In situ images show net erosion evident 35.6 kh
  - Imaging system failed
- Long range images
  - Net erosion to 36.5 kh (621 kg throughput), but net deposition by 41.5 kh
  - 36.5 kh image shows changes have just begun to occur
- Root cause presently unknown
  - At 41.5 kh (2<sup>nd</sup> full power segment), annular net erosion pattern evident
  - Only known mechanism is redistribution of accelerator current

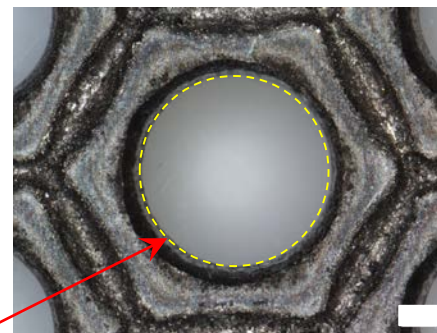
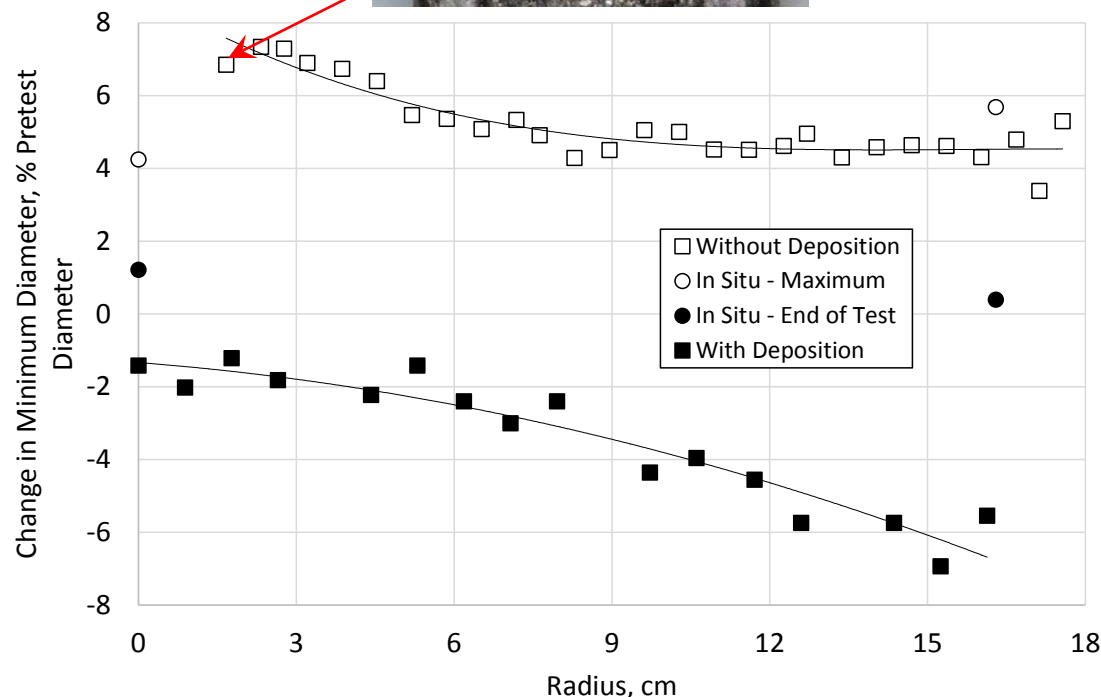
# Accelerator Grid Aperture Enlargement

- Minimum aperture diameters without deposition increased by ~5-7% of pretest measurements
  - In situ measurements indicate that minimum diameter increases occurred during throttled power operation (13.0-29.2 kh)
- Smaller than NSTAR changes, which was as large as 24% of pretest
  - In addition to different operating voltages, lower peak beam current density & 11% larger BOL diameter
- With deposition, diameters decreased due to back-sputtered carbon
  - In situ measurements detected minimum diameter decrease at 38-42 kh
