# Degradation of $\beta$ -Cloth Covering for a Battery Orbital Replacement Unit in Low Earth Orbit

James R. Gaier, Sammantha Baldwin, Angela D. Folz, Deborah L. Waters, and Alyssa Loos  
NASA Glenn Research Center, Cleveland, OH 44135

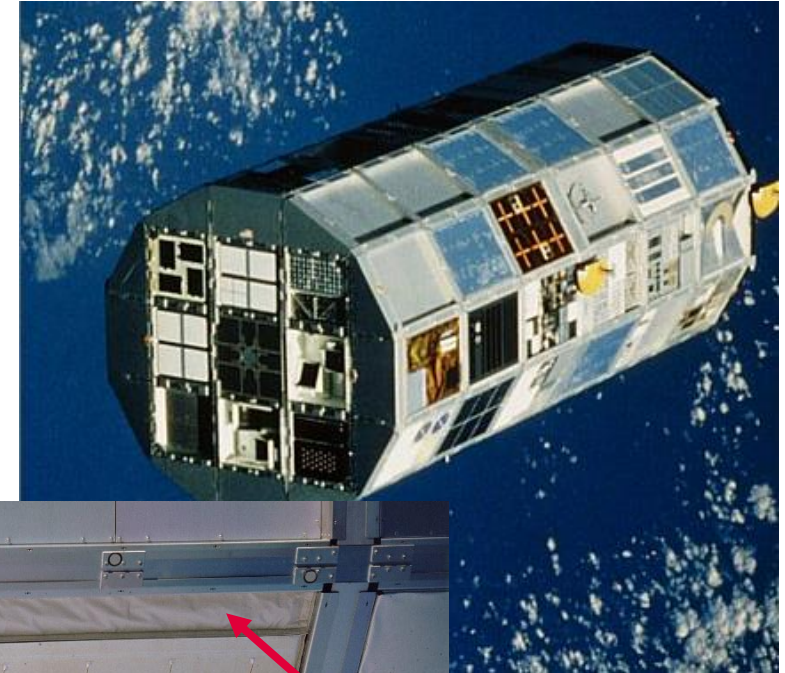
$\beta$ -Cloth on S1005 Experiment Tray B10

- **LDEF in space for 69 months (5.7 yr)**
  - Launched on Challenger April 1984
  - Retrieved by Columbia January 1990
- **Carried  $\beta$ -cloth sample oriented 22° to ram**
  - Well characterized orbital environment
  - **AO darkened the  $\beta$ -cloth**
  - **Erosion of PTFE did not release glass fibers**
  - **Back side showed no appreciable change**

LEO Environment	Exposure
UV Radiation	8,680 Estimated Sun hr
Proton fluence (0.05 – 200 MeV)	$10^9/\text{cm}^2$
Electron fluence (50 keV/3.0 MeV)	$10^{12}/\text{cm}^2$ $10^8/\text{cm}^2$
Atomic oxygen	$8.14 \times 10^{21}/\text{cm}^2$
Thermal cycles	~32,000

R.C. Linton, A.F. Whitaker, and M.M. Finckenor, "Space Environment Durability of Beta Cloth in LDEF Thermal Blankets", *LDEF Materials Results for Spacecraft Applications*, NASA CP-3257 (1994), 31-45.

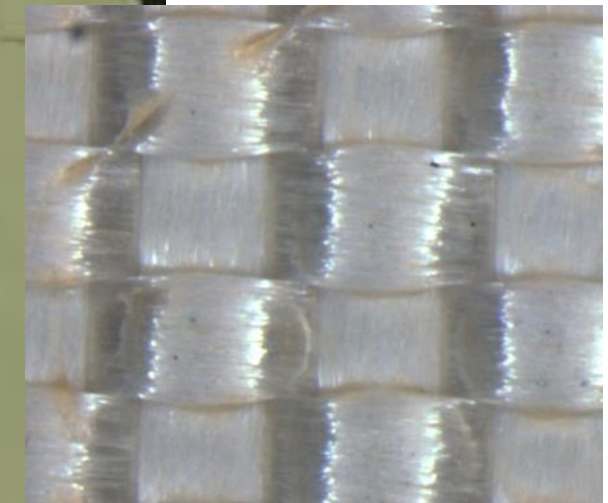
LDEF results indicated a darkening of  $\beta$ -cloth  
Attributed to AO texturing of PTFE  
Glass fibers were not released

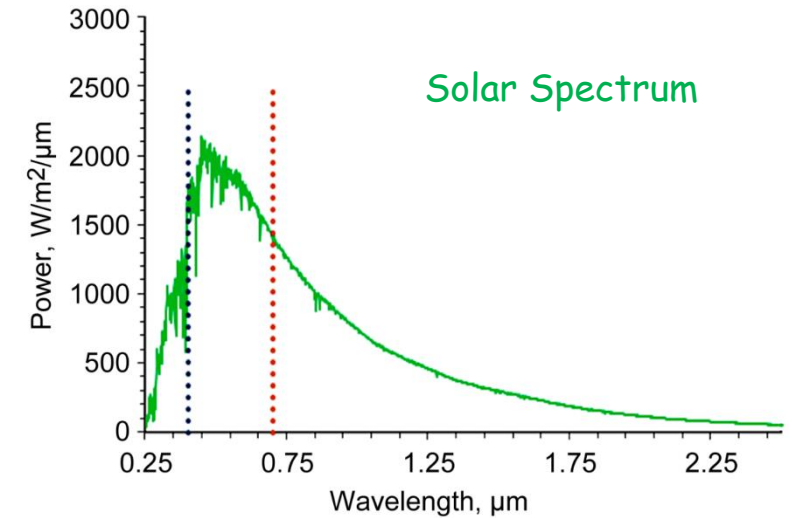
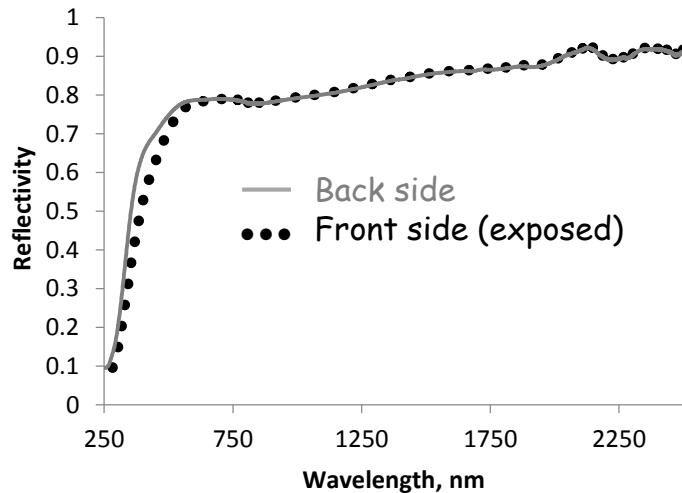
# UV-Vis-NIR Spectroscopy

- **Most solar radiation (98+%) emitted 250-2500 nm**
  - Want materials to be highly reflective to reduce heat load
  - Exposure lowered reflectivity in 250 - 650 nm region
- **Difference spectrum centered 360-375 nm**
  - Higher in UV/blue part of spectrum (so looks redder)
  - Solar spectrum intense in this region

- Back side  $\alpha$  was  $0.248 \pm 0.005$ , with a range of 0.015

- Front side  $\alpha$  was  $0.267 \pm 0.020$  with a range of 0.018
  - Front/Back  $\rightarrow$  average  $\alpha$  increased 7.7 < 1%
  - If Front/Back under trim  $\rightarrow$  average 44%
    - As high as 61%
