# **Self-healable Electrical Insulation for High Voltage Applications**

Tiffany S. Williams, Ph.D.  
Materials and Structures Division  
NASA Glenn Research Center  
Cleveland, OH, USA

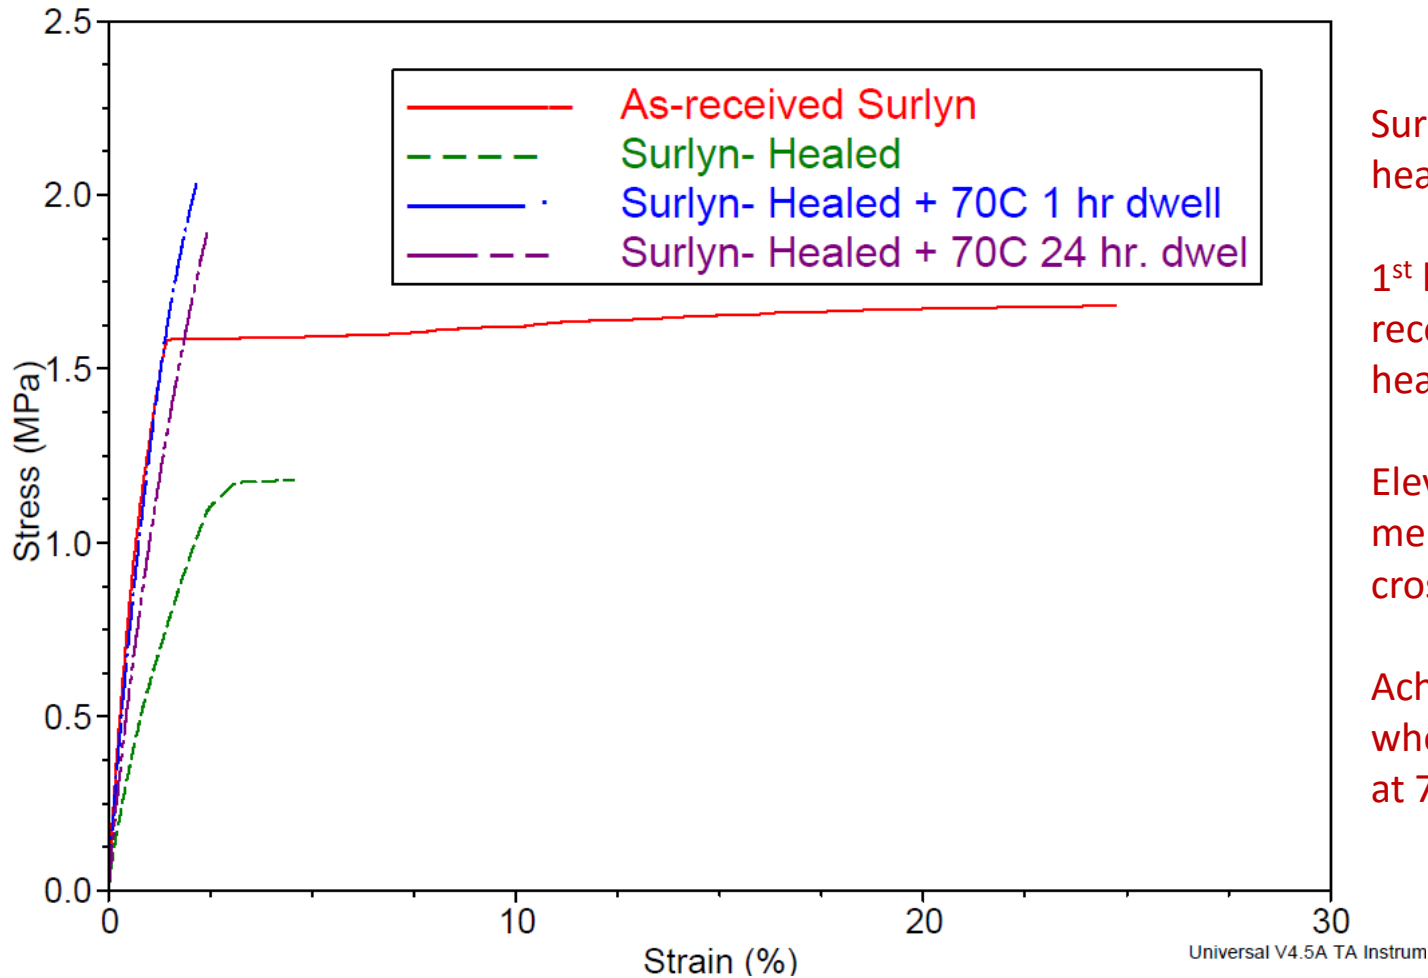
Surlyn disk was cut and then heated to induce healing.

1<sup>st</sup> healing cycle → 67% recovery w/o additional heating

Elevated heating after mending activates ionic crosslinks.

Achieved 90-97% recovery when samples were dwelled at 70°C.

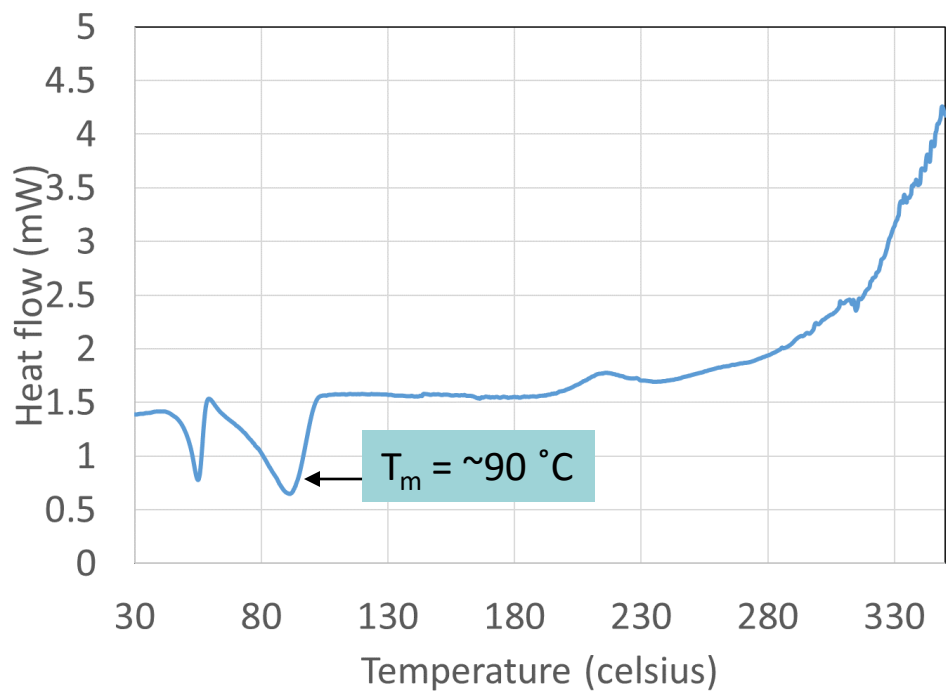
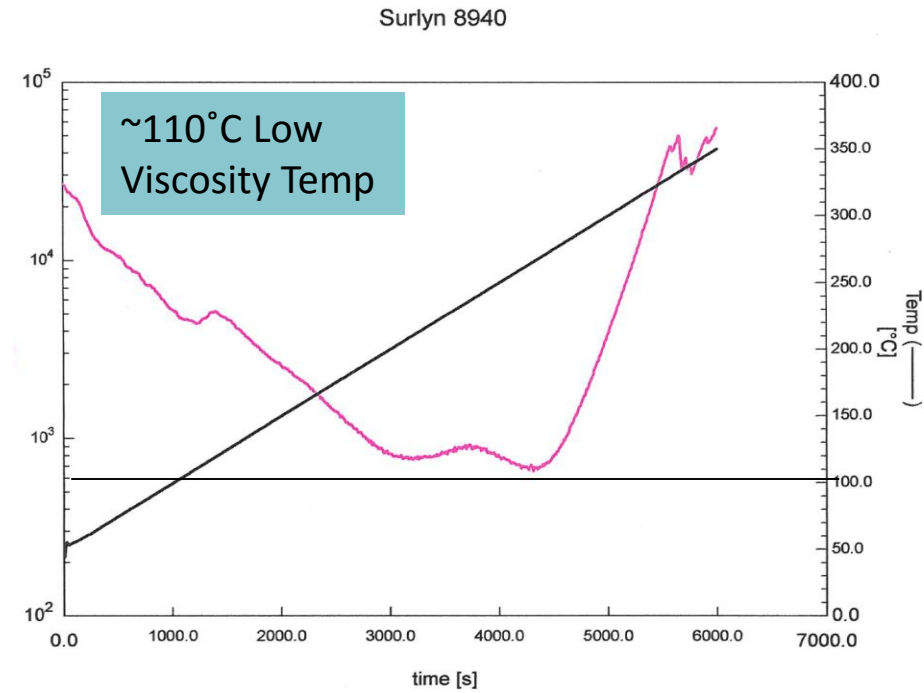
Surlyn films were processed by using a hot press at 115 °C for 1.5 hrs.

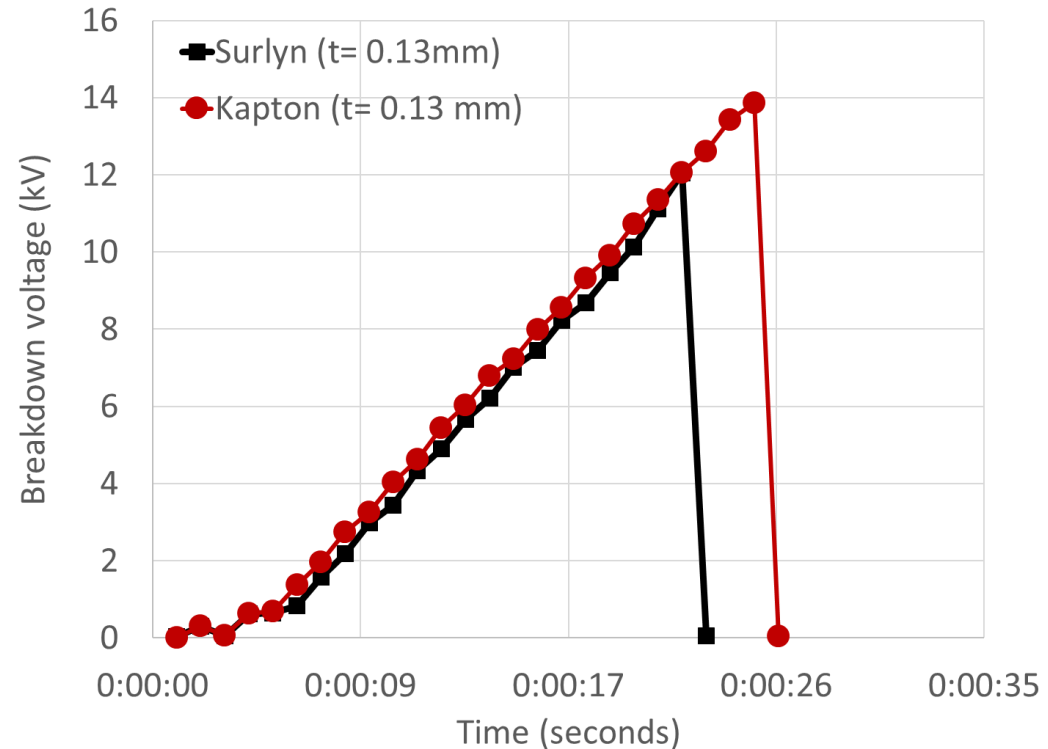
Eaton High Voltage Test Rig  
Output voltage AC:  $V_{max}$  60 kV (~ 84 kV DC)

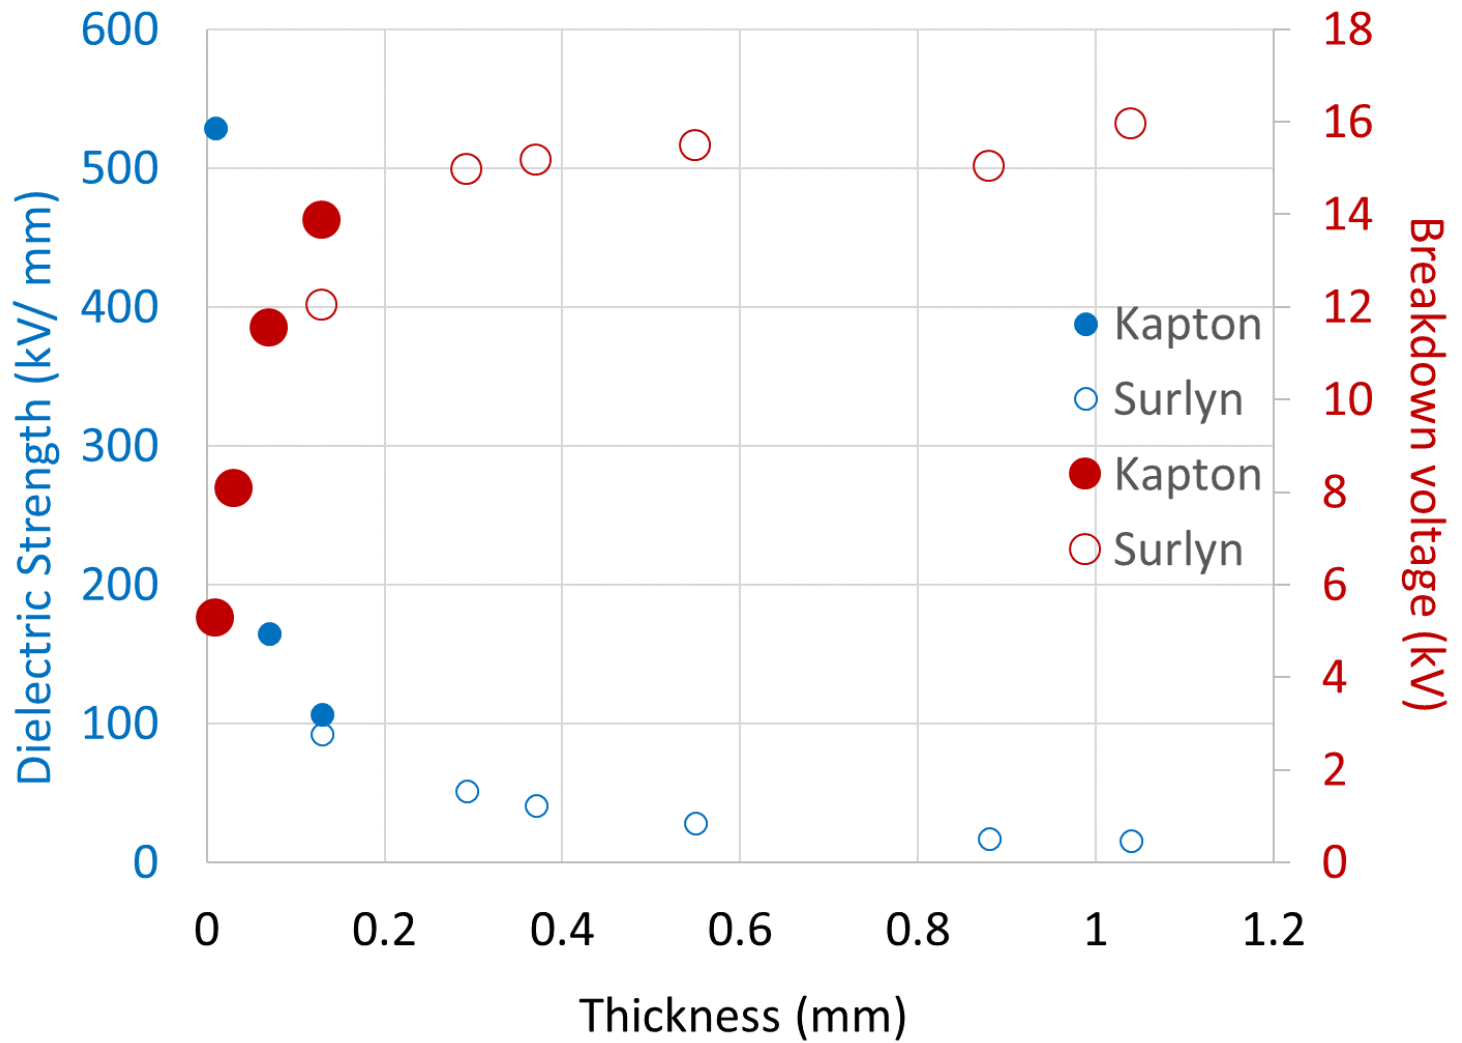
# Effect of thickness on dielectric breakdown

- Strong dependence on dielectric strength and thickness
- Surlyn has lower moisture absorbance than polyimide, but inferior dielectric strength
- Polyimide films displayed severe charring at max. voltage. Surlyn showed some evidence of reversible damage at maximum voltage.
- Charring damage is irreversible.
- External loads are required to facilitate self-healing.
- Polyimide siloxane show good dielectric strength, but chain mobility restrictions and charring from the polyimide component make it difficult for healing to occur.

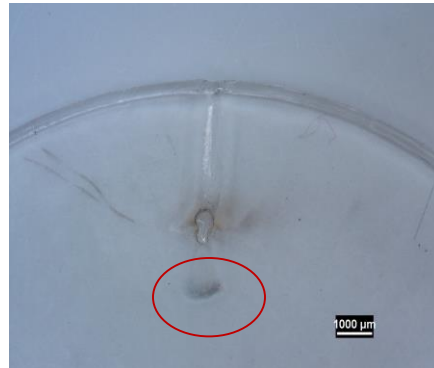
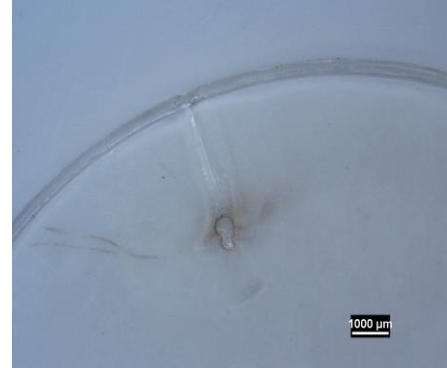
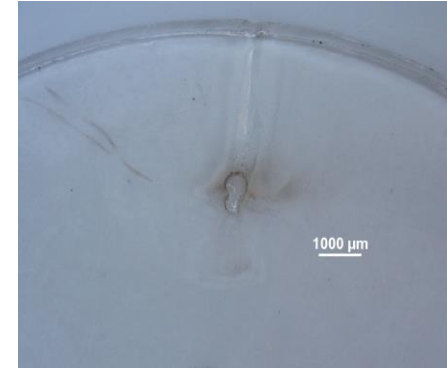
## Surlyn ~0.33 mm thickness

Surlyn did not show evidence of healing at the most severe damaged site, but some discoloration changes were observed in 0.33 mm and 0.55 mm thick samples by day 7 of exposure to 70°C dwell temperature.

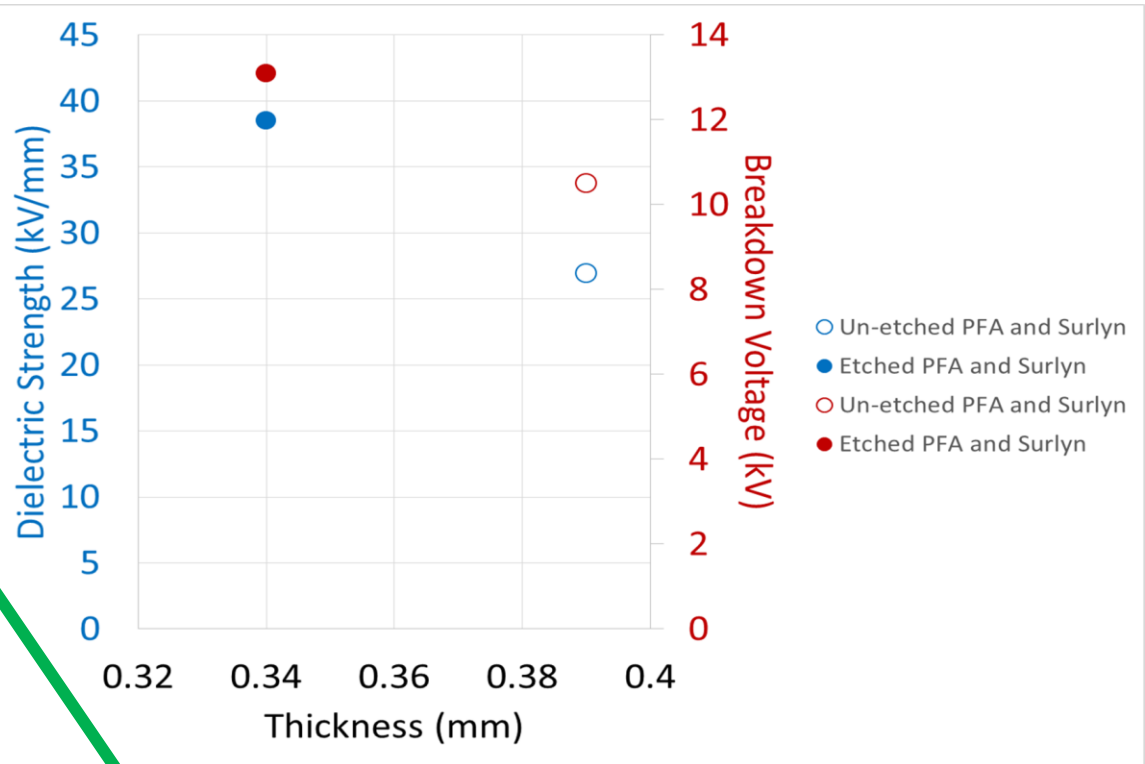
Wrinkling in PFA formed upon melting and flowing of Surlyn pellets.

\*Small puncture still observed after breakdown.

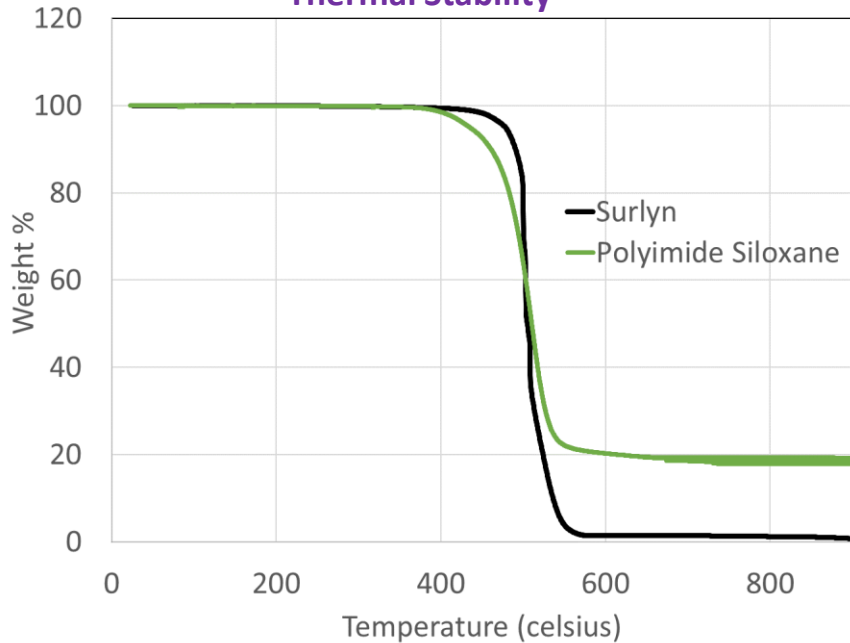
Thermal Stability

Silicone polymers have potential to self-heal as a result of siloxane equilibration (ionic crosslinking). Introduction of a polyimide component could further increase the thermal stability and dielectric strength.
