# Impact of High-Resolution Characterization during Baseline Sampling at Contractors Road Heavy Equipment Area Kennedy Space Center, Florida

Mike Burcham, E.I.T (Geosyntec);  
Anne M. Chrest (NASA); Rebecca  
Daprato, Ph.D., P.E. (Geosyntec); Jill  
Johnson, P.G. (Geosyntec)

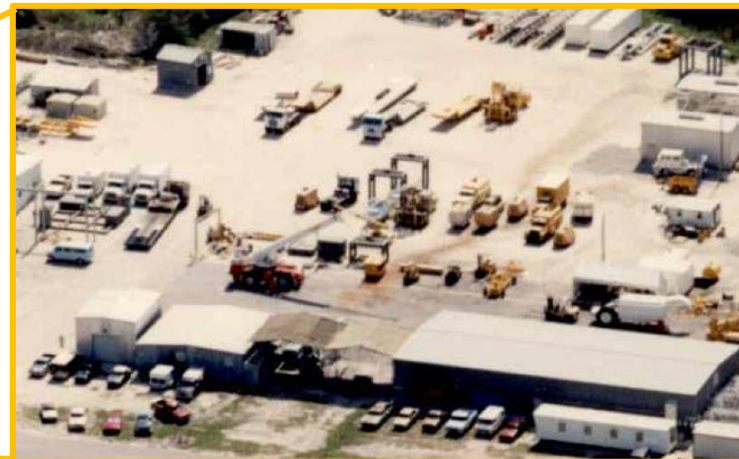
1993 Aerial Photograph

- **Location:** Kennedy Space Center (KSC), FL
- **Historically:** hazardous waste storage/staging facility
- **Currently:** heavy equipment storage and maintenance

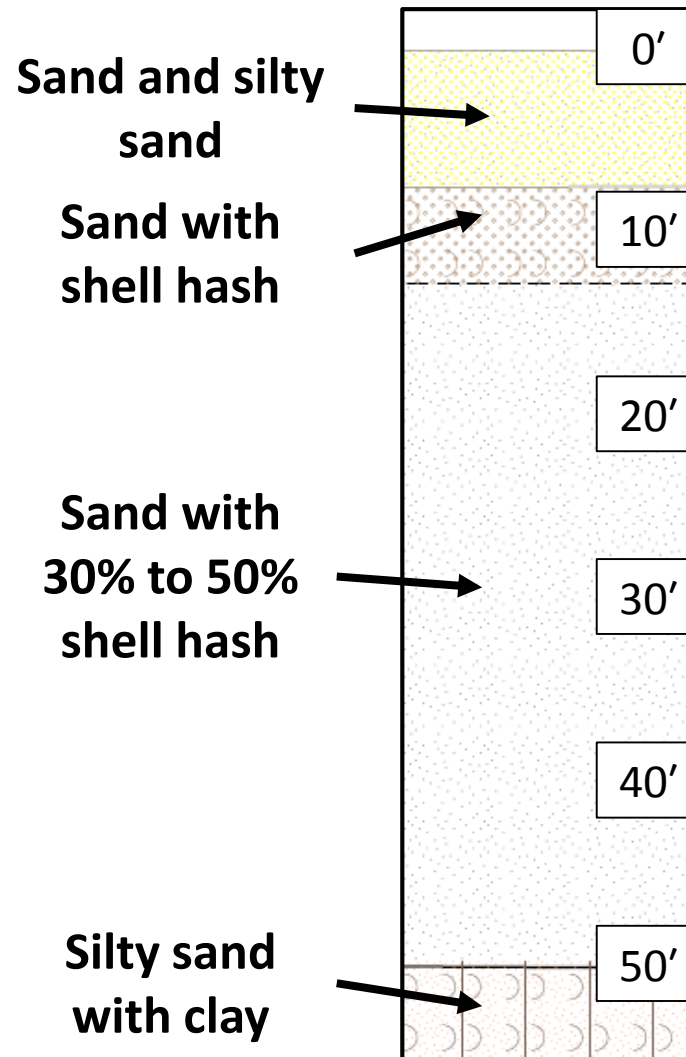
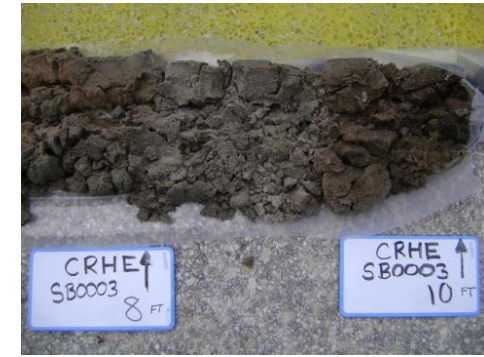
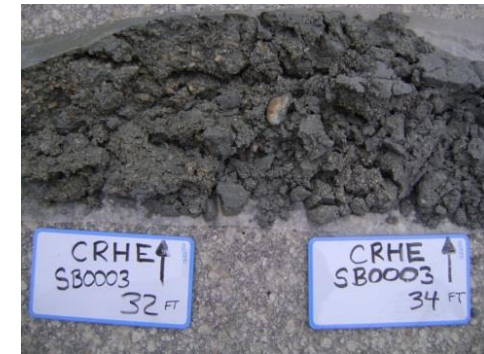
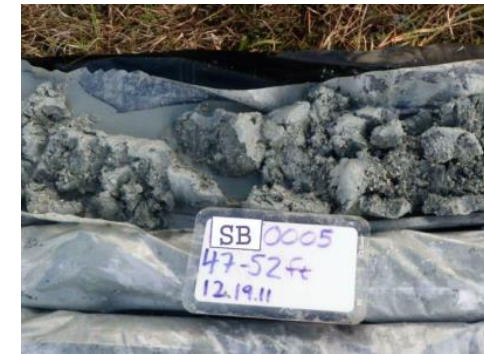
### Lithology with Depth (ft BLS)

- Site Hydrology
  - Groundwater flow in intermediate zone is generally to west
  - Low permeability layer starts ~50 feet below land surface (ft BLS)
  - Depth to groundwater ranges from 2 to 6 ft BLS

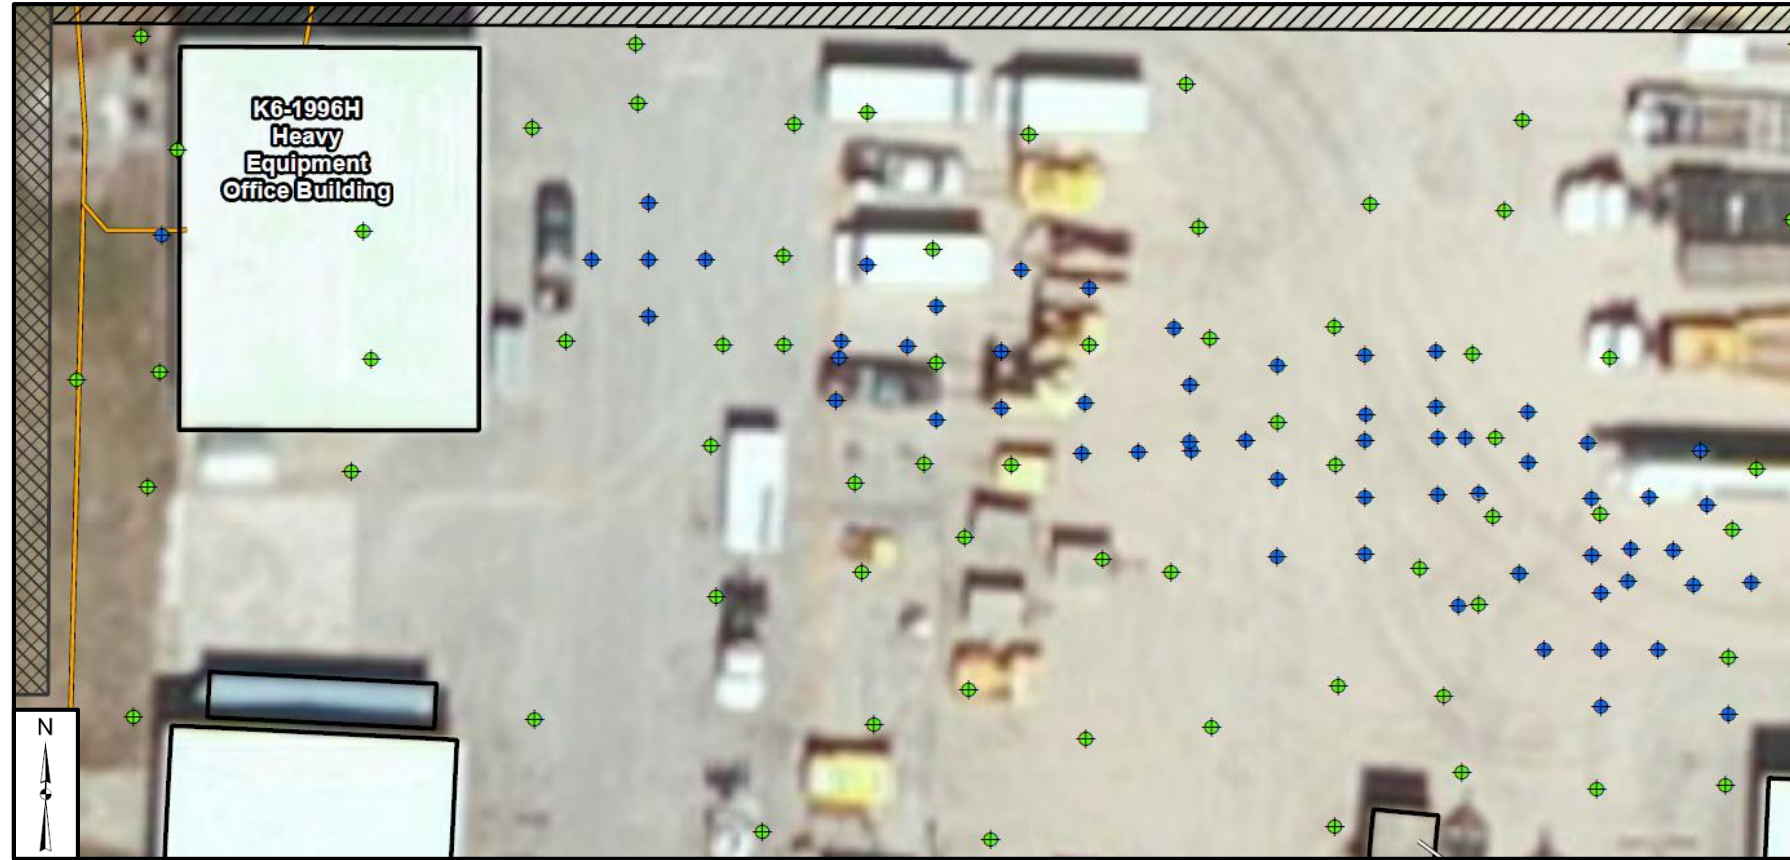
DPT HRSC Locations: Pre-2015 2015-2016

- Baseline HRSC via DPT in Sept and Oct 2015
  - 16 locations
  - 99 samples
  - Additional source area refinement warranted
- Additional HRSC via DPT performed in 2016
  - 44 locations
  - 295 samples

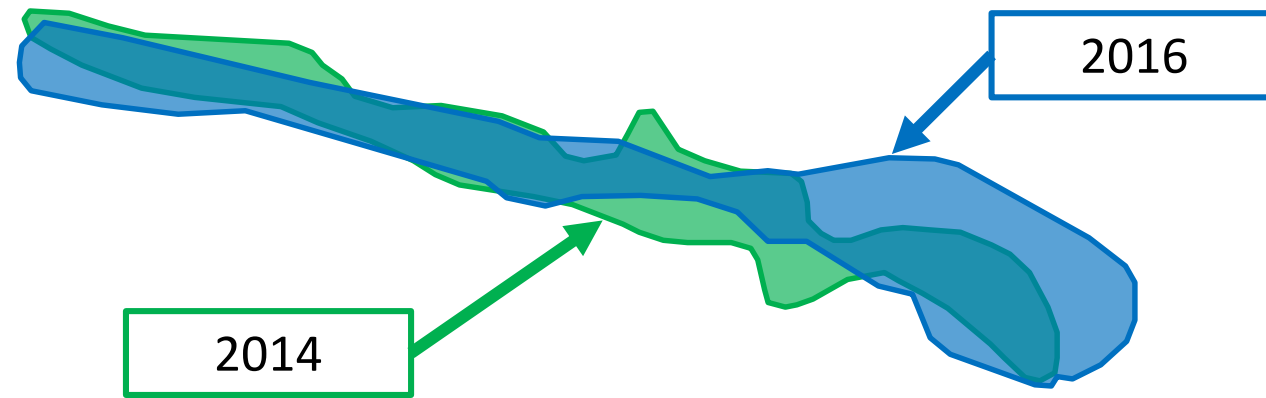
- Horizontal impacts (Source Zone) expanded
  - Area Change: 3,000 ft<sup>2</sup> → 4,800 ft<sup>2</sup>

- More impacts on eastern side of Hot Spot 1
- Vertical impacts (Hot Spot) expanded
  - More shallow (Hot Spot) impacts identified

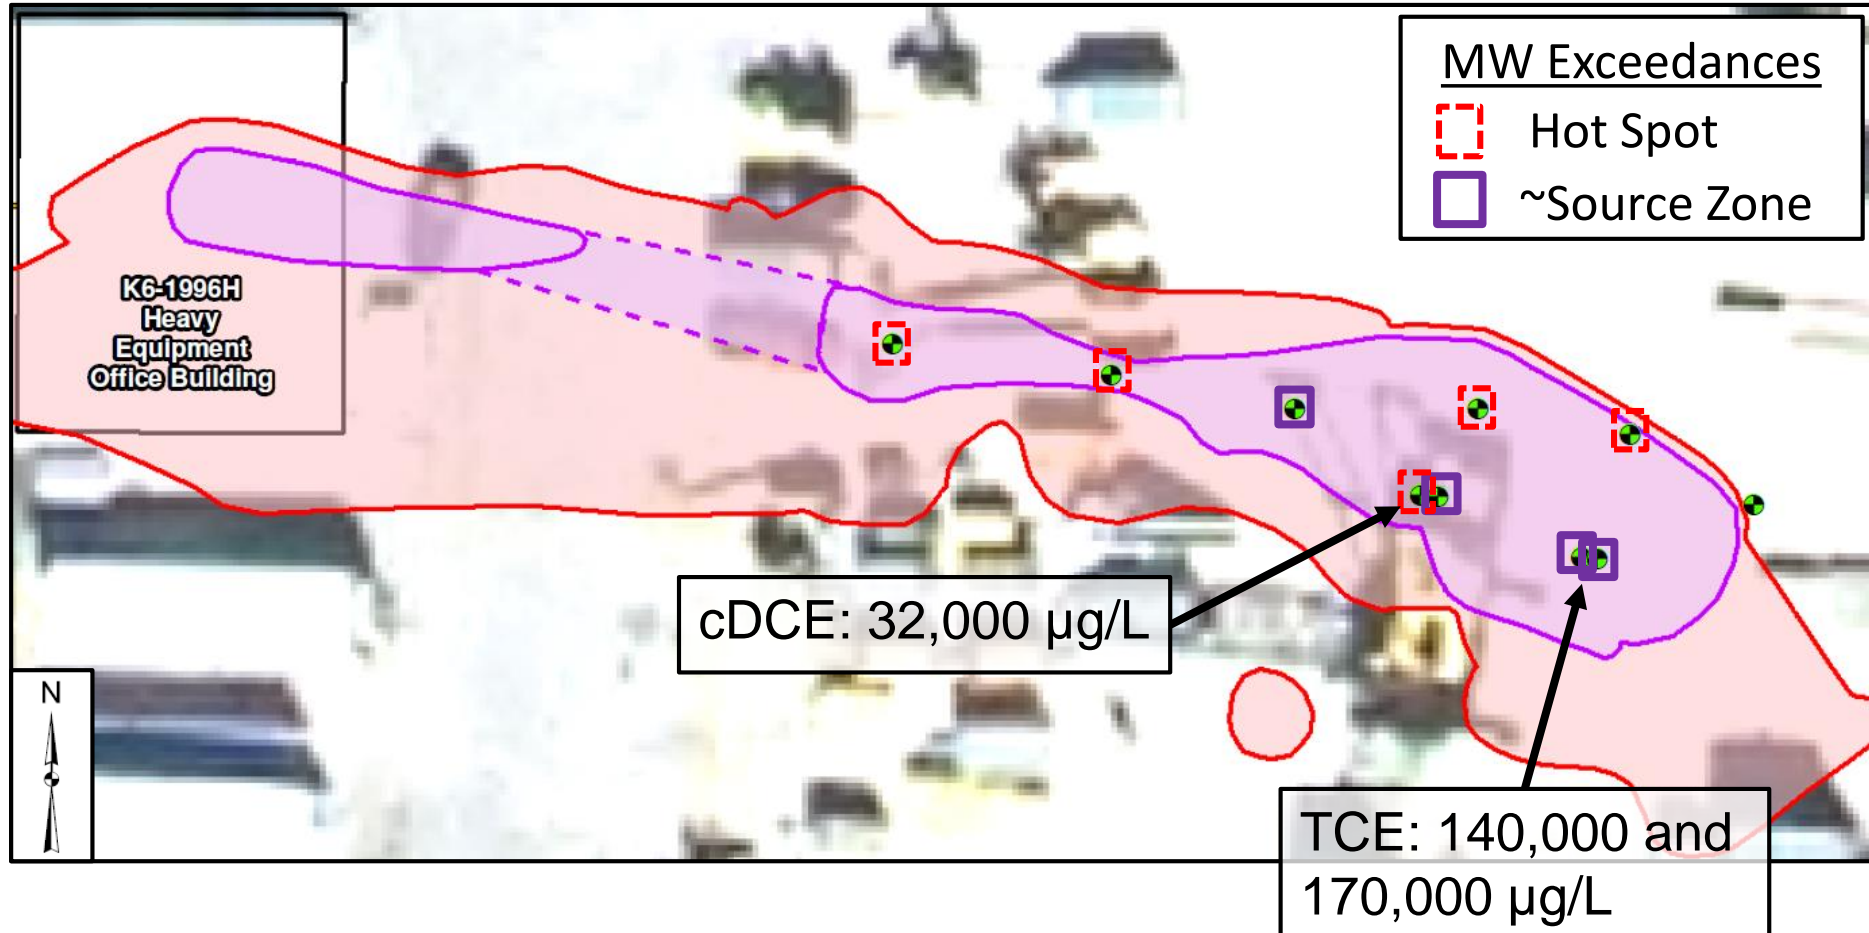
## Impact of Baseline HRSC: Monitoring Plan

- Monitoring well (MW) network adjusted
- Baseline results confirm HRSC CSM refinement
