NASA/TM—2015-218830

Gear Tooth Wear Detection Algorithm

Irebert R. Delgado
Glenn Research Center, Cleveland, Ohio

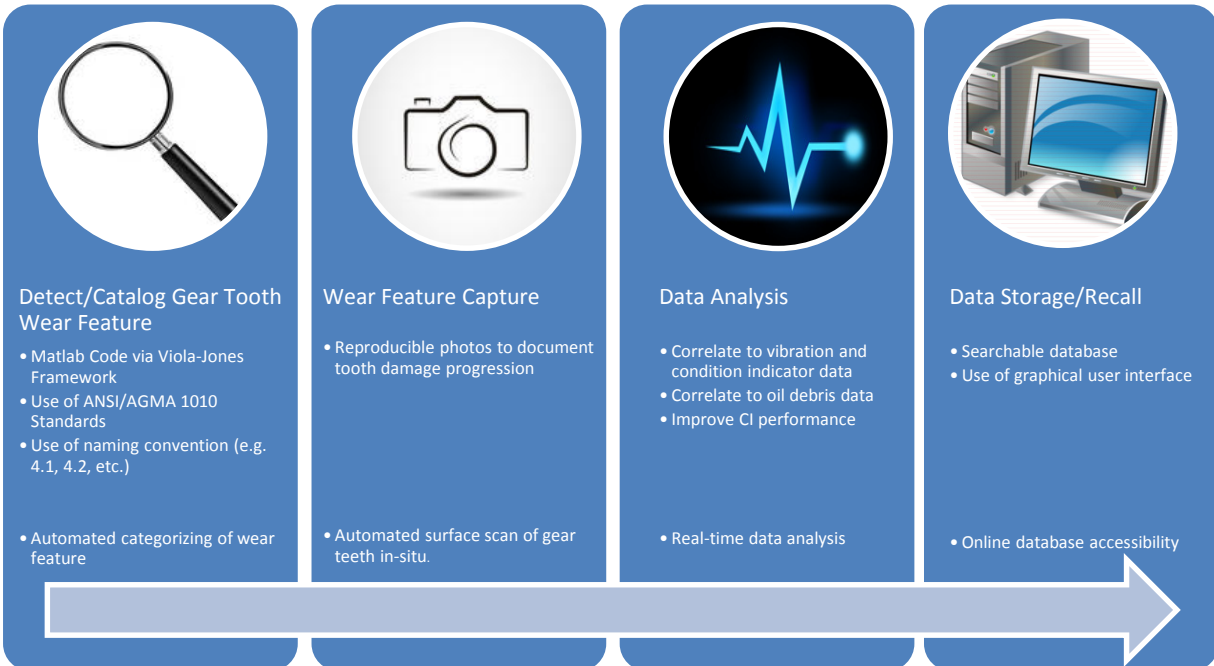
Figure 2.—Notional framework to analyze gear tooth wear.

Figure 2 shows a notional framework for the detection, capture, analysis, and storage of gear tooth wear data with the intent of automating individual processes. This paper specifically addresses gear tooth wear feature detection and capture. Observed gear tooth damage is categorized and defined by ANSI/AGMA 1010 Standards, Appearance of Gear Teeth: Terminology of Wear and Failure (Ref. 12). The Contact Fatigue class is shown in Figure 3. Gear pitting damage is classified under contact fatigue which is subdivided into three general modes: pitting (macropitting), micropitting, and subcase fatigue. Macropitting is further divided into specific modes or degrees, including initial pitting, progressive pitting, flaking, and spalling. Micropitted gears, Figure 4(a), appear frosted, matted, or gray stained. The magnified surface appears to be covered with fine pits. Initially pitted gears, Figure 4(b), exhibit pits less than 1 mm in diameter and are localized on the tooth surface. Progressive pits, Figure 4(c) are significantly larger than 1 mm in diameter. Pitting of this type may continue at an increased rate until a significant portion of the tooth surface has pits of various shapes and sizes. Spalling, Figure 4(d), is progressive pitting where pits coalesce and form irregular craters that cover a significant area of the tooth surface. The scope of this study was limited to accurately detecting both initial and progressive pitting. No attempt was made, at this time, to distinguish between either types of pitting.

An objective of this work would be to automate the detection, cataloging, and capture of gear wear observed on the gear teeth. Large data sets could be catalogued quickly and accurately. A database of results could be queried by users to determine trends in the test data. Addressing the analysis box in Figure 2, these trends could be correlated with existing vibration and oil debris data. Corresponding gear vibration and condition indicators could be improved by fusing this correlation between observed gear wear, vibration, and oil debris data. Ultimately, the improved gear vibration and condition indicators could be implemented on-board HUMS systems for rotorcraft.

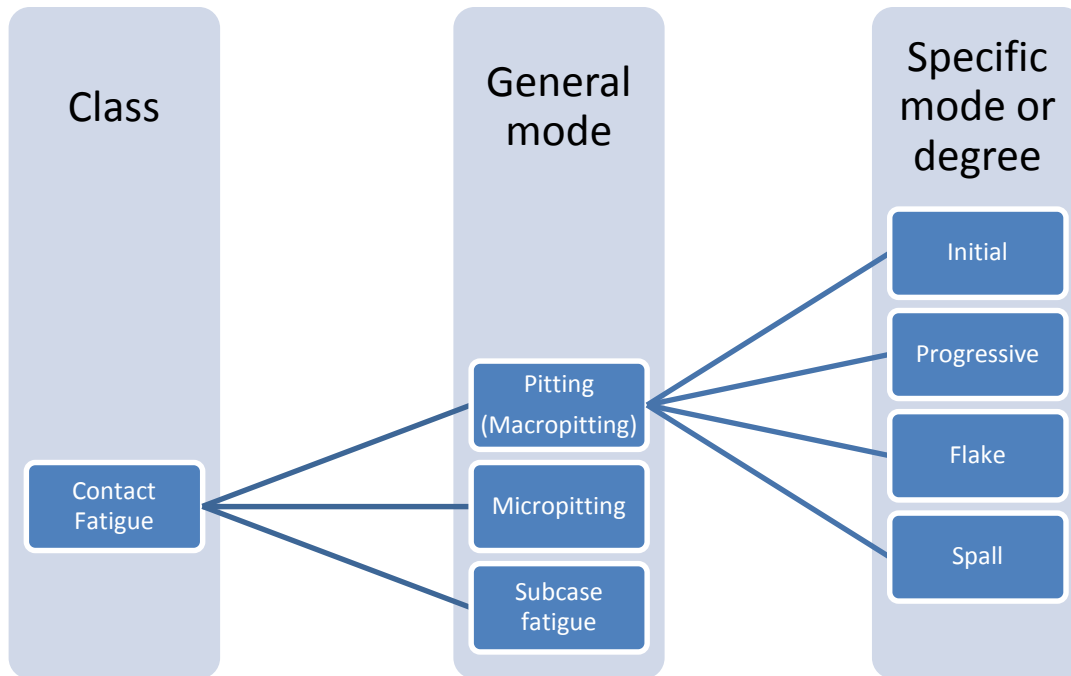
Figure 3.—Gear damage contact fatigue class per ANSI/AGMA 1010 standards (Ref. 12).

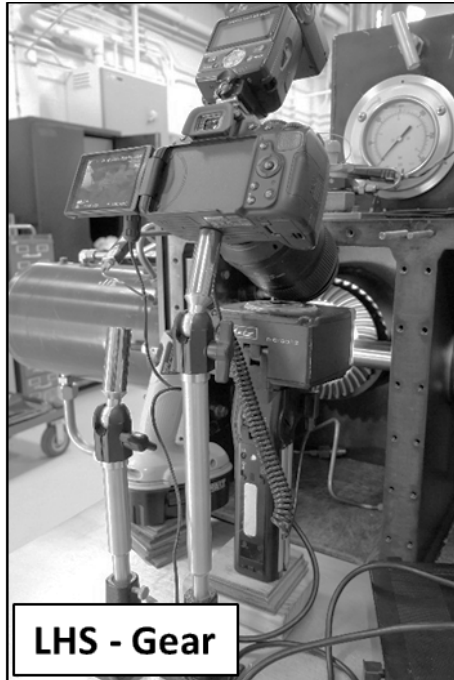
Figure 6.—Pre-set camera positions for gear tooth photos.
