Environmental Barrier Coatings for Ceramic Matrix Composites – An Overview

Kang Lee¹, Mark van Roode², Tania Kashyap³
Dongming Zhu¹, and Valerie Wiesner¹

ICACC 2017, Daytona Beach, FL

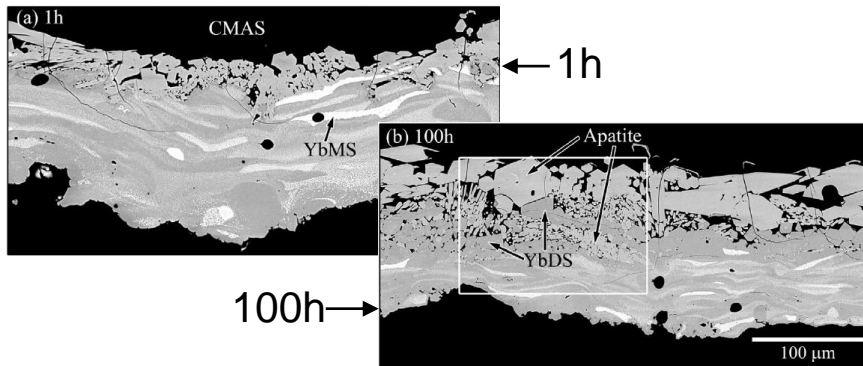
APS $Yb_2Si_2O_7$ (YbDS)
1300C, 30-35 mg/cm² CMAS

CMAS reacted preferentially with YbMS segregates

- Little or no reaction occurs with YbDS (Stolzenburg)
 - Yb_2O_3 activity of YbDS is lower than YbMS by more than three orders of magnitude (Costa and Jacobson)
 - YbMS should react more readily than YbDS
- Reaction intruded into the interior by the preferential reaction with surface-connected YbMS segregates, leaving peninsulas of less reacted YbDS (Zhao et al.)
