Measuring the On-Orbit Clearance between ISS Hardware using Imagery

**The Image Science and Analysis Group
NASA - Johnson Space Center**

Presentation at the 2017 CMSC Conference

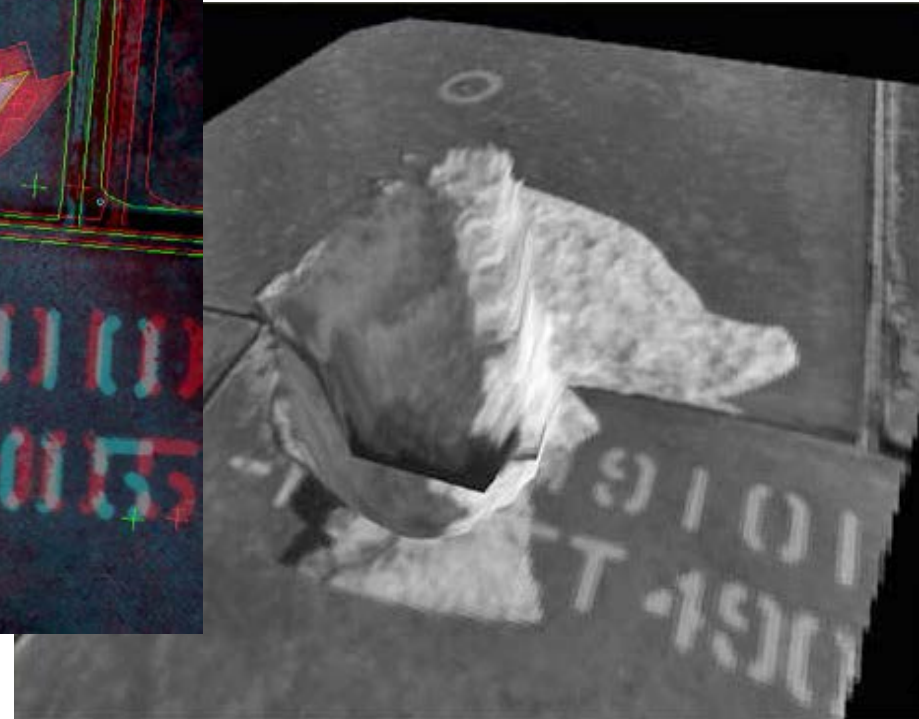
Damage to Thermal
Protection Tile during
Shuttle Mission
STS-118

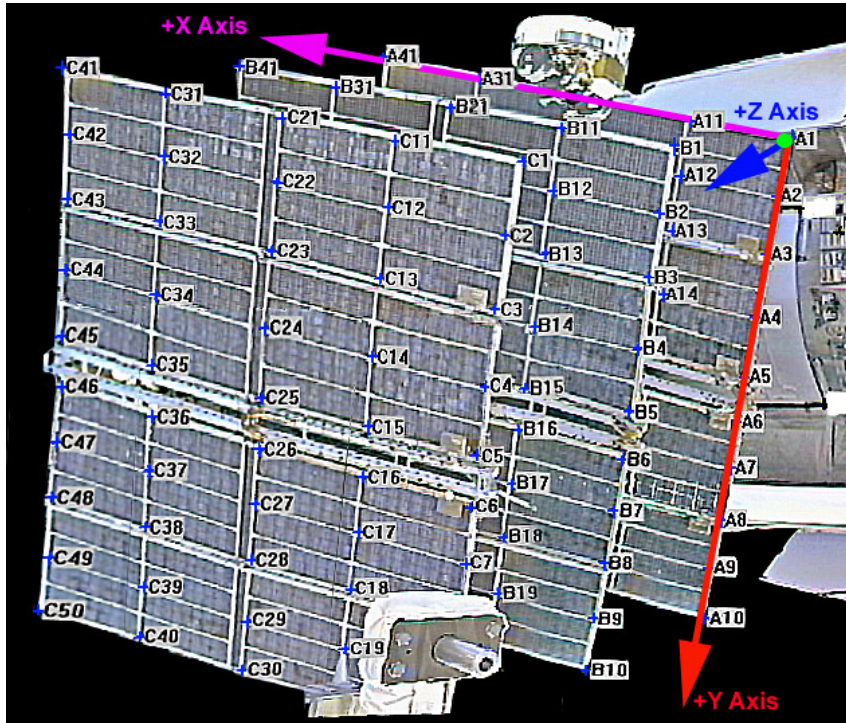
Photogrammetric Measurement of Solar Array using standard definition imagery (640x480 pixels) from the television cameras on the end of the robotic arm

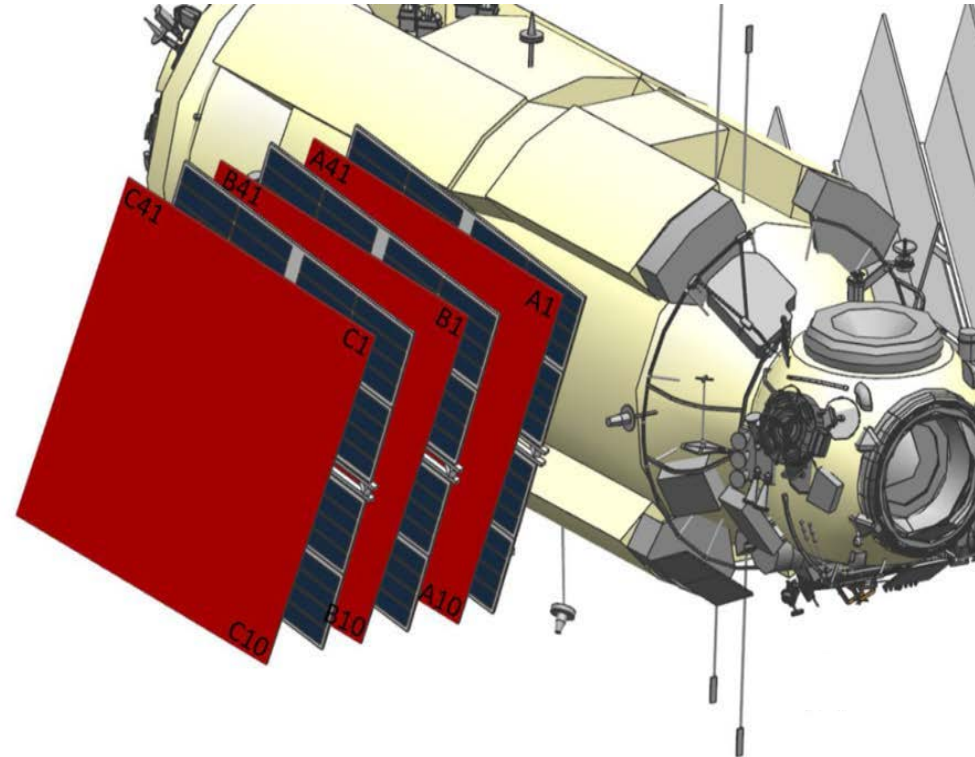
Comparison of Photogrammetric Measurements (in red) to Retracted Design State of the Solar Array (shown in blue)

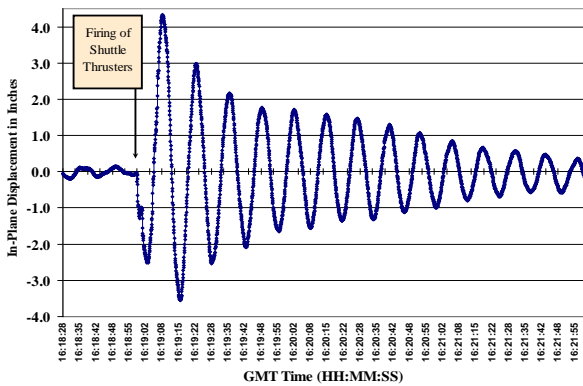
Example of In-Plane Displacement of Solar Array Wing (SAW) Tip

4D (Video)
Photogrammetry
used to quantify
the natural
frequency of the
solar array wings
on the ISS
beginning in
Nov. 2000

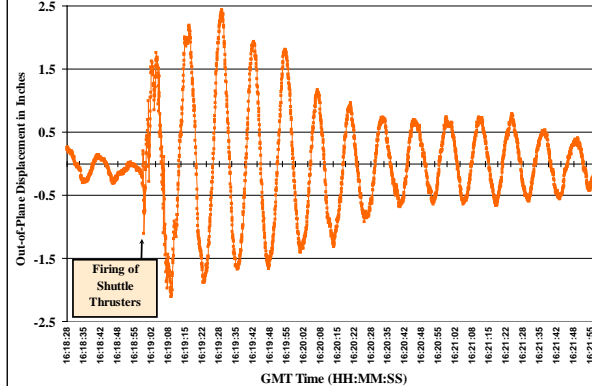
Example of Out-of-plane Displacement of Solar Array Wing (SAW) Tip

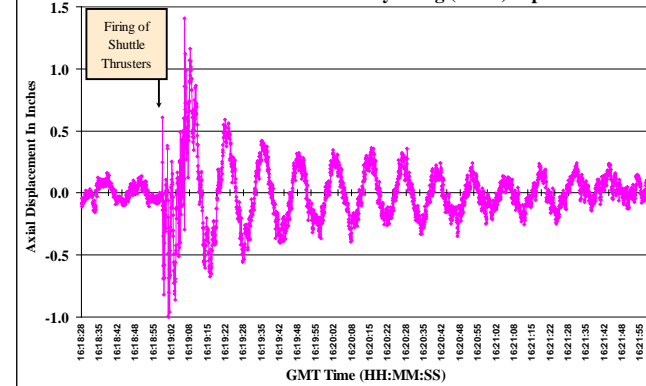
Example of Axial Displacement of Solar Array Wing (SAW) Tip

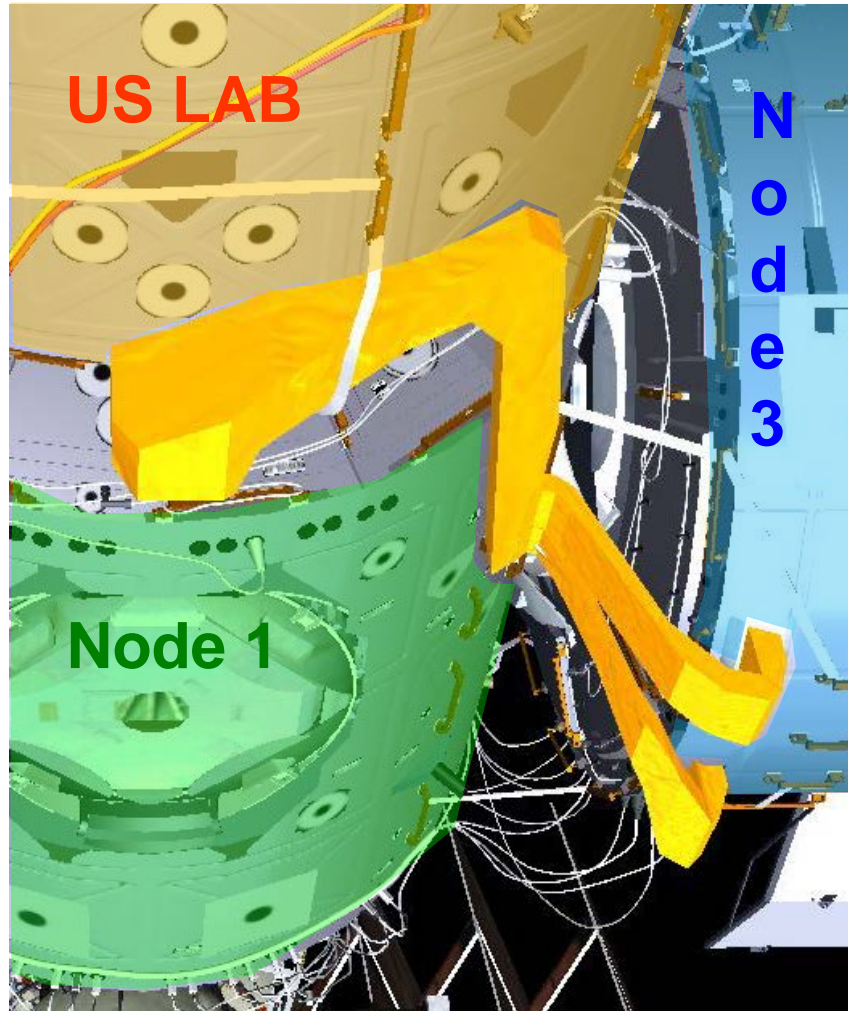
A “generalized” CAD model was developed to represent the shape and position the ammonia lines wrapped in Multi-layer Insulation (MLI). 13

Generalized CAD of Ammonia Line

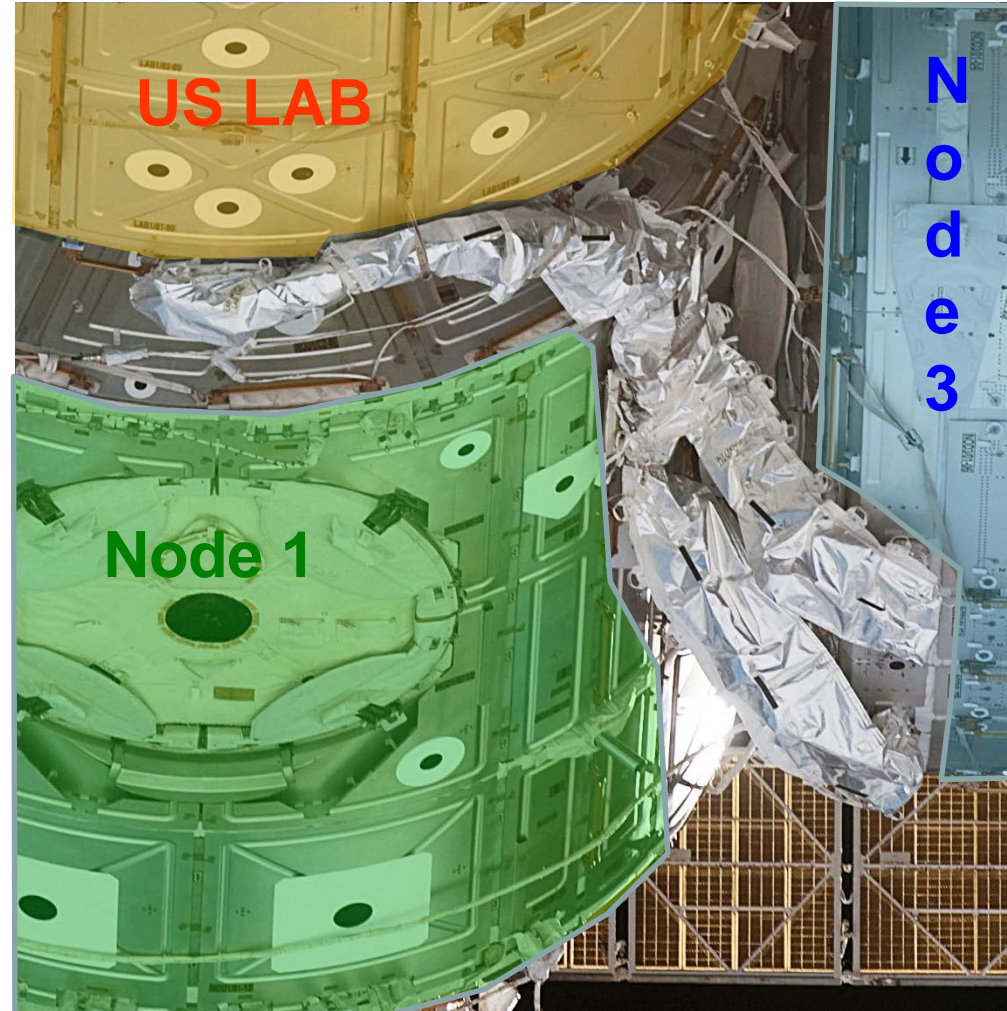
On-Orbit Installed Ammonia Line

The generalized CAD bore a modest resemblance to the actual lines installed on-orbit, but the accuracy of its location was not verified.

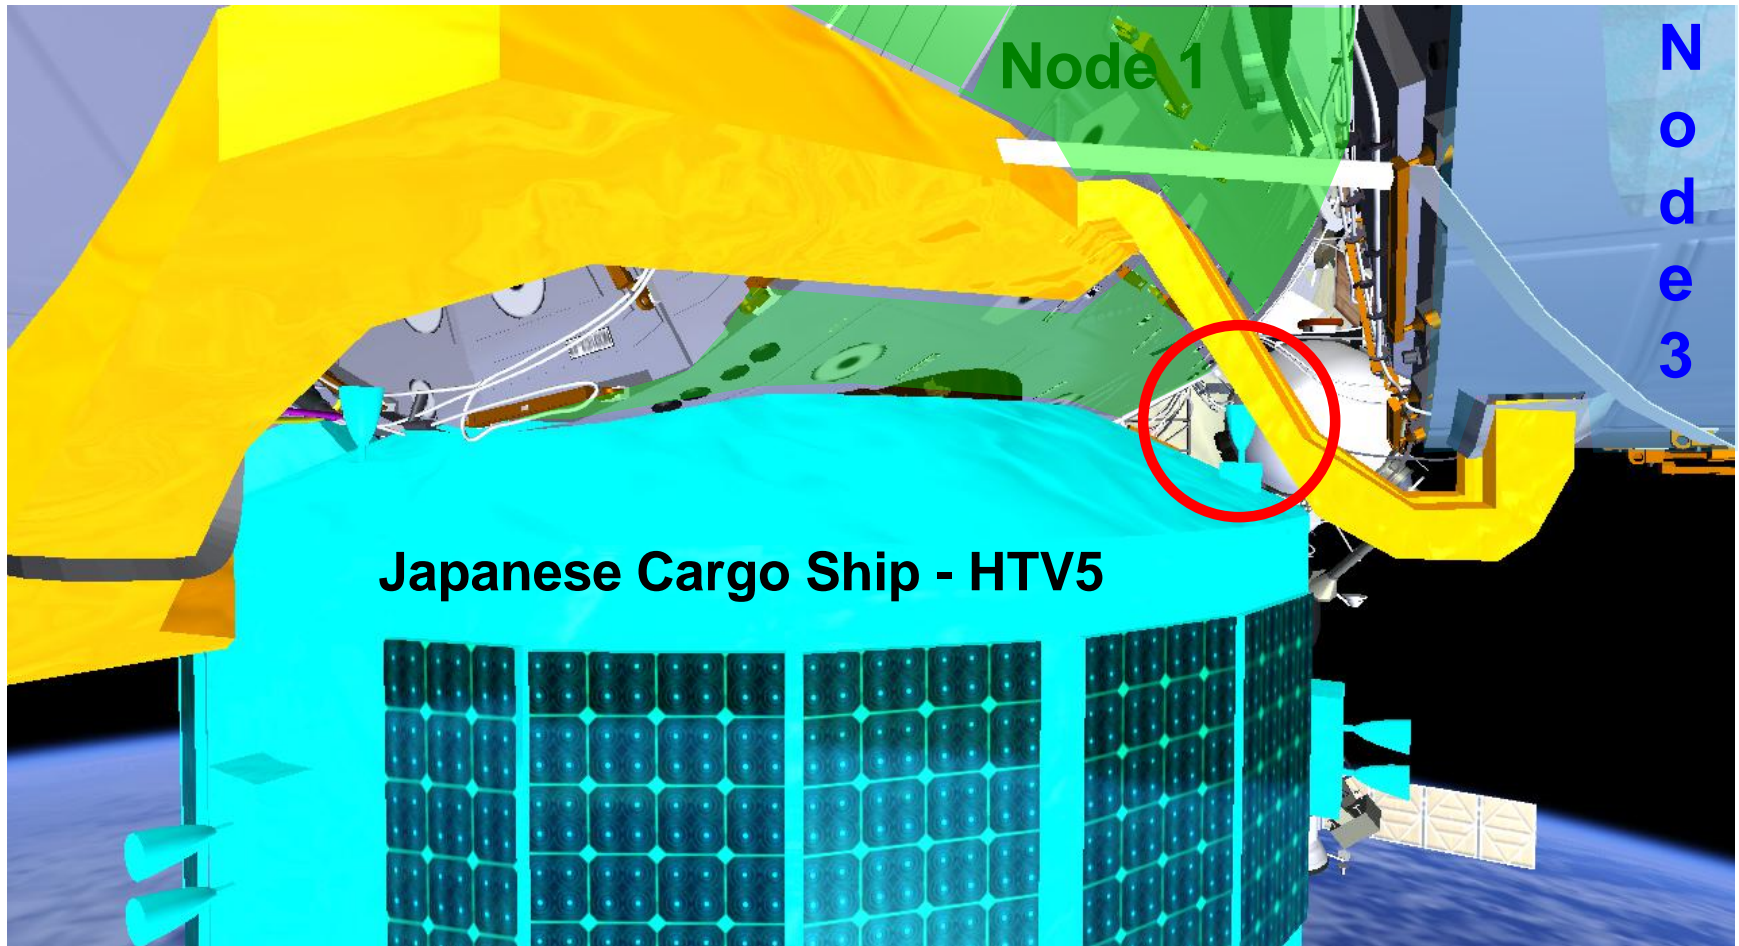
In April 2015 a CAD based analysis showed a four inch negative clearance between the generalized CAD model of the ammonia line and the port thruster nozzle on Japanese HTV Cargo Transfer Vehicle #5, (shown in blue) when berthed to the Node 1, Nadir CBM.

Recognizing that the CAD model was inaccurate, the ISS program requested that IS&AG measure the location of the on-orbit ammonia lines and compute the clearance between them and the berthed HTV5 thruster nozzle.

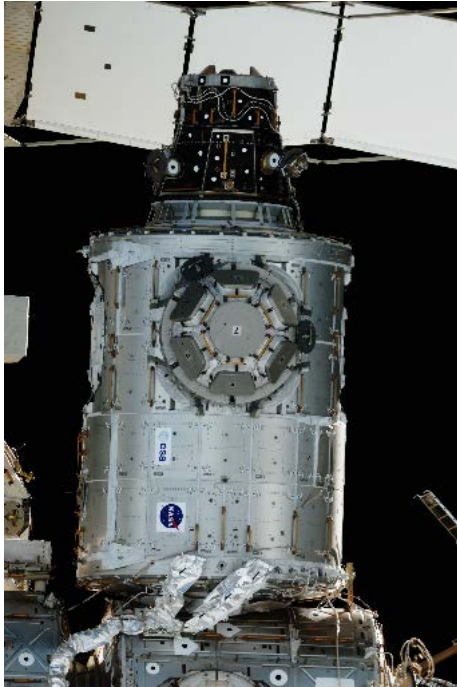
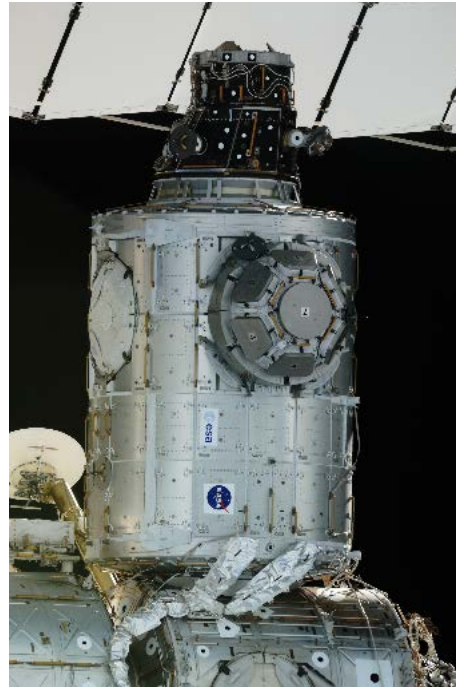
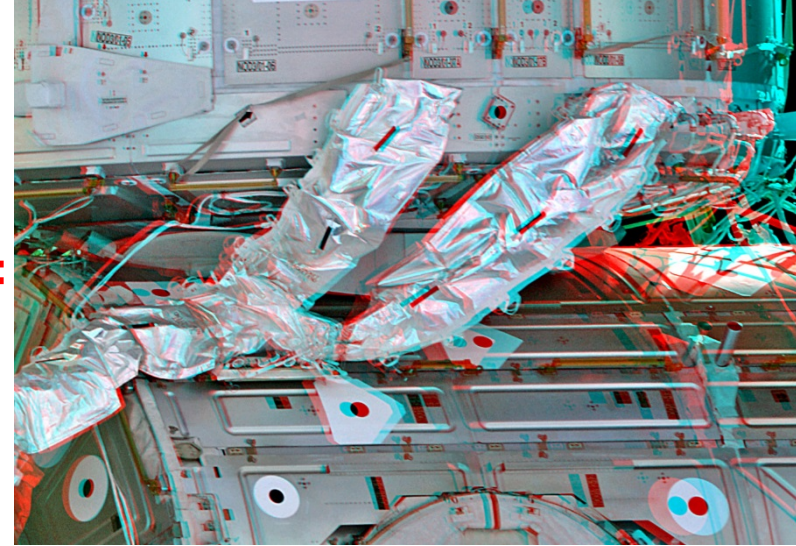
- Using the principles and mathematics of Photogrammetry, a 2D picture added to a second 2D picture, taken from a slightly different perspective, yields a 3D picture.
- The stereo image can not only be viewed in 3-D, but relative measurements of the objects can be made in the 3-D image.

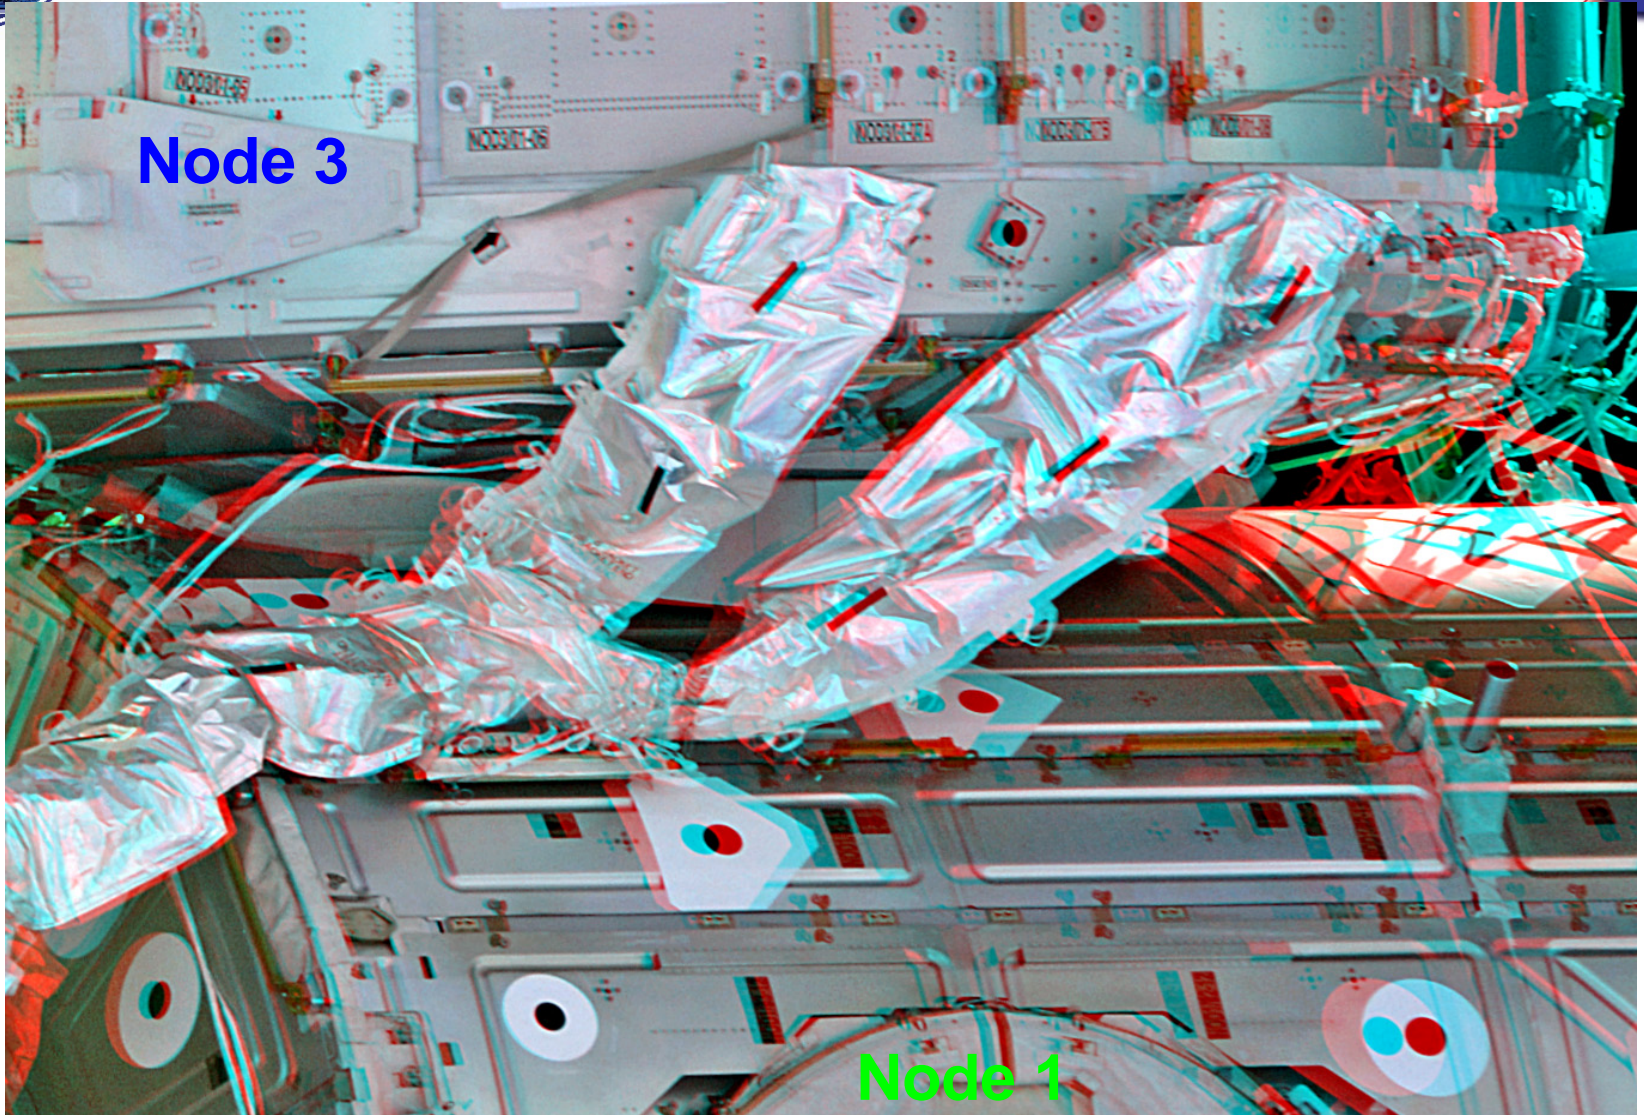
Stereo Imagery of Ammonia Lines

Using control points on the exterior of the Space Station (SVS targets and hand rails stanchions), the analysis was transformed into ISSACS.

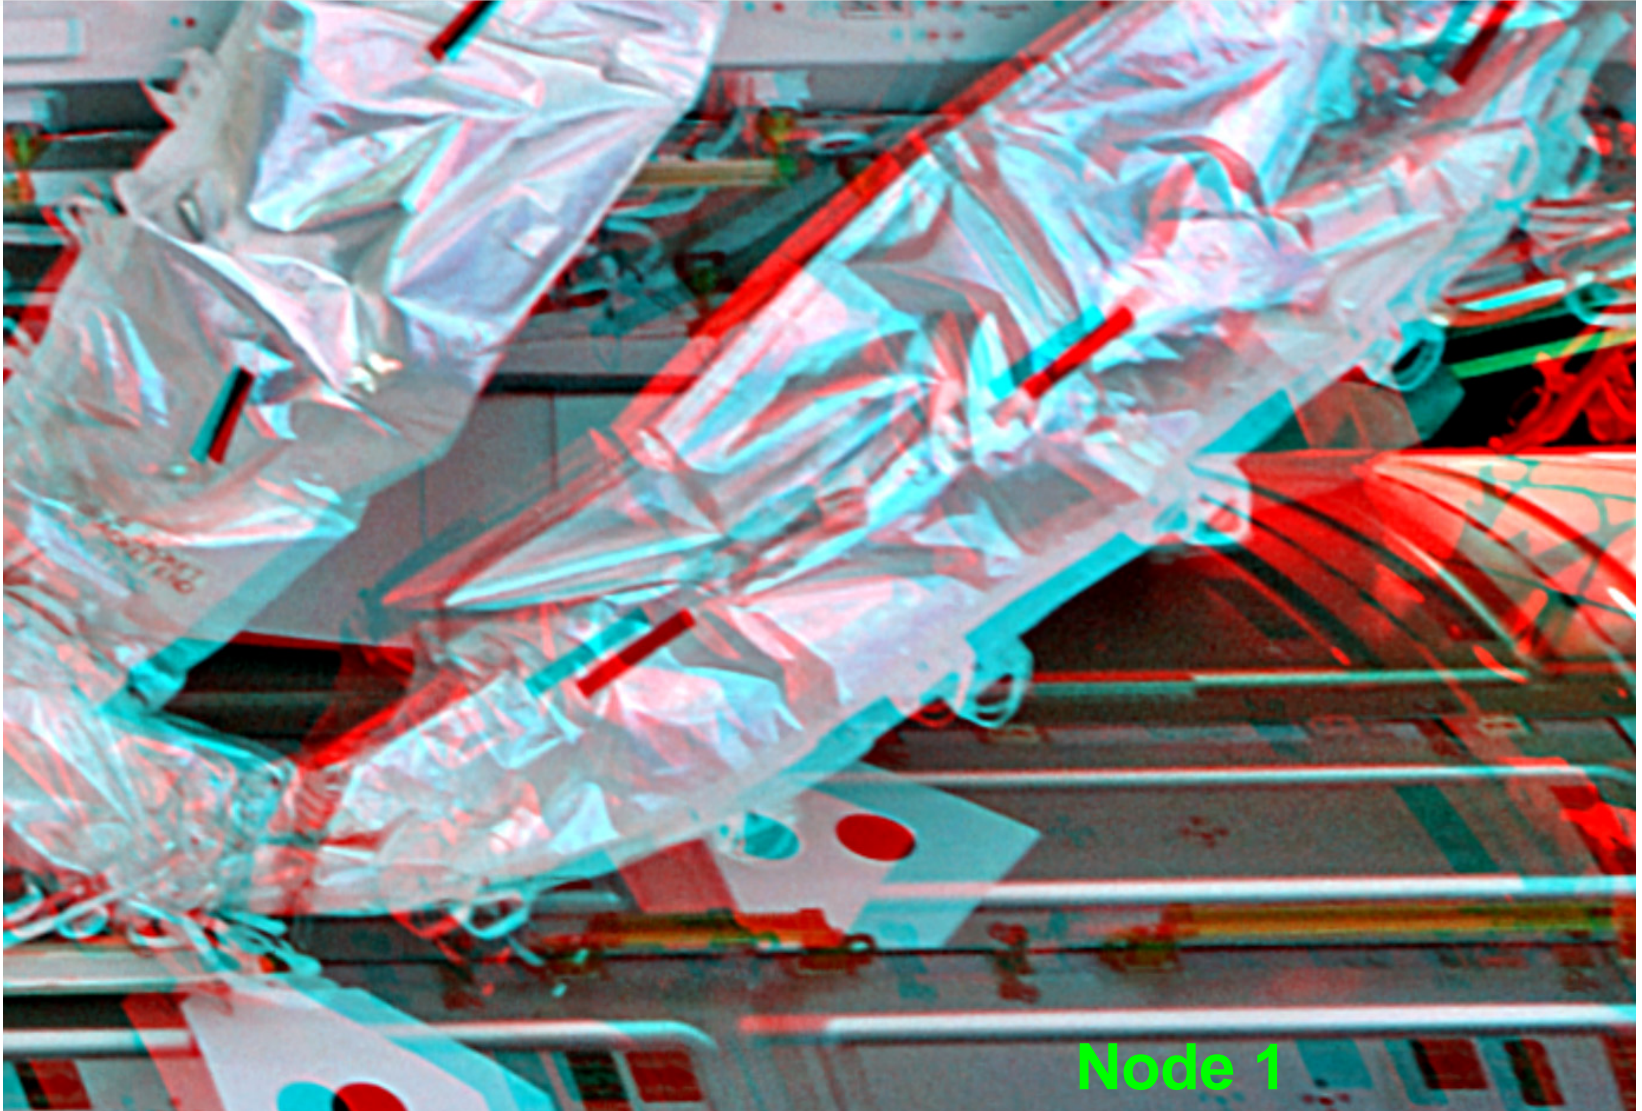
Stereo Imagery of Ammonia Lines

A closer view of the MLI wrapped ammonia lines.

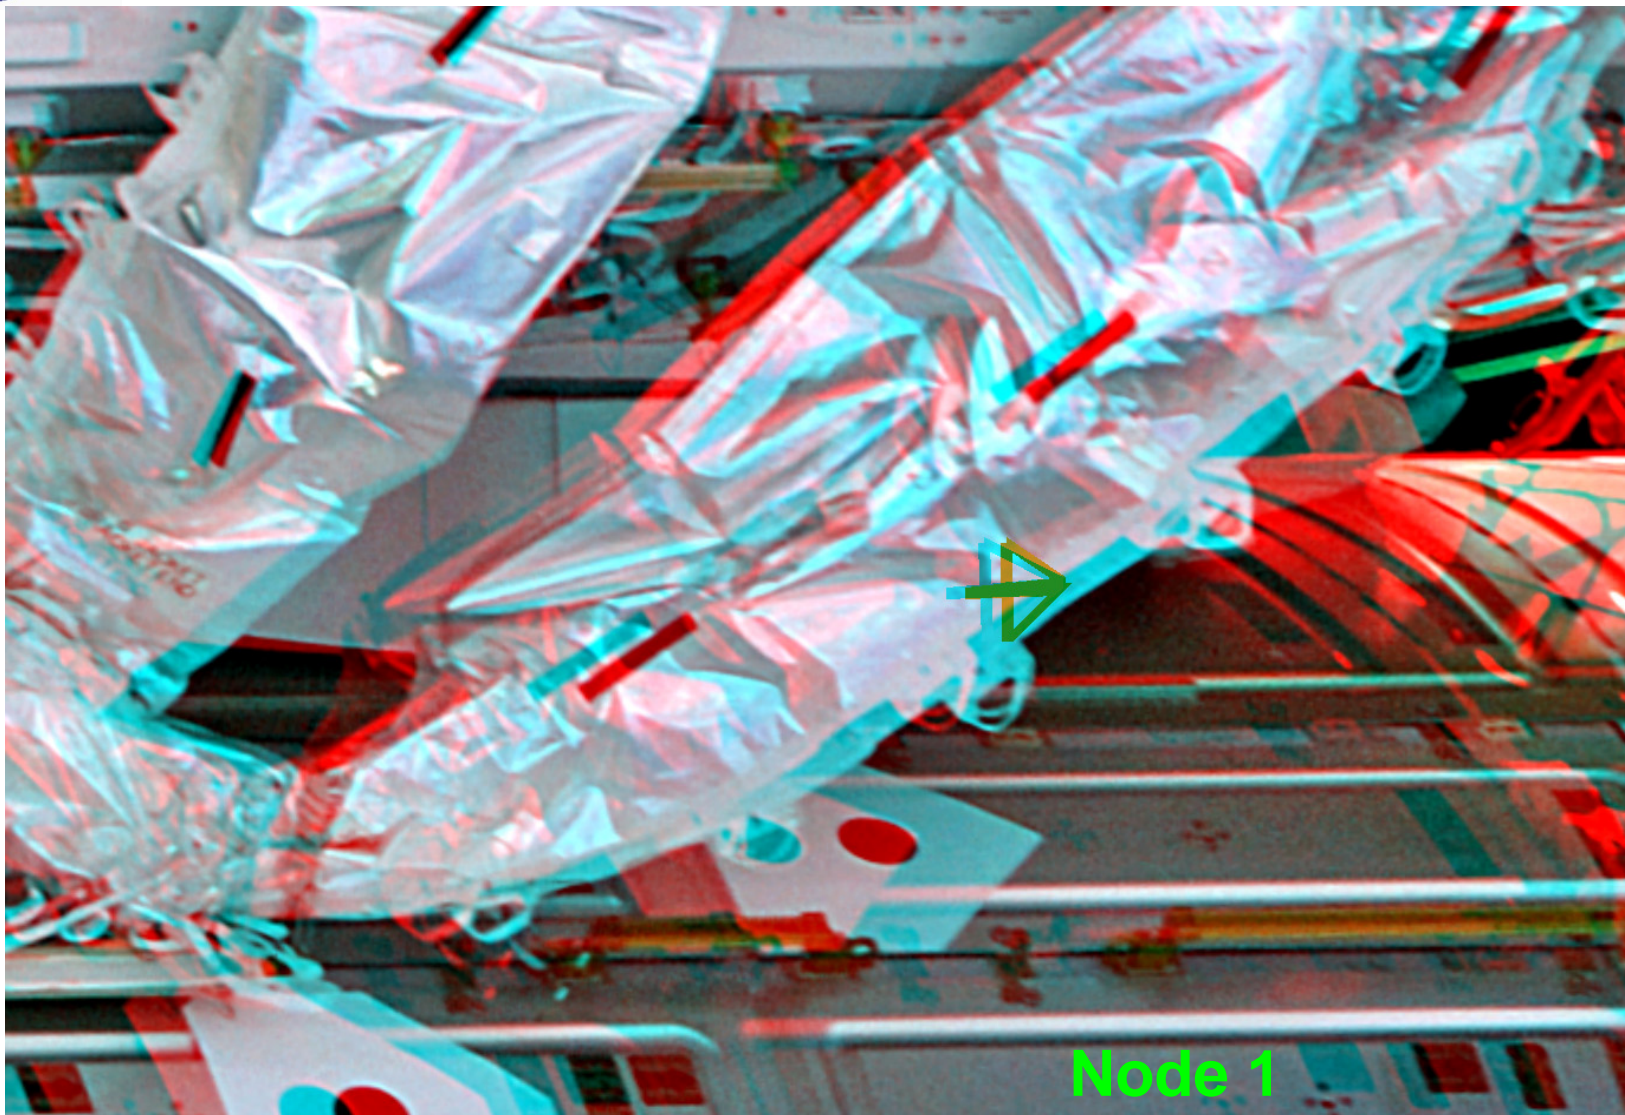
Stereo Imagery with HTV5 Thruster Location Indicated

The nominal berthed position of the HTV5 Thruster Nozzle in ISSACS was displayed in the stereo image above (as indicated by the green triangles).

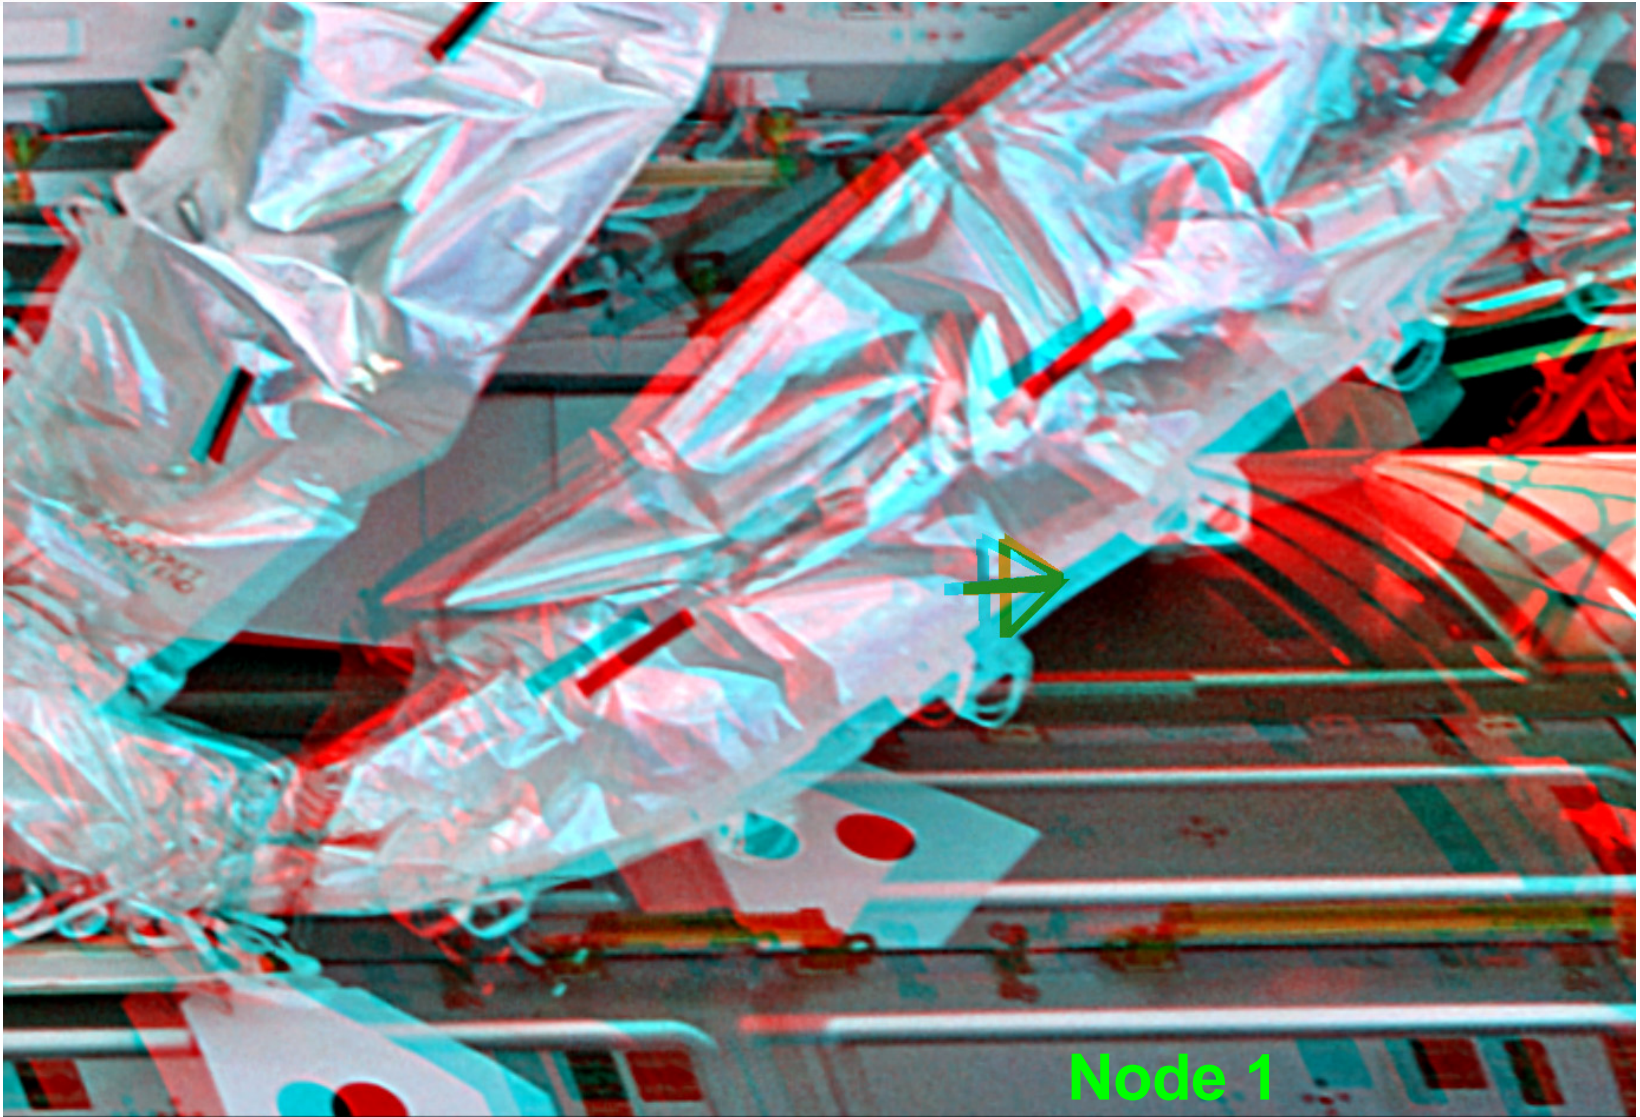
Stereo Imagery with HTV5 Thruster Location Indicated

The visible clearance between the thruster nozzle location and the surface of the MLI wrapped ammonia lines indicates positive clearance.

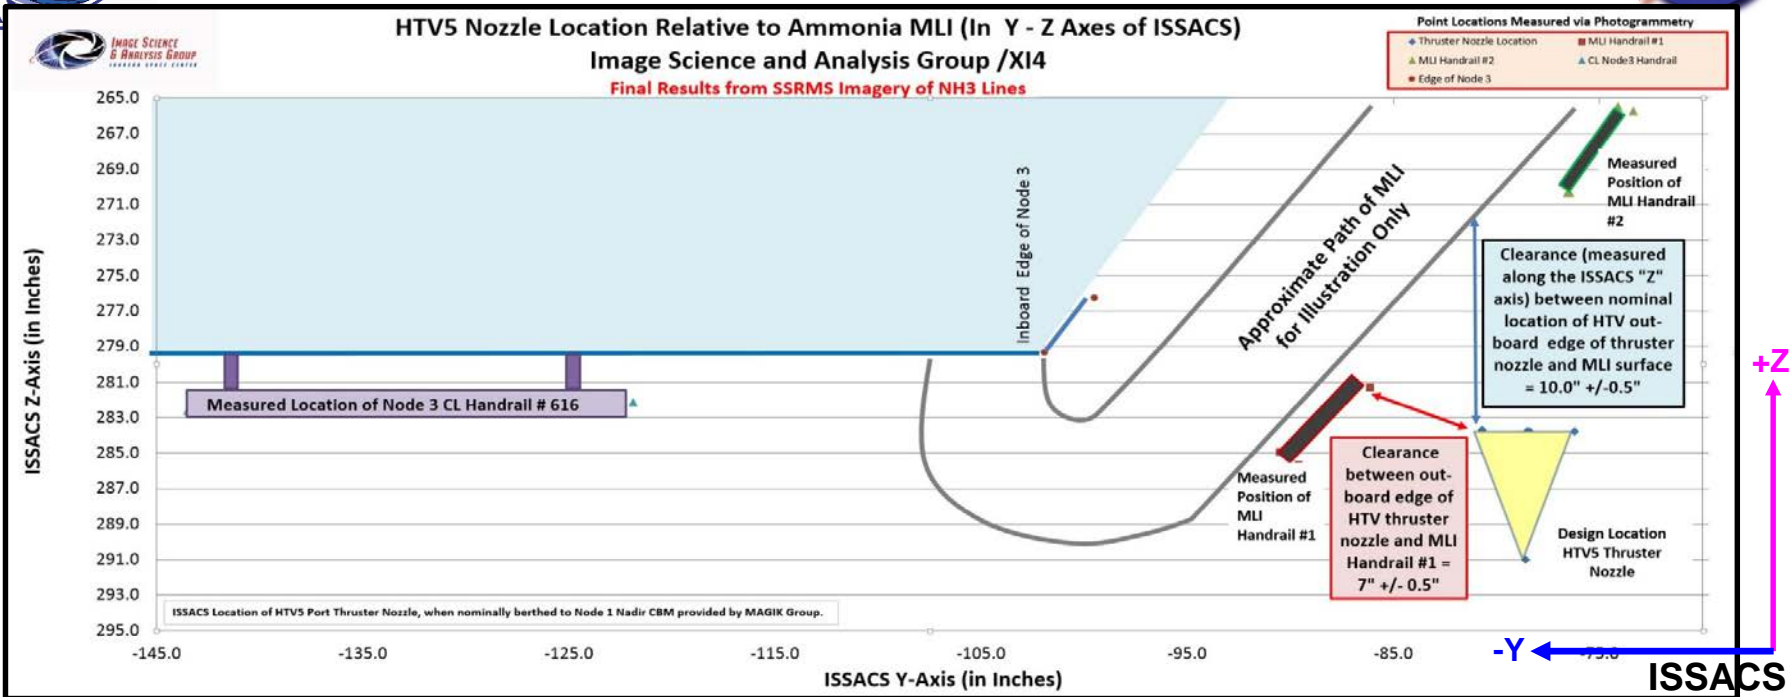
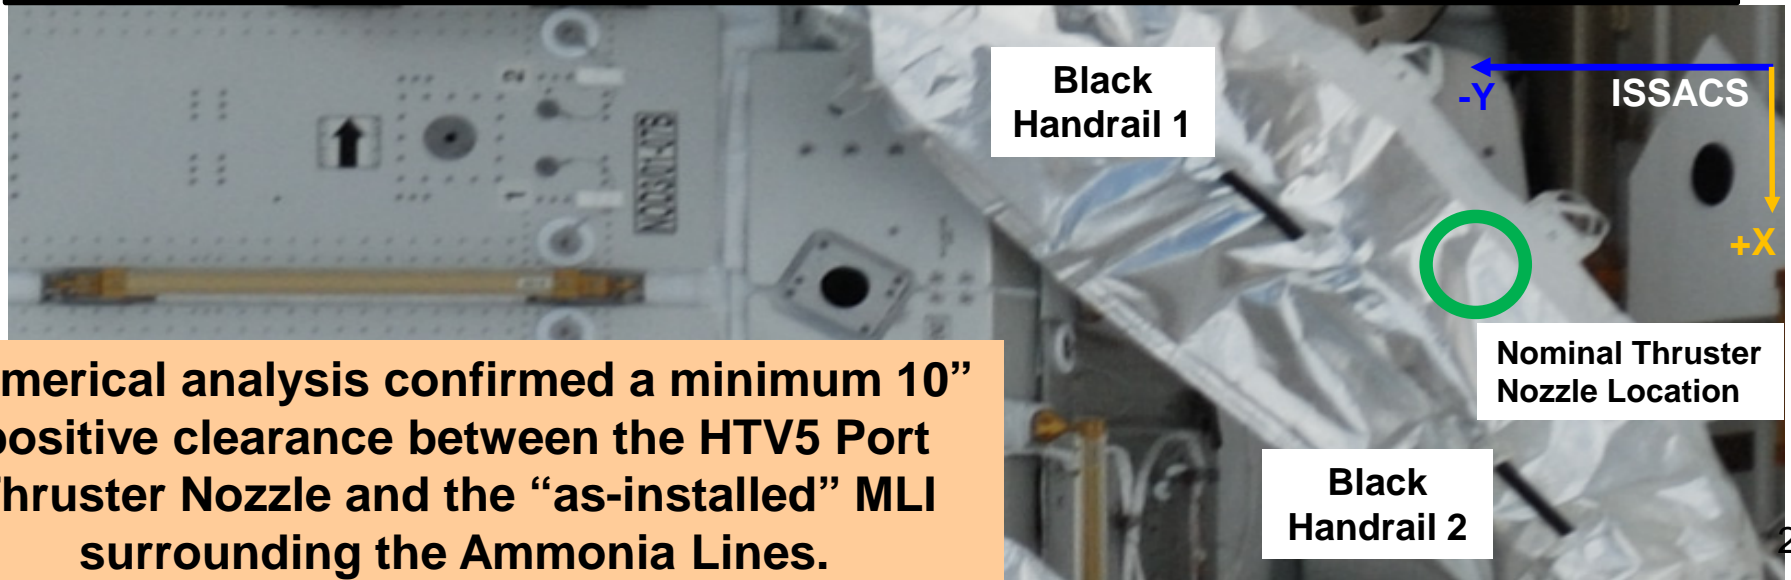
Numerical Measurement of Clearance

Numerical analysis confirmed a minimum 10" positive clearance between the HTV5 Port Thruster Nozzle and the "as-installed" MLI surrounding the Ammonia Lines.

- The initial analysis to prove positive clearance was completed over a 2 day weekend, by a single analyst.
- As the initial analysis used imagery from 2010, the ISS program approved a resurvey to acquire new imagery in the summer of 2015.
- Final results using the 2015 imagery confirmed a minimum 10" +/- 0.5" positive clearance between the HTV5 Port Thruster Nozzle and the "as-installed" MLI wrapped ammonia lines.
- IS&AG used photogrammetry to generate a CAD model of the current MLI wrapped surface of the ammonia lines.
- The IS&AG CAD proved that there was positive clearance between the thruster nozzle and the MLI wrapped lines regardless of the berthing configuration.
- The IS&AG produced CAD model of the MLI wrapped ammonia lines will replace the "generalized" model in the master ISS CAD database.

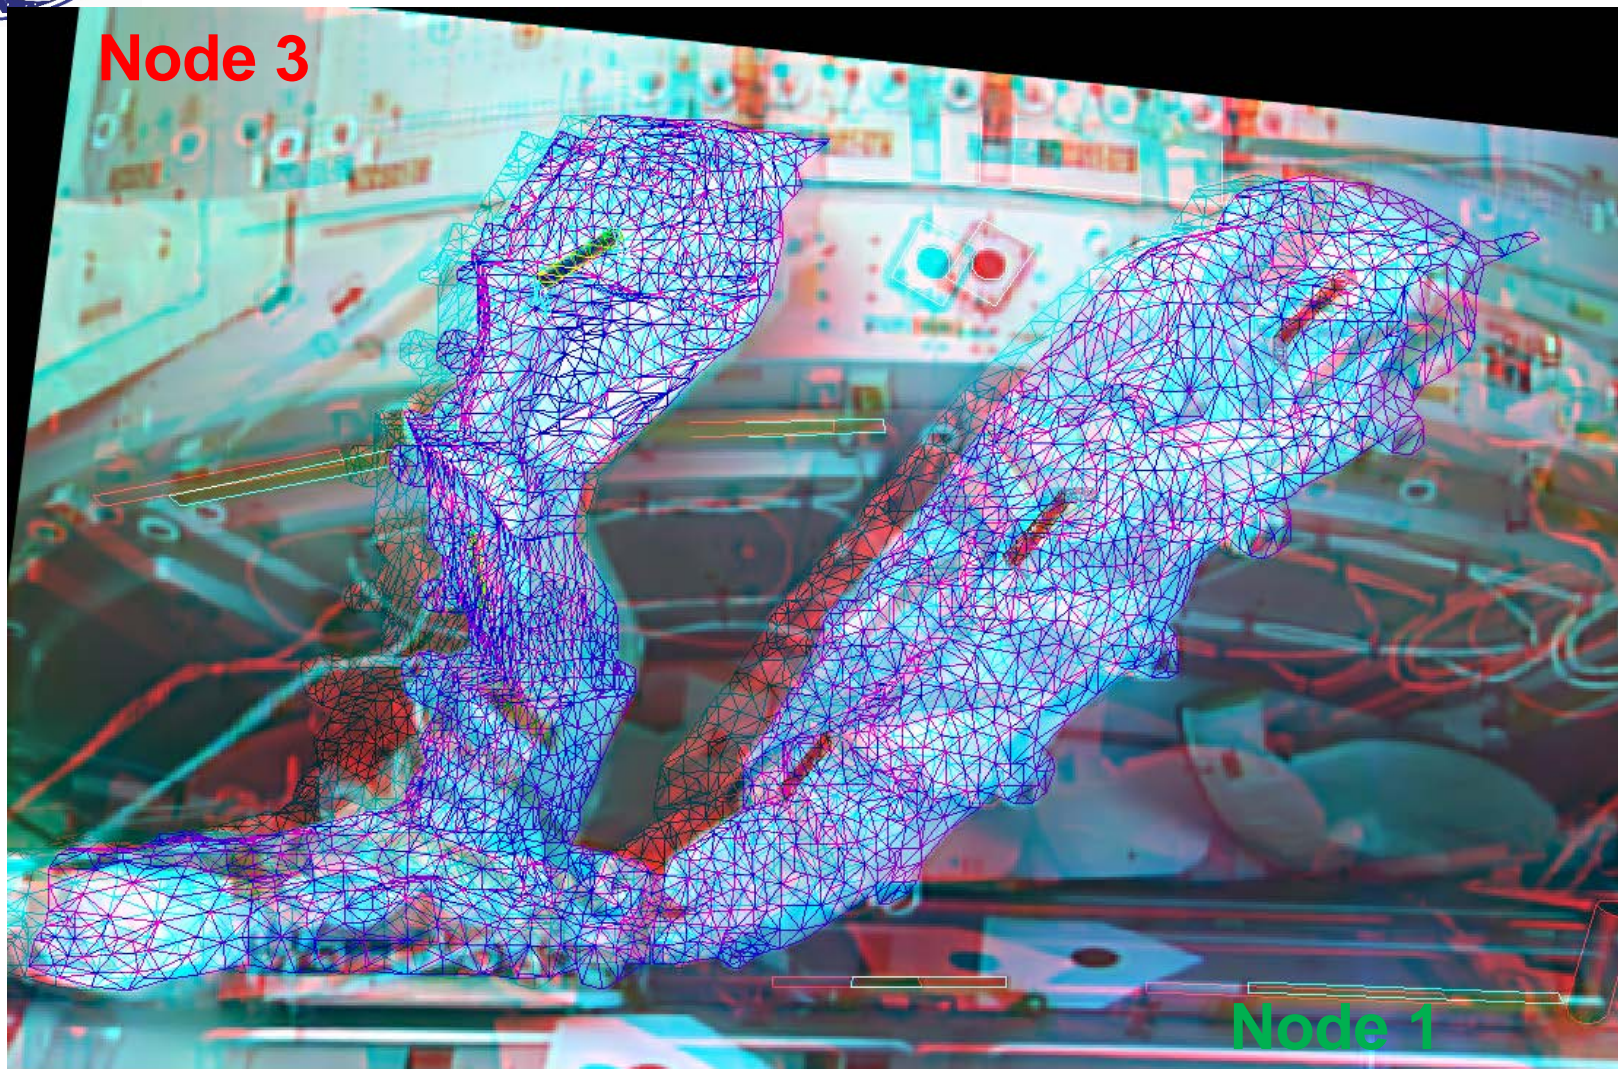
Full CAD Model of On-Orbit Configuration

As this analysis only accounted for a nominal HTV5 berthing configuration, IS&AG then produced a CAD model of the full MLI surface which was used to conduct a clearance analysis for off-nominal berthing configurations.
